Nunavik Abandoned Mineral Exploration Sites Rehabilitation Project

2018-2019 Activity Report

May 2019

Kativik Regional Government
Renewable Resources, Environment, Lands and Parks Department

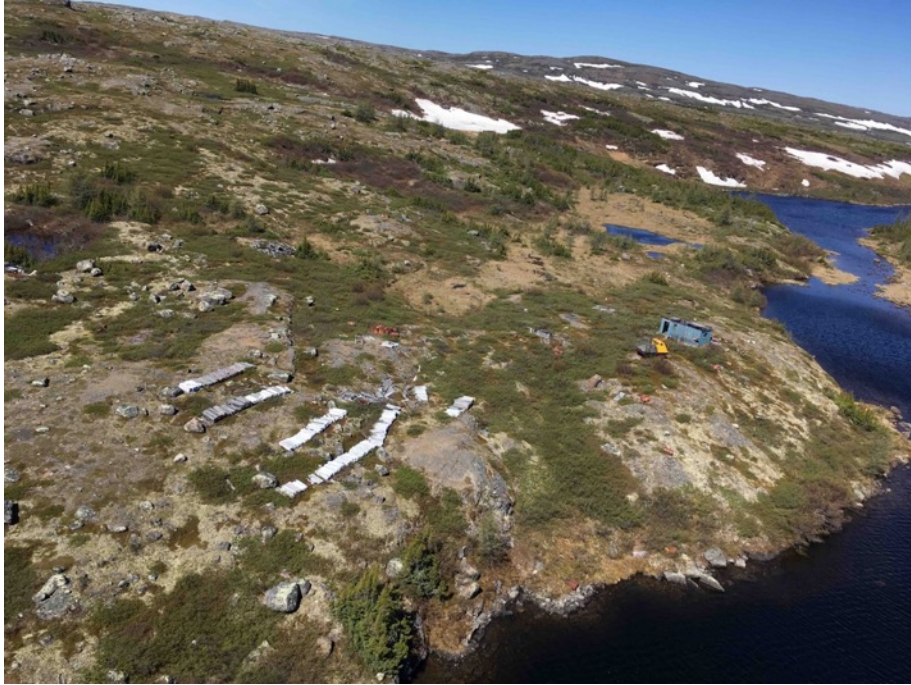
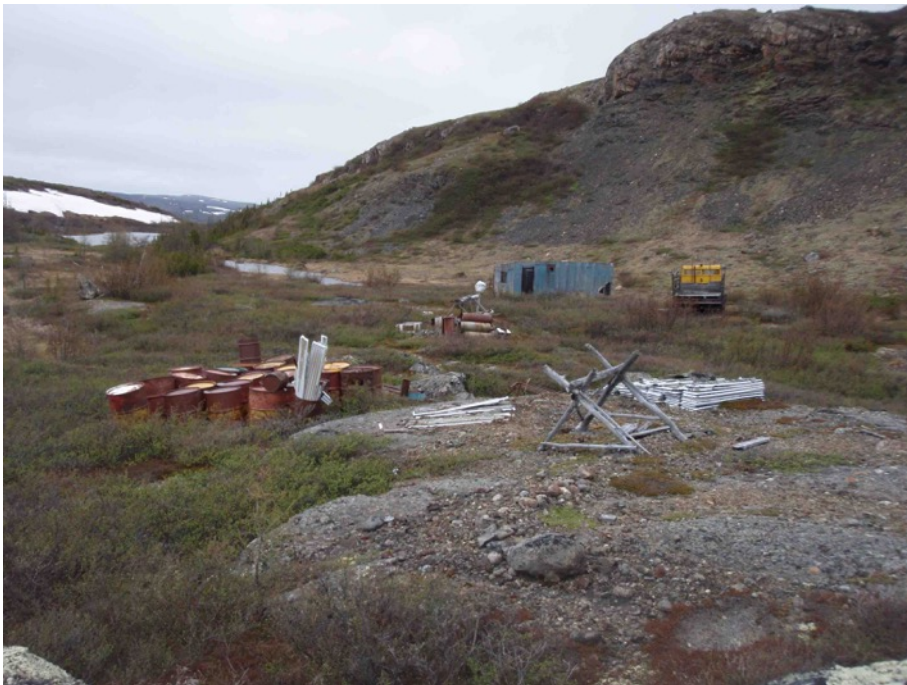
Figure 1 Jordon Lake-1, during inspections, July 2017

Figure 2 Jordon Lake-1, during inspections, July 2017

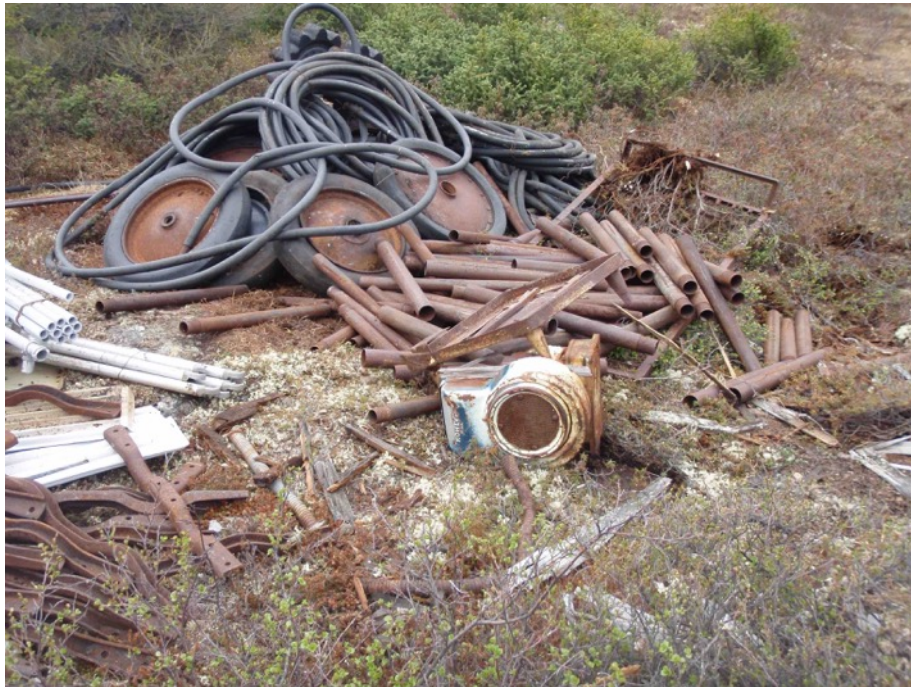
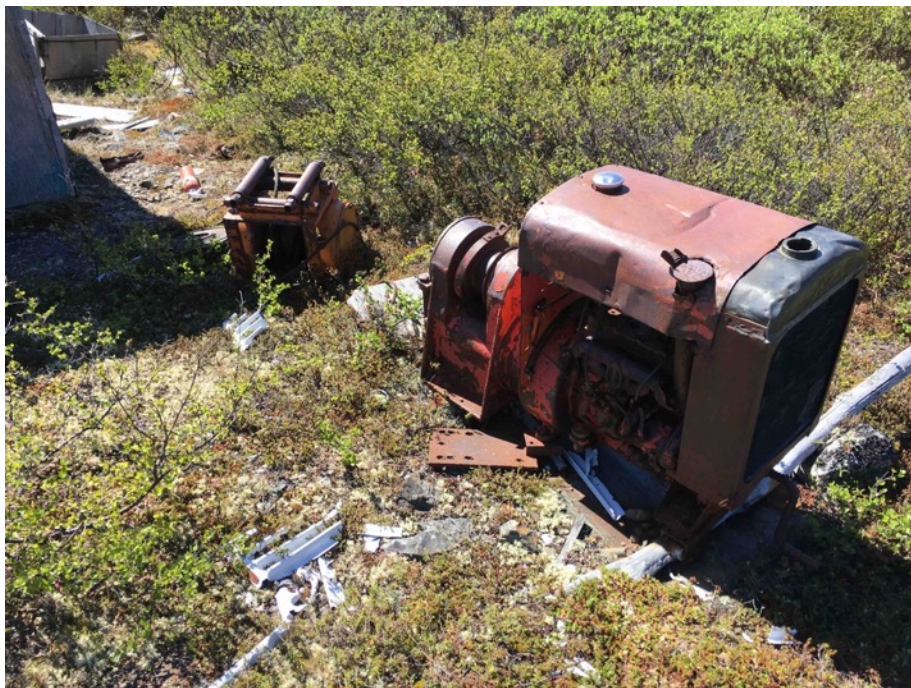
Figure 3 Material collected at Jordon Lake-1 during cleanup, July 2018

Figure 4 Material collected at Jordon Lake-1 during cleanup, July 2018

Approximately 12,000 pounds of material was transported to Kuujjuaq by helicopter and stored in a marine container that will be shipped in 2019. Additionally, non-toxic combustible material, notably the small building and wood debris were burned on site. Jordon Lake-1 is considered as partially complete due to the fact that there remains a muskeg on site. Photos of this work and remaining material, including a large volume of core samples and trays, can be found in Appendix 3.

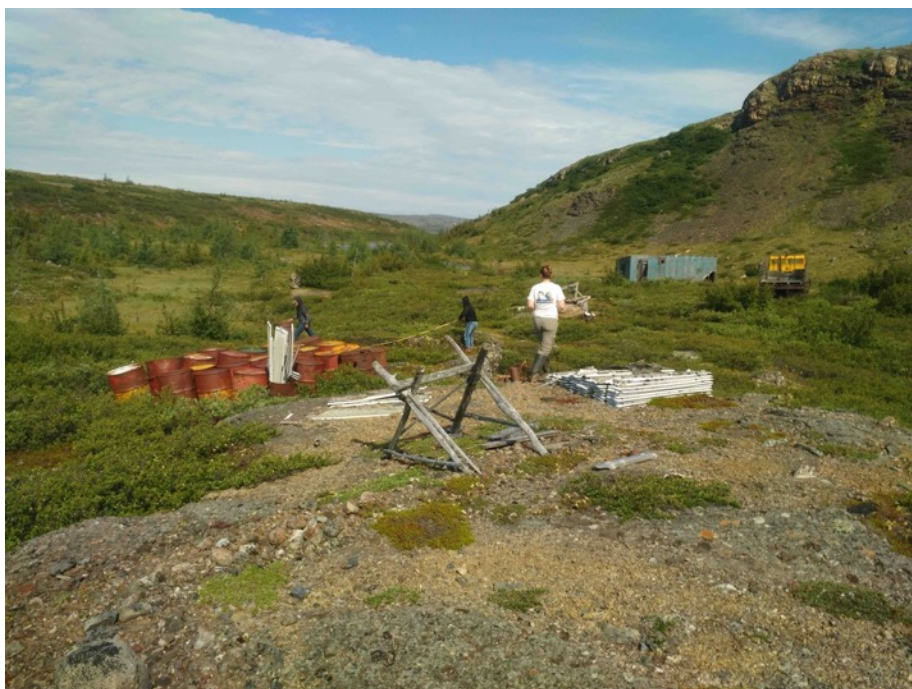
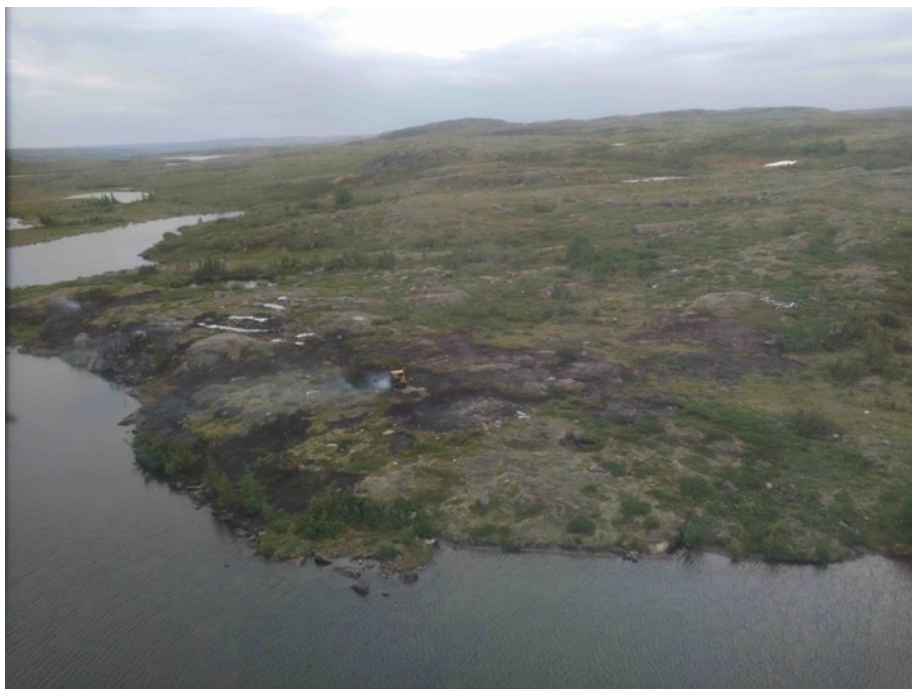
Figure 5 Jordon lake-1 during rehabilitation activities, July 2018

Figure 6 Jordon Lake-1 after rehabilitation activities, July 2018

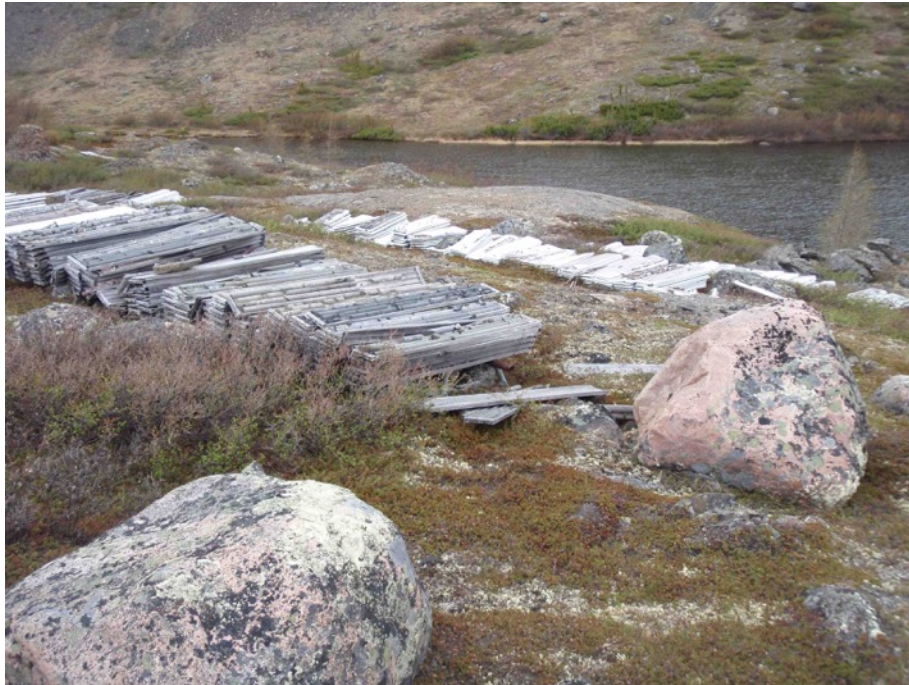
Figure 7 Core trays remaining on site Jordon Lake-1, July 2018

Following rehabilitation activities that occurred in July 2018, there remains a small amount of debris from burning the non-toxic combustible material on site as well as a muskeg. In 2019, KRG will need to coordinate with the Northern Village of Kuujjuaq a two-day field work campaign. This work will involve collecting and packaging the debris as well as using a mobile welding machine and necessary equipment to cut and disassemble the muskeg so that it, and the debris, can be safely transported to Kuujjuaq by helicopter. This material will then be properly stored in a marine container already located in the community and prepared for shipment to a waste recovery facility.

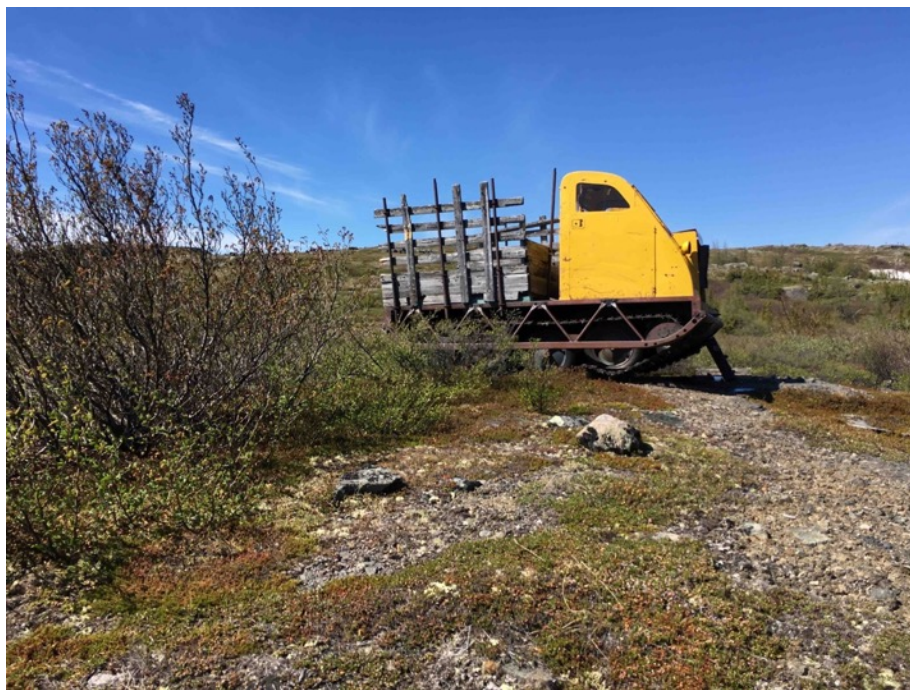
Figure 8 Muskeg remaining at Jordon Lake-1, July 2018

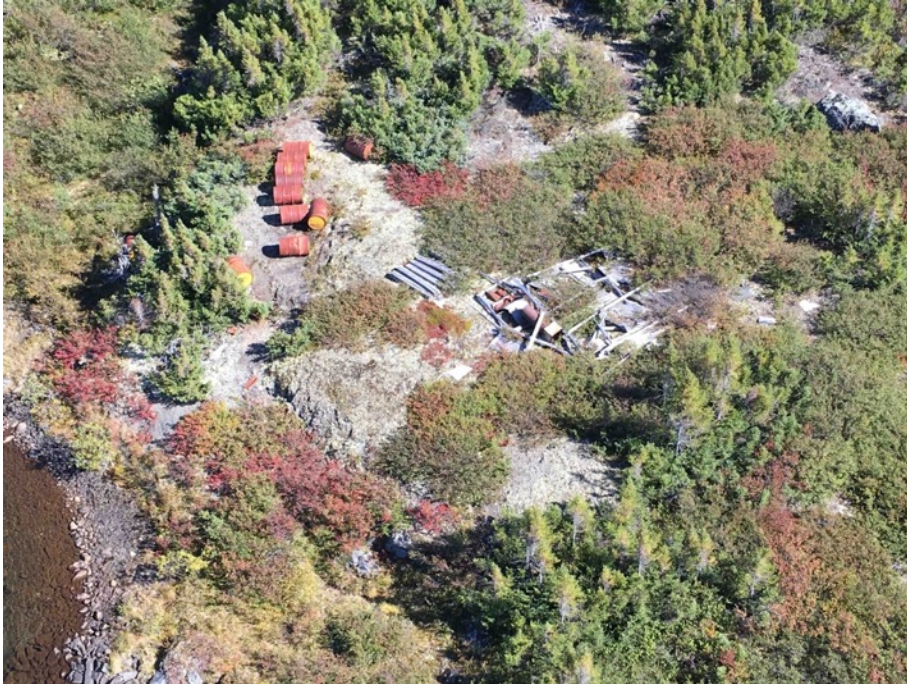
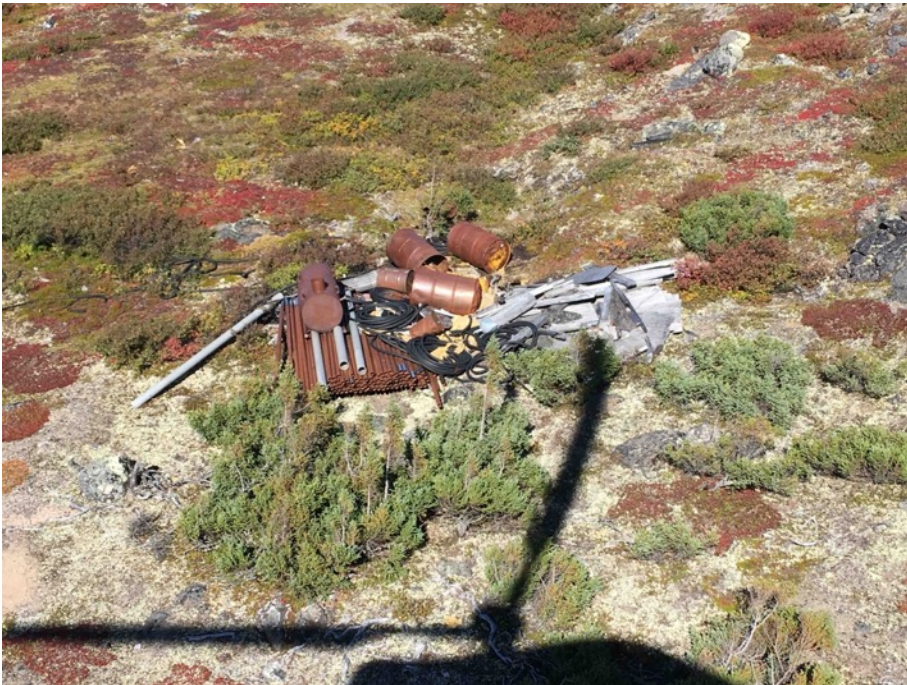
Figure 9 Jordon Lake-3 during inspections, July 2017

Figure 10 Jordon Lake-3 during inspections, July 2017

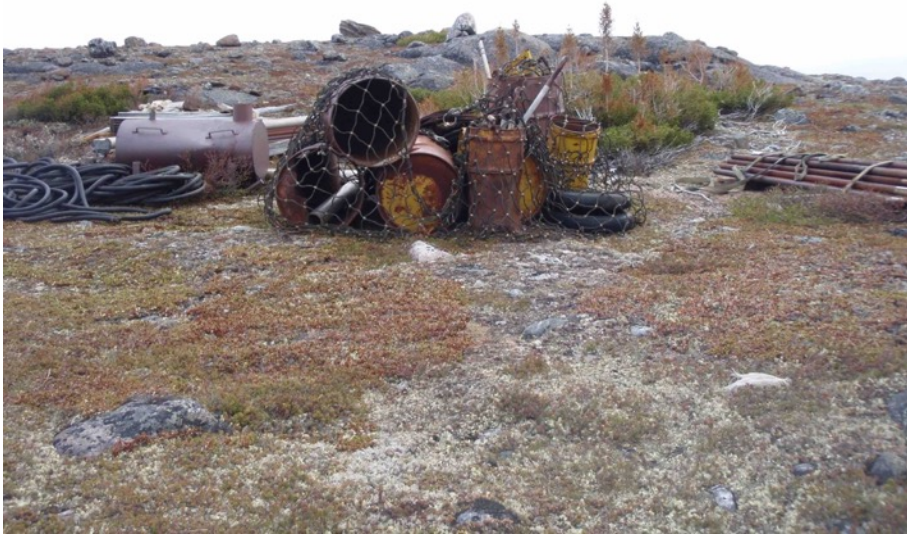
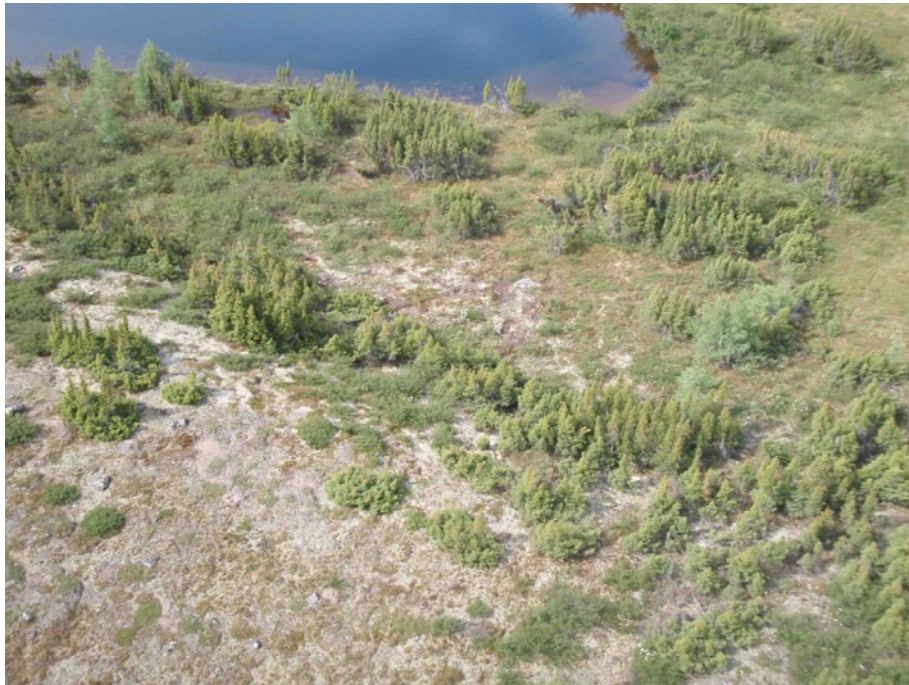
Approximately 8,650 pounds of material was transported to Kuujjuaq by helicopter and stored in a marine container that will be shipped in 2019. Additionally, non-toxic combustible material, notably wood debris was collected into a pile to be burned on site. Jordon Lake-3 is considered as

Figure 11 Jordon Lake-3 during rehabilitation activities, July 2018

Figure 12 Jordon Lake-3 after rehabilitation activities, July 2018

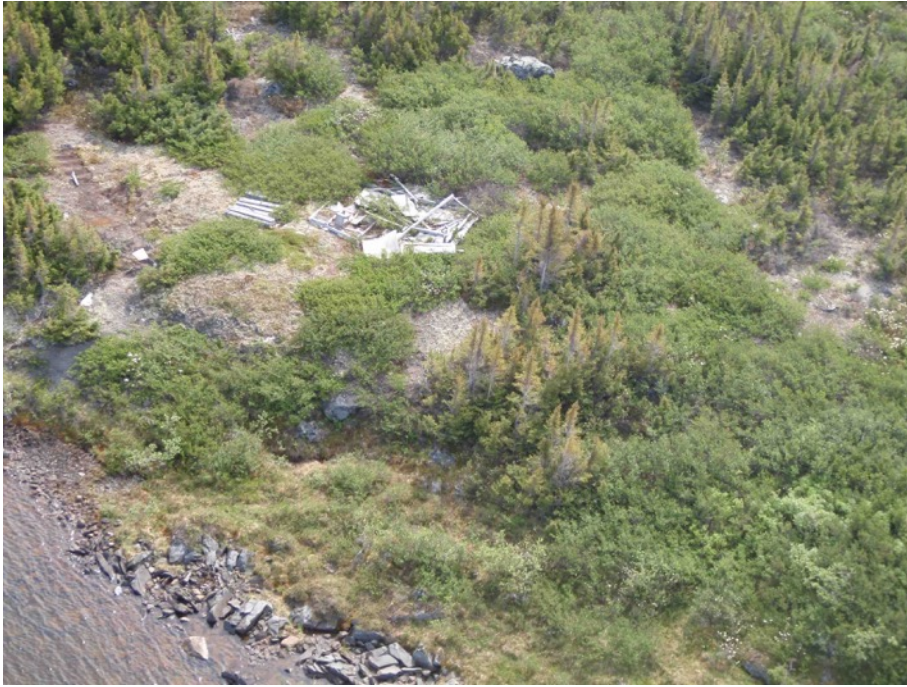
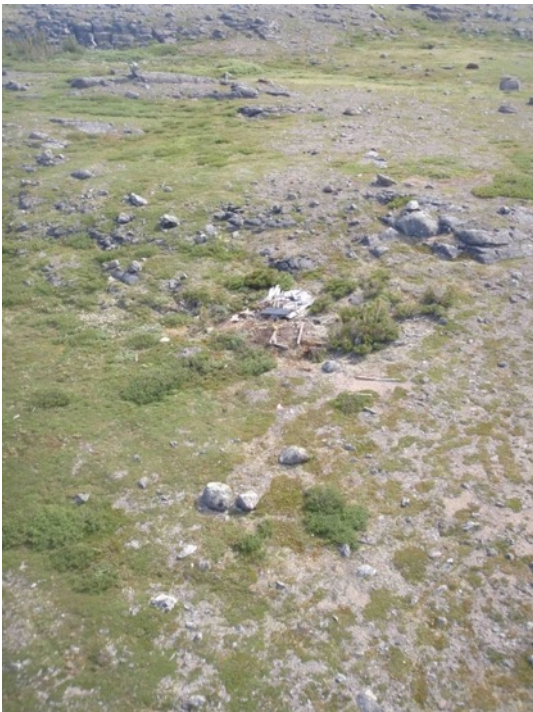
partially complete due to the remaining wood debris on site. Photos of this work and remaining material, can be found in Appendix 3.

Figure 13 Wood debris remaining at Jordon Lake-3, July 2018

Figure 14 Wood debris remaining at Jordon Lake-3, July 2018

Following rehabilitation activities that occurred in July 2018, there remains a small amount of non-toxic combustible material on site. In 2019, KRG will need to coordinate with the Northern Village of Kuujjuaq a short field work campaign that will involve burning the debris. This can be done in tandem with work planned at Jordon Lake-2 due to their proximity to each other. If this work cannot be realized in 2019 and bearing in mind the debris remaining poses no immediate risk to the environment, the site can be left as is and considered as complete.

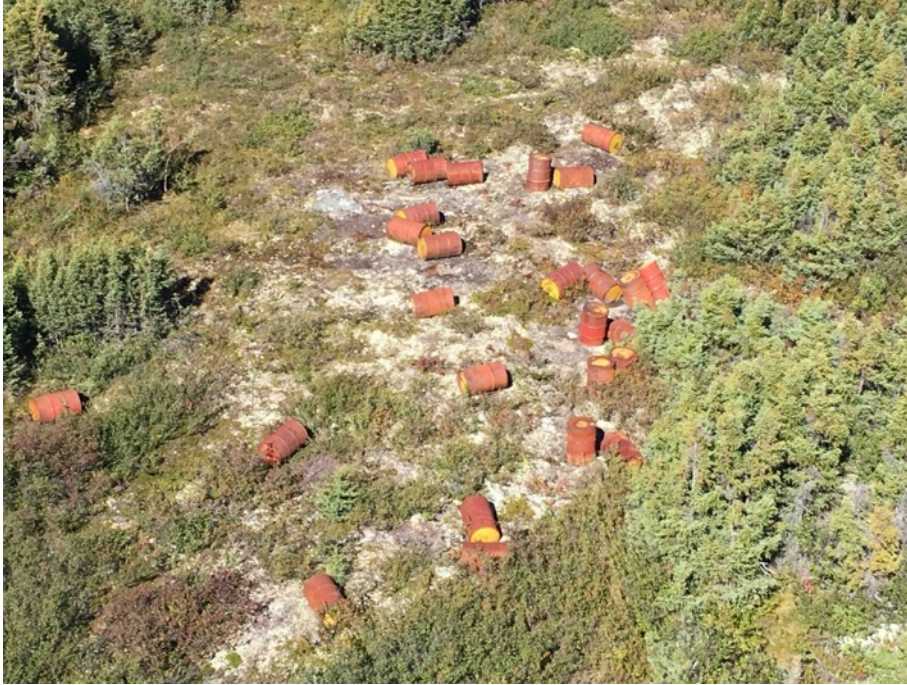
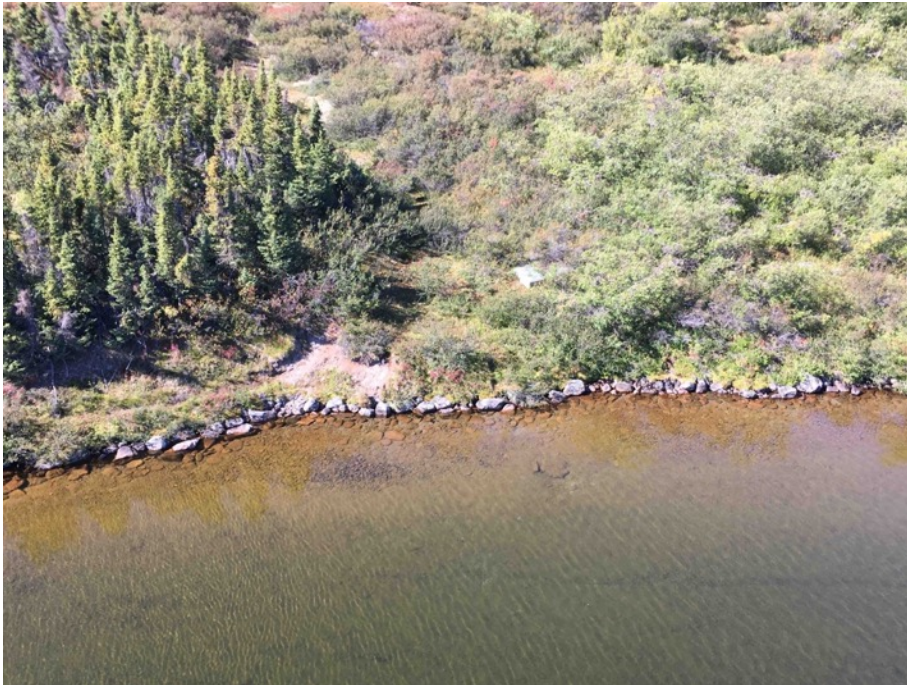
Figure 15 Jordon Lake-4 during inspections, July 2017

Figure 16 Jordon Lake-4 during inspections, July 2017

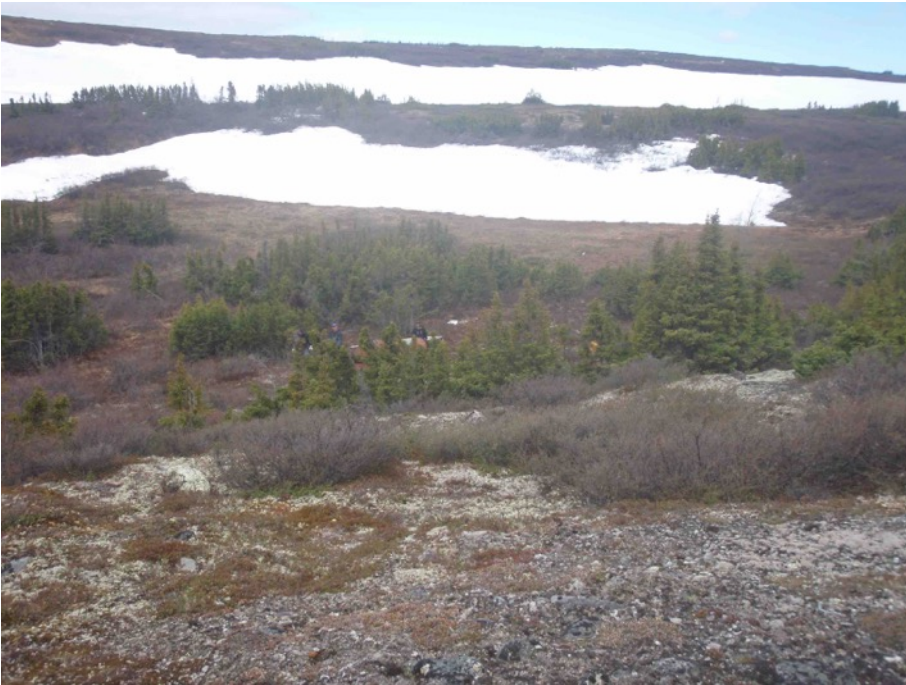
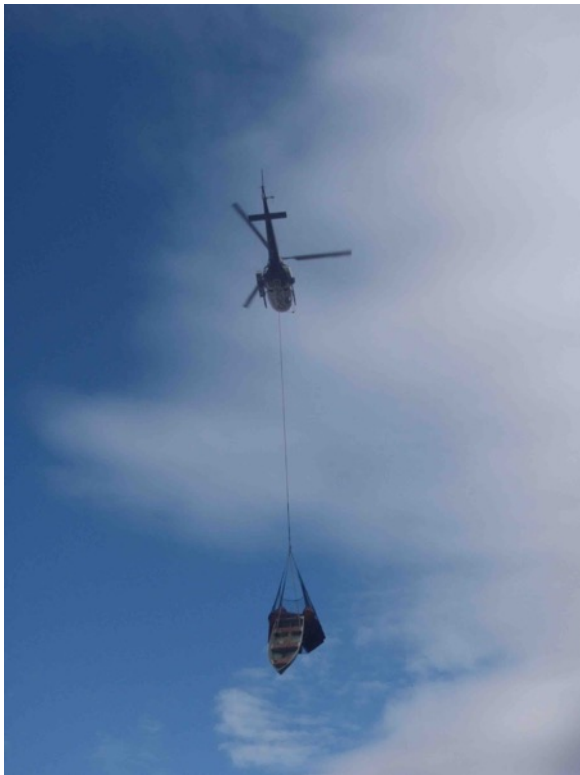
Figure 17 Jordon Lake-4 during rehabilitation activities, July 2018

Figure 18 Jordon Lake-4 during rehabilitation activities, July 2018

Approximately 4,200 pounds of material was transported to Kuujjuaq by helicopter and stored in a marine container that will be shipped in 2019. Jordon Lake-4 is considered as complete. Photos of this work can be found in Appendix 3.

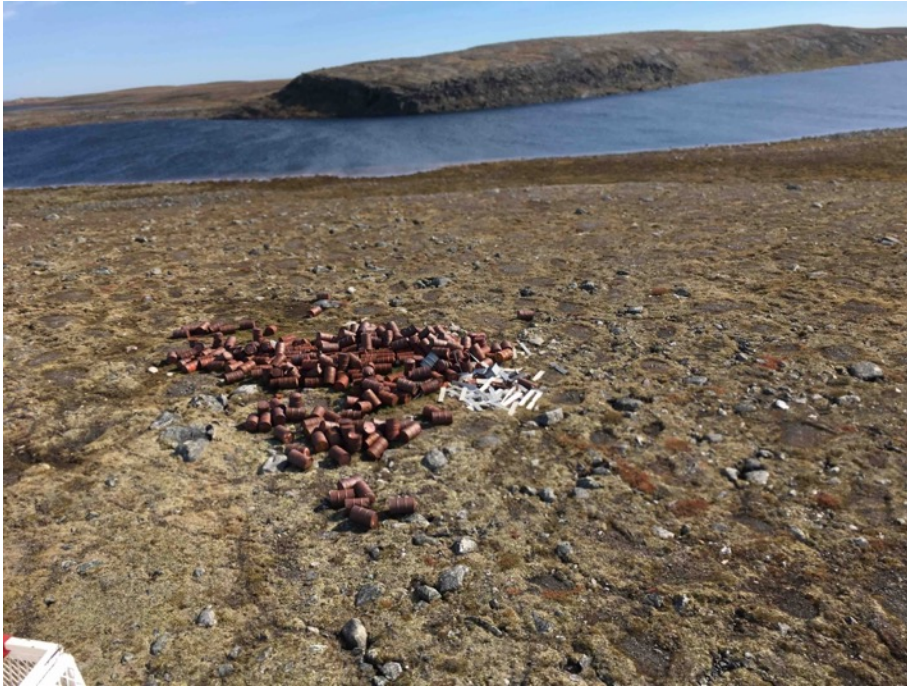
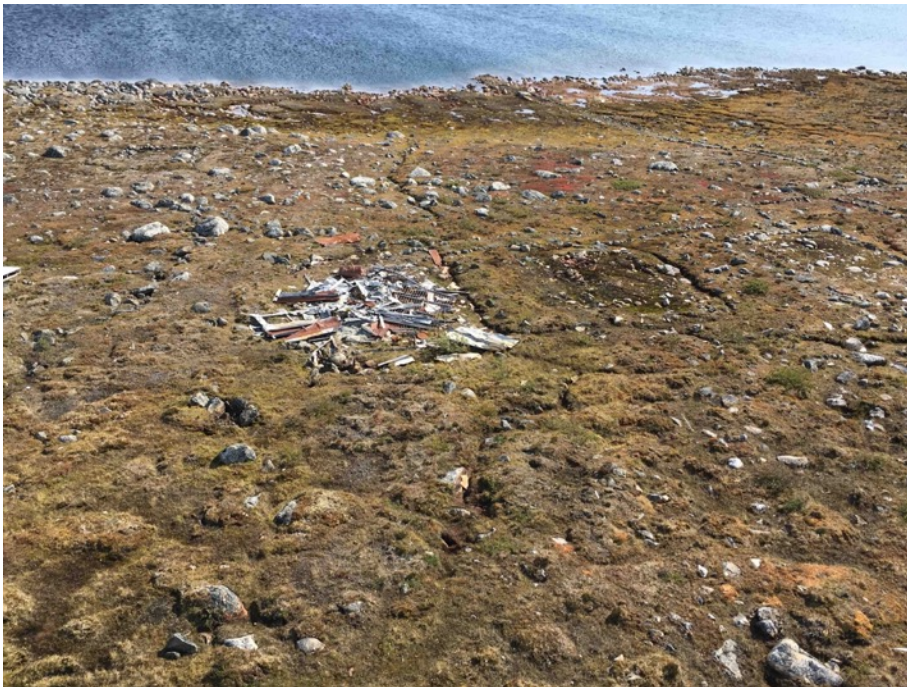
- 192 drums (empty, crushed);
- 1 drum (with fluid);
- 1 small boat
- Metal debris: Aluminum core trays, 2 rill rods, rusty drums

Figure 19 *KG-1 during inspections, July 2017*

Figure 20 *KG-1 during inspections, July 2017*

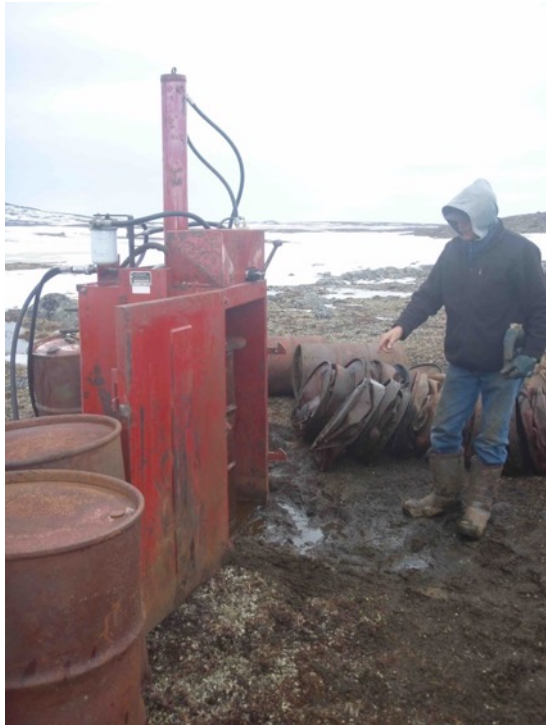
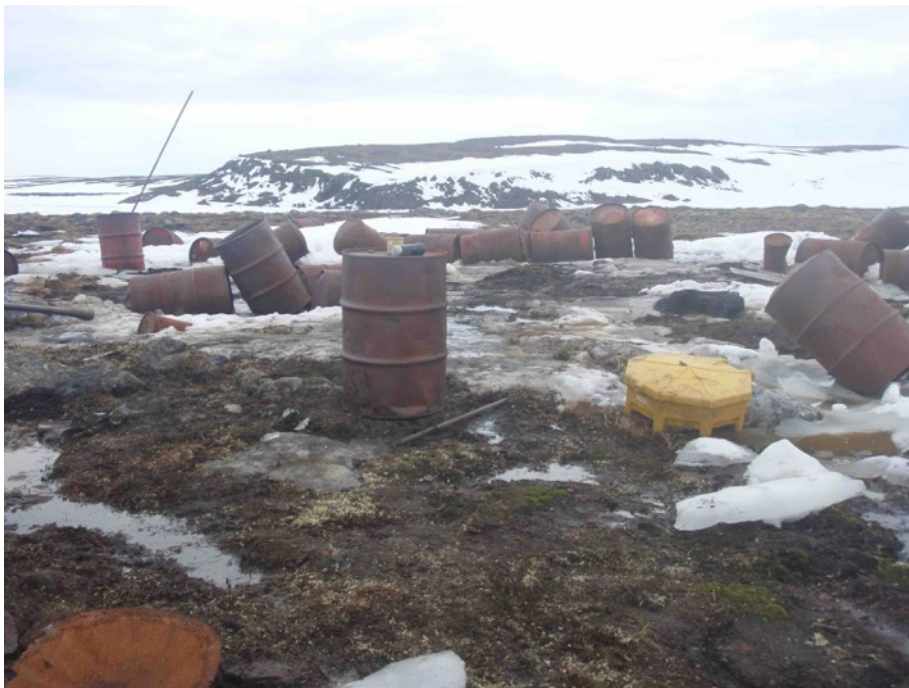
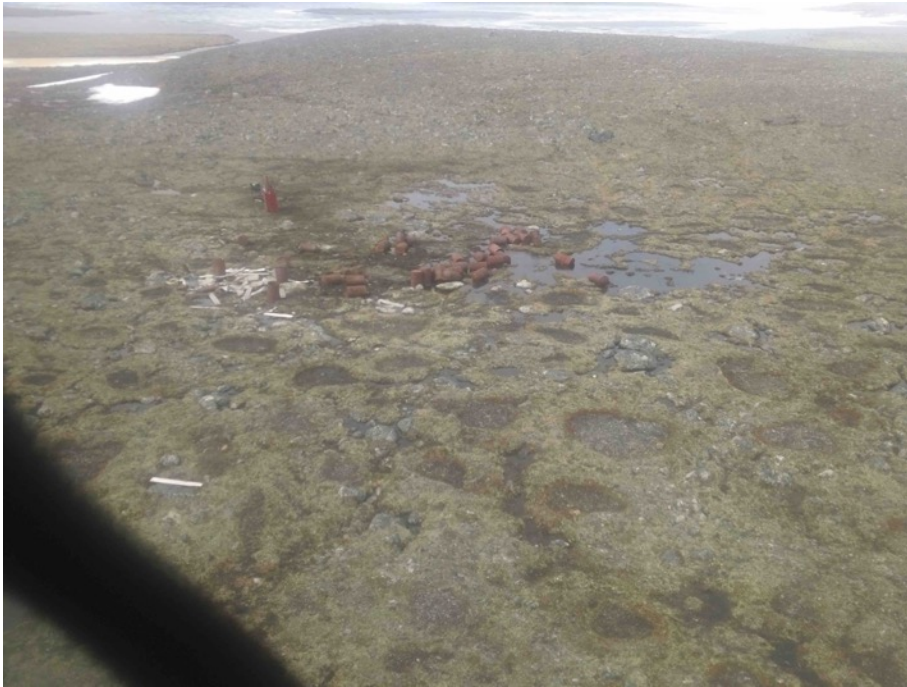
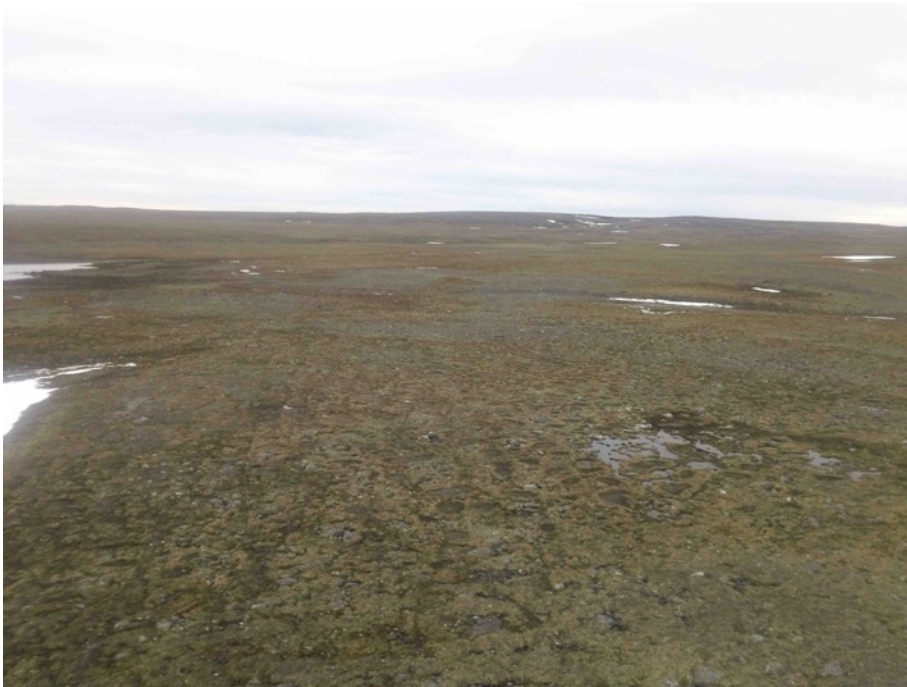
Figure 21 KG-1 during rehabilitation activities, June 2018

Figure 22 KG-1 during rehabilitation activities, June 2018

Figure 23 KG-1 during rehabilitation activities, July 2018

Figure 24 KG-1 after rehabilitation activities, July 2018

Approximately 19,000 pounds of material was transported to Kangirsuk by helicopter and stored in a marine container that was shipped to a recovery facility in southern Québec in October 2018. KG-1 is considered as complete. Photos of this work can be found in Appendix 3.

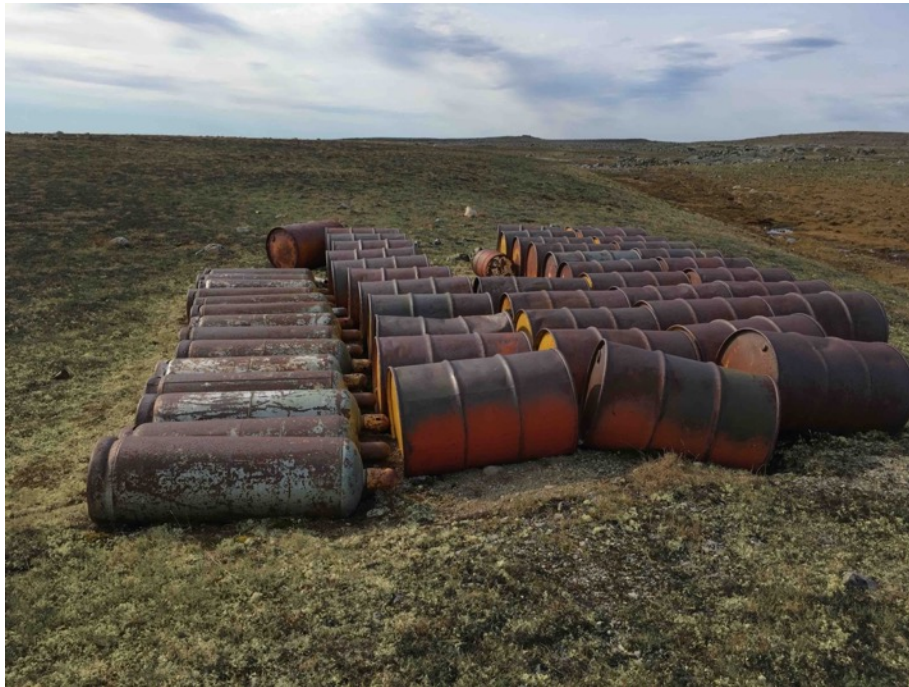
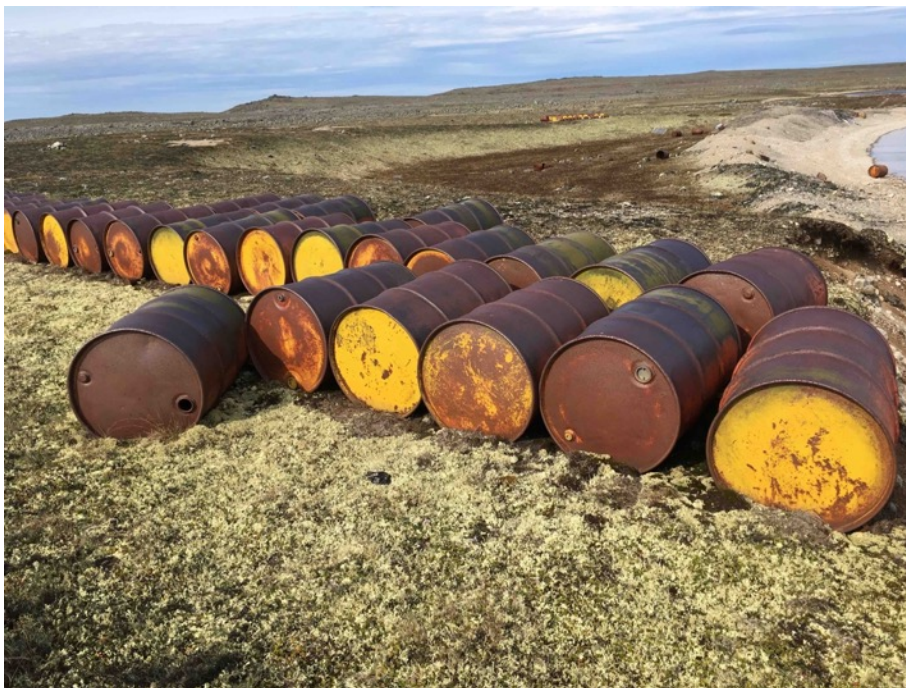
Figure 25 KG-2 during inspections, July 2017

Figure 26 KG-2 during inspections, July 2017

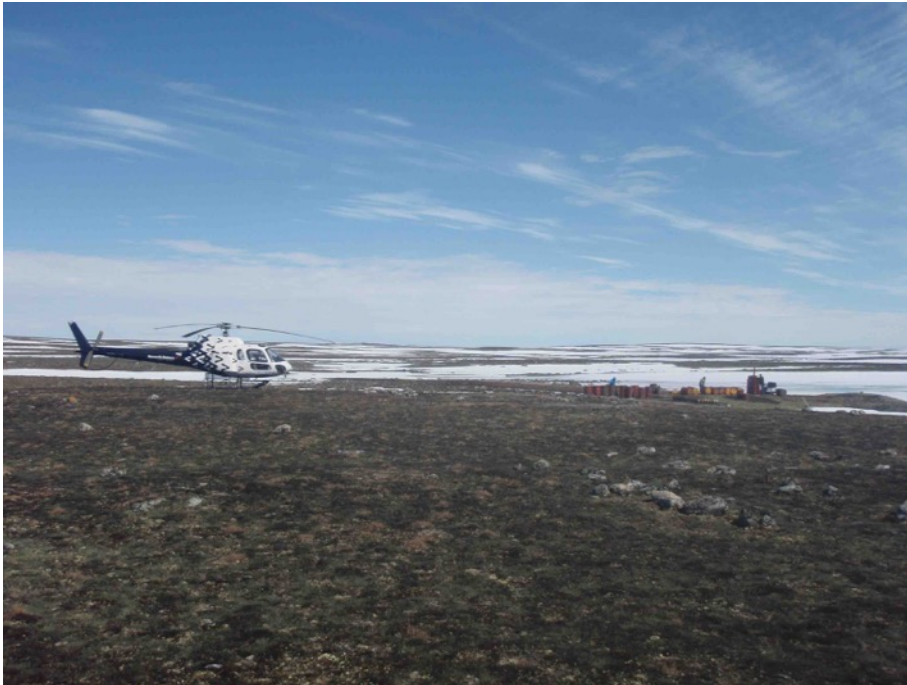
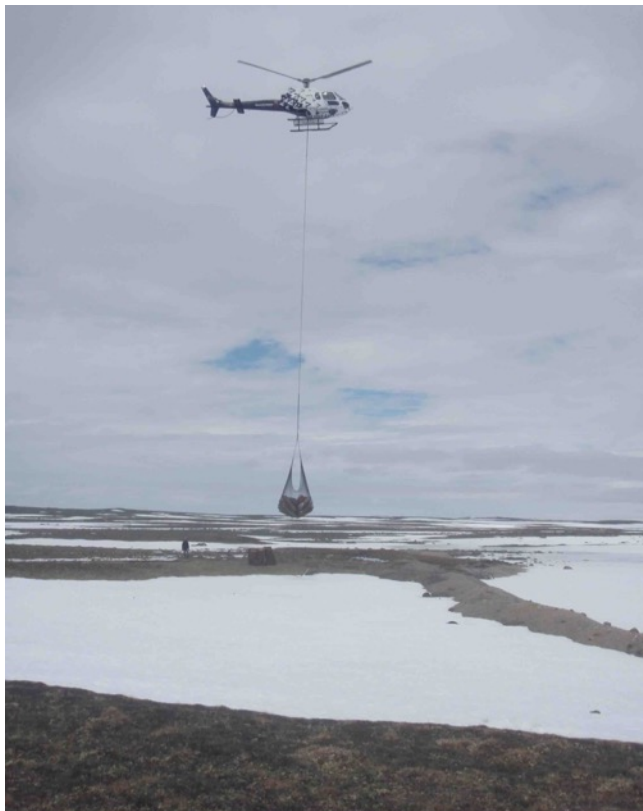
Figure 27 KG-2 during rehabilitation activities, June 2018

Figure 28 KG-2 during rehabilitation activities, June 2018

Approximately 10,000 pounds of material was transported to Kangirsuk by helicopter and stored in a marine container that was shipped to a recovery facility in southern Québec in October 2018. The propane tanks, drums with fluids and batteries removed from sites KG-1 and KG-2 are considered as hazardous waste and cannot be shipped in a marine container. They will be properly packaged and transported by ship in 2019. Details concerning this work can be found in section 7 of the document. KG-2 is considered as complete. Photos of this work can be found in Appendix 3.

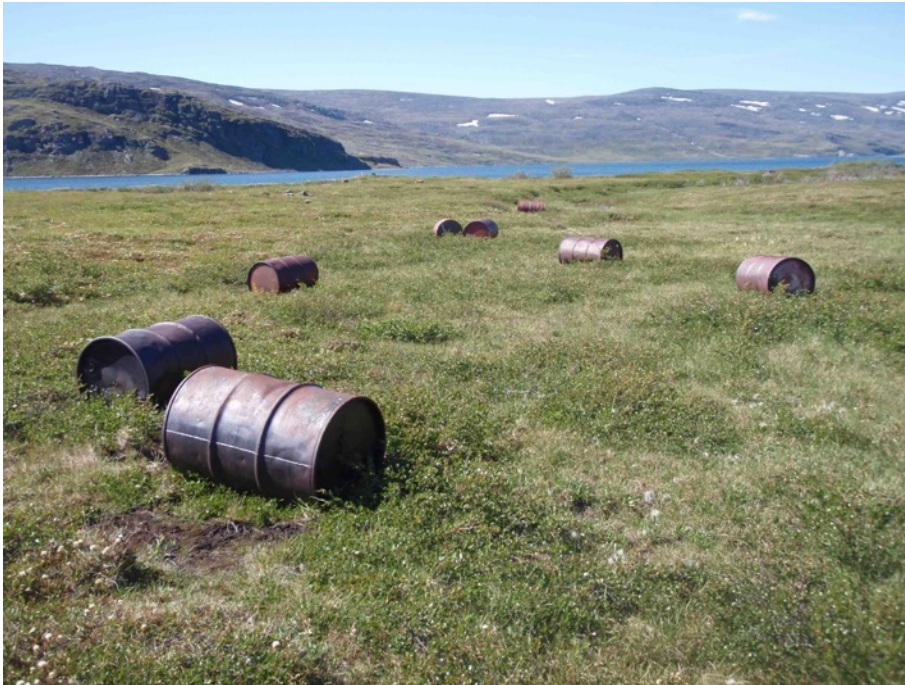
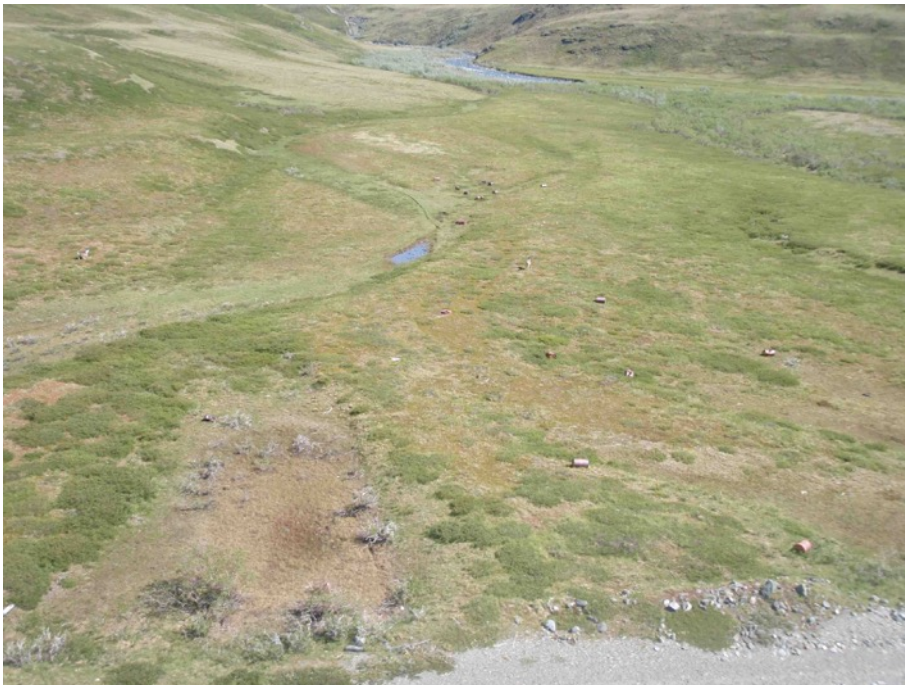
Figure 29 Watts Lake-1 during rehabilitation activities, July 2018

Figure 30 Watts Lake-1 during rehabilitation activities (with caribou), July 2018

This material was transported to Salluit by helicopter where it was treated Orford Mining at their storage facility in the community. The material was transported to a recovery facility in southern Québec in October 2018 by way of in-kind contribution. Watts Lake-1 is considered as complete. Photos of this work can be found in Appendix 3.

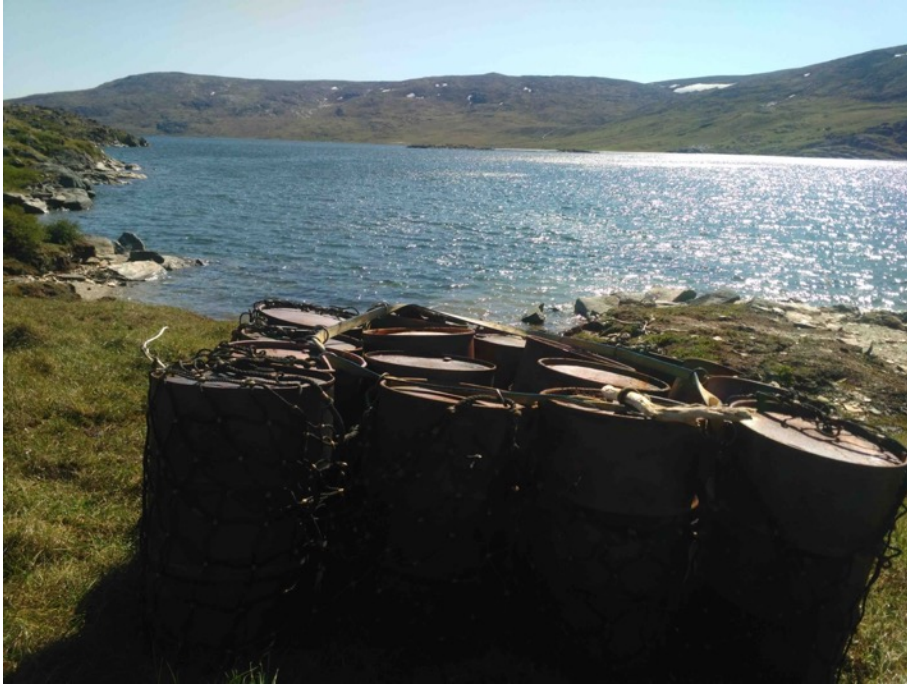
Figure 31 Watts Lake-2 during rehabilitation activities, July 2018

This material was transported to Salluit by helicopter where it was treated Orford Mining at their storage facility in the community. The material was then transported to a recovery facility in southern Québec in October 2018 by way of in-kind contribution. Watts Lake-2 is considered as complete. Photos of this work can be found in Appendix 3.

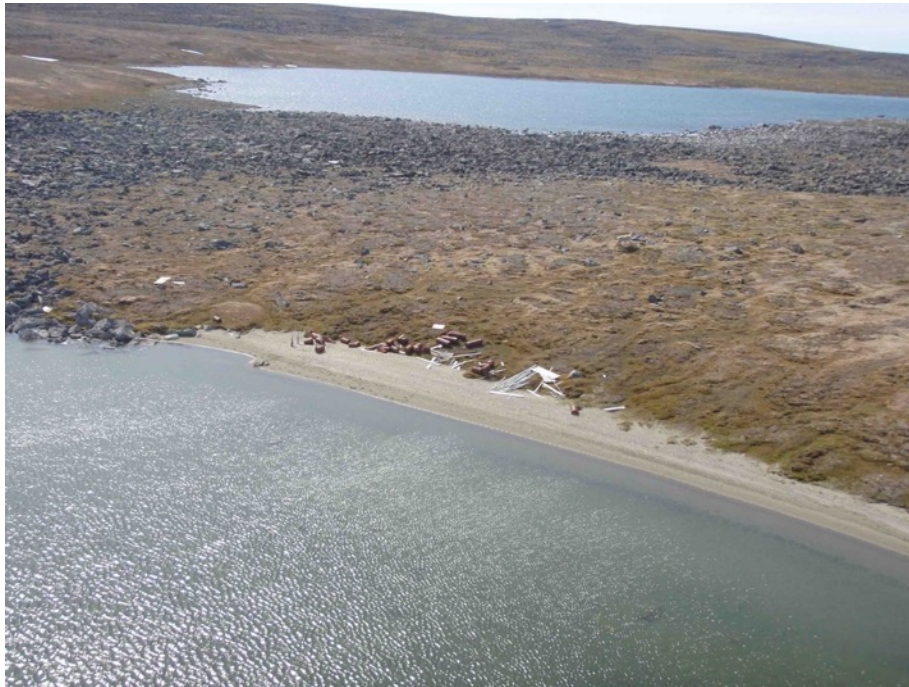
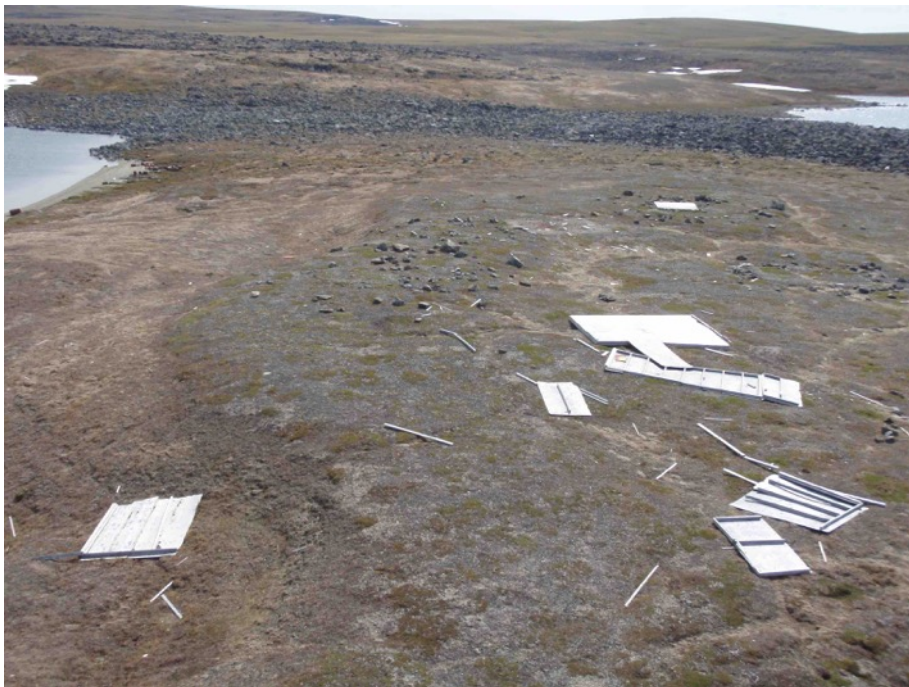
Figure 32 SW-27C during inspections, July 2017

Figure 33 SW-27C during inspections, July 2017
