Nunavik Abandoned Mineral Exploration Sites Rehabilitation Project

2018-2019 Activity Report

May 2019

Kativik Regional Government
Renewable Resources, Environment, Lands and Parks Department

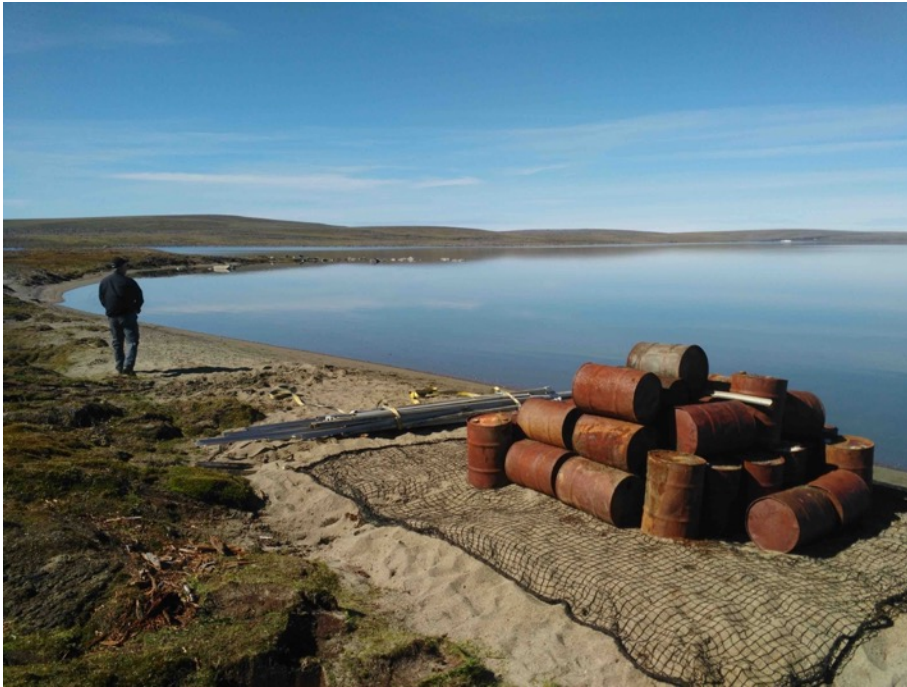
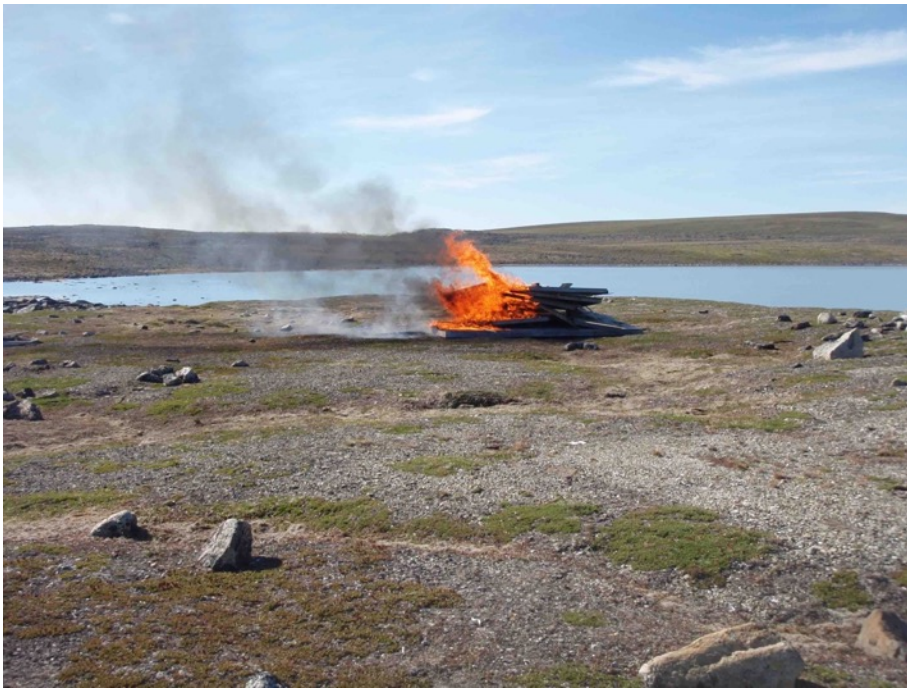
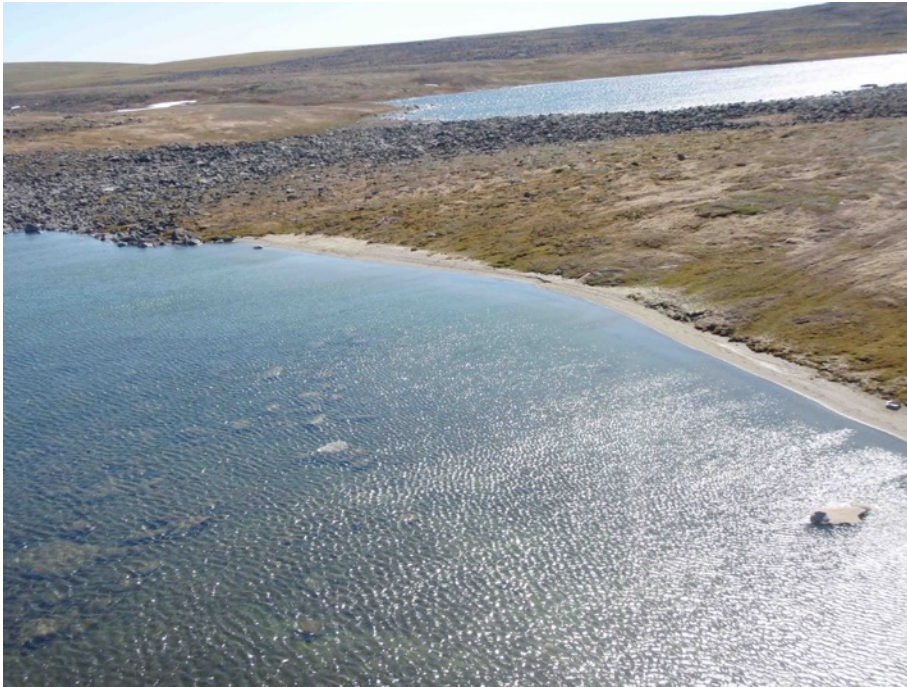
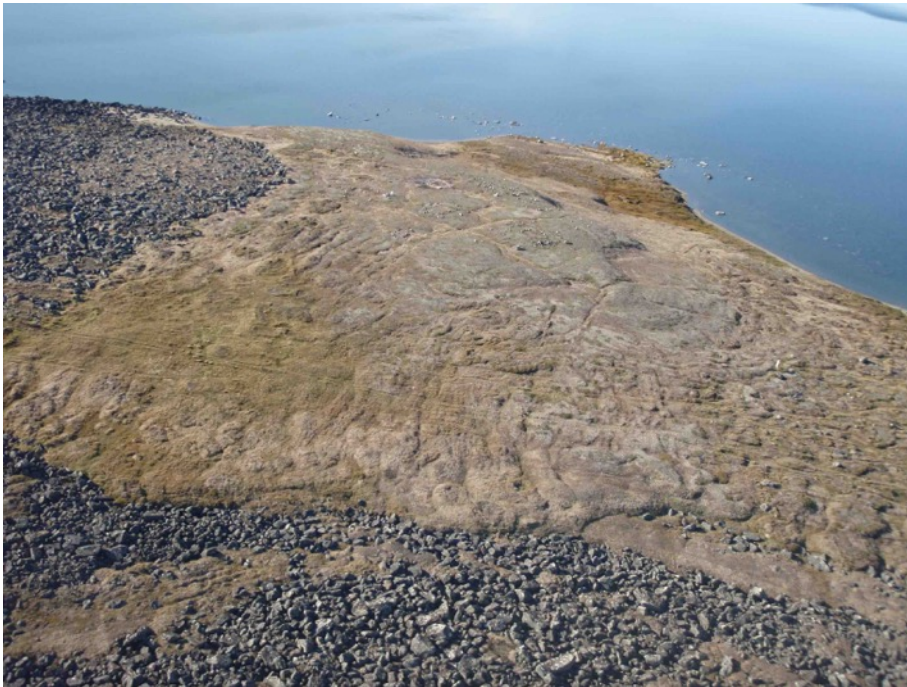
Figure 34 *SW-27C during rehabilitation activities, July 2018*

Figure 35 *SW-27C during rehabilitation activities, July 2018*

Figure 36 SW-27C after rehabilitation activities, July 2018

Figure 37 SW-27C after rehabilitation activities, July 2018

This material (approximately 1,450 pounds) was transported to Salluit by helicopter where it was treated by Orford Mining at their storage facility in the community. The material was then transported to a recovery facility in southern Québec by ship in October 2018 by way of in-kind contribution. A small pile of non-toxic combustible material, mostly wood, was burned on site. SW-27C is considered as complete. Photos of this work can be found in Appendix 3.

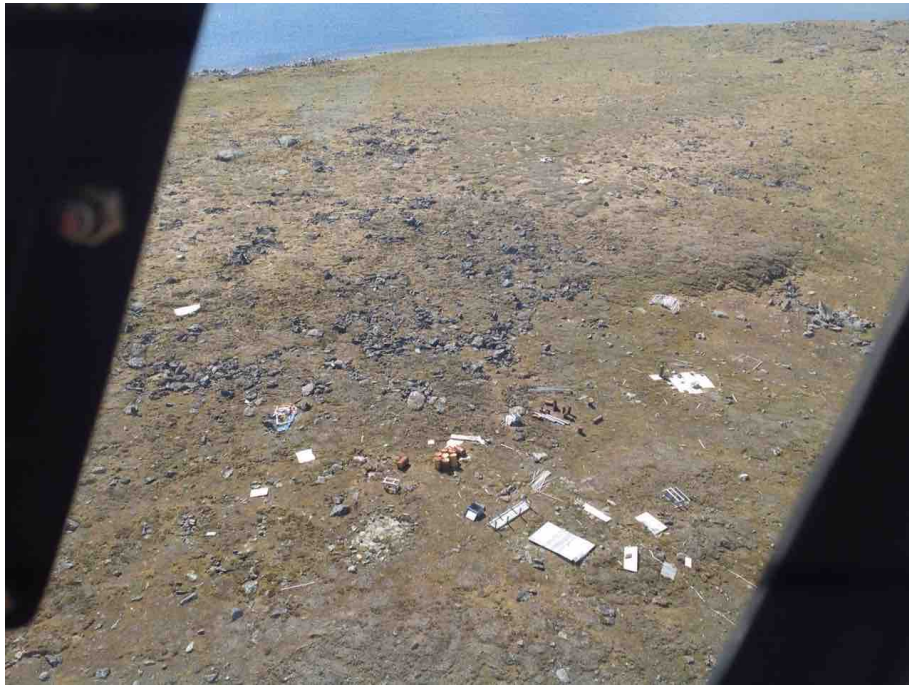
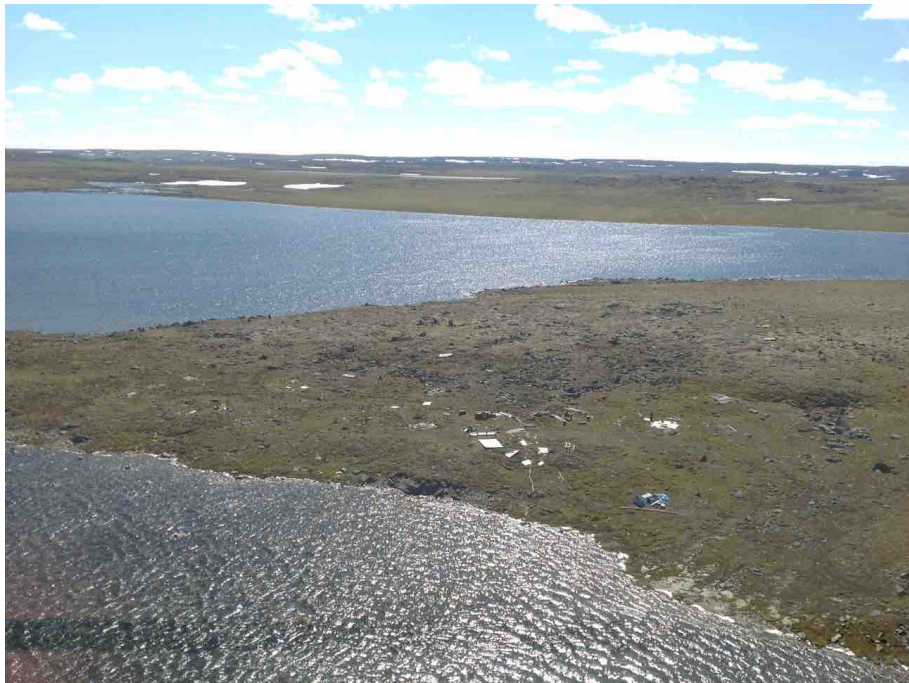
Figure 38 SW-27D during inspections, July 2017

Figure 39 SW-27D during inspections, July 2017

This material (approximately 3,950 pounds) was transported to Salluit by helicopter where it was treated by Orford Mining at their storage facility in the community. The material was then transported to a recovery facility in southern Québec by ship in October 2018 by way of in-kind contribution. A large volume of non-toxic combustible material, mostly wood, was burned on site. SW-27D is considered as complete. Photos of this work can be found in Appendix 3.

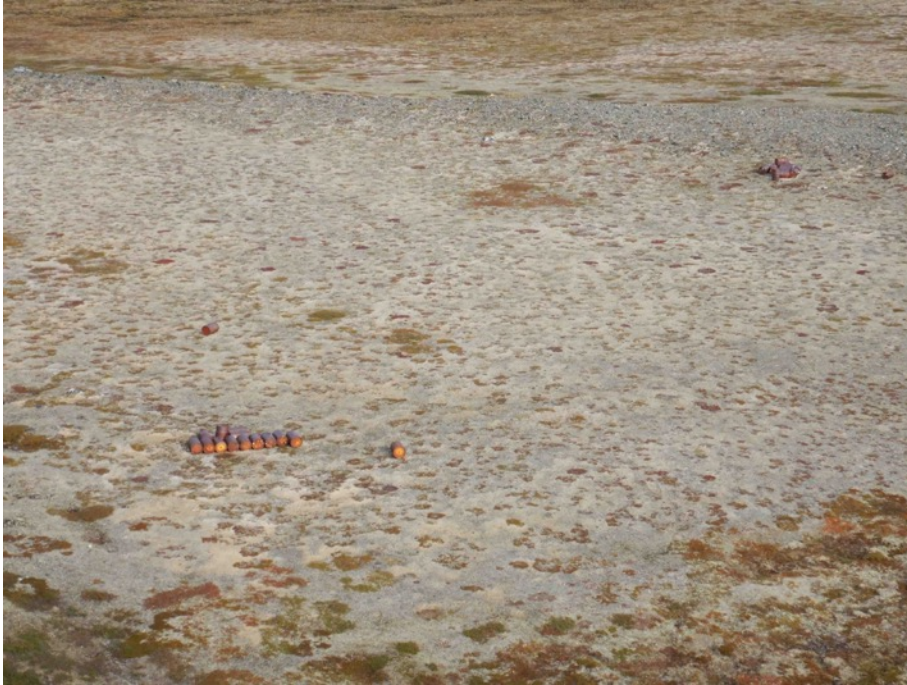
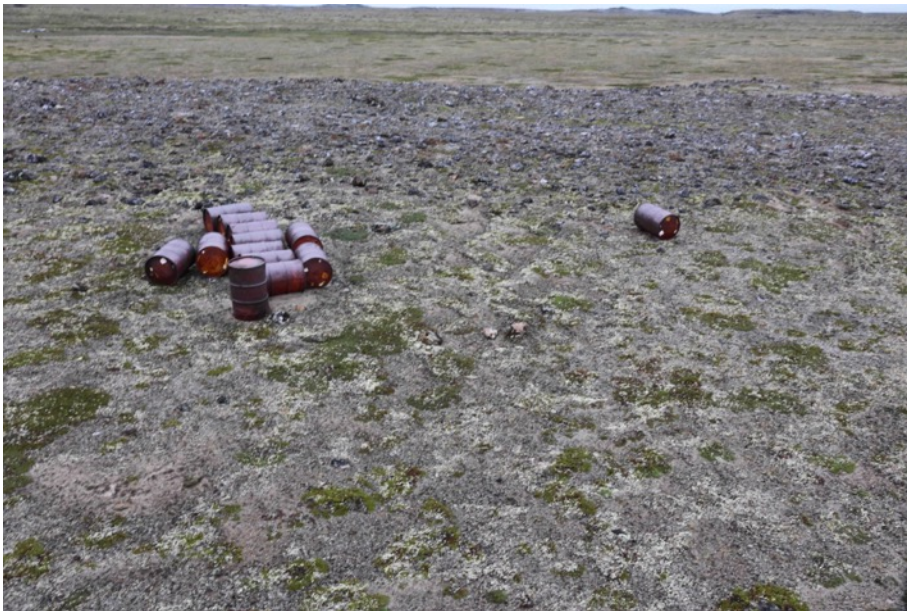
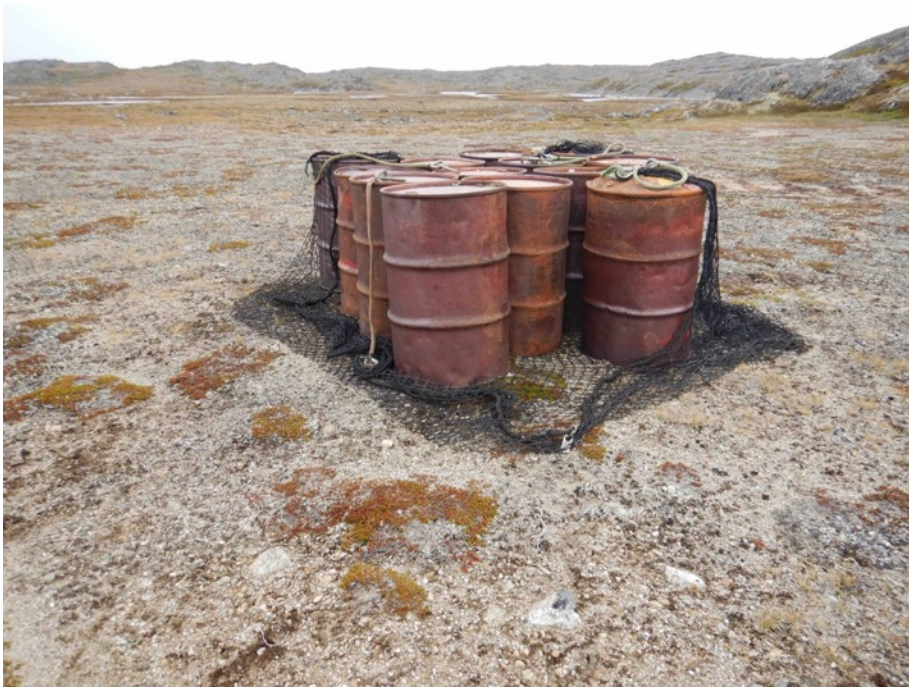
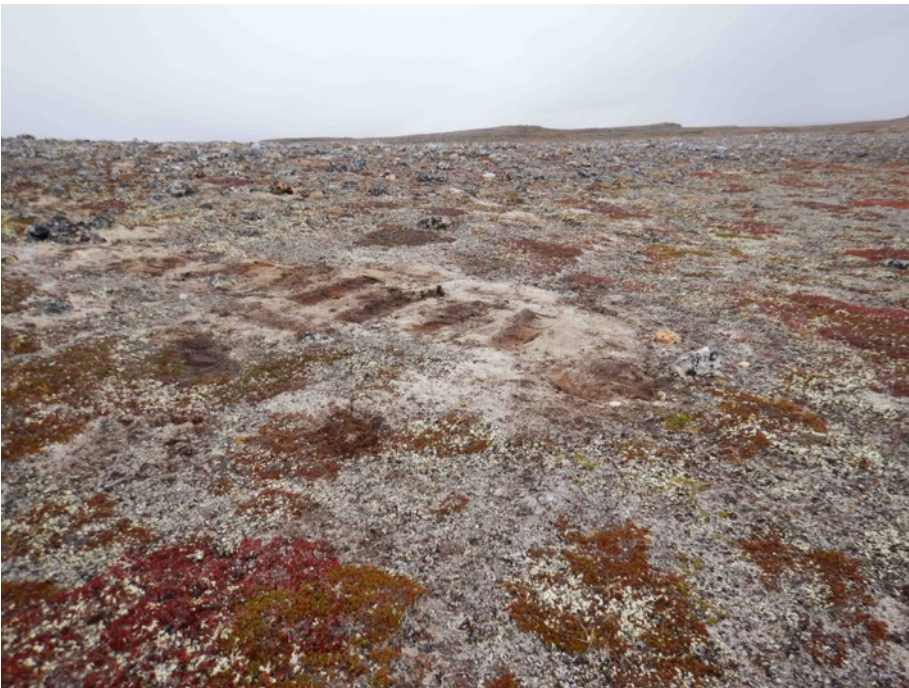
Figure 40 GR-1 before rehabilitation activities, September 2018

Figure 41 GR-1 before rehabilitation activities, September 2018

Figure 42 GR-1 during rehabilitation activities, September 2018

Figure 43 GR-1 after rehabilitation activities, September 2018

Approximately 3,400 pounds of material was transported to an airstrip, located a Waymouth outfitting camp by helicopter where it is currently stored and will be treated in 2019. A description of this work is provided in section 7 of the document. GR-1 is considered as complete. Photos of this work can be found in Appendix 3.

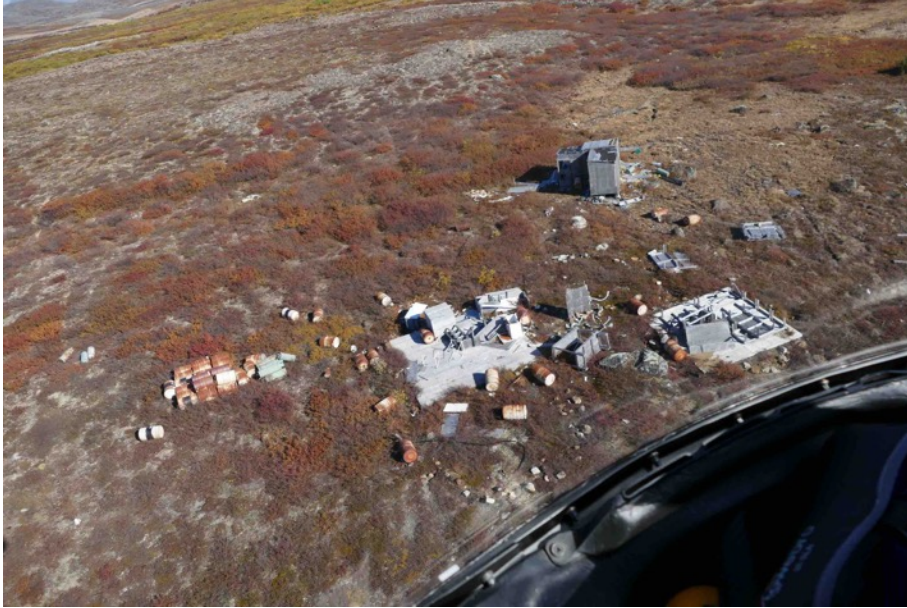
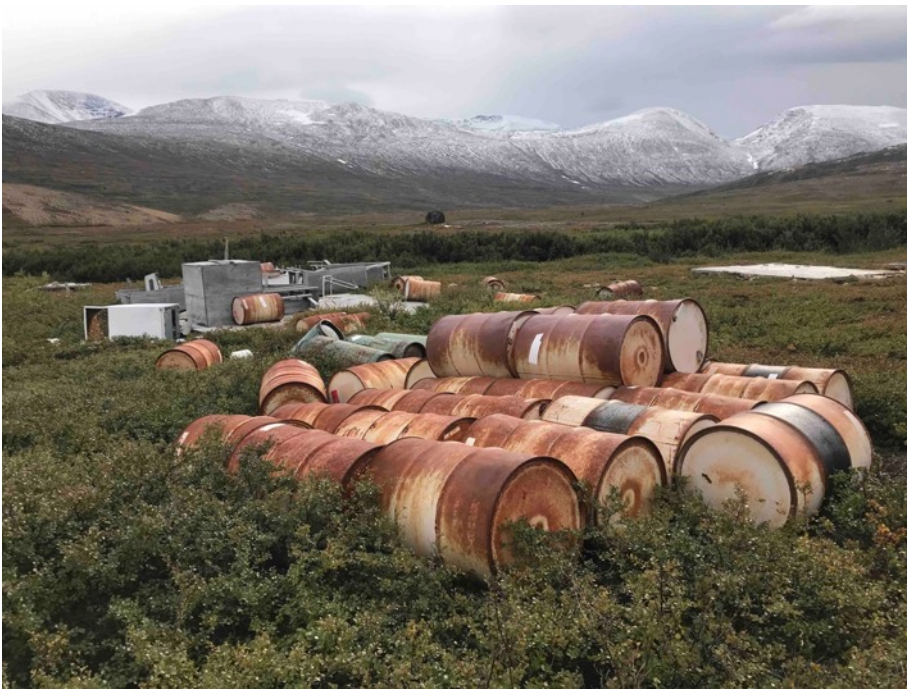
Figure 44 GR-2 during identification by informant, September 2017

Figure 45 GR-2 before rehabilitation activities, September 2018

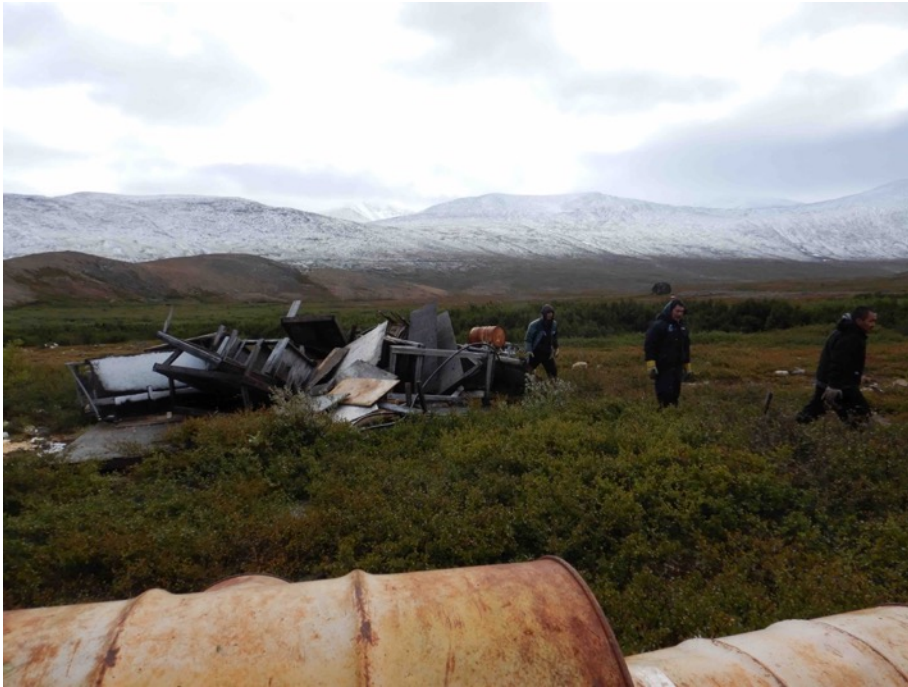
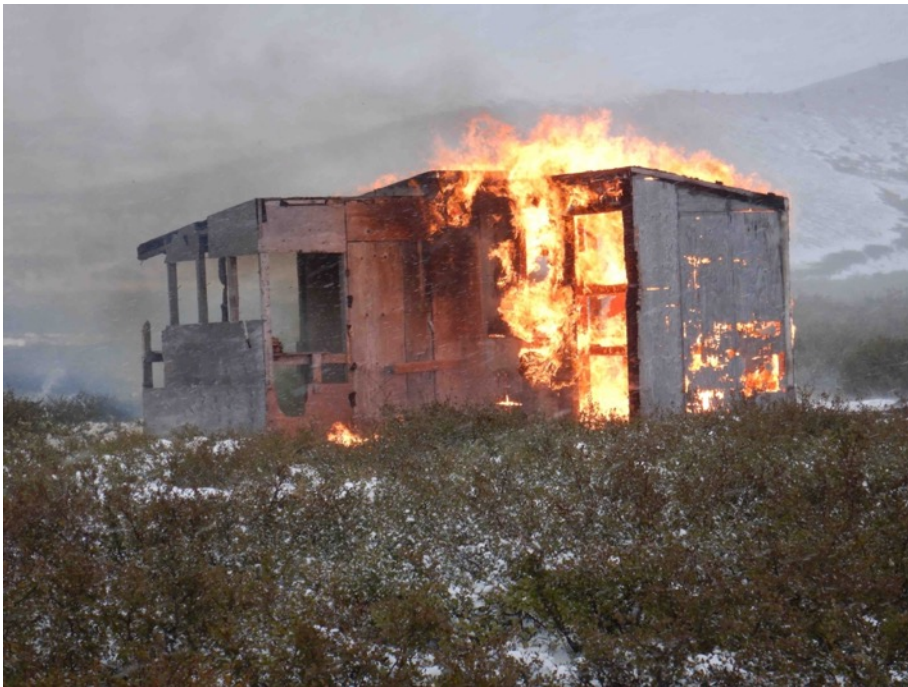
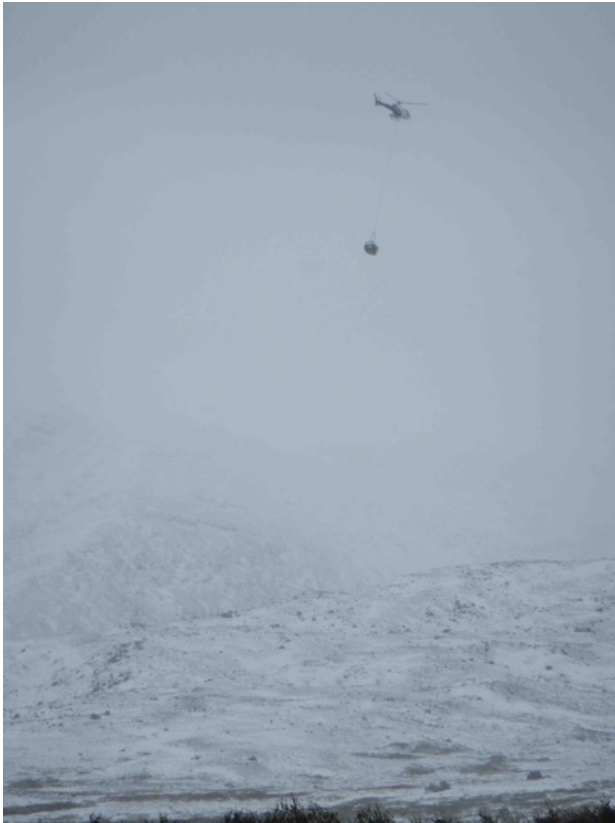
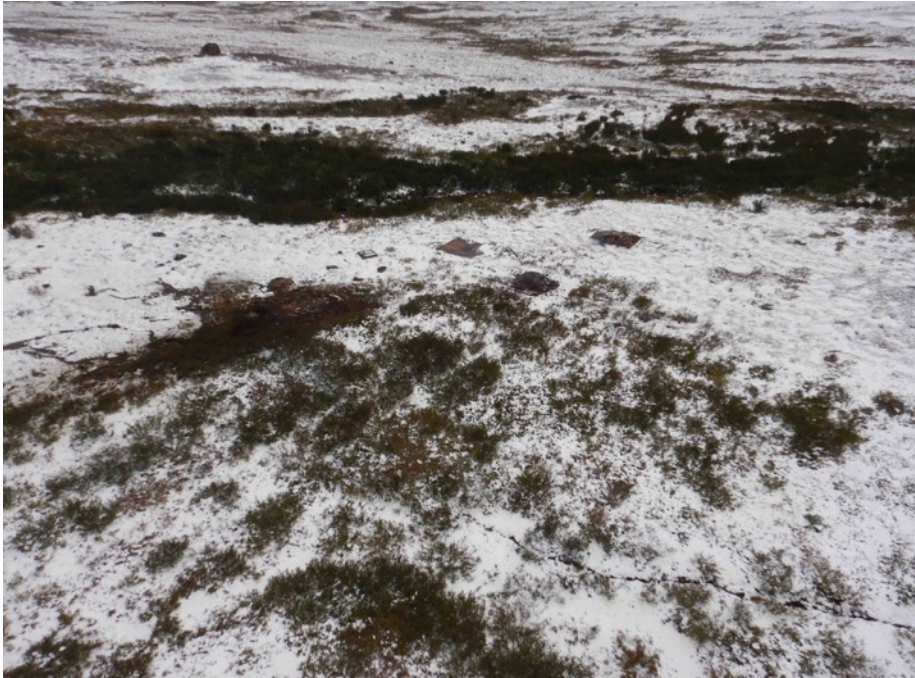
Figure 46 GR-2 during rehabilitation activities, September 2018

Figure 47 GR-2 during rehabilitation activities, September 2018

Figure 49 GR-2 after rehabilitation activities, September 2018

Approximately 10,650 pounds of material was transported to an airstrip, located a Waymouth outfitting camp by helicopter where it is currently stored and will be treated in 2019. A description of this work is provided in section 7 of the document. A small building, 2 wooden platforms and wood debris was burned on site. GR-2 is considered as complete. Photos of this work can be found in Appendix 3.

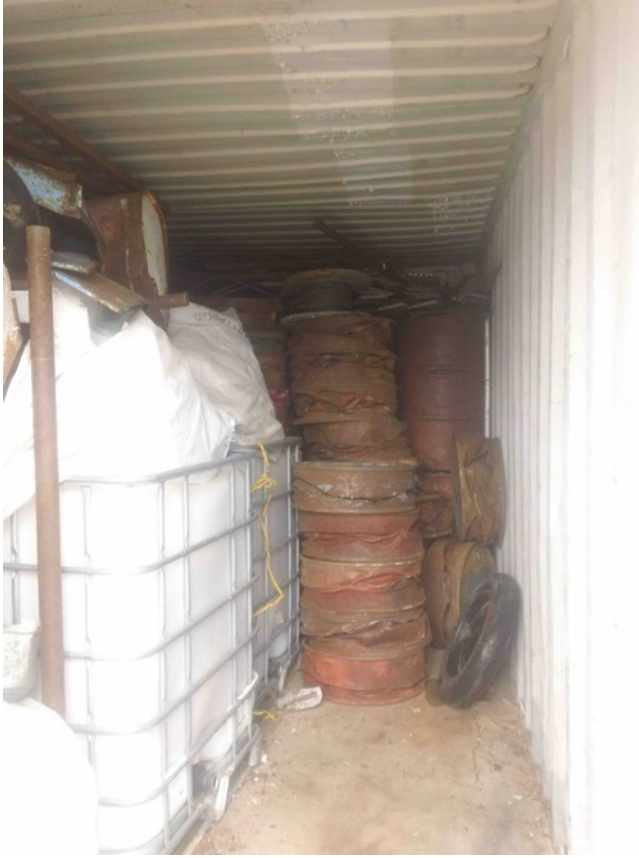
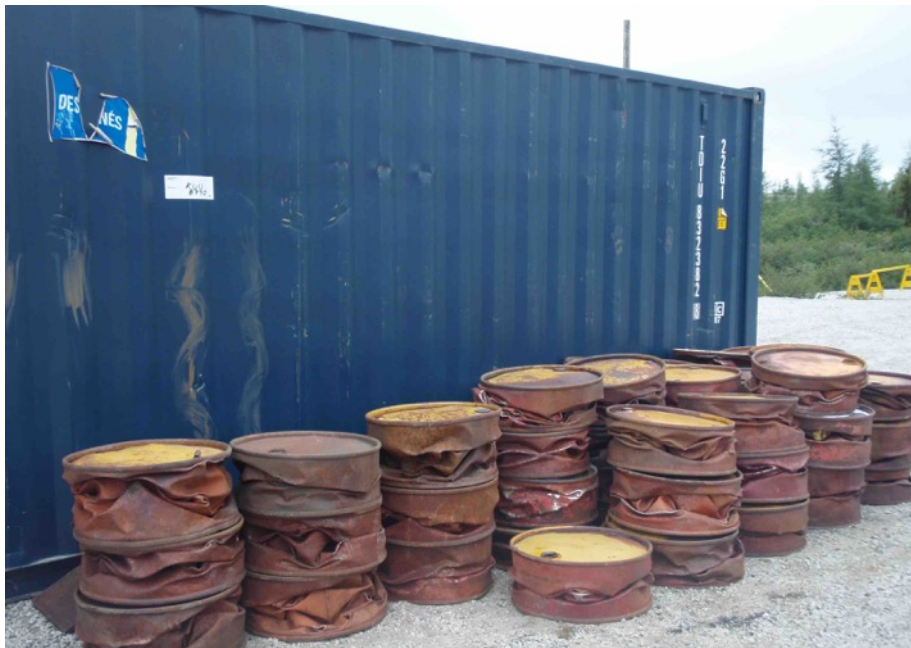
Figure 50 Container and material remaining in Kuujjuaq

Figure 51 Container and material remaining in Kuujjuaq

Currently there are 2 marine containers in the community of Kuujjuaq that are being used to store materials removed from various sites in this sector of Nunavik. Due to logistical issues with the marine shipping company, these containers were not transported to a waste recover facility in 2018. Therefore, in 2019, KRG in collaboration with the Northern Village of Kuujjuaq will need to ensure the containers and hazardous materials stored in the same area are properly packaged and ready to be transported during the shipping season.

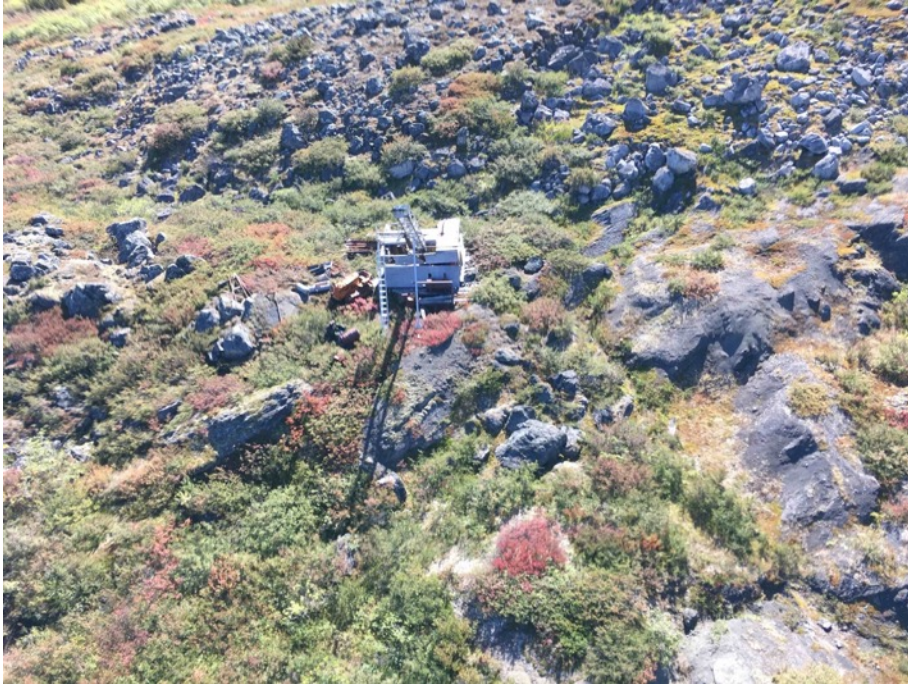
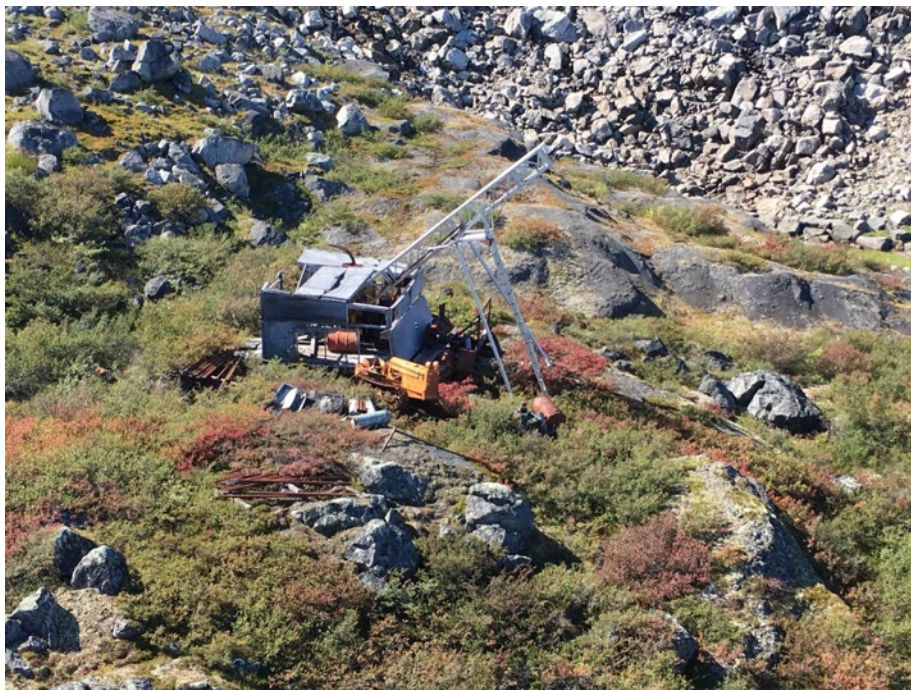
Figure 52 *Jordon Lake-2 during inspections, September 2017*

Figure 53 *Jordon Lake-2 during inspections, September 2017*

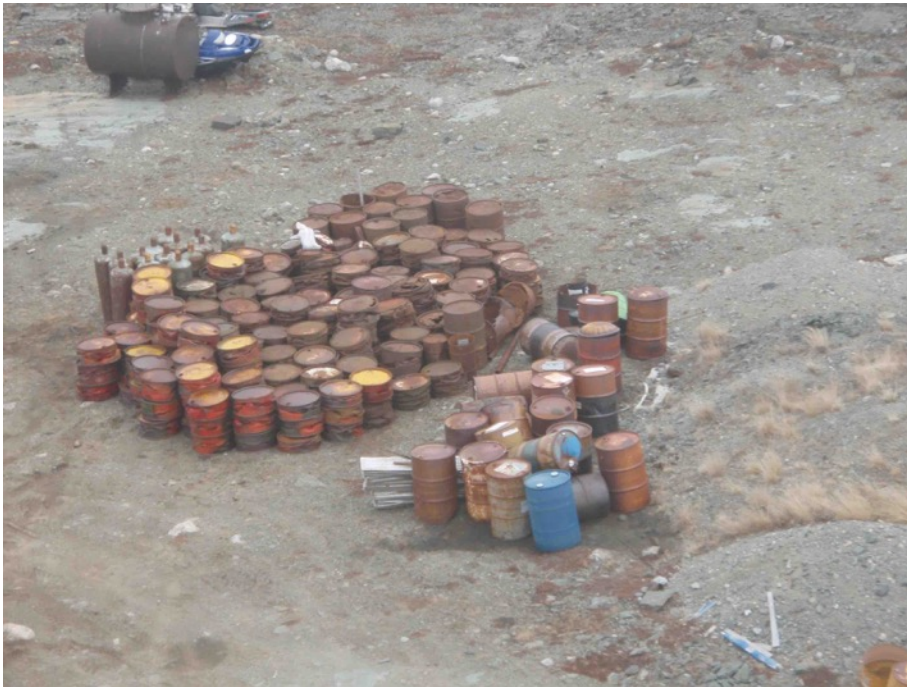
Figure 54 Material (propane tanks only) remaining in Kangirsuk

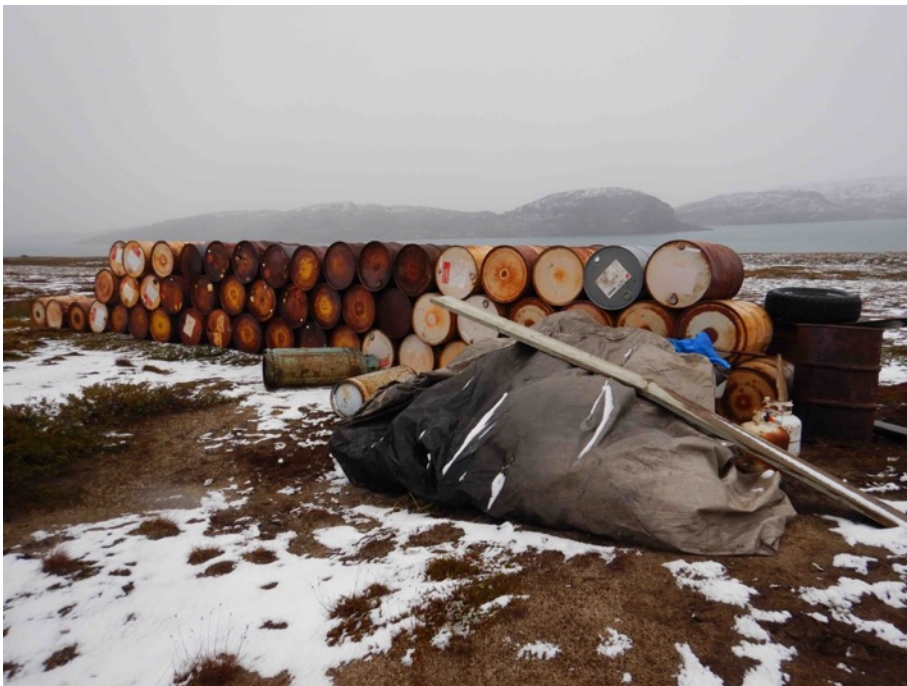
The sites GR-1 and GR-2 were completed in 2018 however all the material removed from these sites are currently being stored at an airstrip located adjacent to Waymouth Outfitting Camp, approximately 46 miles from the community of Kangiqsualujjuaq. Due to this distance, it is recommended that KRG communicate with Air Inuit who can access the airstrip with a Twin Otter to remove and transport the material to Kangiqsualujjuaq. This will be more efficient and cost effective than using a helicopter.

Figure 55 Material remaining at Waymouth airstrip

In this case, the KRG will also need to collaborate with the Northern Village of Kangiqsualujjuaq in order to undertake the work of removing the material from Waymouth, transporting it to the community and having it packaged in a marine container and prepared for shipment to a waste management recovery facility. Considering the number of drums now stored at Waymouth (nearly 100), transporting the mobile drum crusher to the site would be recommended. A helicopter could be used for this and to carry out rehabilitation activities on nearby sites, effectively having 2 teams working in tandem.

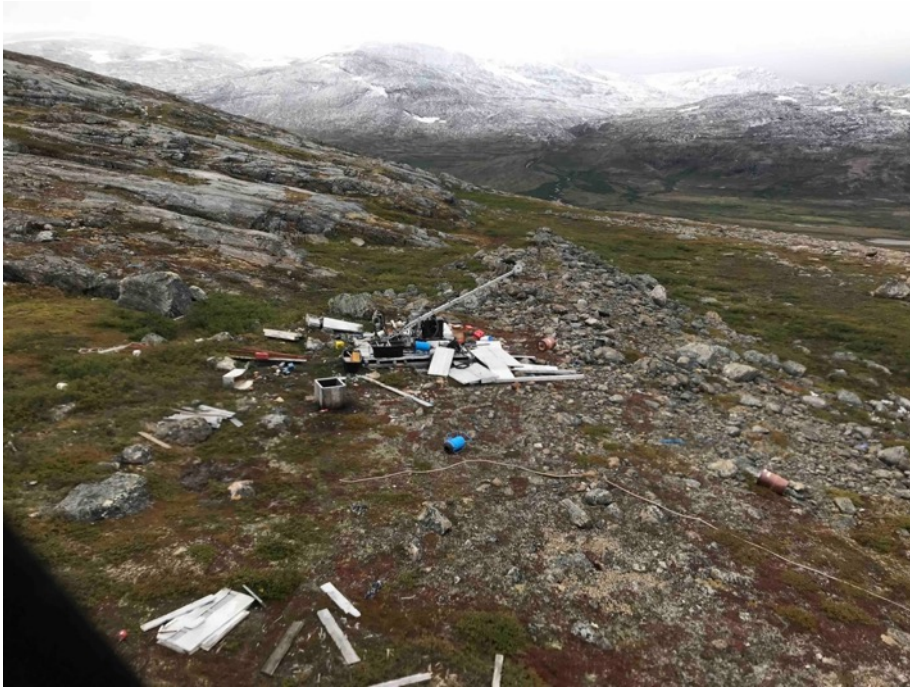
Figure 56 Site GR-3 during inspections, September 2018

In order to rehabilitate this site, KRG, in collaboration with the Northern Village of Kangiqsualujjauq will need to organize a 5-day work campaign during the summer of 2019. The rehabilitation activity will involve collecting and packaging the debris as well as using a mobile welding machine and necessary equipment to cut and disassemble the drill so that it, and the debris, can be safely transported to Waymouth by helicopter. Due to the distance of Waymouth to the nearest community, it is recommended that KRG communicate with Air Inuit who can access the airstrip with a Twin Otter to remove and transport the material to Kangiqsualujjauq.
