REHABILITATION OF ABANDONED MINERAL EXPLORATION SITES IN NUNAVIK

2014-2015 ACTIVITY REPORT

Kativik Regional Government

April 2015

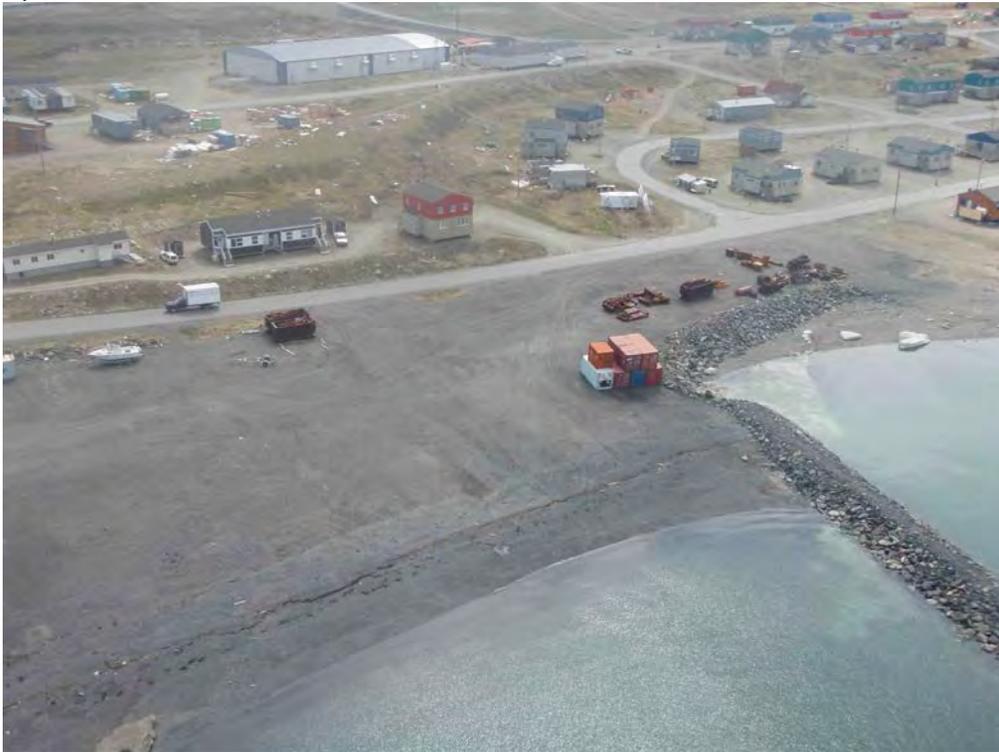
PJ-1

Figure 1 : Material ready for marine transport at Aupaluk marina, June 2014

The remaining material is being stored in the community of Aupaluk and will be transported in 2015. Pictures of this work and remaining material can be found in Appendix 2.

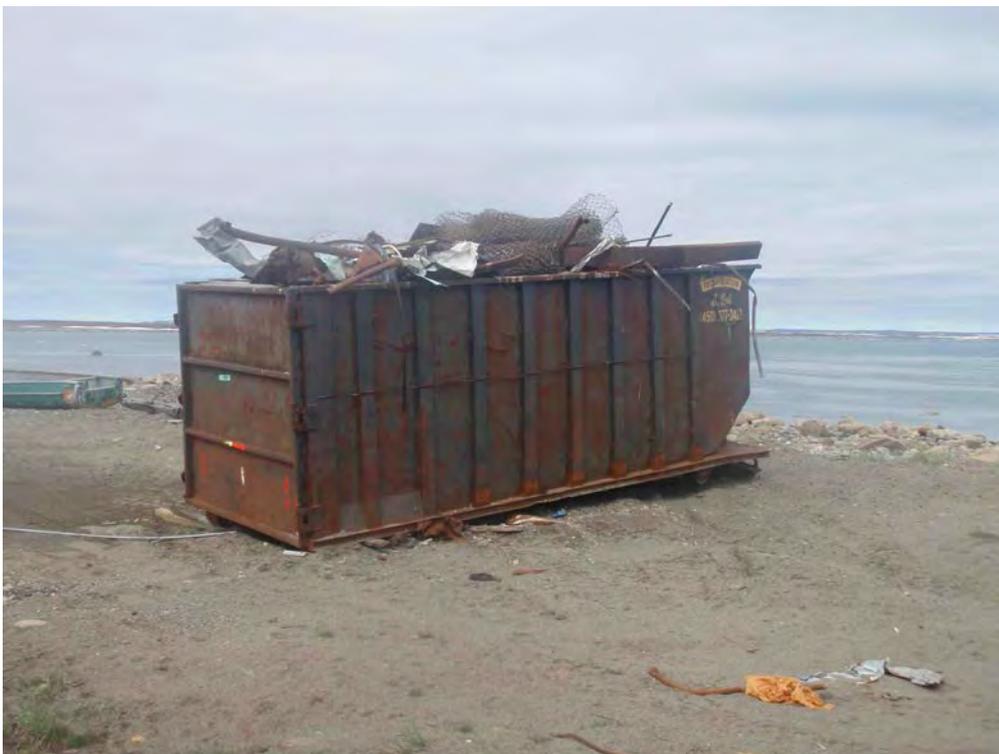
Figure 2 : Open-top container stored next to Aupaluk municipal garage, June 2014

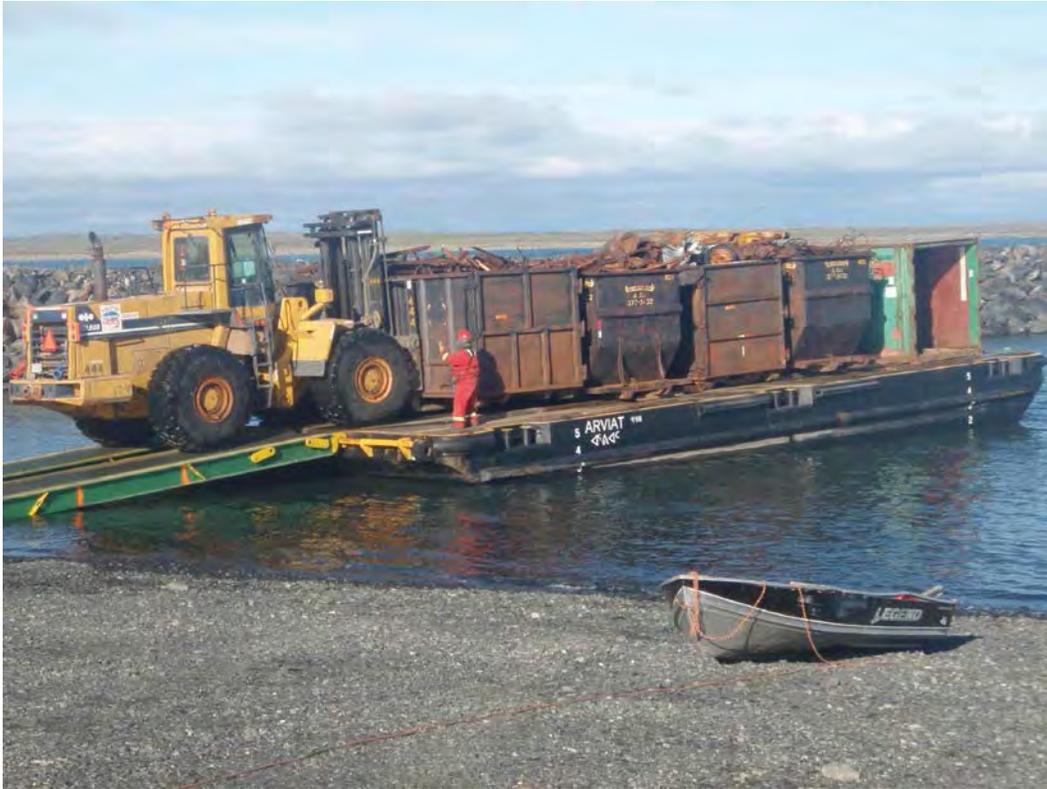
Figure 3: Containers being loaded onto barge in Aupaluk, July 2014

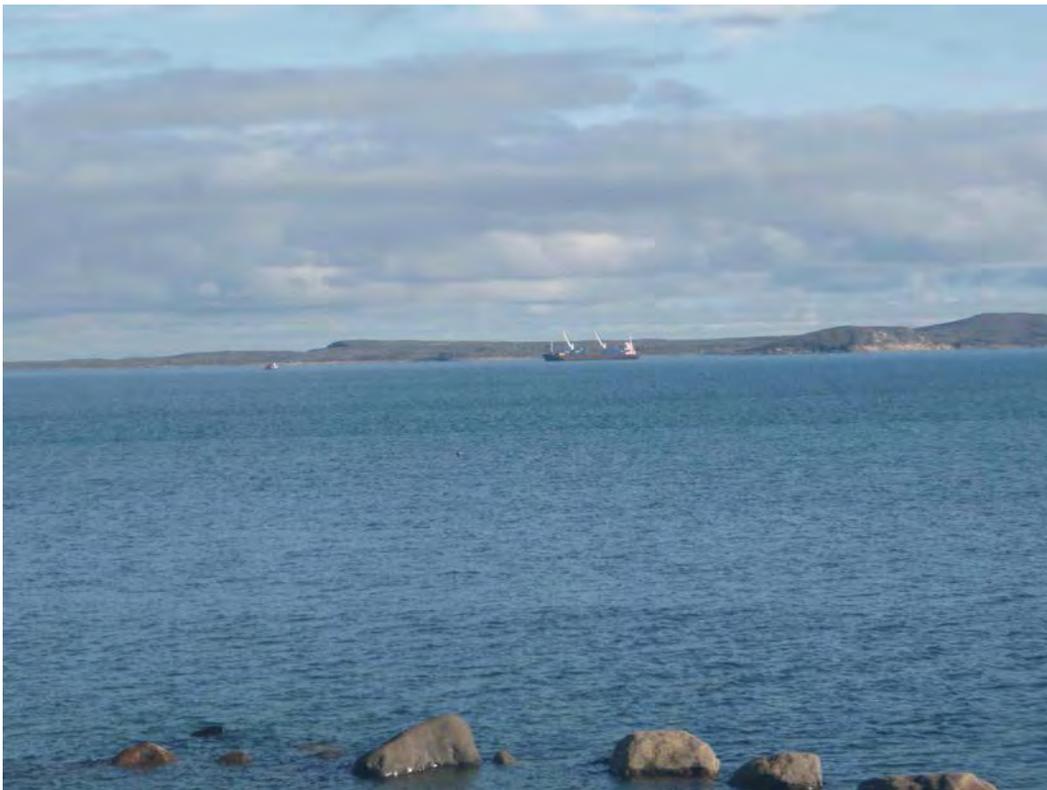
Figure 4: Material being transported by barge to main ship, Aupaluk, July 2014

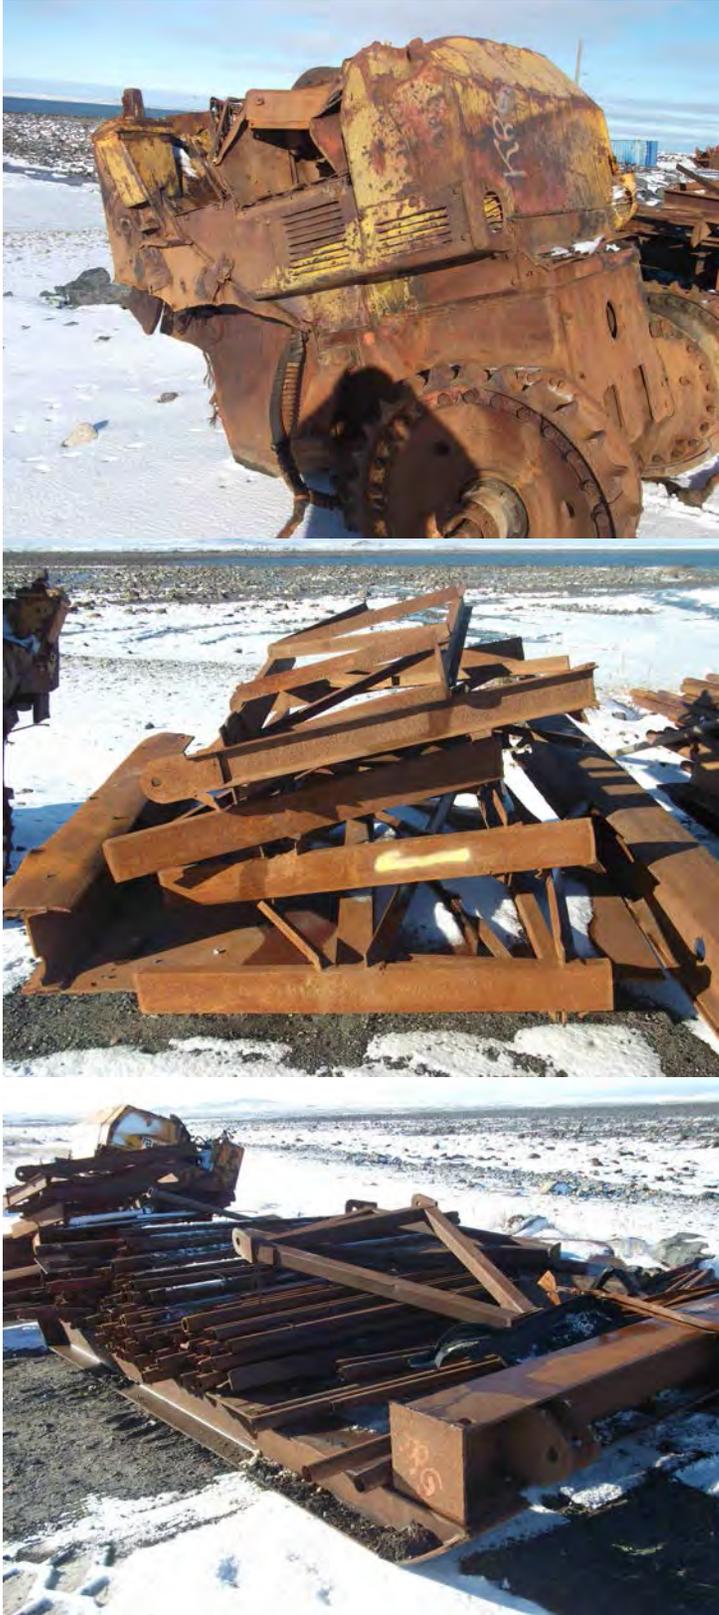
Figure 5: Three remaining pieces of debris in Aupaluk to be transported in 2015, October 2014

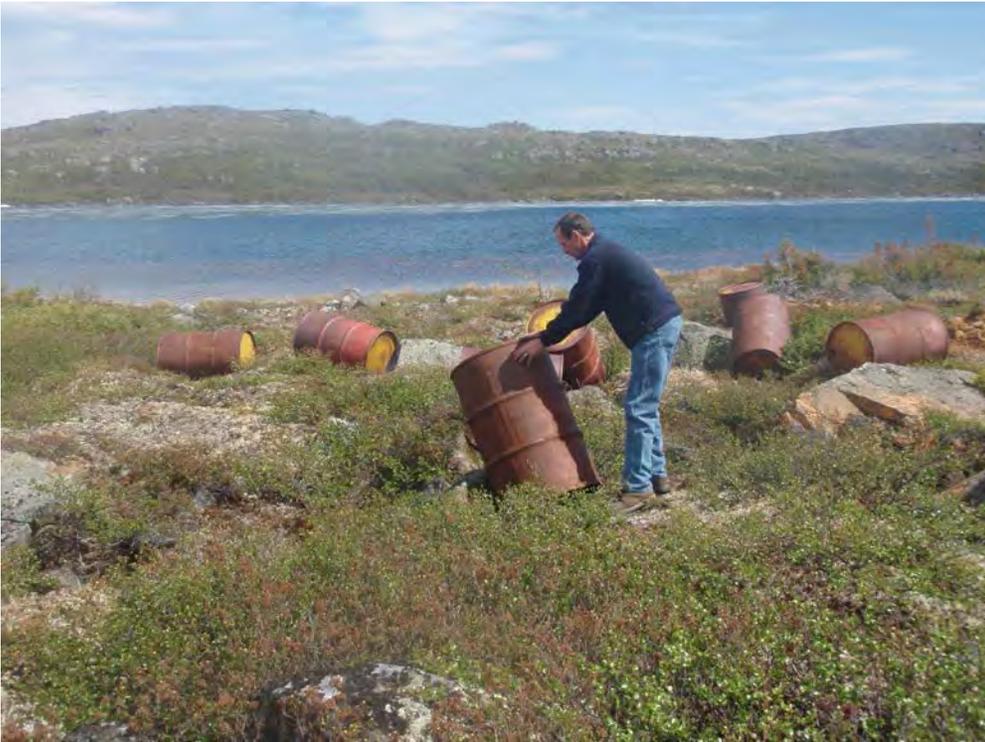
TA-1

Figure 6: Field Technician, Richard Knoxleet, inspecting drums on site TA-1, June 2014

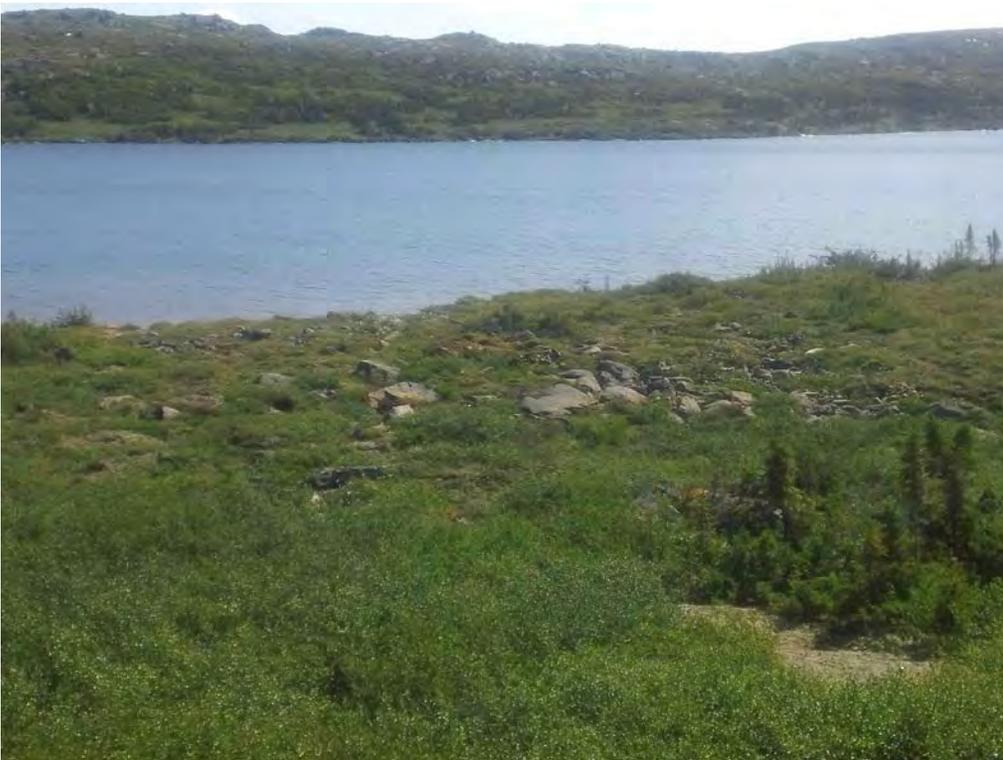
Figure 7: Site TA-1 after rehabilitation work, September 2014

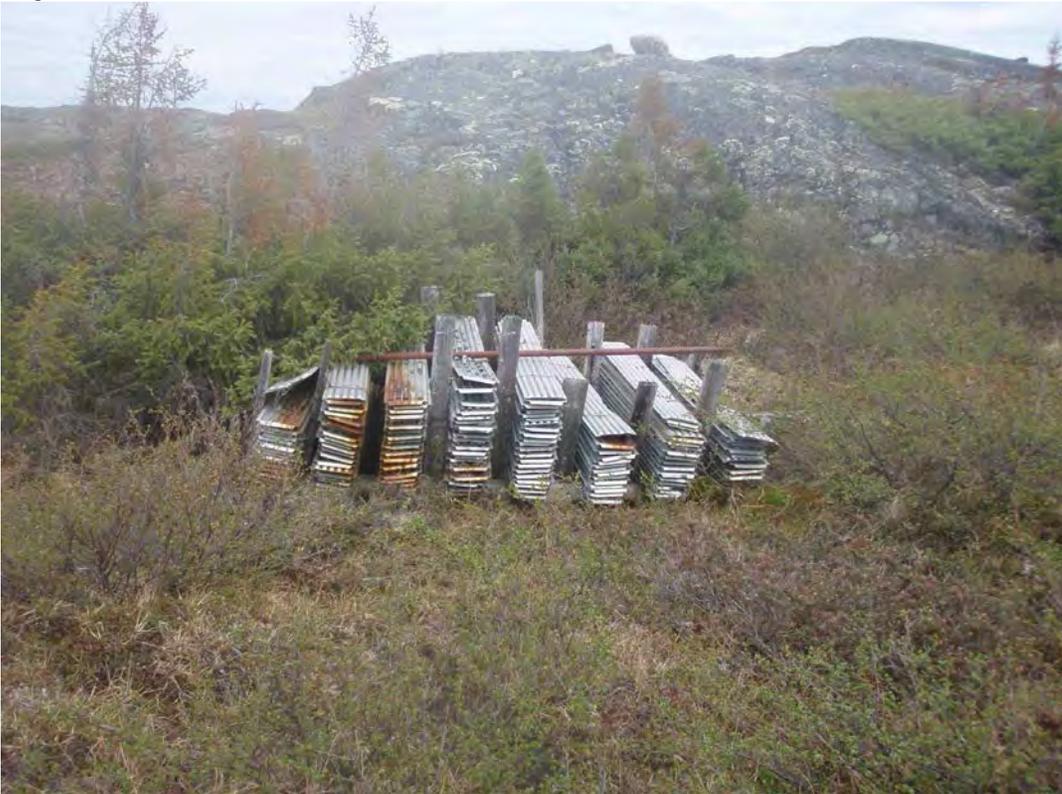
TQ-6

Figure 8: Core samples in aluminum trays on site TQ-6, June 2014

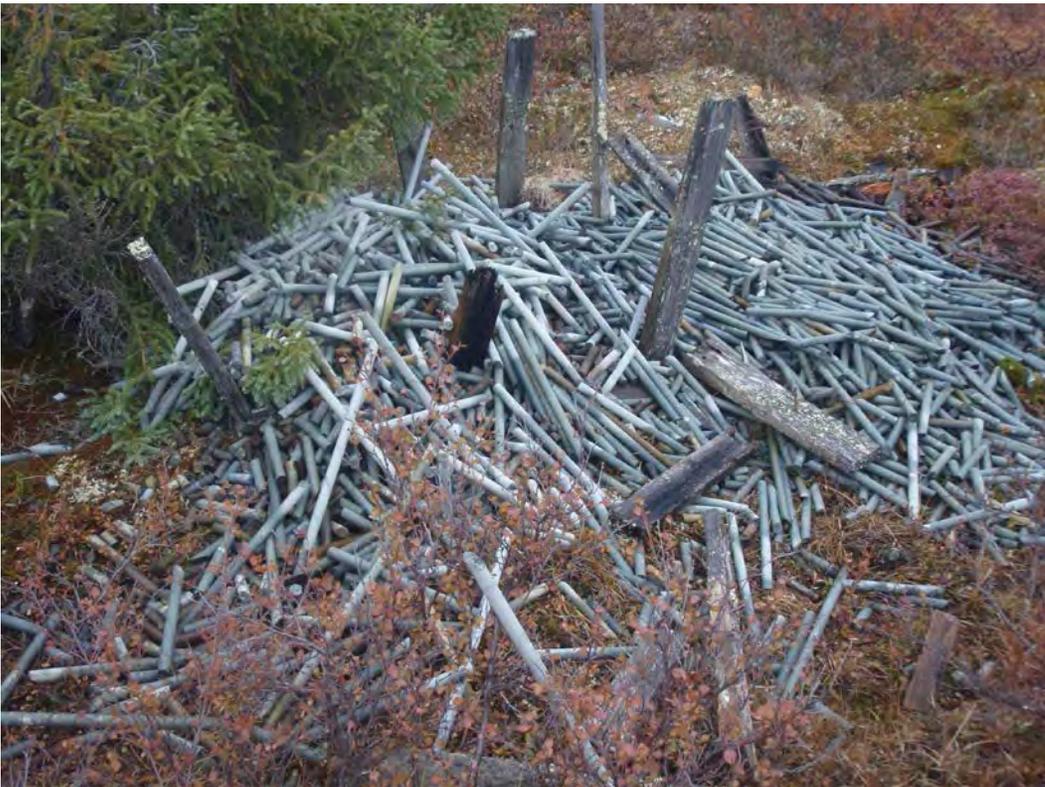
Figure 9: Core after aluminum trays were removed, September 2014

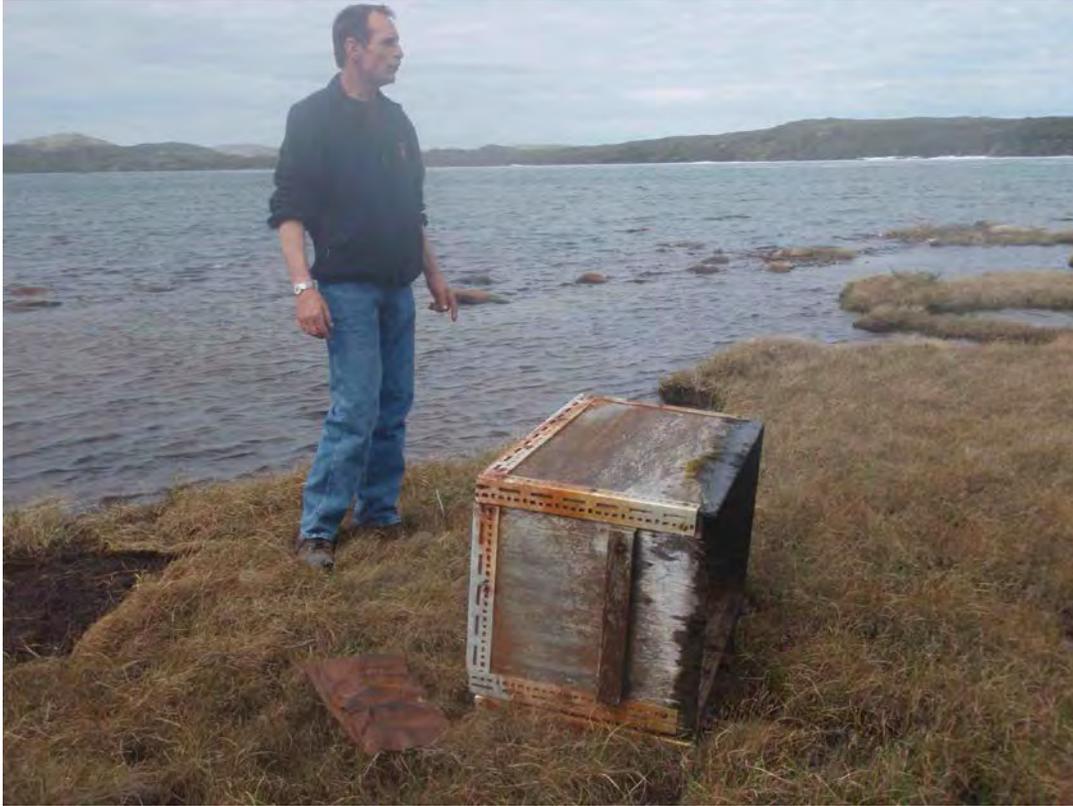
Figure 10: Wooden box found on site TQ-6, June 2014

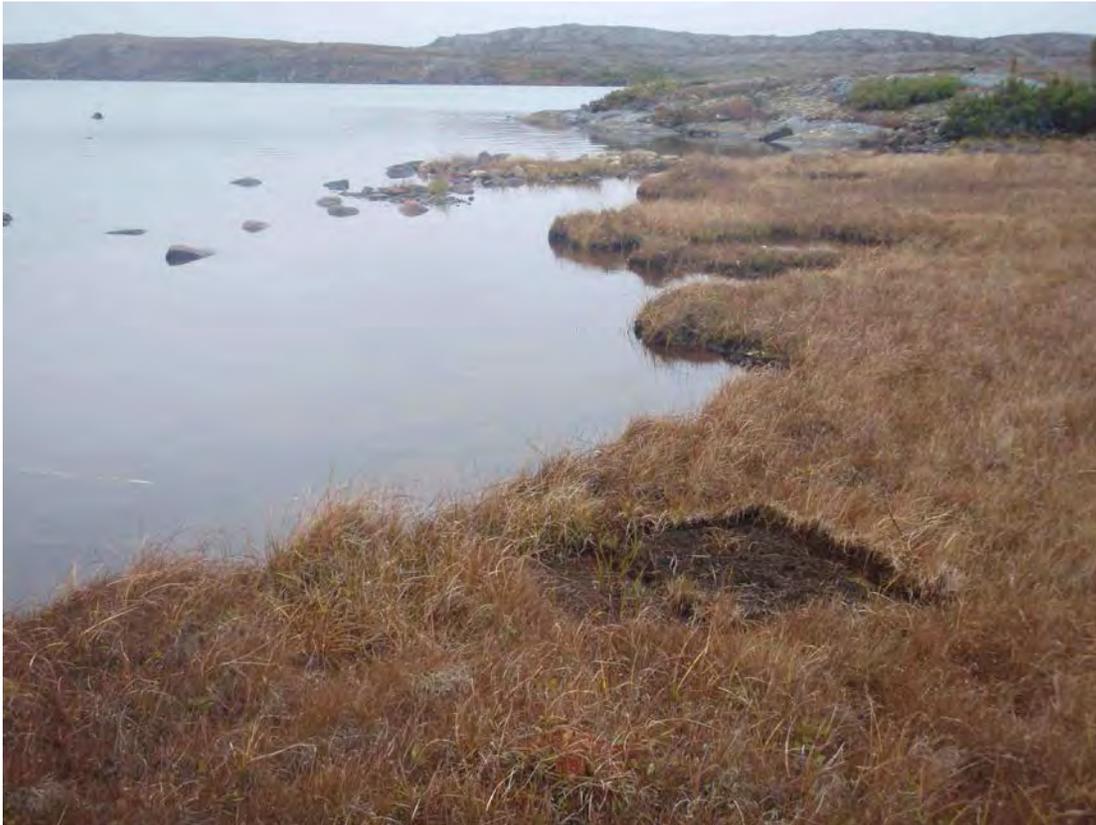
Figure 11: Site TQ-6 after box was removed, September 2014

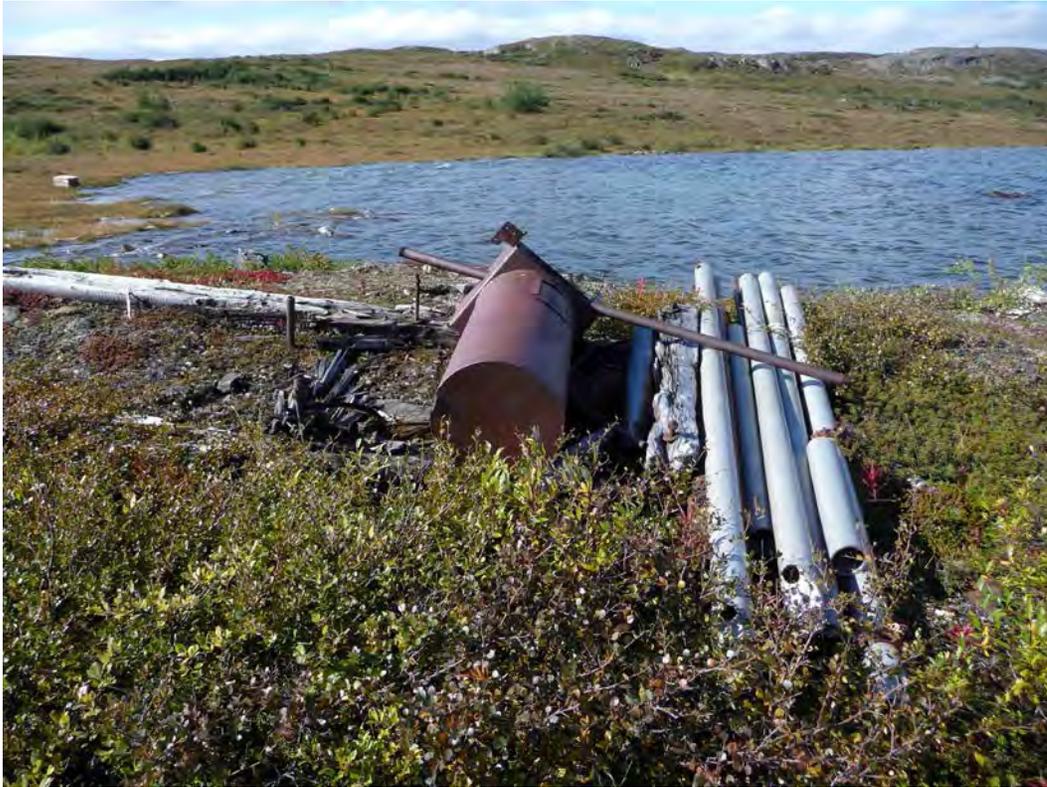
Figure 12: Debris found on site TQ-6, June 2014

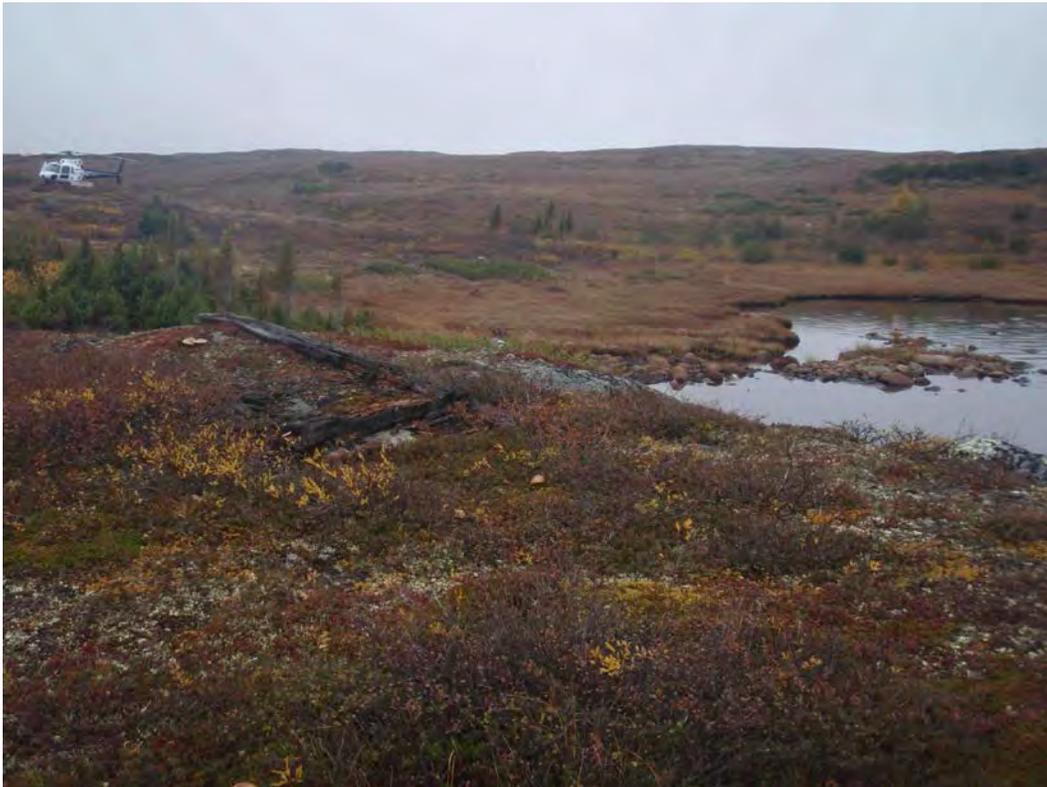
Figure 13: Site TQ-6 after debris was removed, September 2014

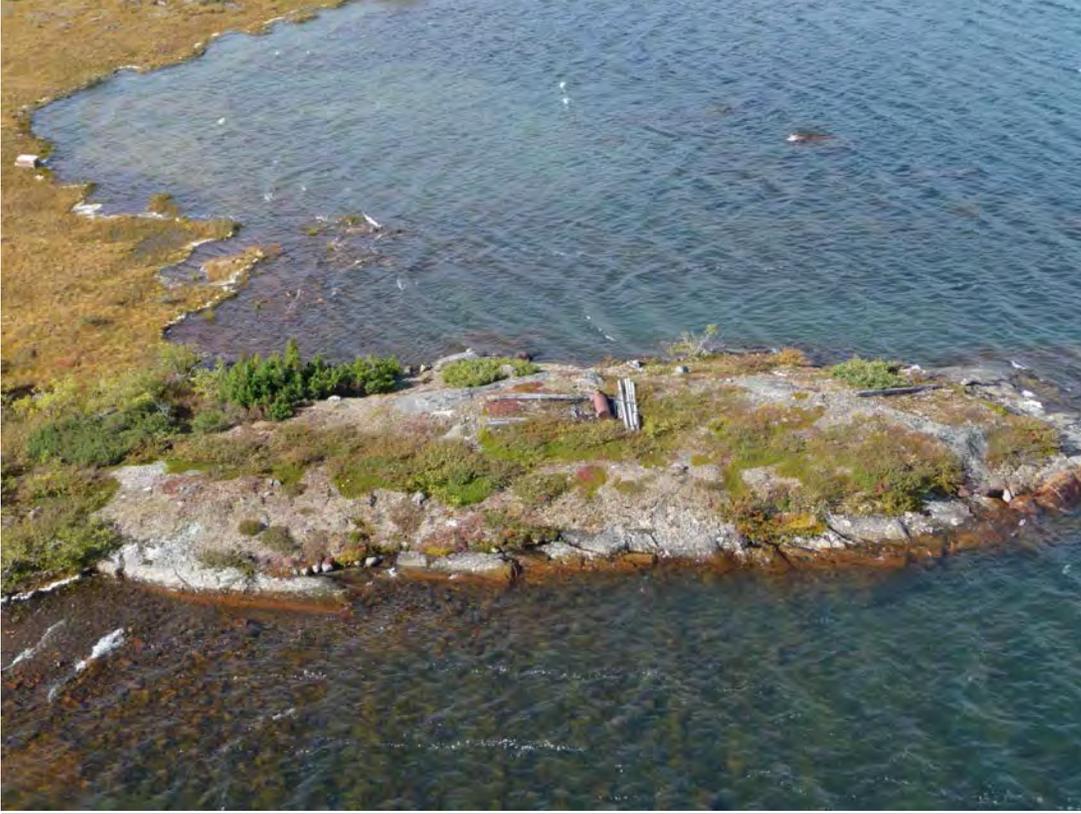
Figure 14: Partial view of site TQ-6, September 2011

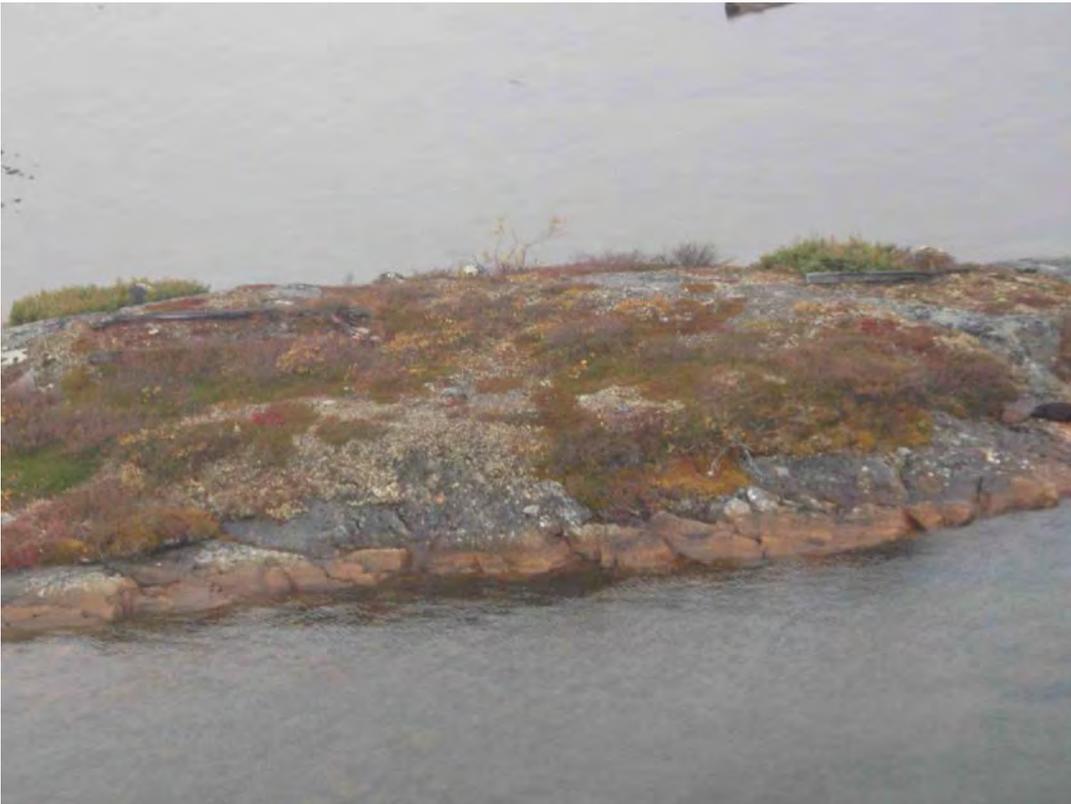
Figure 15: Same view of site TQ-6, after rehabilitation work, September 2014

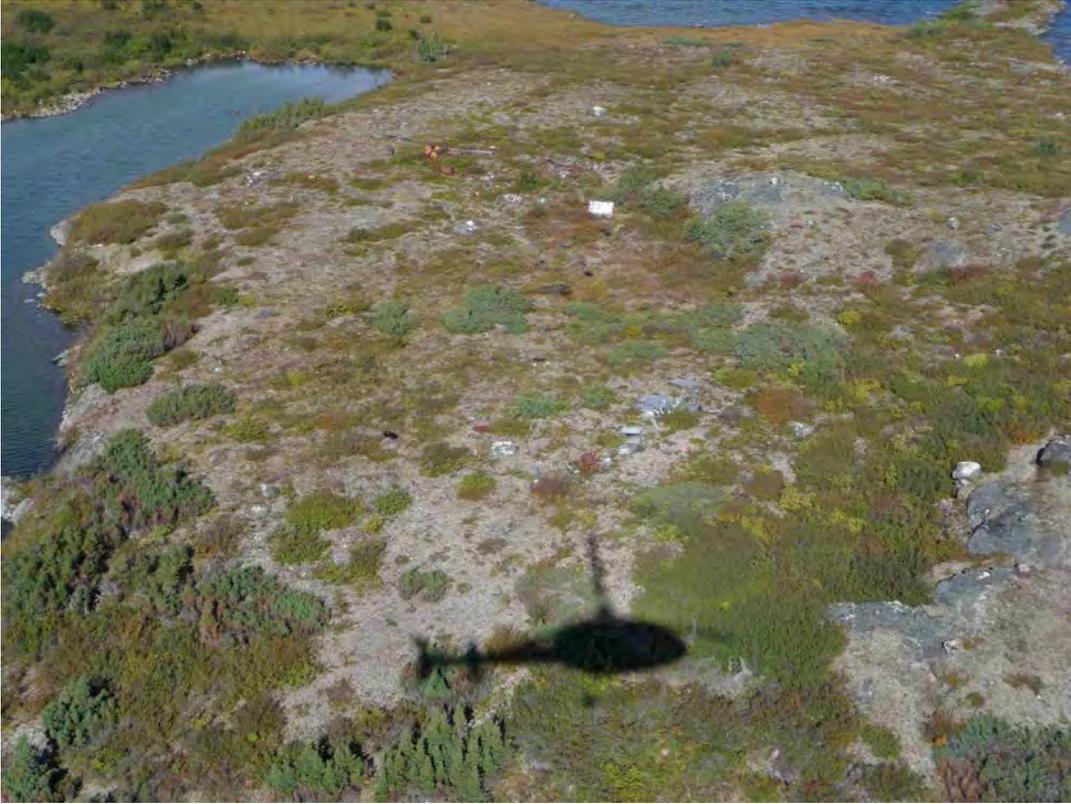
Figure 16: Partial view of site TQ-6, September 2011

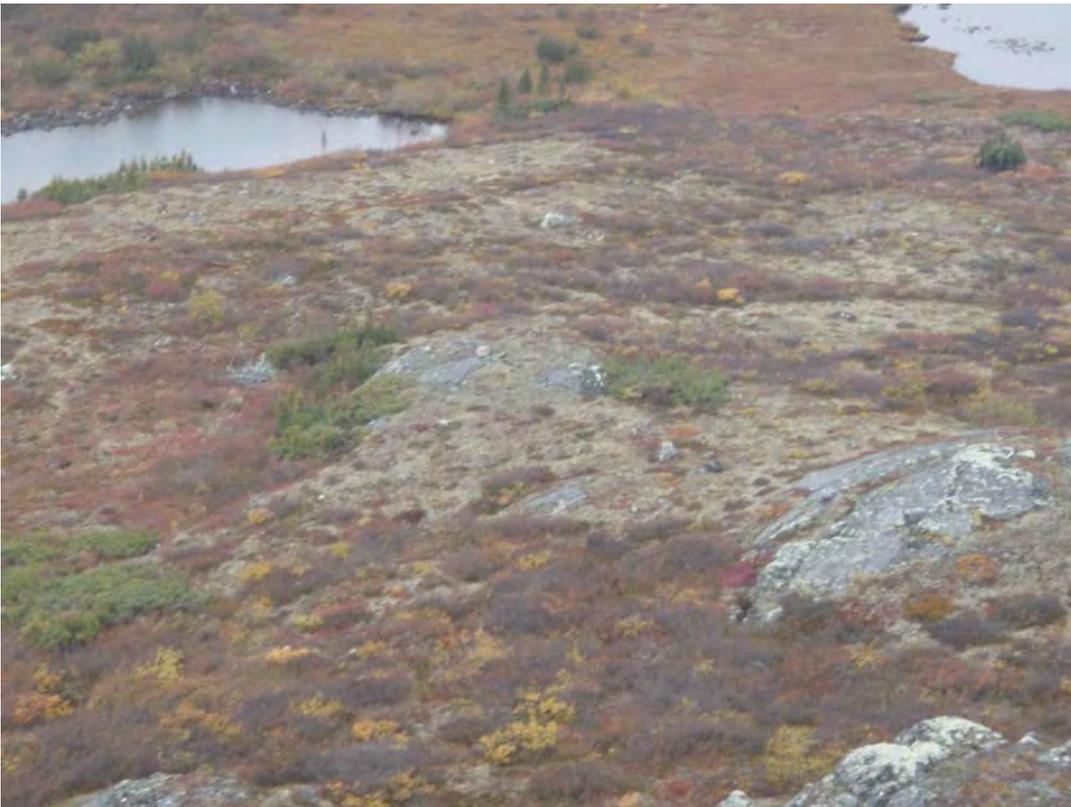
Figure 17: Same view of site TQ-6 after rehabilitation work, September 2014

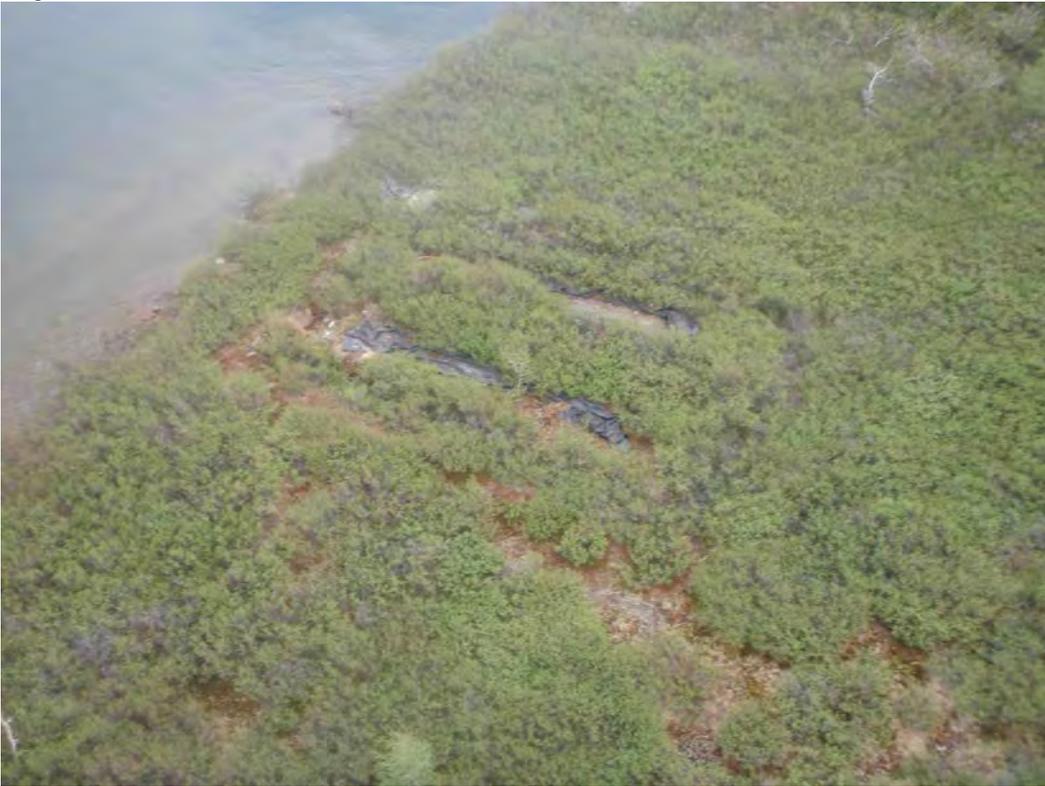
TQ-10

Figure 18: Bladders found on site TQ-10, June 2014

bladders, approximately 10 meters long, as well as several pipes, 1 pump and 1 motor were removed from this site and brought to the airstrip at Gerido Lake by helicopter for temporary storage. A few days later the bladders were brought to Kuujjuaq by helicopter and stored in a marine container. This site is now complete and pictures can be found in Appendix 2.

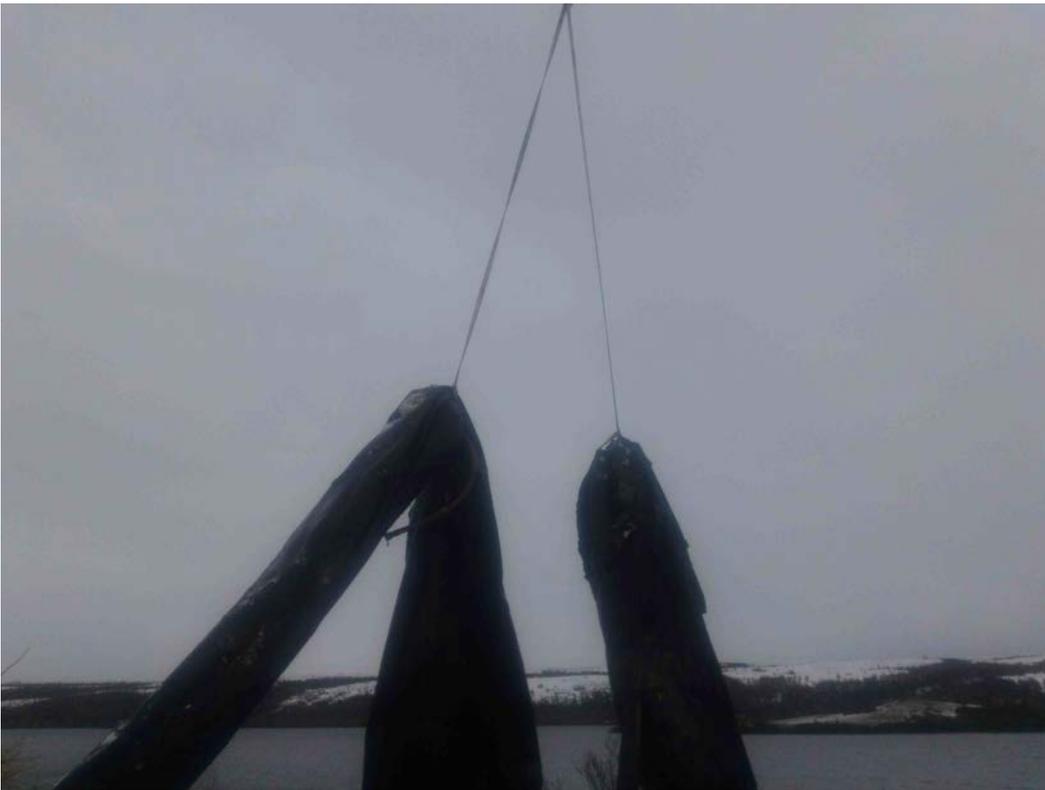
Figure 19: Bladders being removed by helicopter from site TQ-10, October 2014

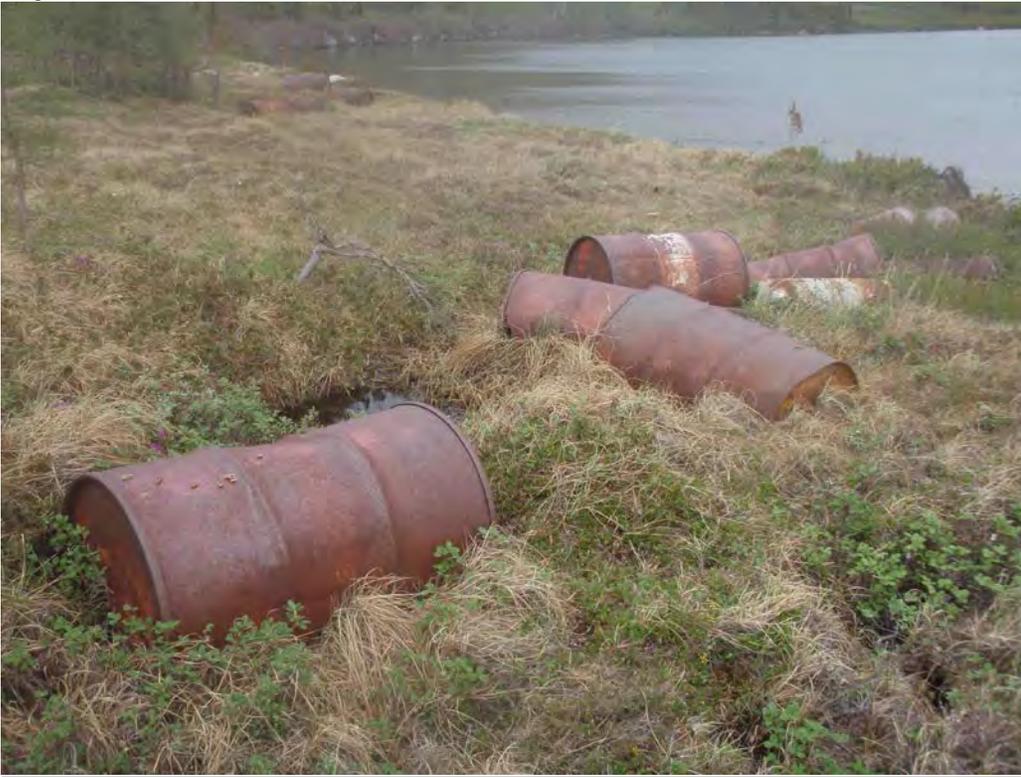
TQ-14

Figure 20: Debris found on site TQ-14, June 2014

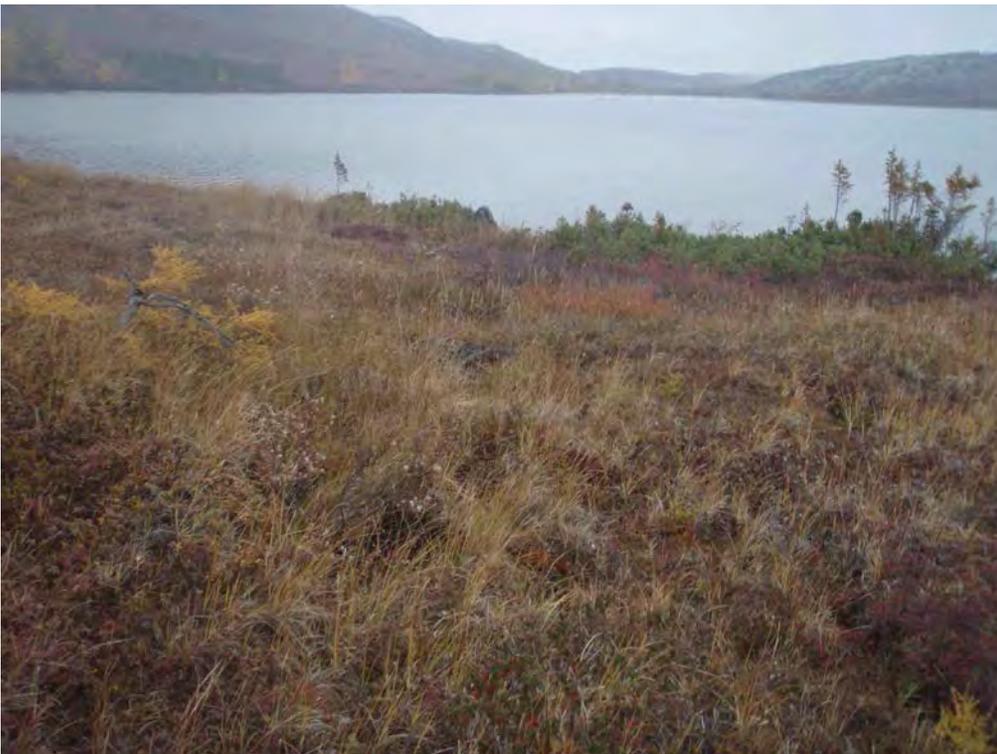
Figure 21: Site TQ-14 after rehabilitation work, September 2014

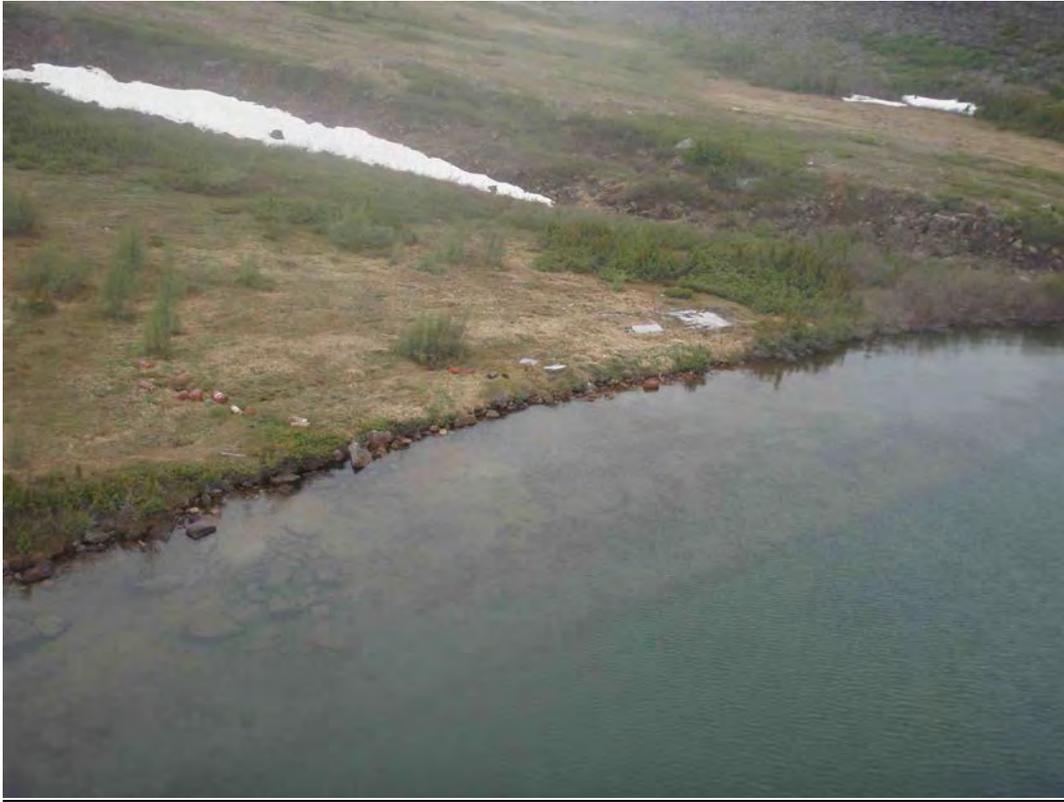
Figure 22: Site TQ-14, June 2014

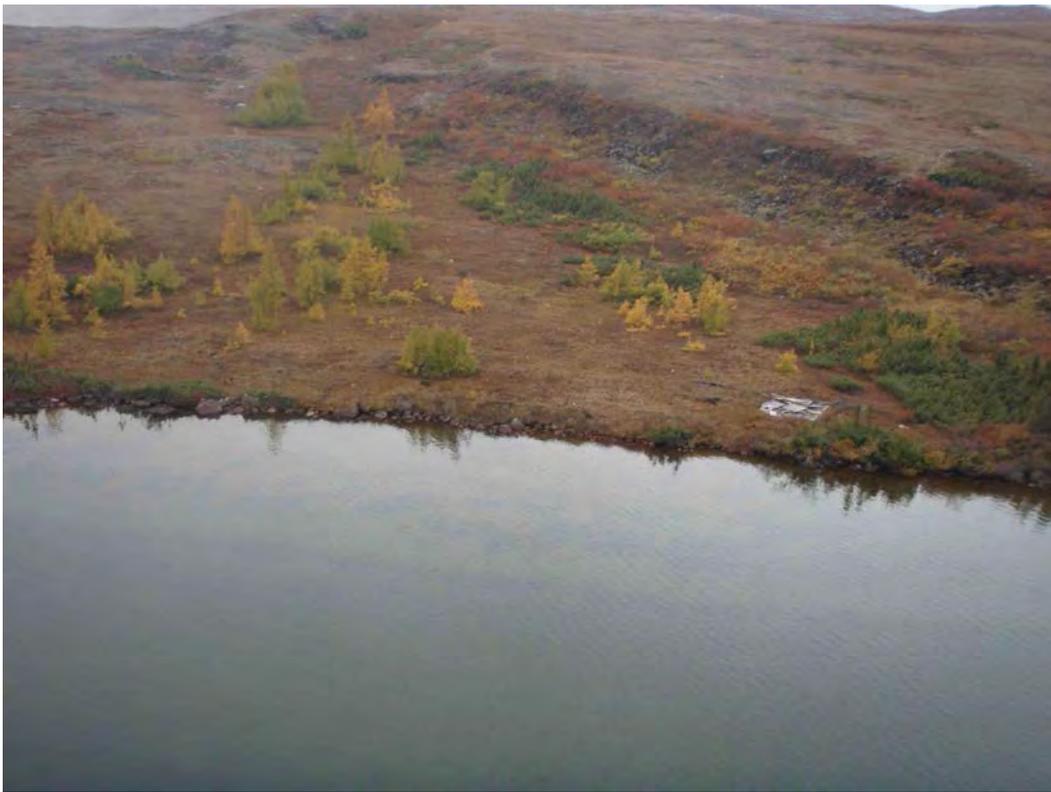
Figure 23: Site TQ-14 after rehabilitation work, September 2014

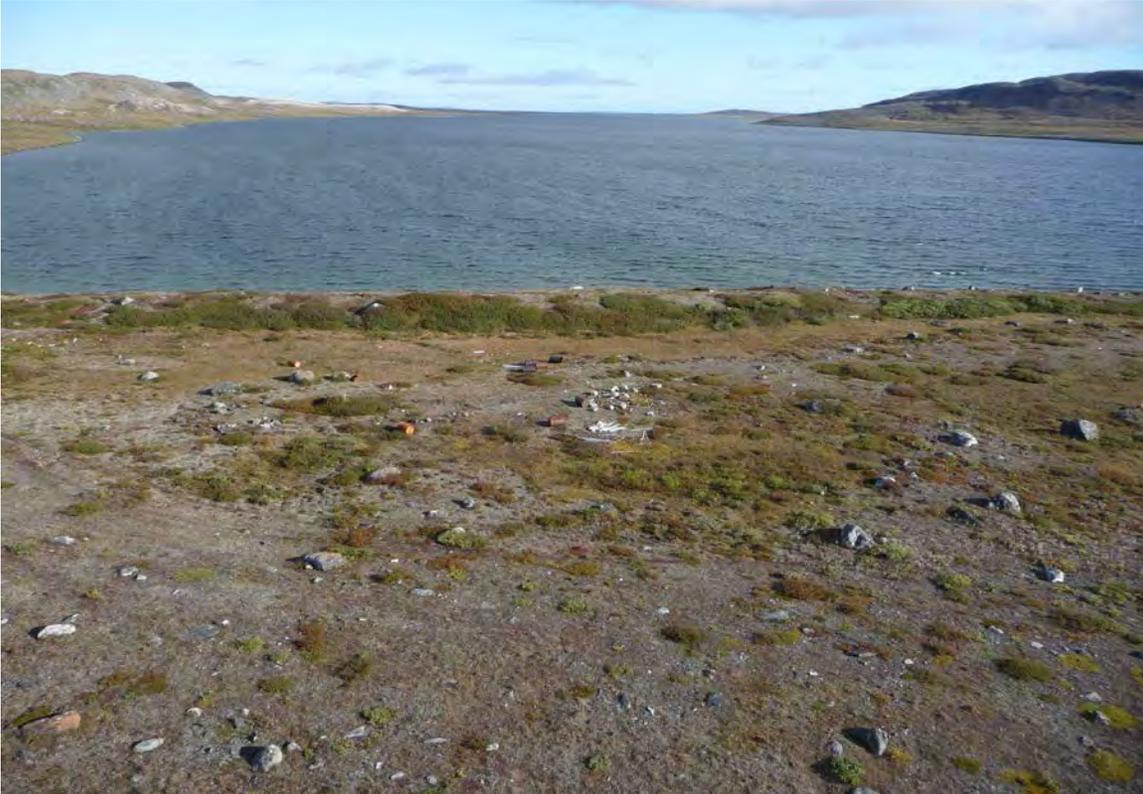
G-24-N4-3

Figure 24: Aerial view of site G-24-N4-3, September 2011

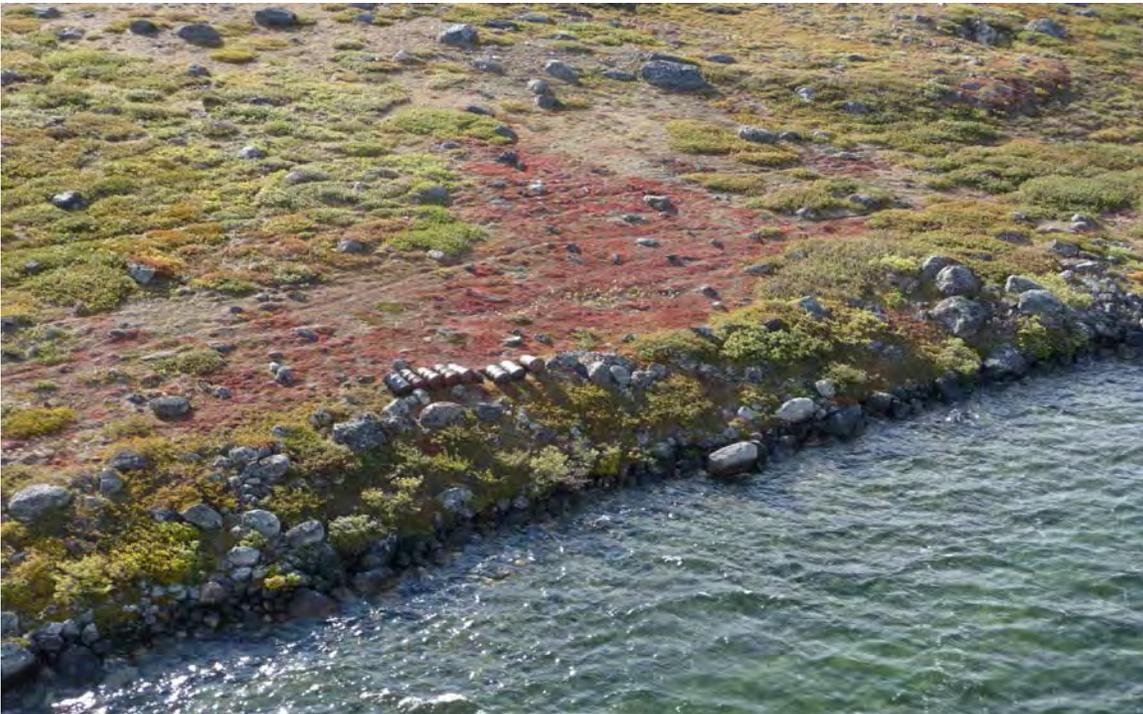
Figure 25: Aerial view of barrels found on site G-24-N4-3, September 2011

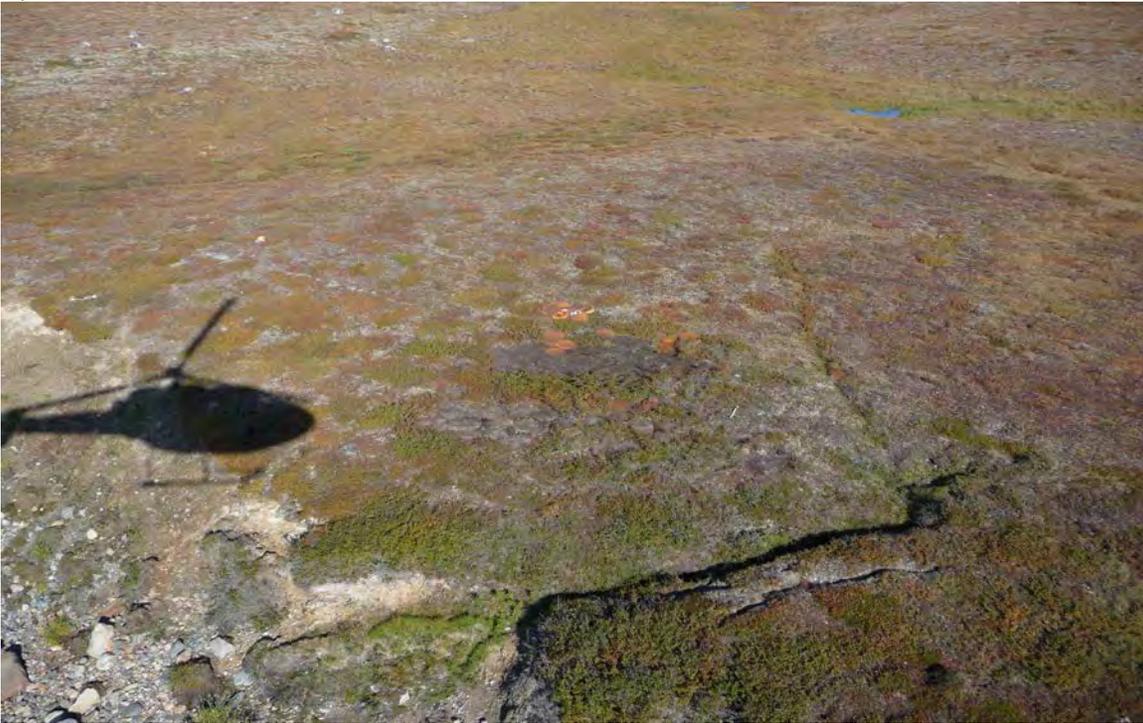
Figure 26: Aerial view of site PJ-19, September 2011

Site PJ-19 is located just south of Aupaluk (59° 18.91' N, 69° 46.06' W) and is considered as requiring intermediate cleanup (Map 5). The KRG, in collaboration with the community of Aupaluk, had previously undertaken the cleanup of this site during the spring of 2010, however several drum covers had been seen during previous inspections. In June 2014 the Project Coordinator removed 64 drum covers from the site by helicopter and brought them to Aupaluk. The site is now considered as complete and pictures can be found in Appendix 4.
