REHABILITATION OF ABANDONED MINERAL EXPLORATION SITES IN NUNAVIK

2014-2015 ACTIVITY REPORT

Kativik Regional Government

April 2015

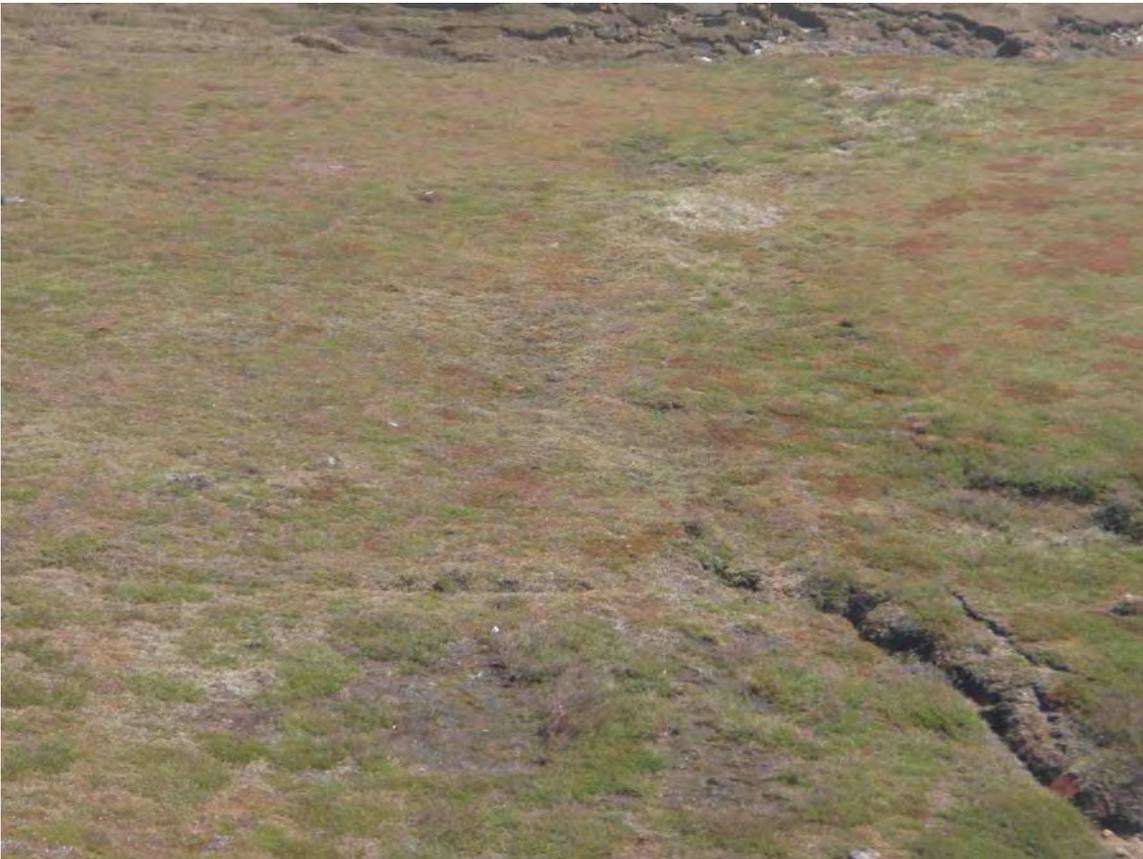
Figure 27: View of site PJ-19 after removal of drum covers, June 2014

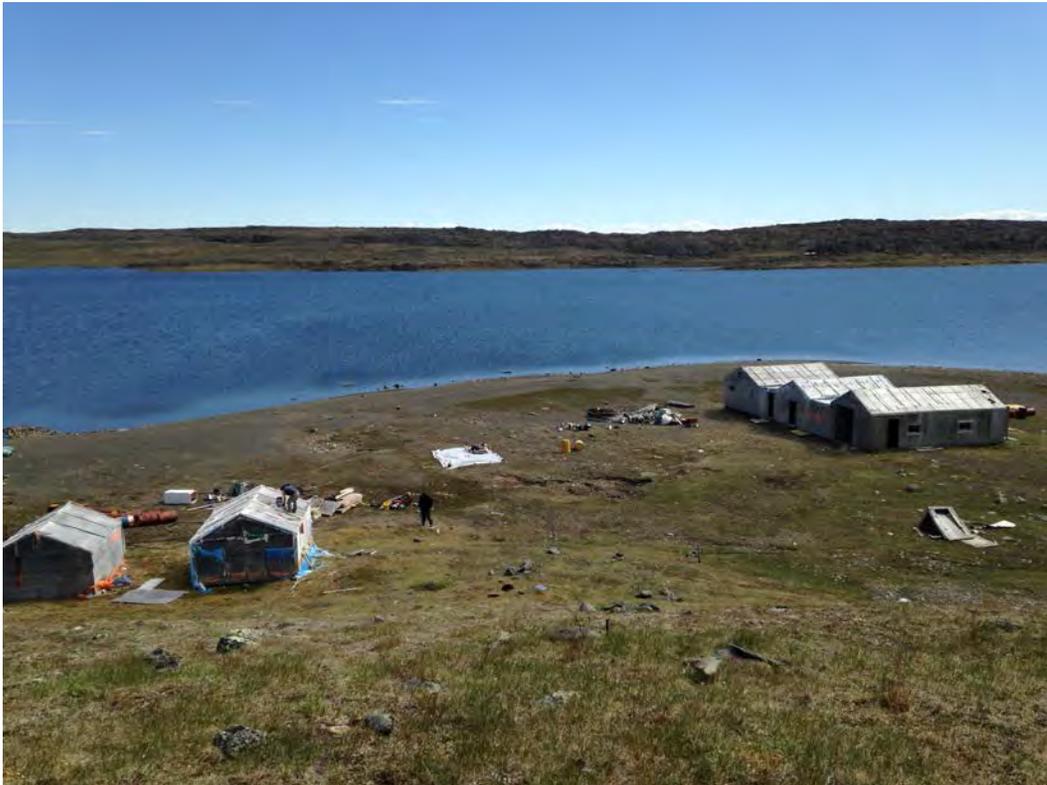
Figure 28: Site WB-9 during first cleanup session, July 2014

The objective for 2014 at site WB-9 was to empty all buildings of non-combustible material and to remove, if nothing else, the hazardous waste from the site. In collaboration with the NV of Salluit, the Project Coordinator and 4 workers undertook a first cleanup session at the site in July 2014. During this time, all non-combustible material was removed from each of the 11 buildings found on site and organized according to category outside in piles. A tarp was laid out on the ground for the hazardous material to be stored on. After 4 days of work a large volume of material was amassed into 3 piles. Table 6 lists the material found on site.

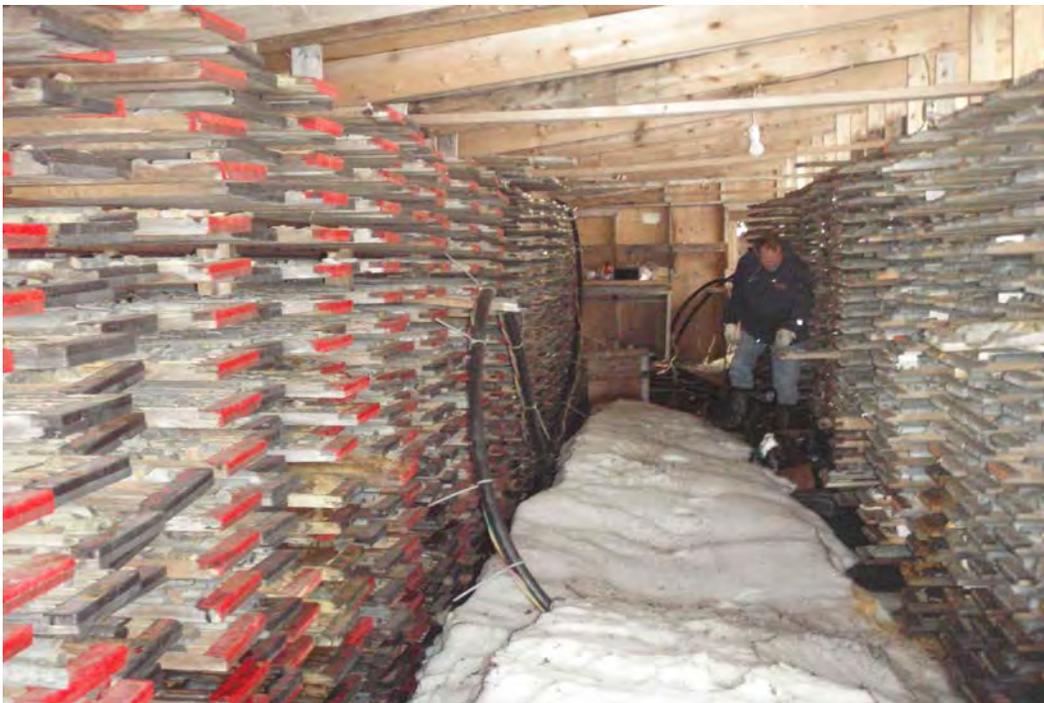
Furthermore, there are 11 buildings found on this site. One of these buildings contains a large amount of core samples, which is to remain on site. The majority of the other buildings are in poor condition and could pose a safety risk to wildlife and to people who may choose to use them as shelter. To this effect, these buildings will be demolished and burned on site in 2015. Again, the KRG will need to plan for the logistical and safety elements regarding this work. The work team will be organized in collaboration with the NV of Salluit.

Figure 29: Core samples inside one of the buildings, June 2012

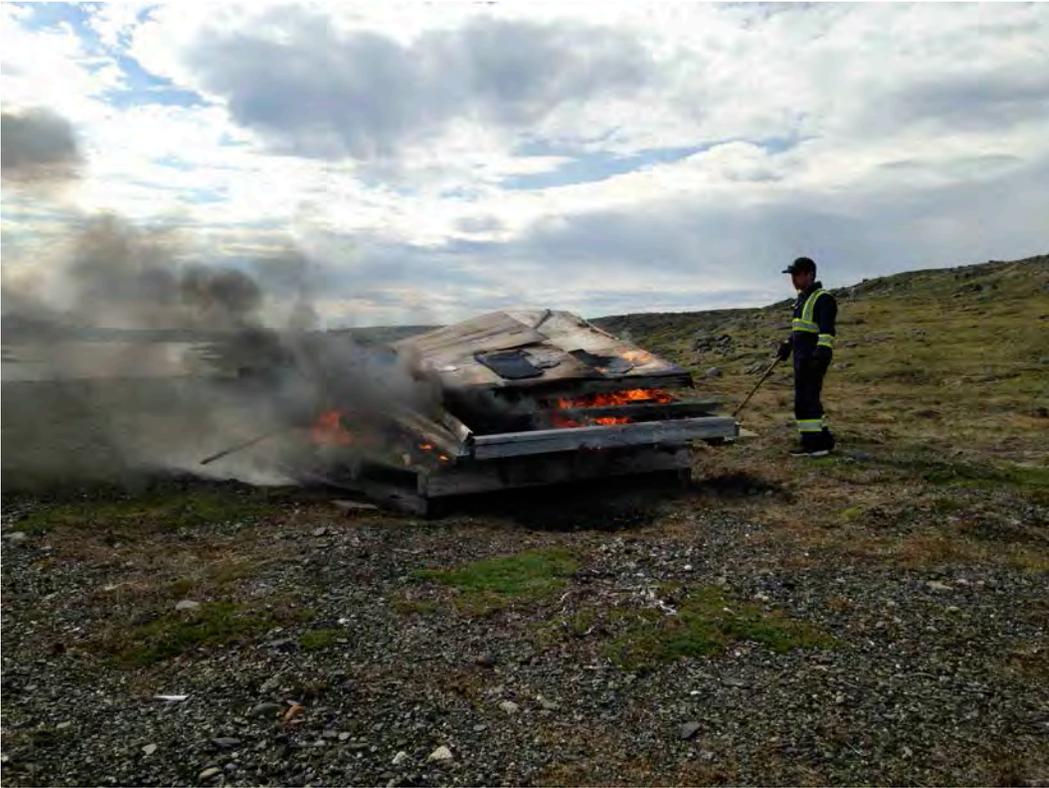
Figure 30: Burning combustible material on site WB-9, July 2014

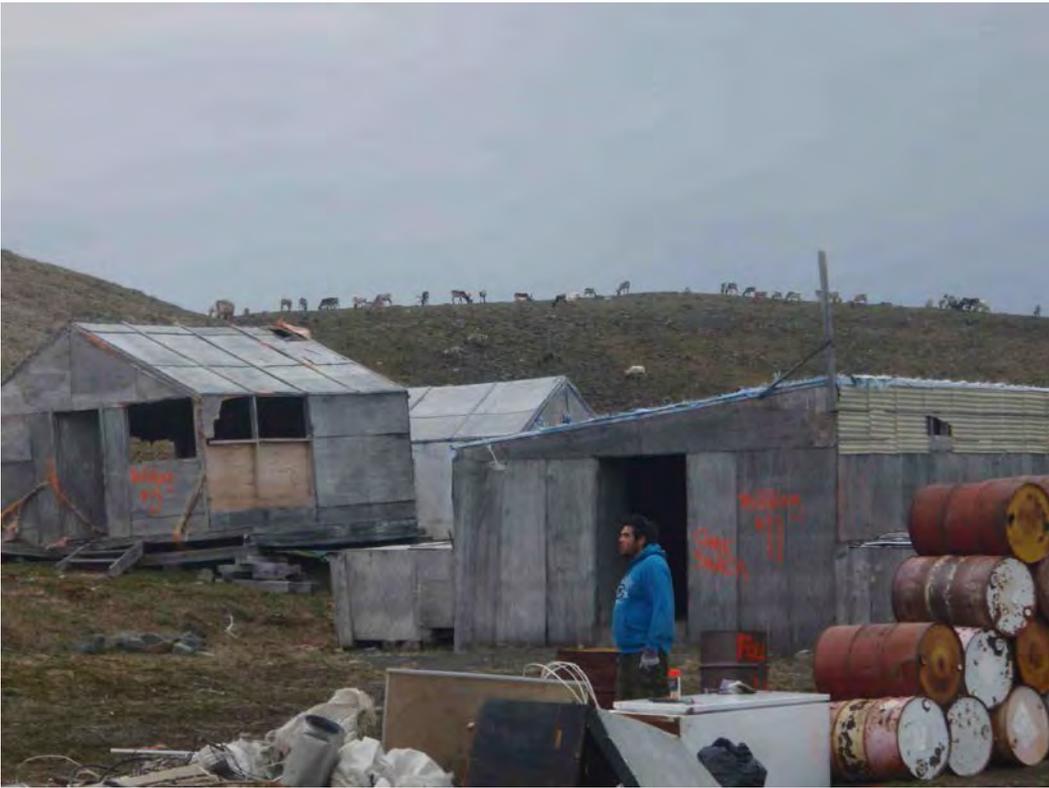
Figure 31: Caribou seen at site WB-9, July 2014

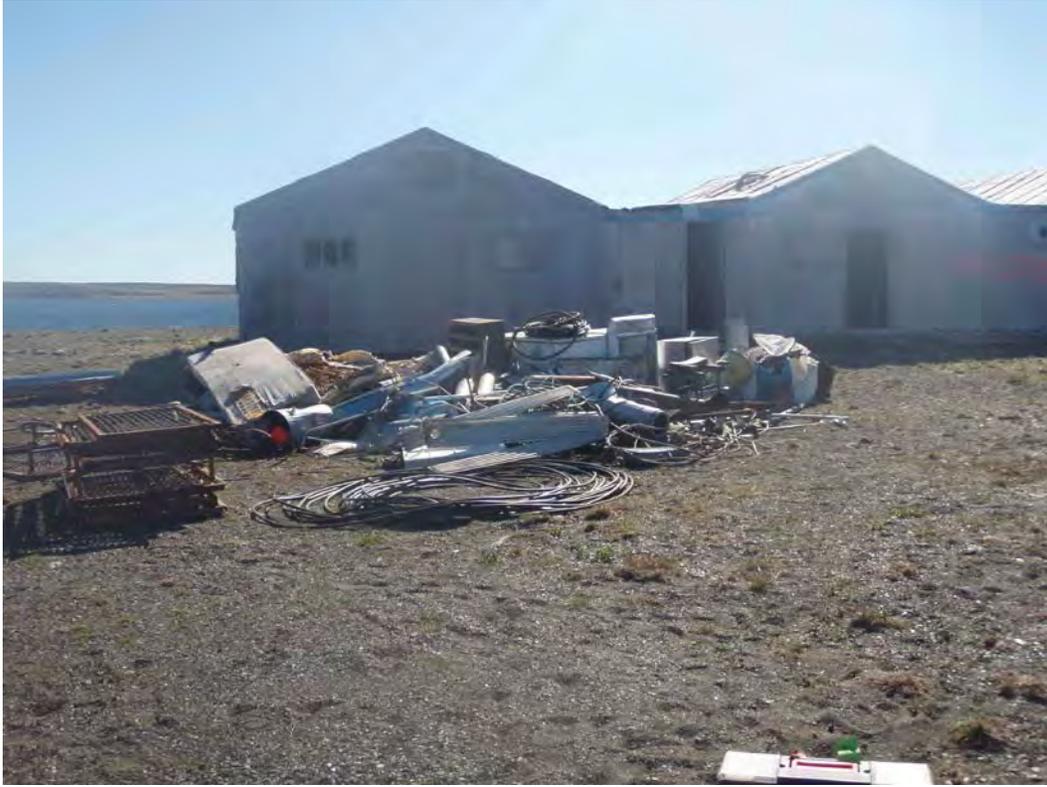
Figure 32: Some of the debris removed from buildings on site WB-9, July 2014

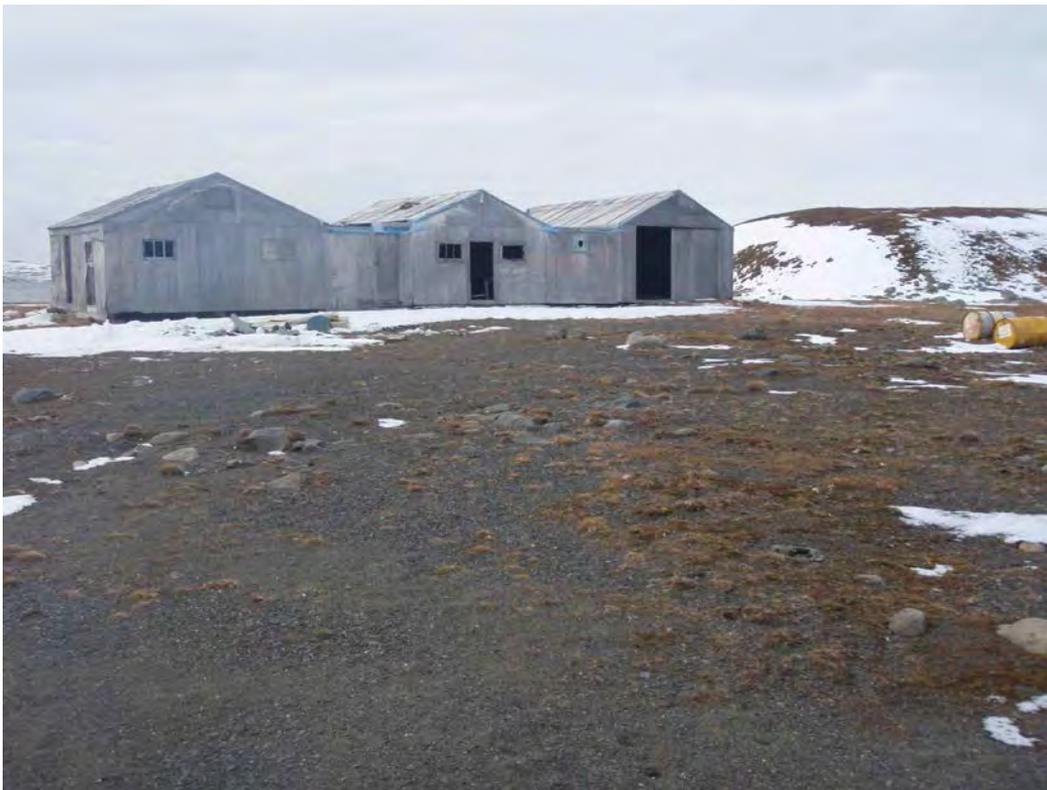
Figure 33: View of site WB-9 after removal of debris, September 2014

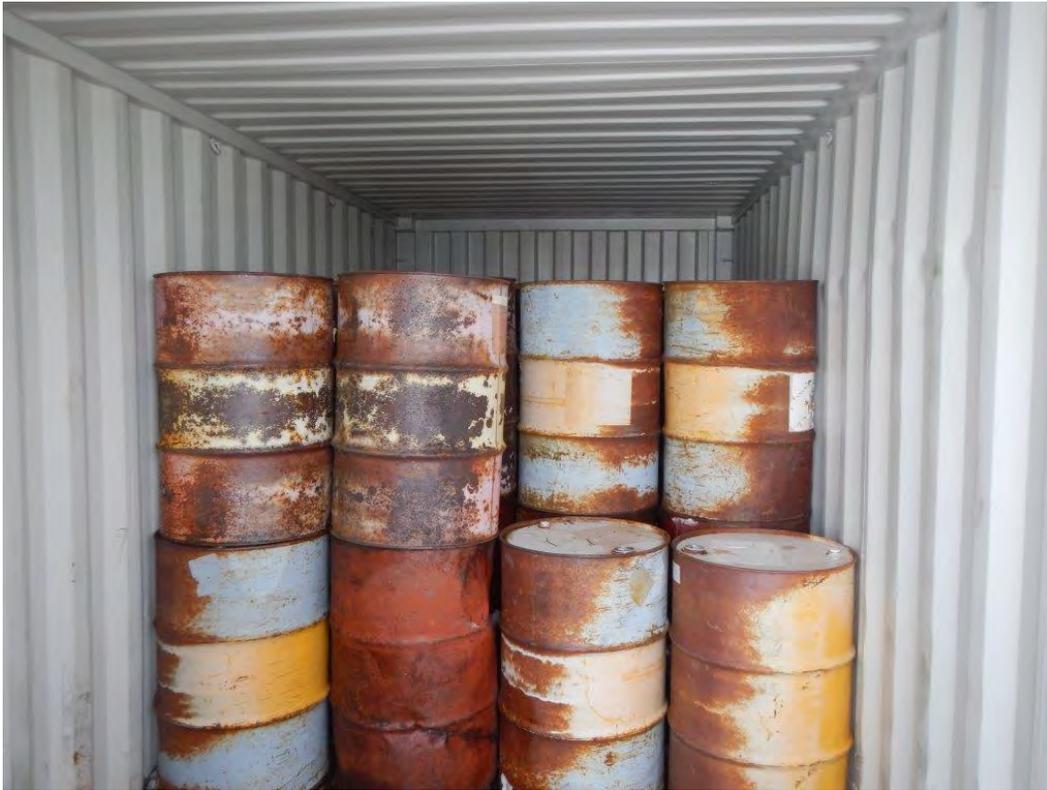
Figure 34: Empty drums from site WB-9 stored in marine container at East Lake, September 2014

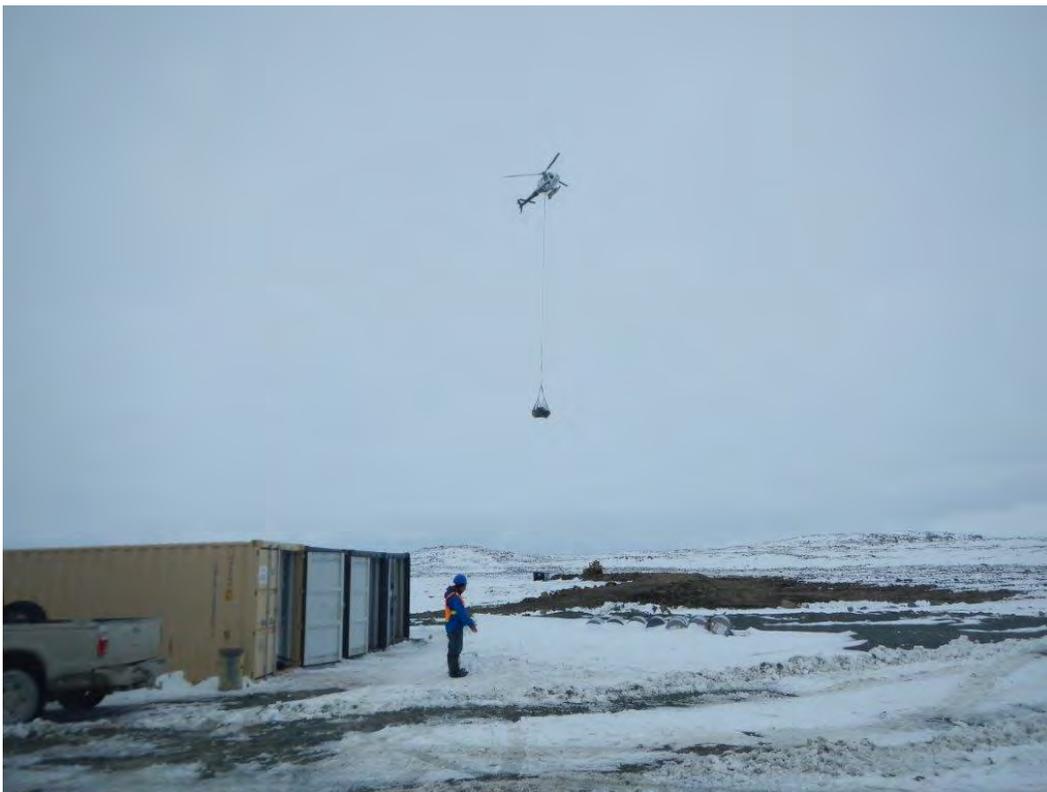
Figure 35: Singing loads of debris from site WB-9 to East Lake, September 2014

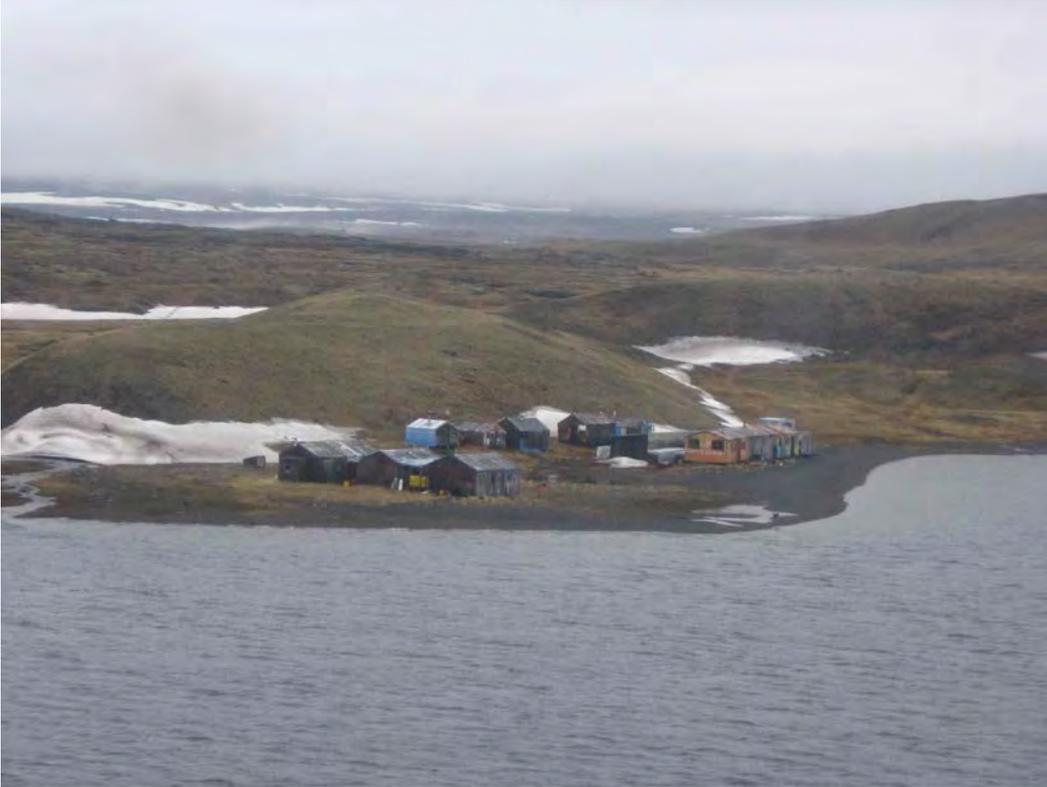
Figure 36: View of WB-9, July 2007

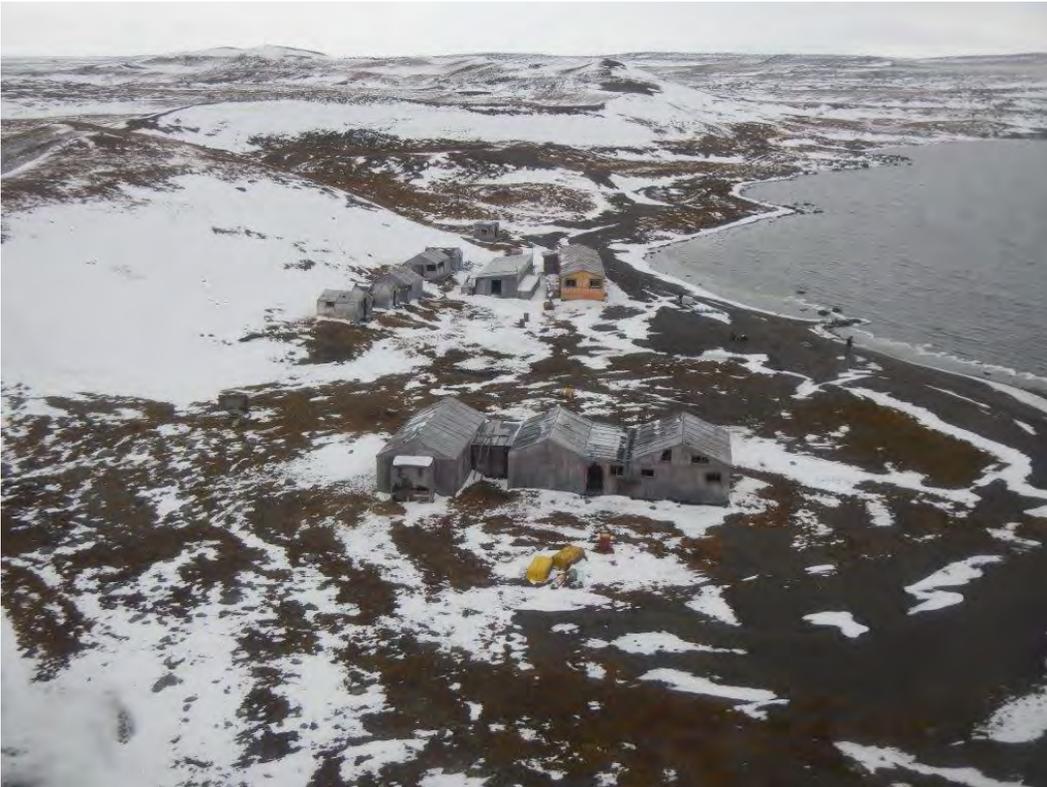
There remain approximately 33 full drums at site WB-9 and a small volume of debris. One of the full drums has a puncture and will need to be transferred into a suitable replacement drum. Conditional to a repeat partnership with Glencore in 2015, this material will need to be transported, by helicopter, to East Lake and stored in marine containers where it will be shipped to a recycling facility in Montréal. The KRG will need to communicate with Glencore regarding this work and organize any necessary logistics.

Figure 37: Site WB-9 after Phase 1 of cleanup, September 2014

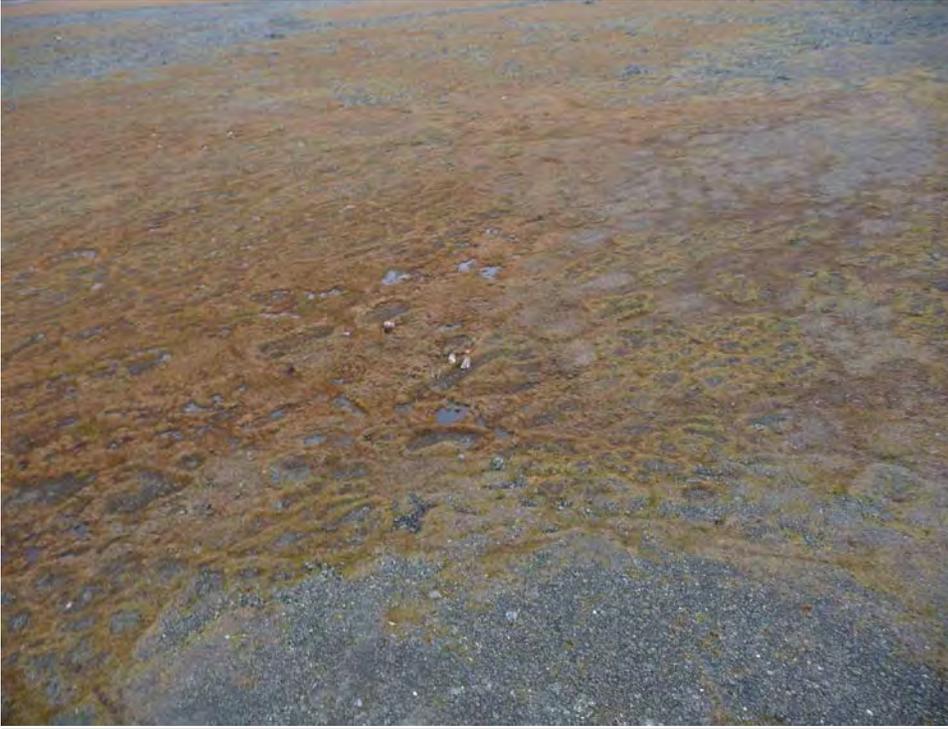
Parent Lake

Figure 38: Debris found at site known as Parent Lake, September 2011

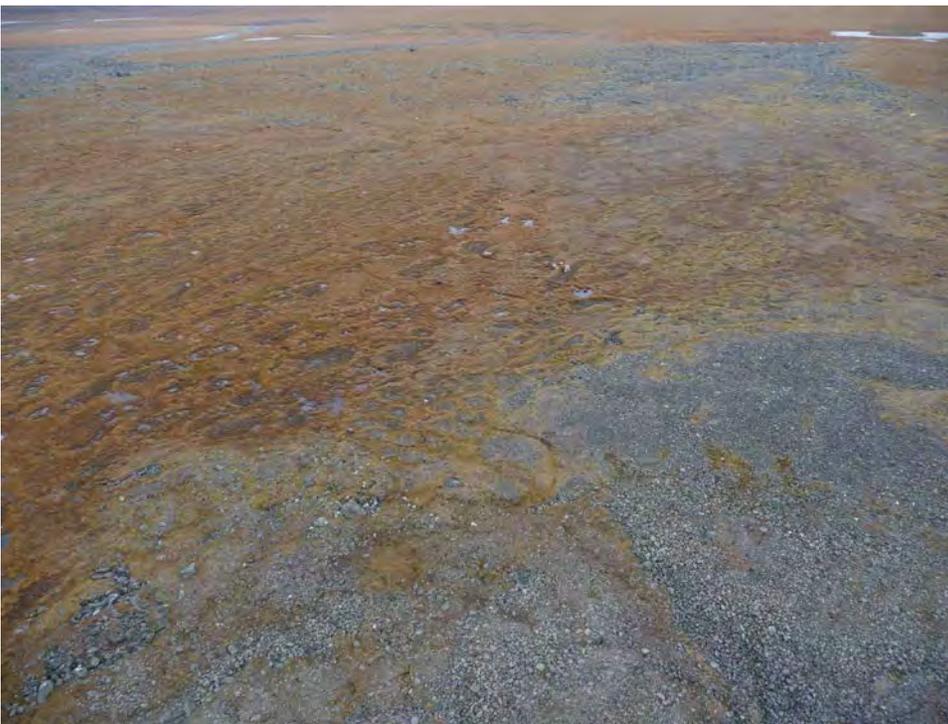
Figure 39: Debris found at site known as Parent Lake, September 2011

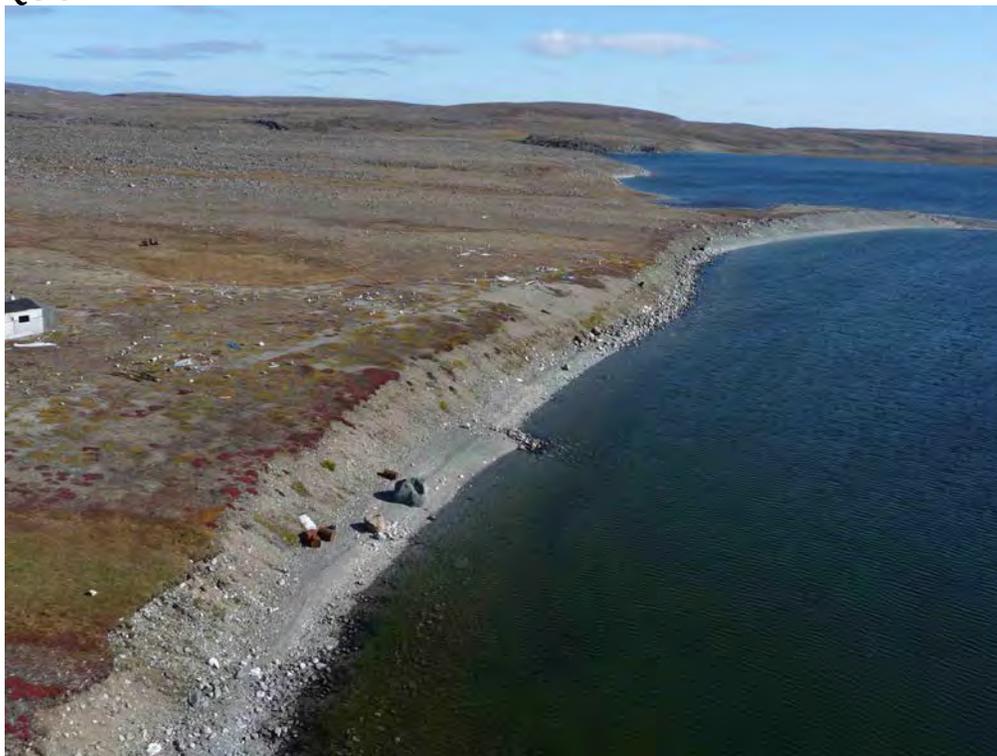
QC-3

During the 2011 inspection it was noted that an active Inuit camp occupied the site. Approximately 25 drums were found on or near the site as well as other debris.

Figure 40: Debris and Inuit camp located at site QC-3, September 2011

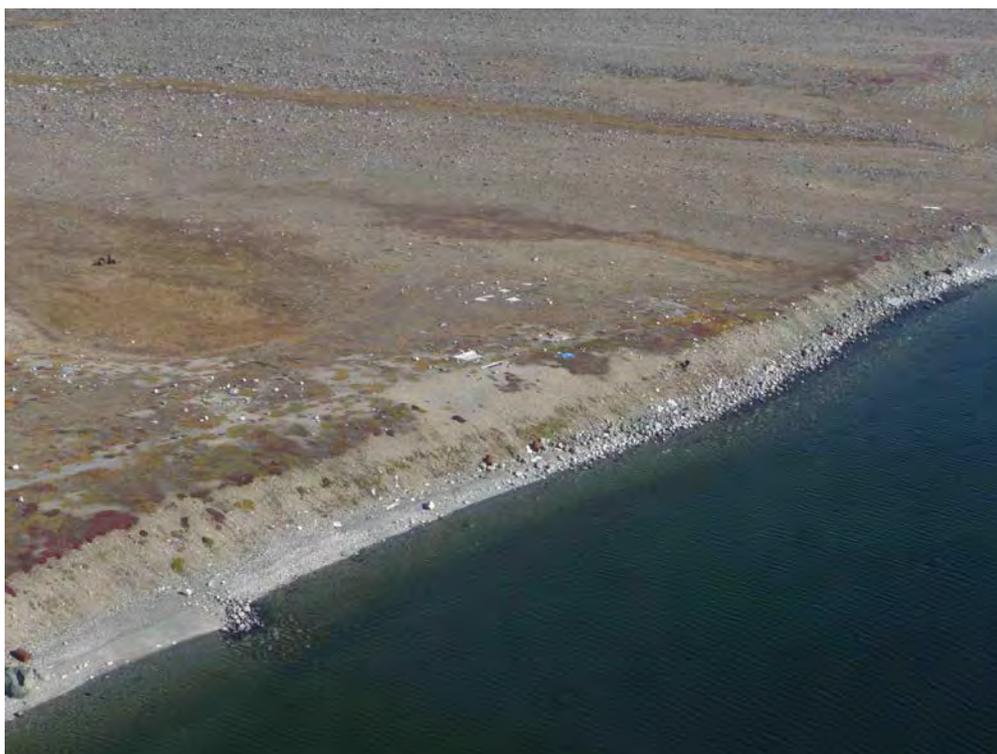
Figure 41: Debris at site QC-3, September 2011

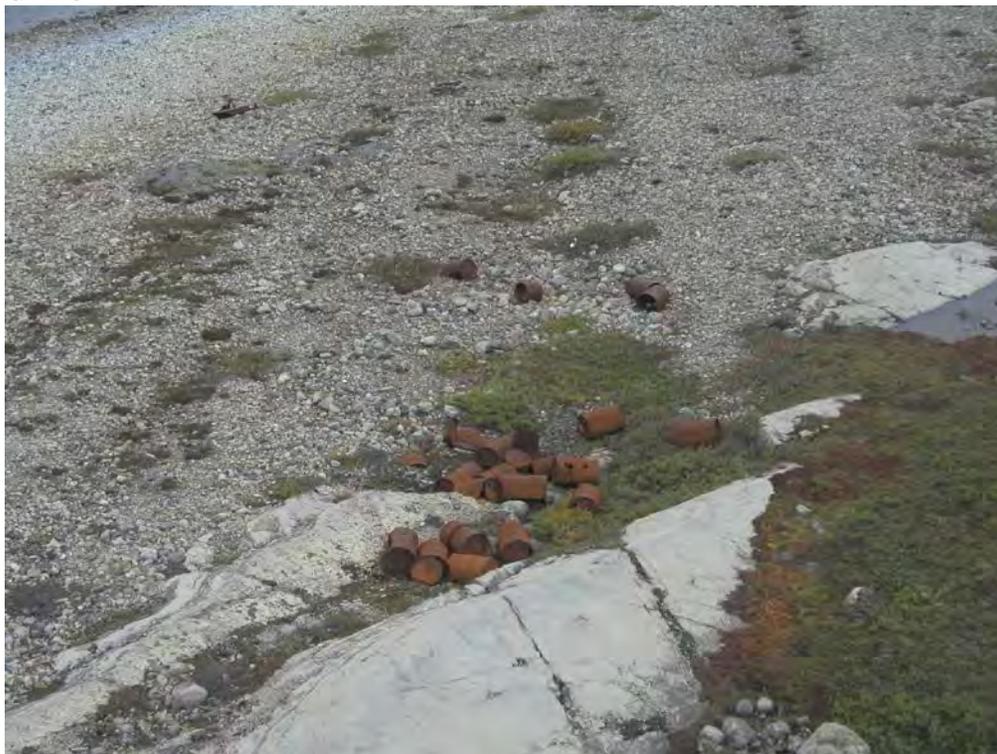
GW-8

The 2001-2002 inventory noted that 25 drums and a snowmobile are located at this site. Due to its location on the Hudson Coast, far from other sites, no follow-up

Figure 42: Site GW-8, located on the Hudson Coast, September 2002

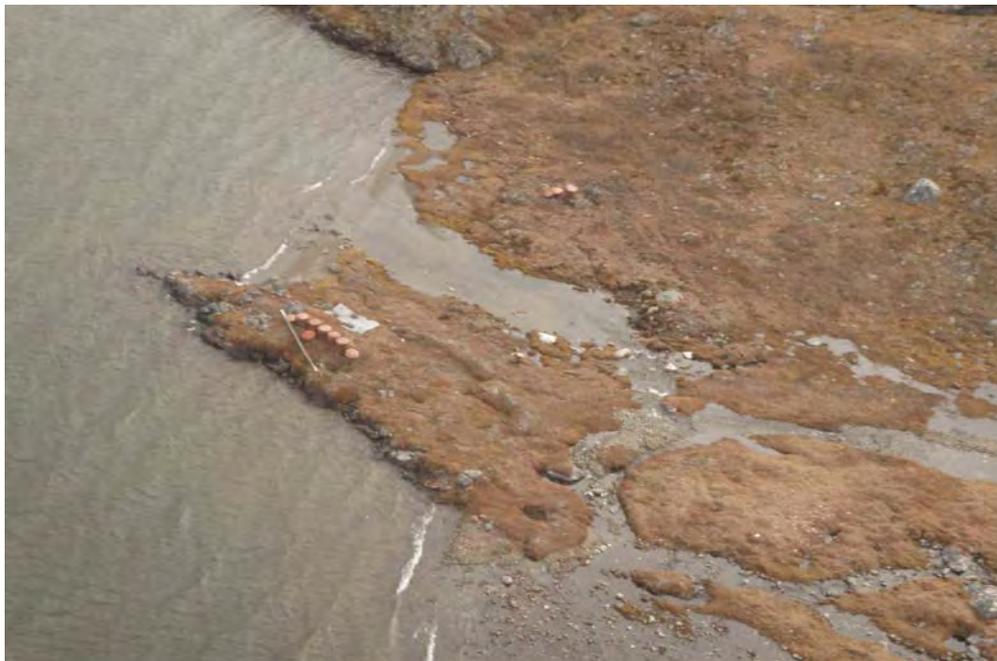
Figure 43: Sector 2 of site KV-1 containing crushed drum and wood, September 2012

Work will consist of gathering barrels and other debris to be removed from the site by helicopter. The combustible material can be burned on location. The site was inspected in September 2012 and photographs are found in Appendix 4.

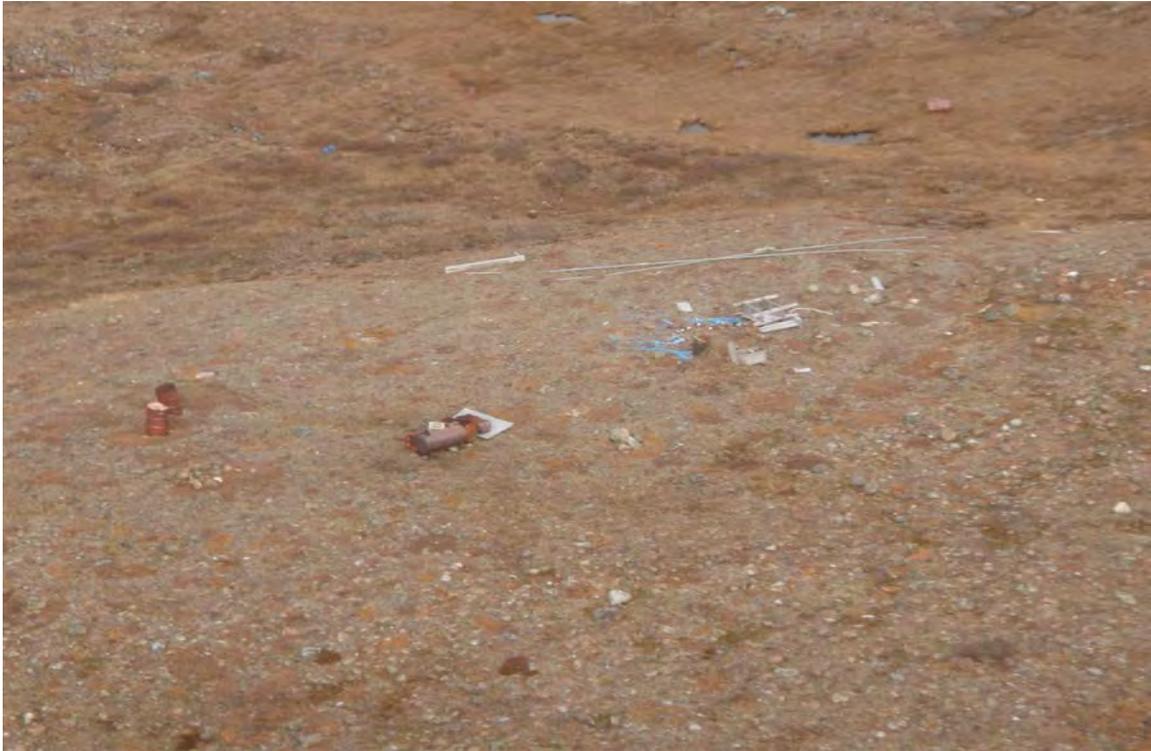
Figure 44: Sector 1 of site KV-1 containing various debris and wood, September 2012

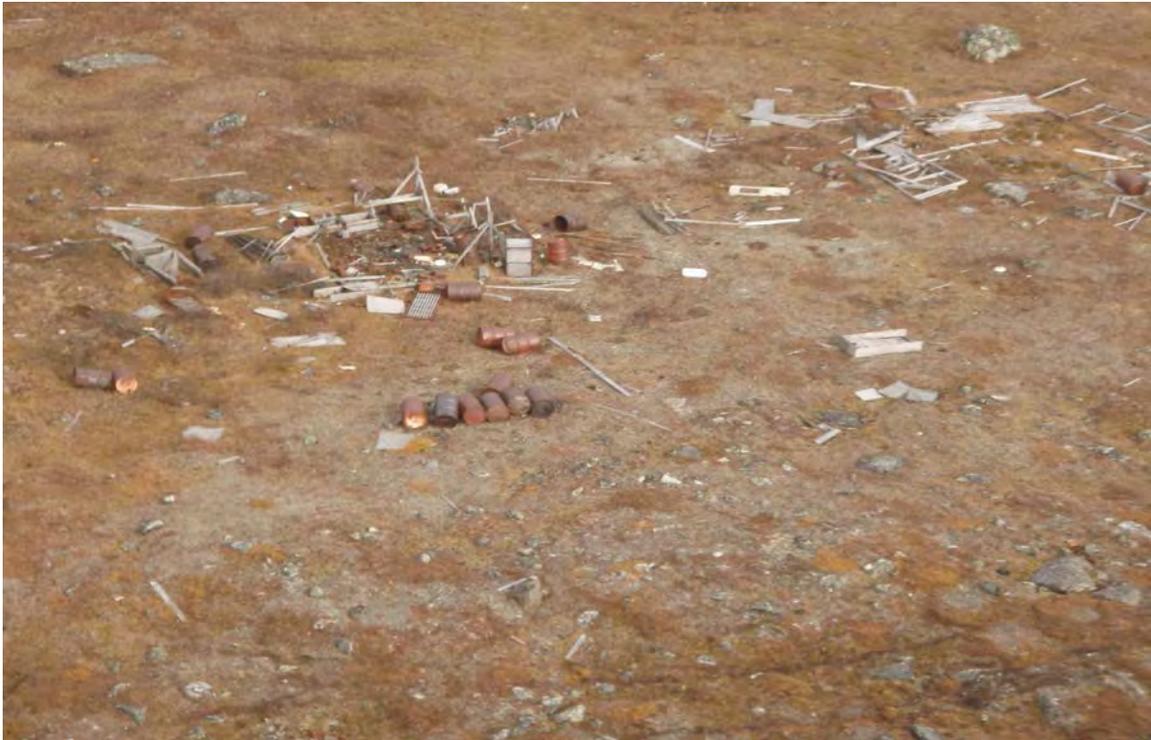
Site SW-27 contains a significant quantity of residual material and hydrocarbons residue: roughly 1650 L of diesel, 260 L of grease and 26 L of oil. Although covering only 2.5 m², hydrocarbon soil contamination is still very evident. Open or damaged barrels of grease were also observed. The site was inspected in September 2012 and photographs are found in Appendix 4.

Figure 45: Sector 1 of site SW-27, containing wood debris, barrels, propane tanks and hazardous waste, September 2012

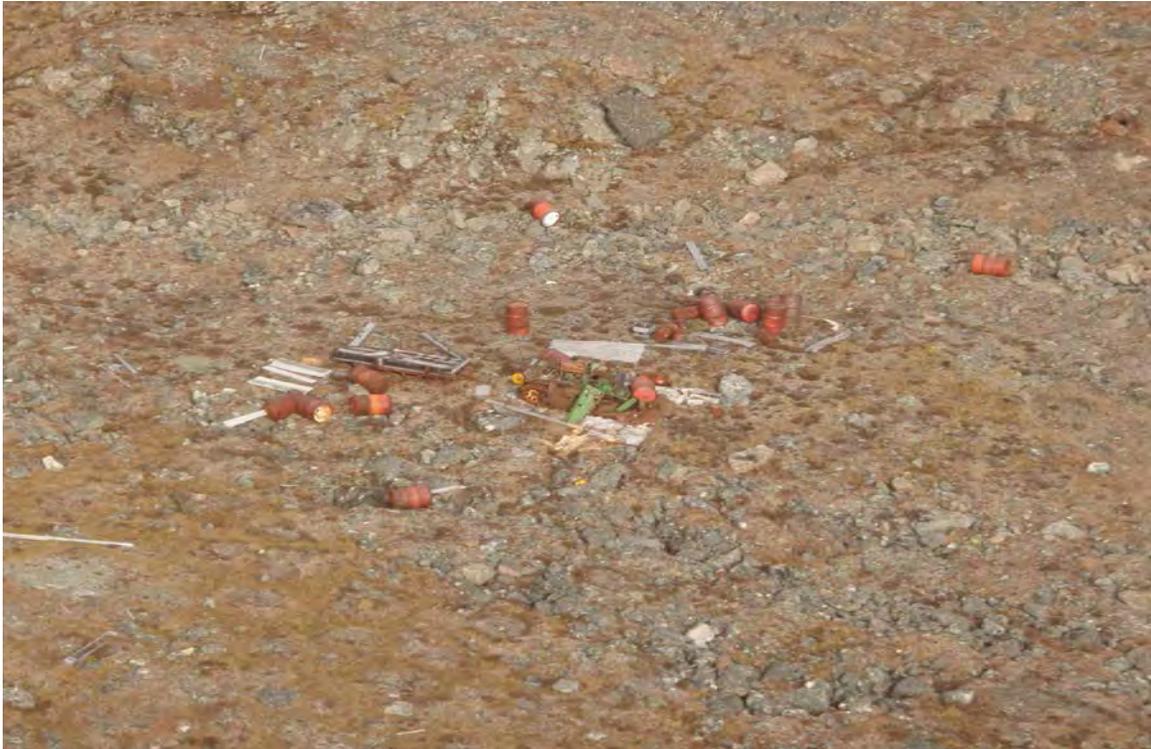
Figure 46: Sector 2 of site SW-27, containing barrels, muskeg, trailer, debris and hazardous waste, September 2012

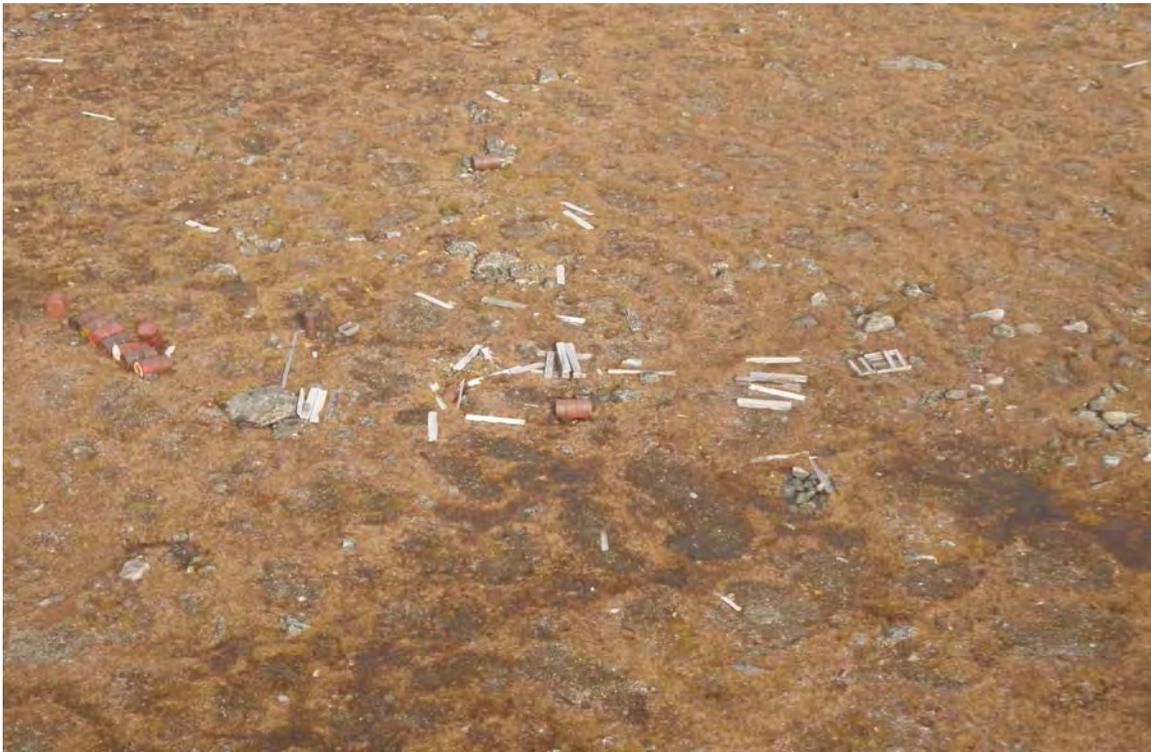
Figure 47: Sector 3 of site SW-27, containing barrels, wood and debris, September 2012

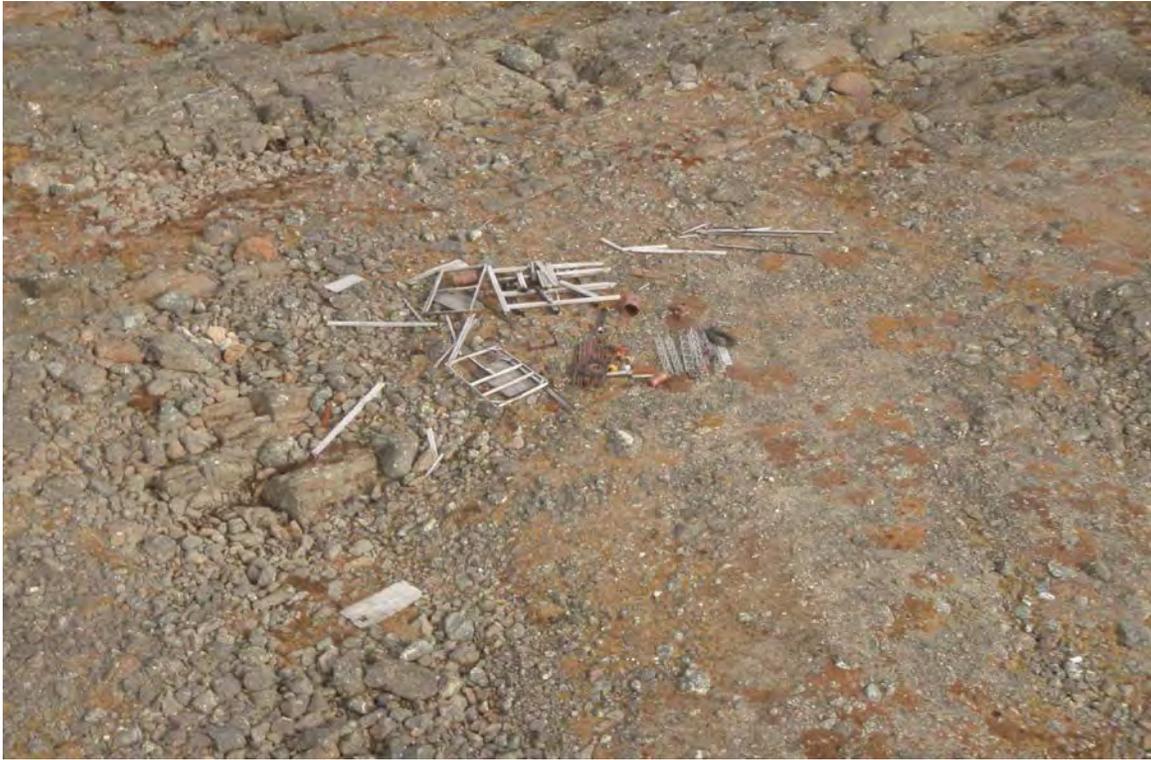
Figure 48: Sector 4 of site SW-27, containing barrels, debris and hazardous waste, September 2012
