# REHABILITATION OF ABANDONED MINERAL EXPLORATION SITES IN NUNAVIK

## 2015-2016 ACTIVITY REPORT

**Kativik Regional Government**

**April 2016**

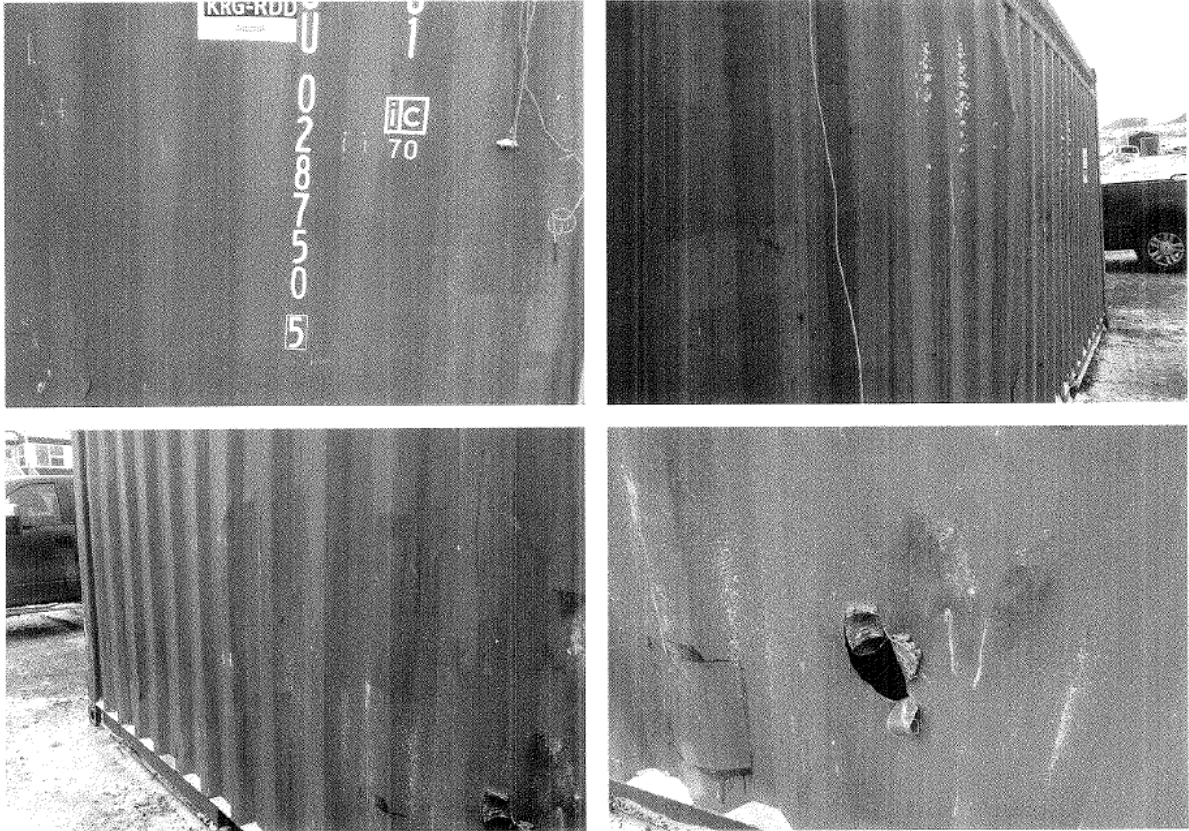
In October 2015 the field technician travelled to Aupaluk to assist the community with the preparation of the remaining material for transportation. The large pieces of equipment had to be stored in open-top containers, one of which was damaged

during the loading process. Due to this unfortunate circumstance, this container will remain in Aupaluk until next sealift season, at which point the container will need to be replaced. In 2015, 15 tonnes of material was removed from the community of Aupaluk. Pictures of this work and remaining material can be found in Appendix 2.

Figure 1: Photo of damaged container that will remain in Aupaluk, October 2015

In 2015 nearly all of the material being stored in the community of Aupaluk was removed by ship. However, one final container of metal will need to be properly packaged and ready to be transported by ship. Due to the damage incurred during the loading of this container, a replacement will be needed.

In 2016, the KRG will need to find a replacement container in Aupaluk or have one ordered and delivered by ship at the beginning of the sealift season. The material will need to be removed from the damaged container and stored in the replacement

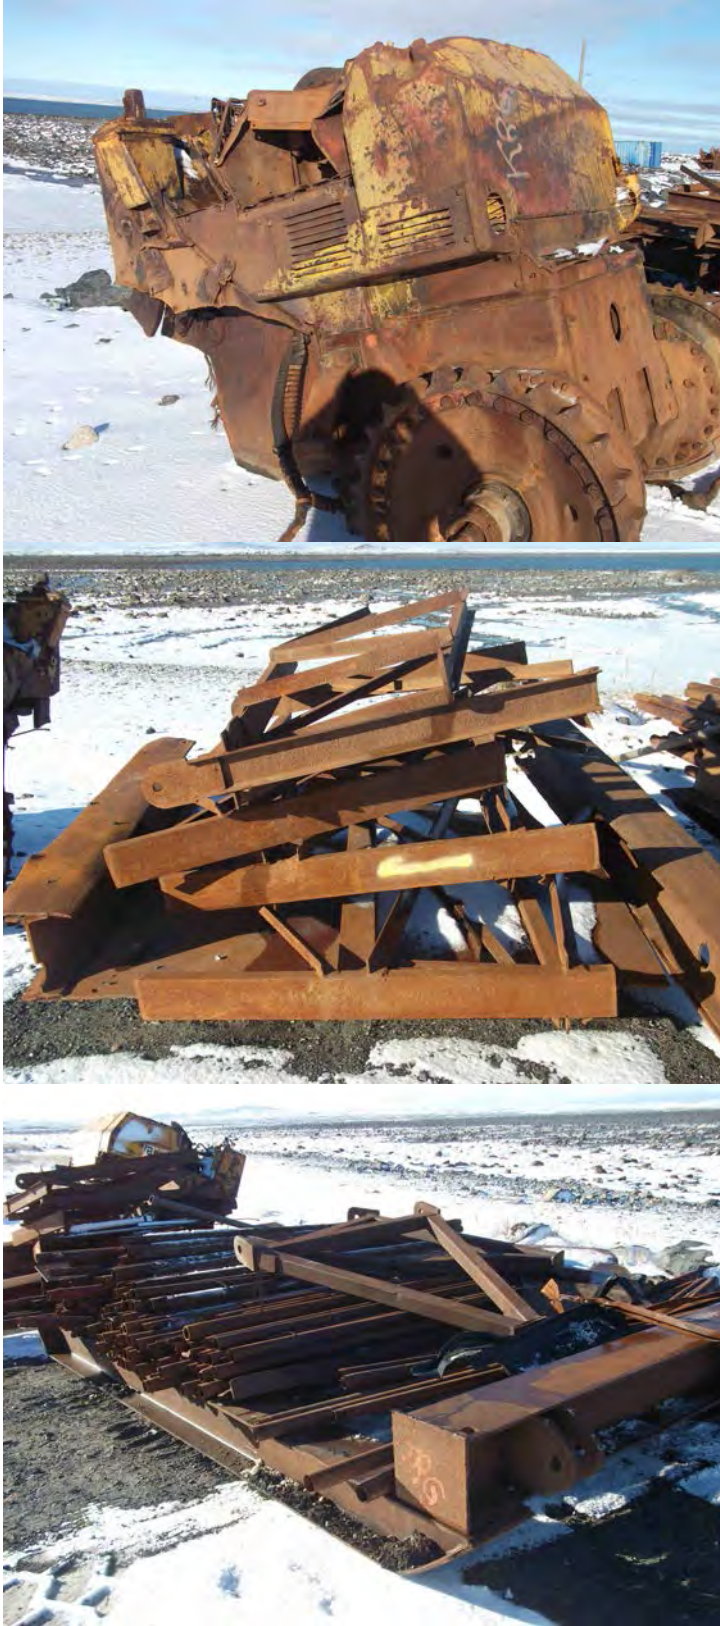
Figure 2: Example of debris that was transported from Aupaluk, October 2014

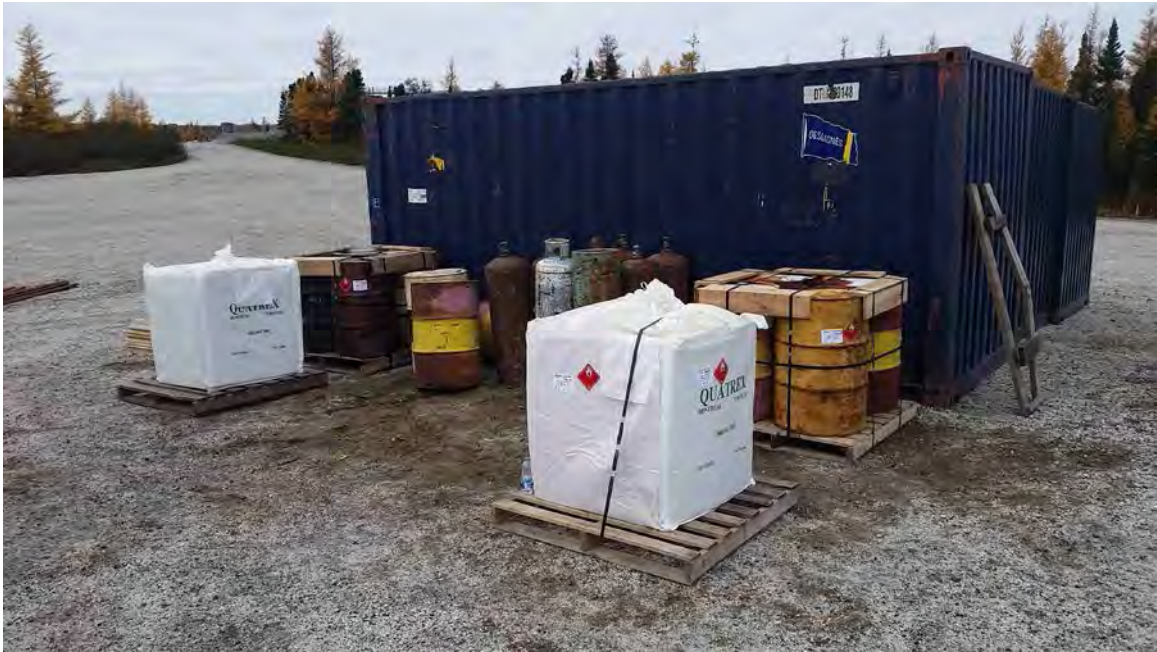
Figure 3: Hazardous material from Gerido Lake packaged and ready for transportation, September 2015.

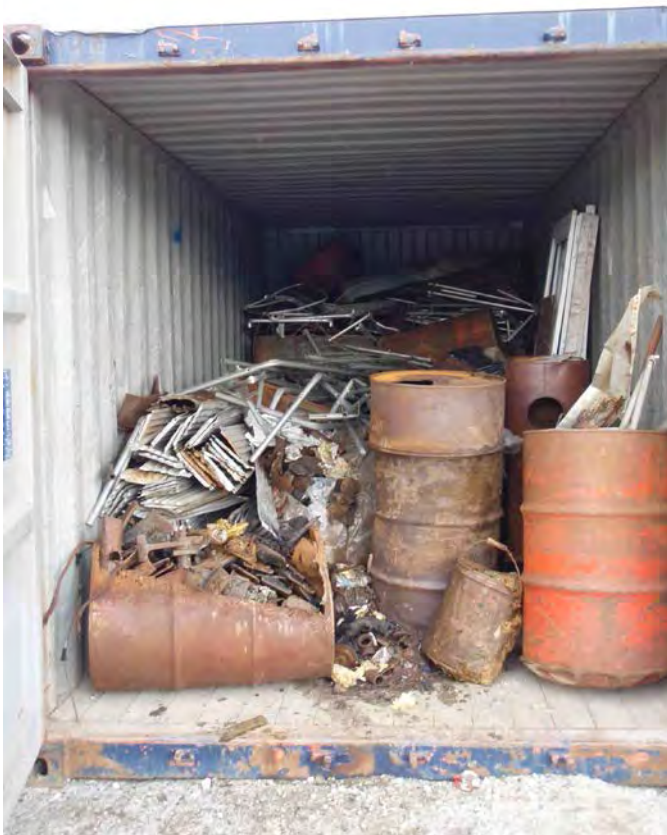
Figure 4: Container of material from Gerido Lake, ready for transportation, September 2015

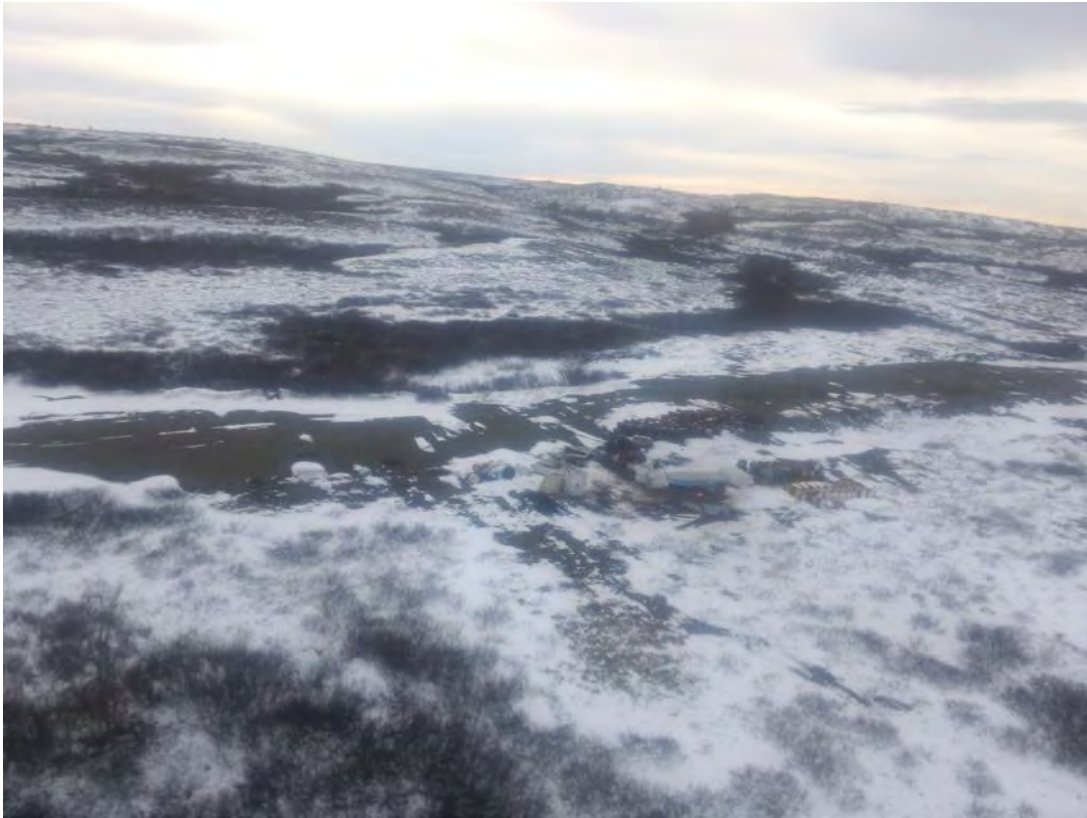
Figure 5: Gerido Lake airstrip, before cleanup, September 2015

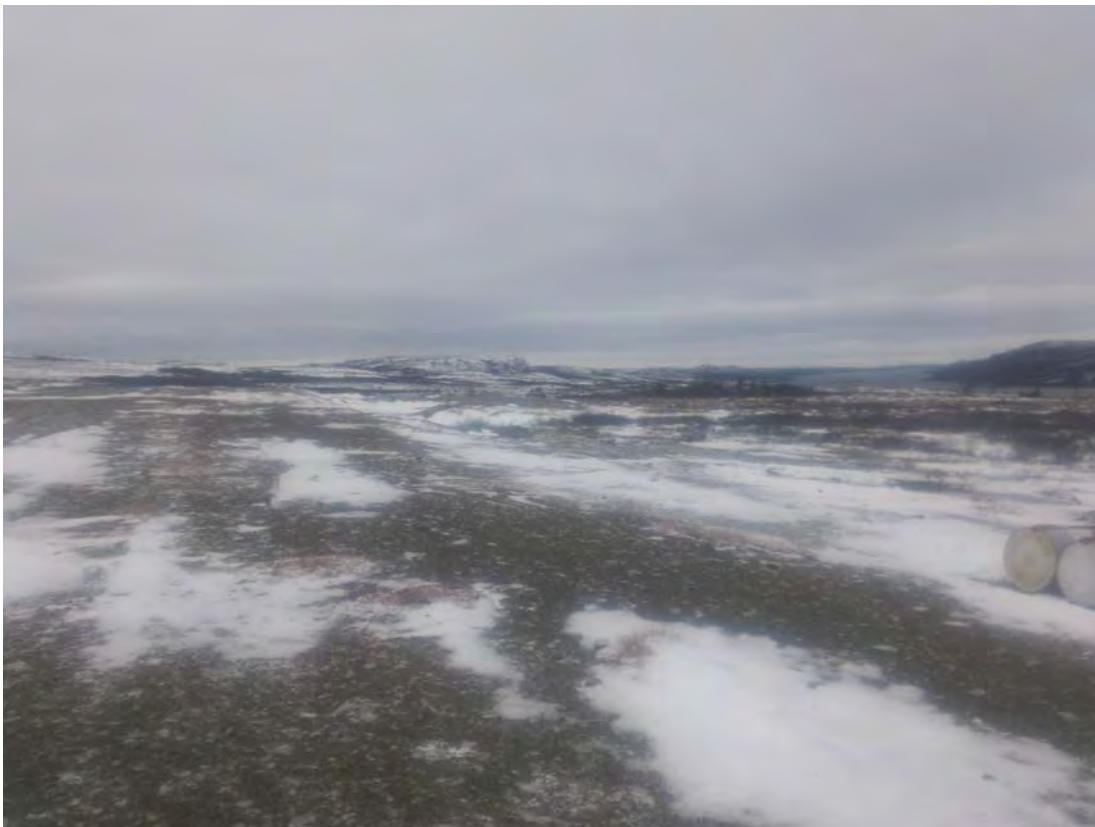
Figure 6: Gerido Lake airstrip, after cleanup, September 2015

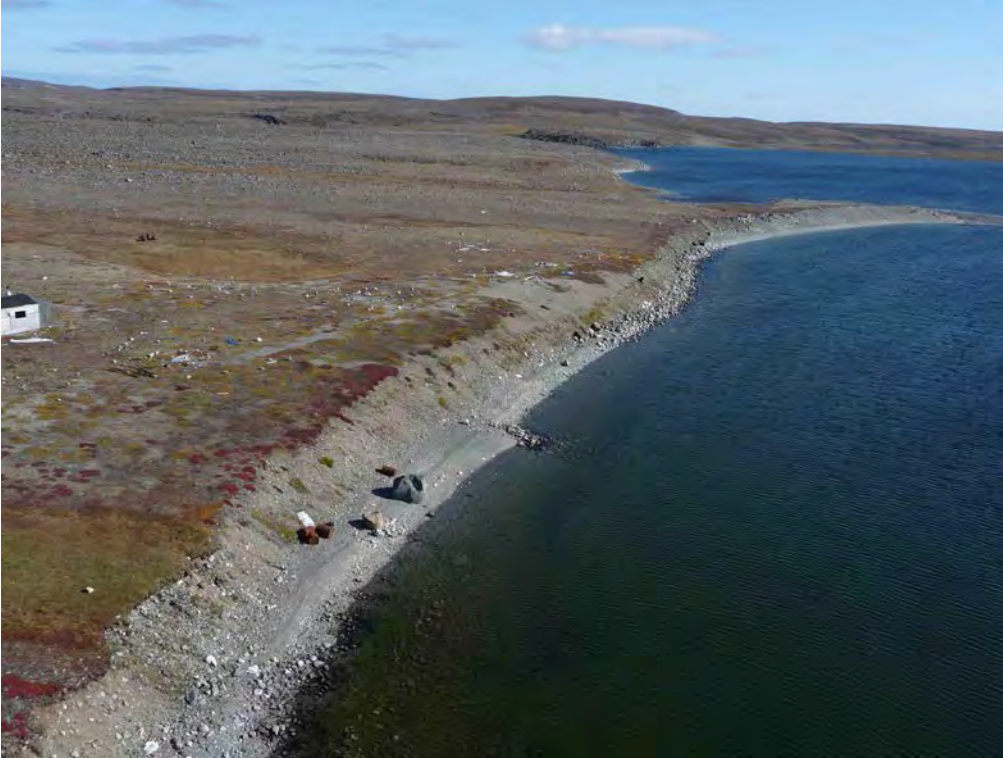
During the 2011 inspection it was noted that an active Inuit camp occupied the site. Approximately 25 drums were found on or near the site as well as other debris.

Figure 7: Debris and Inuit camp located at site QC-3, September 2011

In 2015 the Field technician, with assistance from the community of Kangirsuk and 4 workers, removed all debris from the site, which was transported by helicopter to the community of Kangirsuk and stored in a marine container. The container was then shipped, in October 2015, to a recycling facility in Montreal. Approximately 14 tons of material was removed from site QC-3 and is now considered as complete. Pictures of this work can be found in Appendix 2.

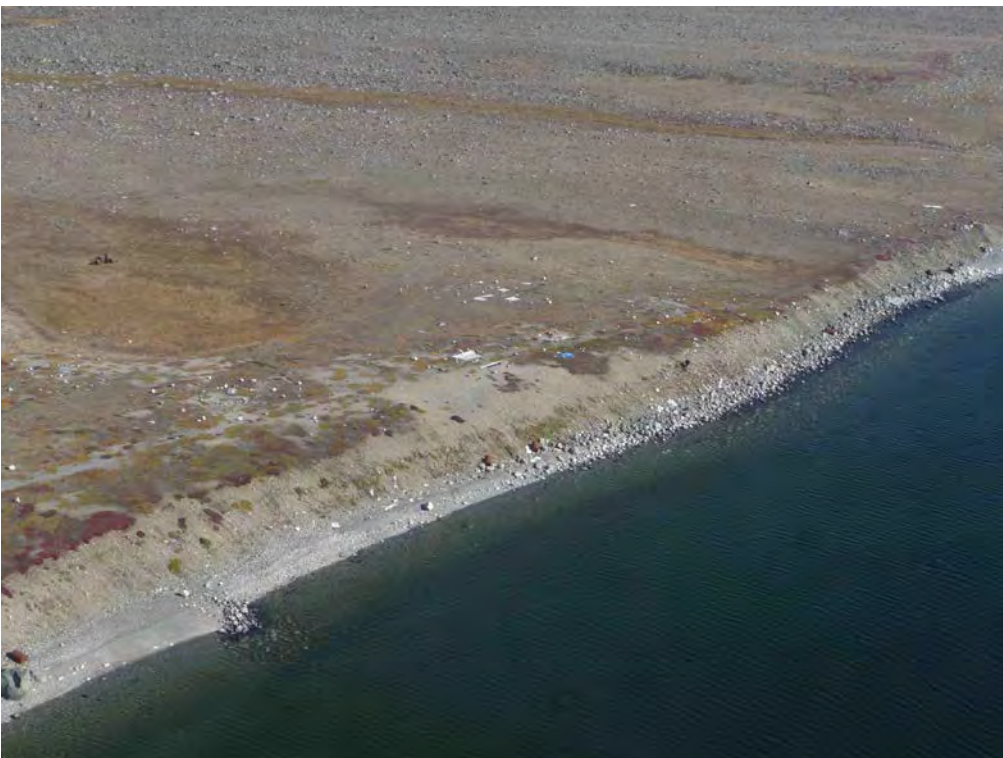
Figure 8: Debris at site QC-3, September 2011

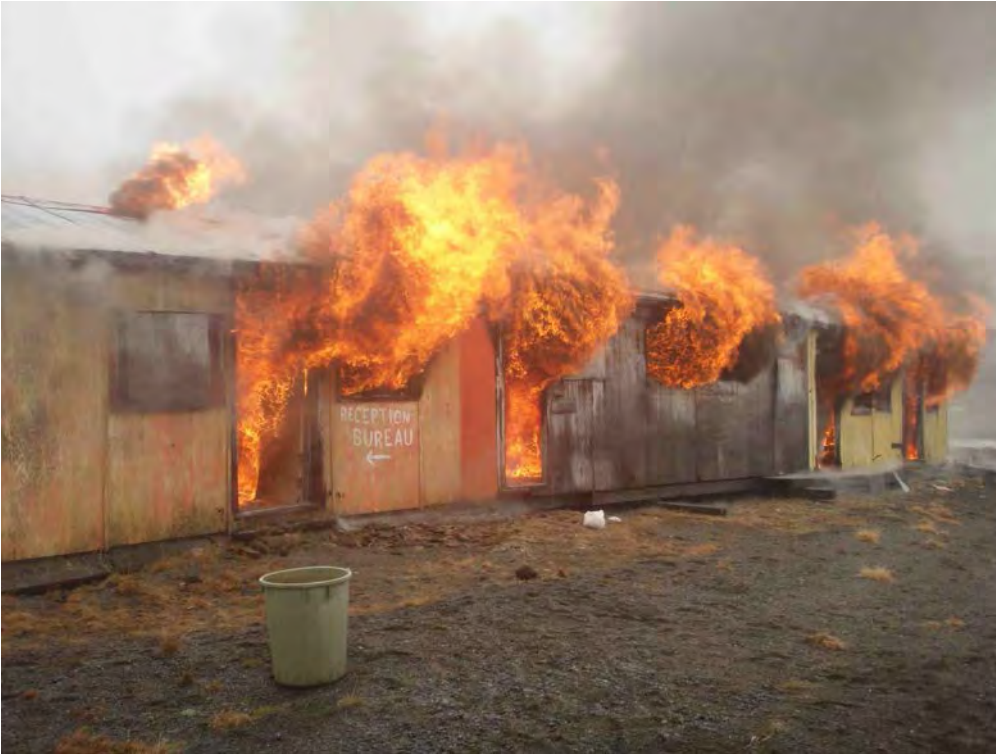
Figure 9: Burning building #10 at site WB-9, July 2015

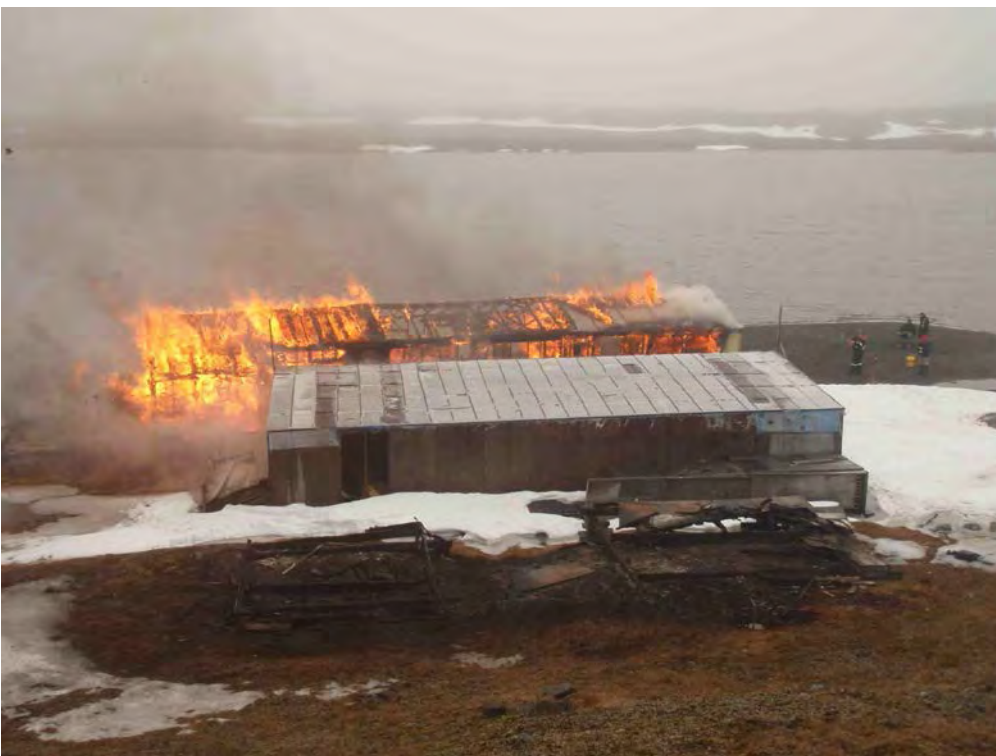
Figure 10: Burning building #10 at site WB-9 (Core shack in forefront), July 2015

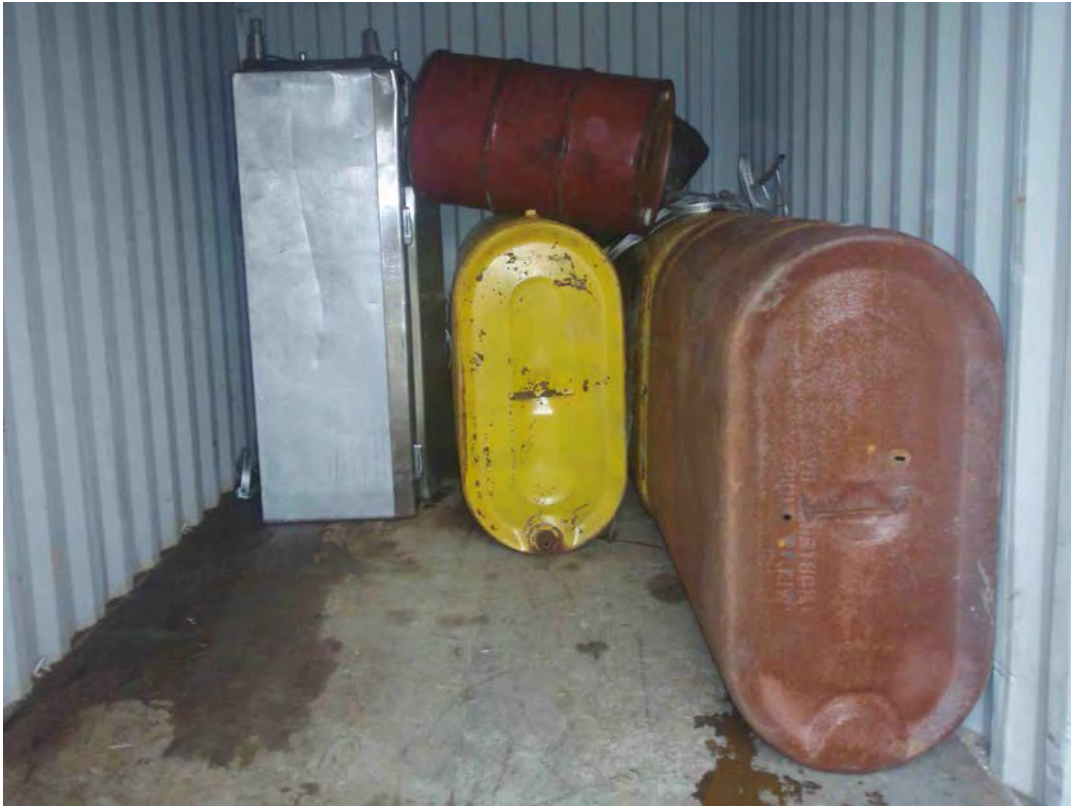
Figure 11: Material from WB-9 stored in containers at East Lake, July 2015

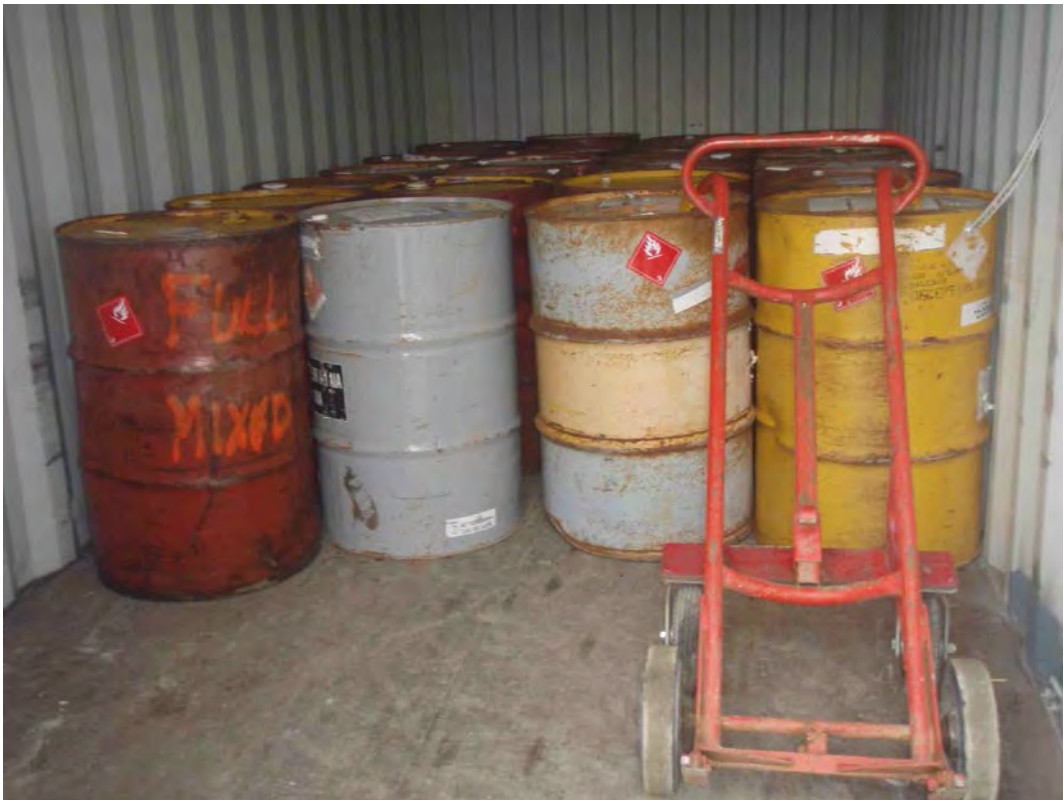
Figure 12: Material from WB-9 stored in containers at East Lake, July 2015

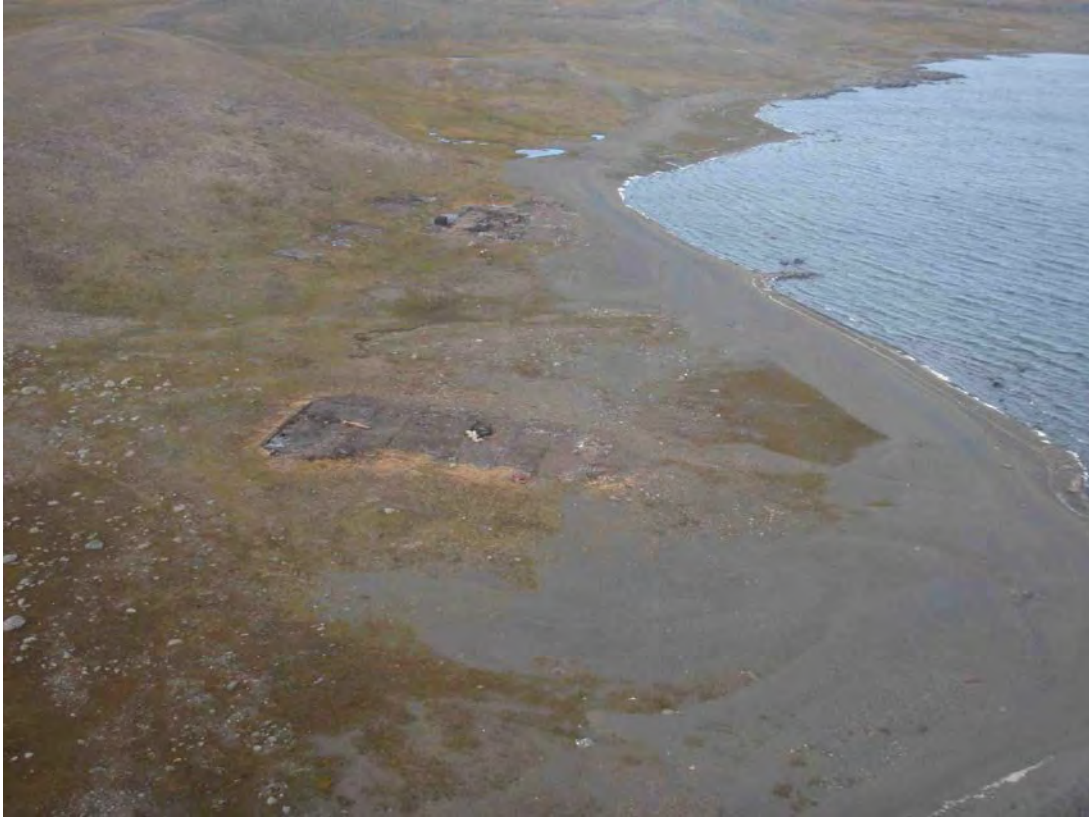
Figure 13: Site WB-9, aerial view of buildings #7-11, September 2015.

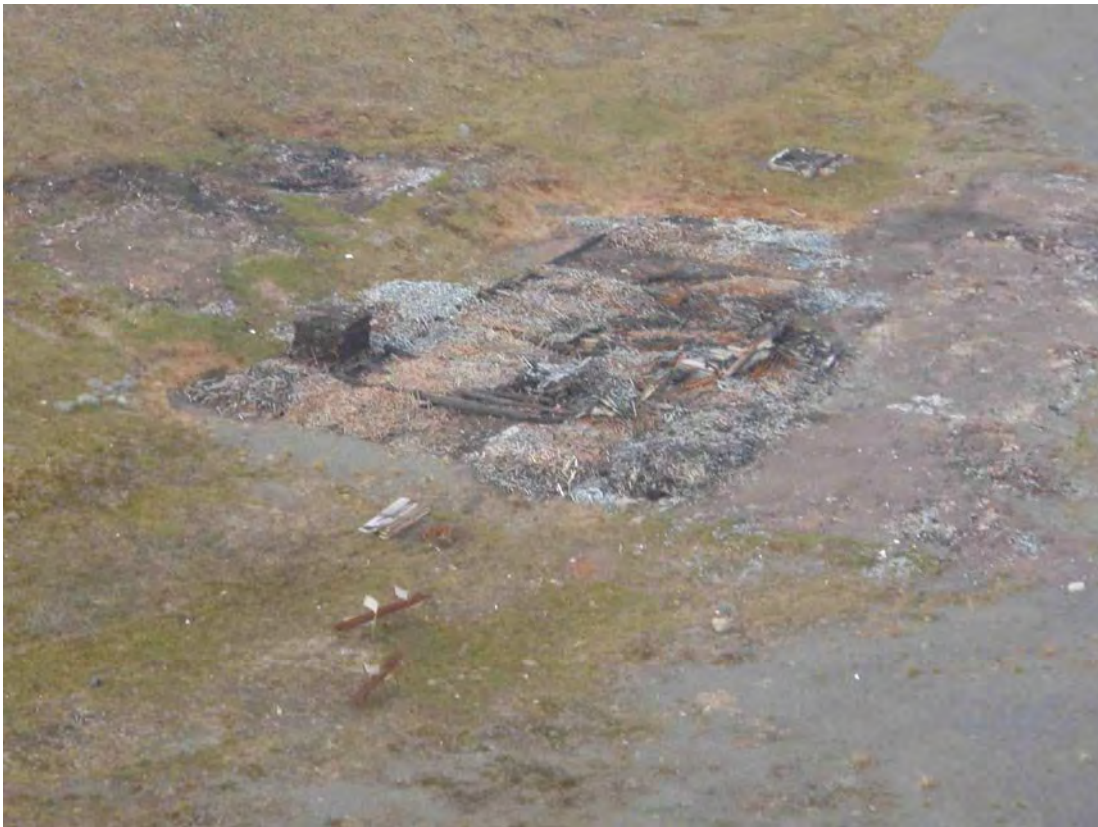
Figure 14: Site WB-9, aerial view of buildings #5, 6, 7, 10 and 11, September 2015.

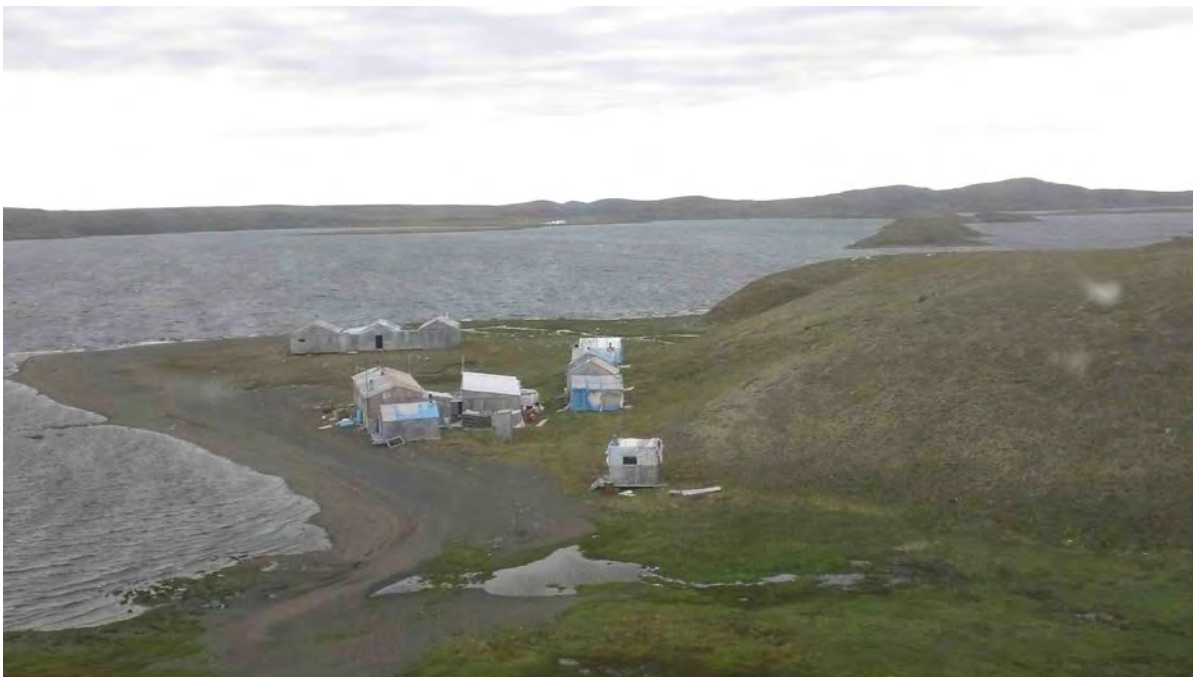
Figure 15: View of WB-9, before cleanup, July 2015

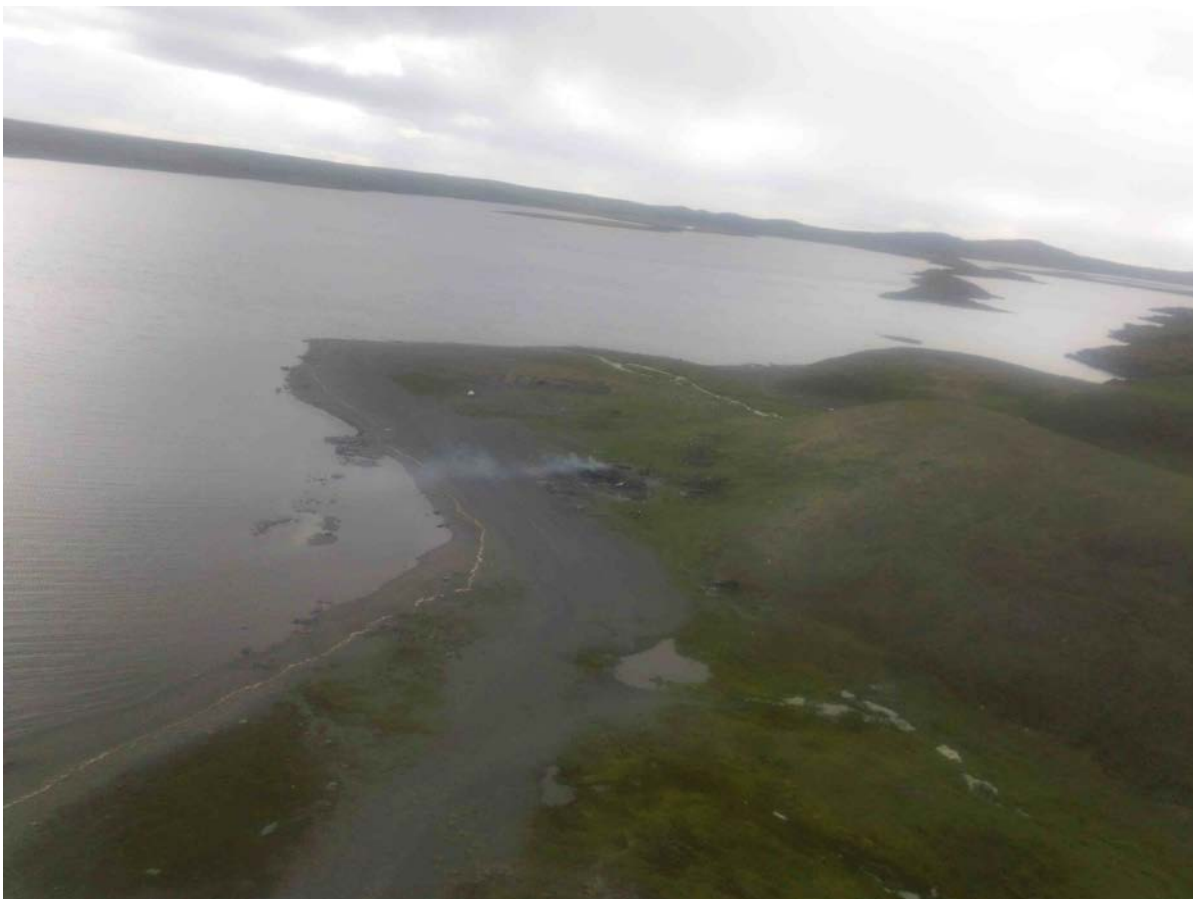
Figure 16: Site WB-9 after cleanup, September 2015

Due to the amount of buildings burned on site it recommended that a final cleanup be undertaken at the site to ensure all smaller pieces of metal and debris have been removed. Consequently, work will continue of this site in 2016 and is described in Section 6 of this report.

After having burned all combustible material on site in 2015, a final sweep of the site will be necessary in 2016 to remove any smaller debris that may have been difficult to see while buildings burned or smoldered. In collaboration with the Northern Village of Salluit, a team of workers, accompanied by a field supervisor, will need to spend 1-2 days on site collecting the debris and preparing it for transportation by helicopter. It is suggested that a magnet be purchased and used in order to collect smaller debris such as nails and screws. Conditional to a repeat partnership with Glencore, this material will need to be transported, by helicopter, to East Lake and stored in marine containers where it will be shipped to a recycling facility in Montréal. The KRG will need to communicate with Glencore regarding this work and organize any necessary logistics.

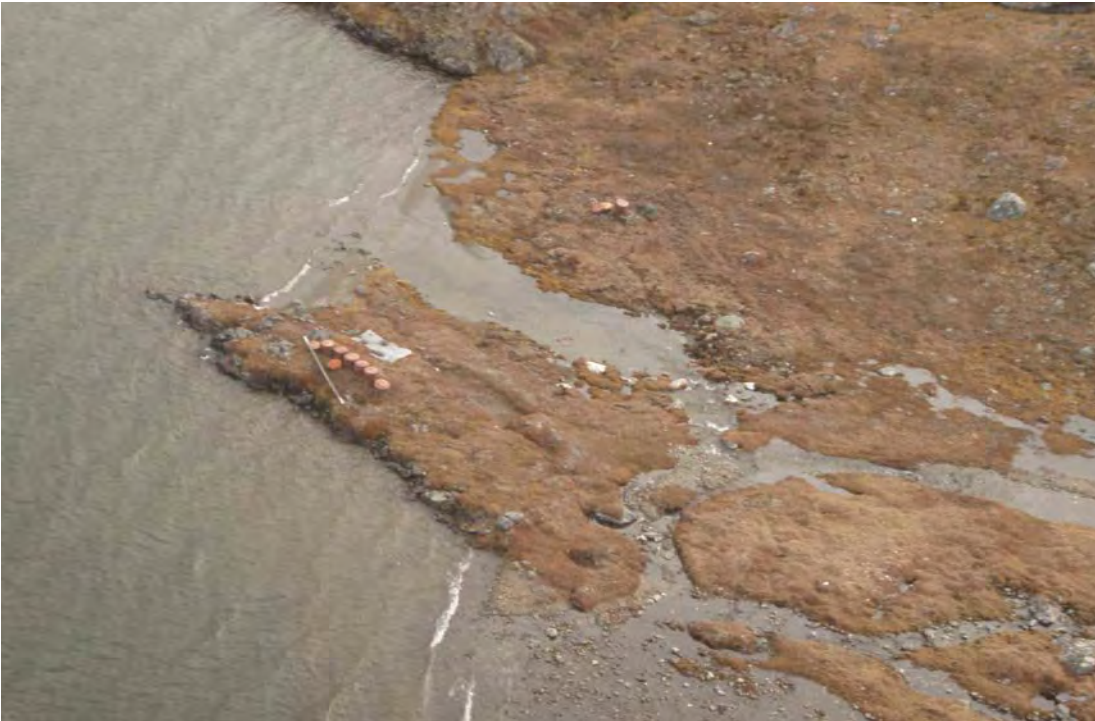
Figure 17: Sector 2 of site KV-1 containing crushed drum and wood, September 2012

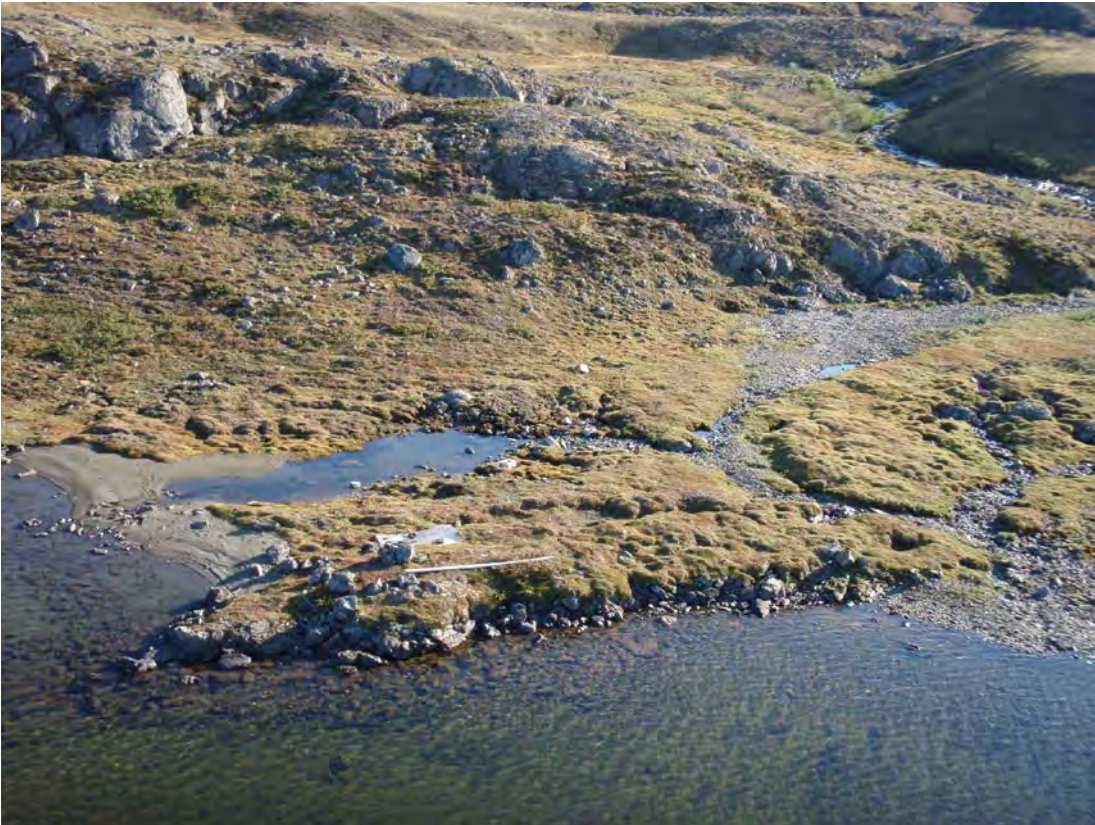
Figure 18: Sector 2 of site KV-1 after metal debris removed, September 2015

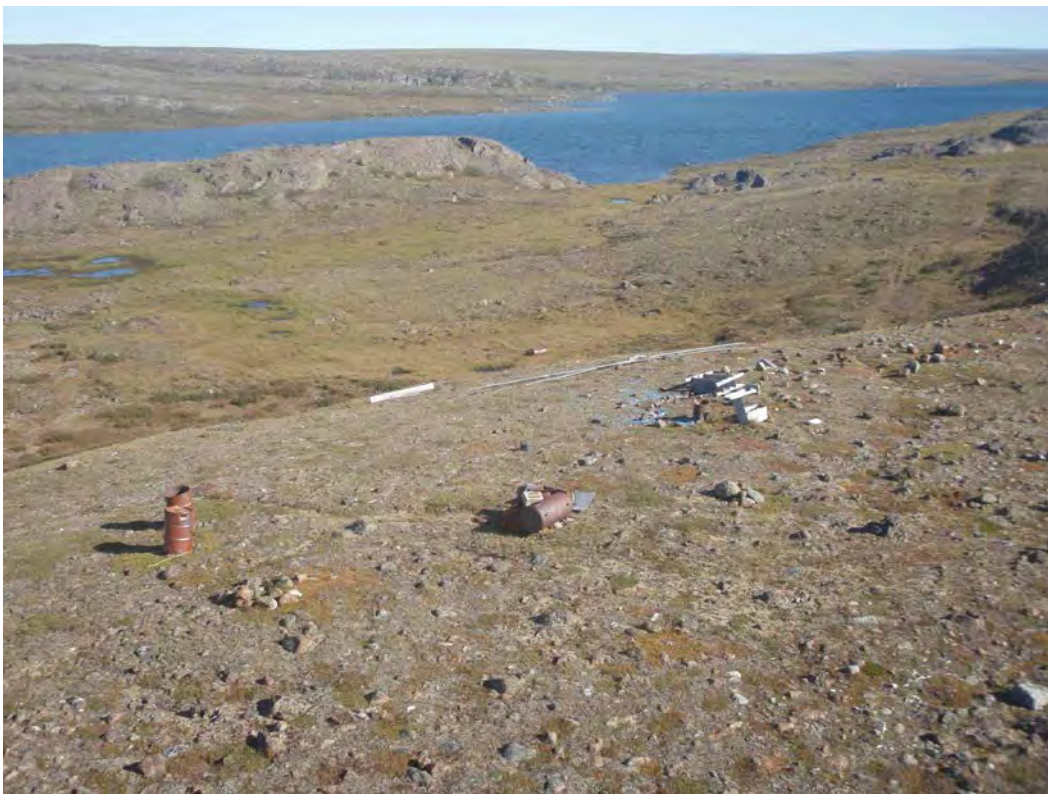
Figure 19: Sector 1 of site KV-1 containing drums, metal debris and wood, September 2015

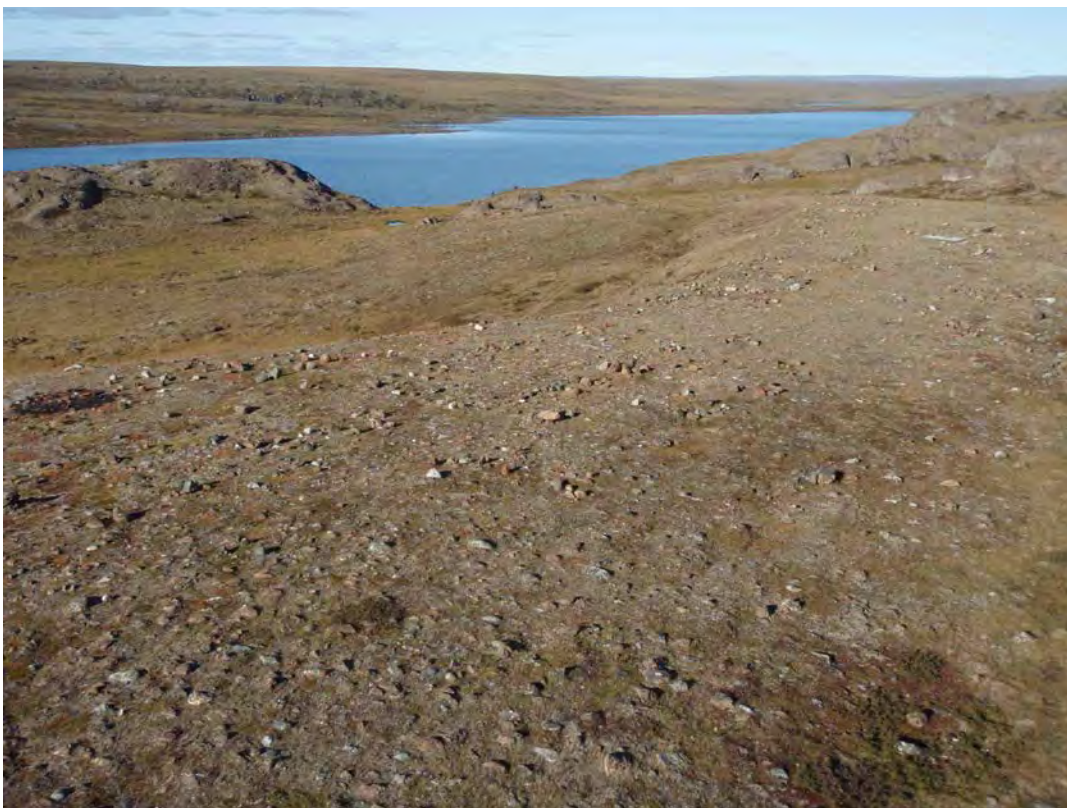
Figure 20: Sector 1 of site KV-1 after material was removed, September 2015

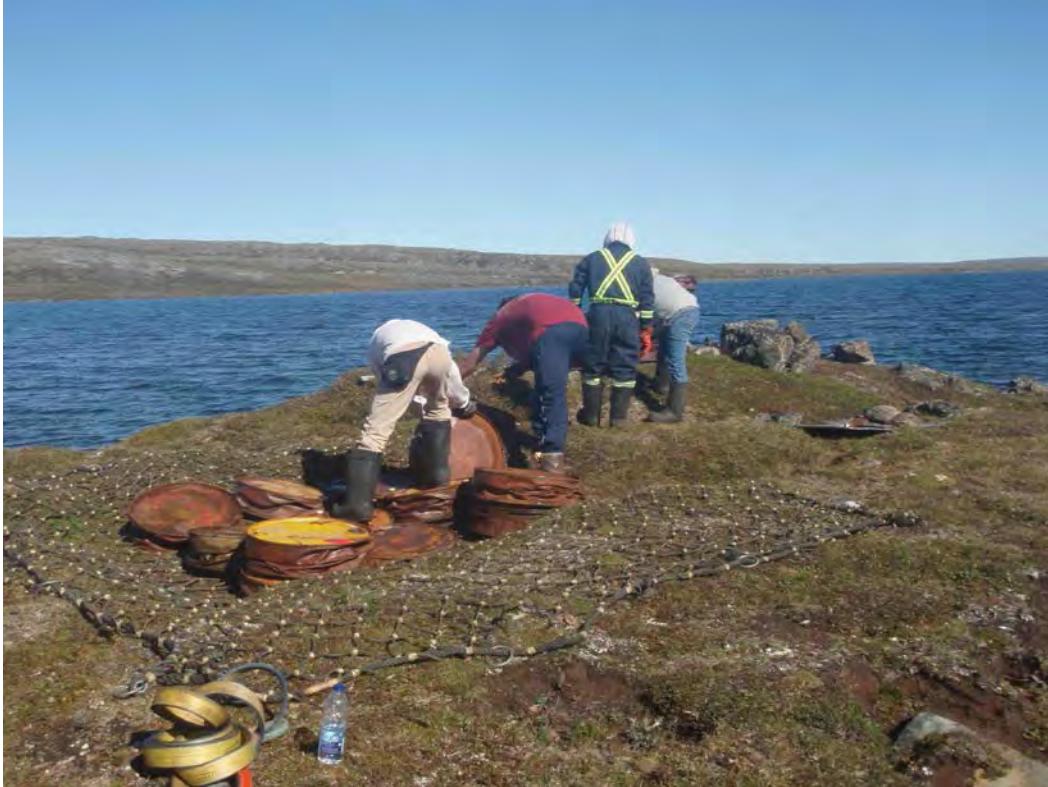
Figure 21: Workers preparing nets for helicopter in Sector 2 of site KV-1, September 2015

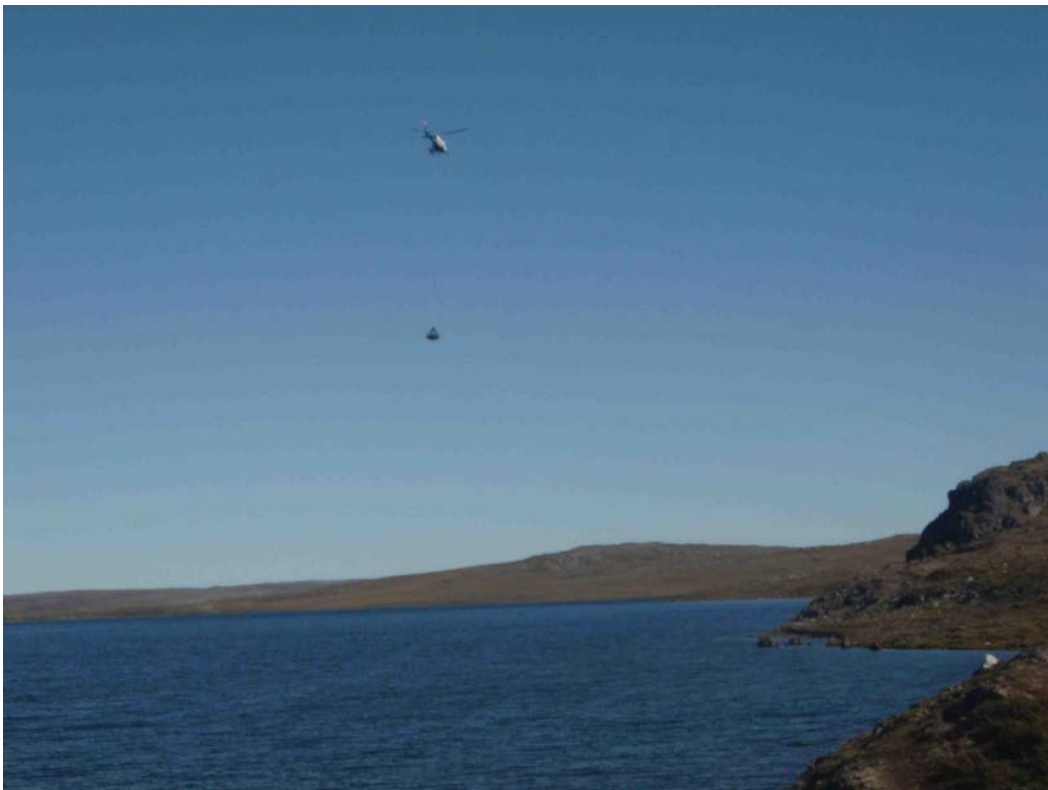
Figure 22: Helicopter transporting material from site KV-1 to site SW-27, September 2015

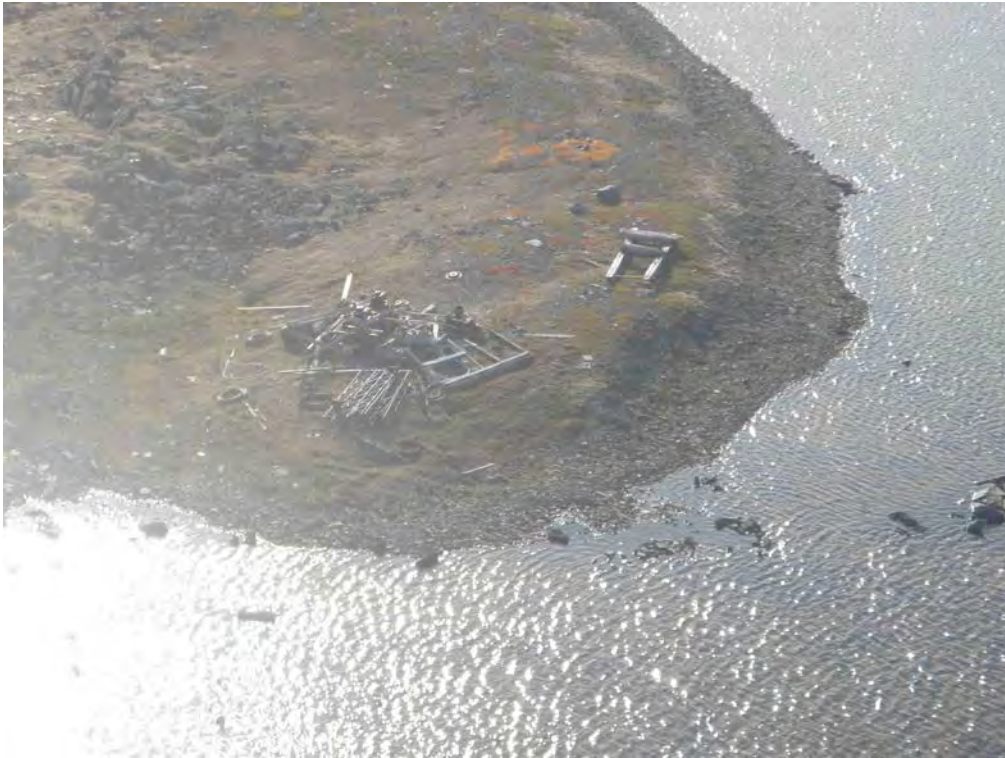
Figure 23: Sector 1 of site SW-27, before cleanup, September 2015

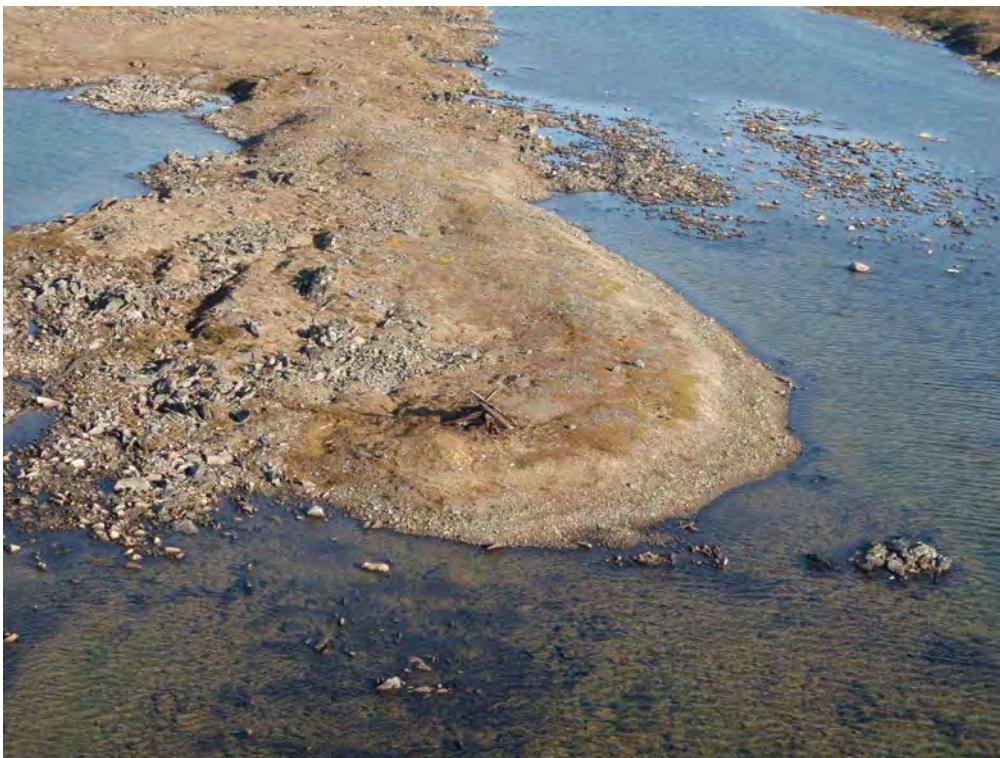
Figure 24: Sector 1 of site SW-27, after cleanup, September 2015

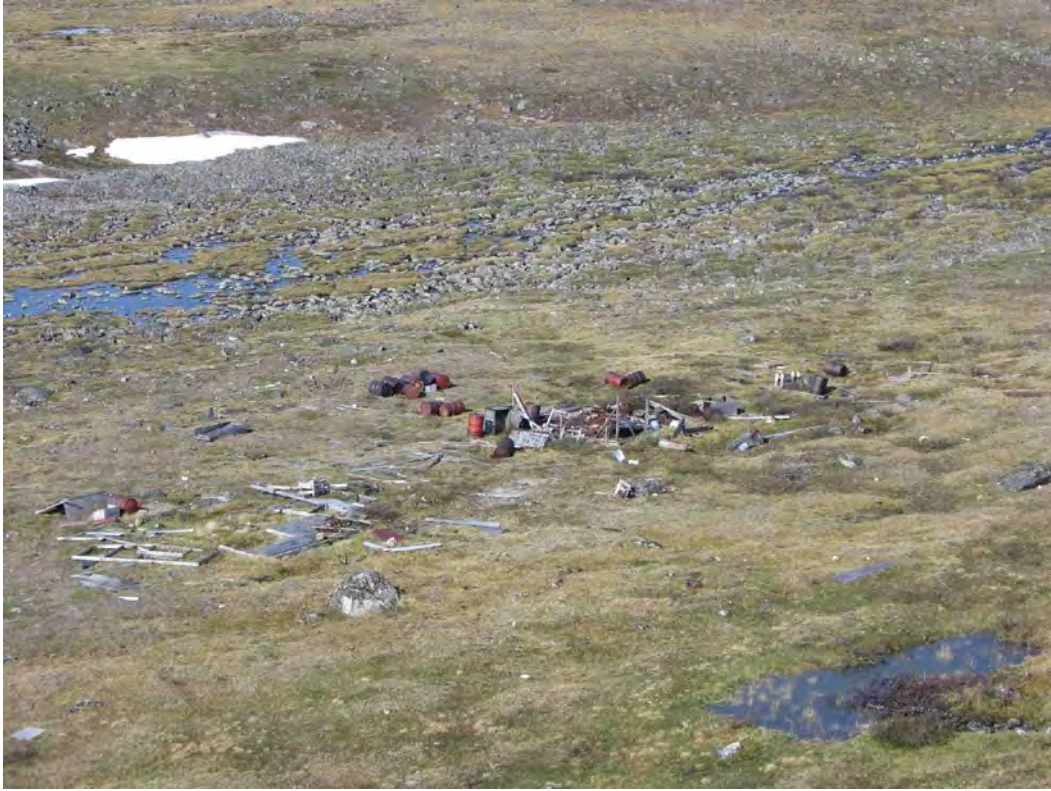
Figure 25: Sector 2 of site SW-27, before cleanup, September 2015

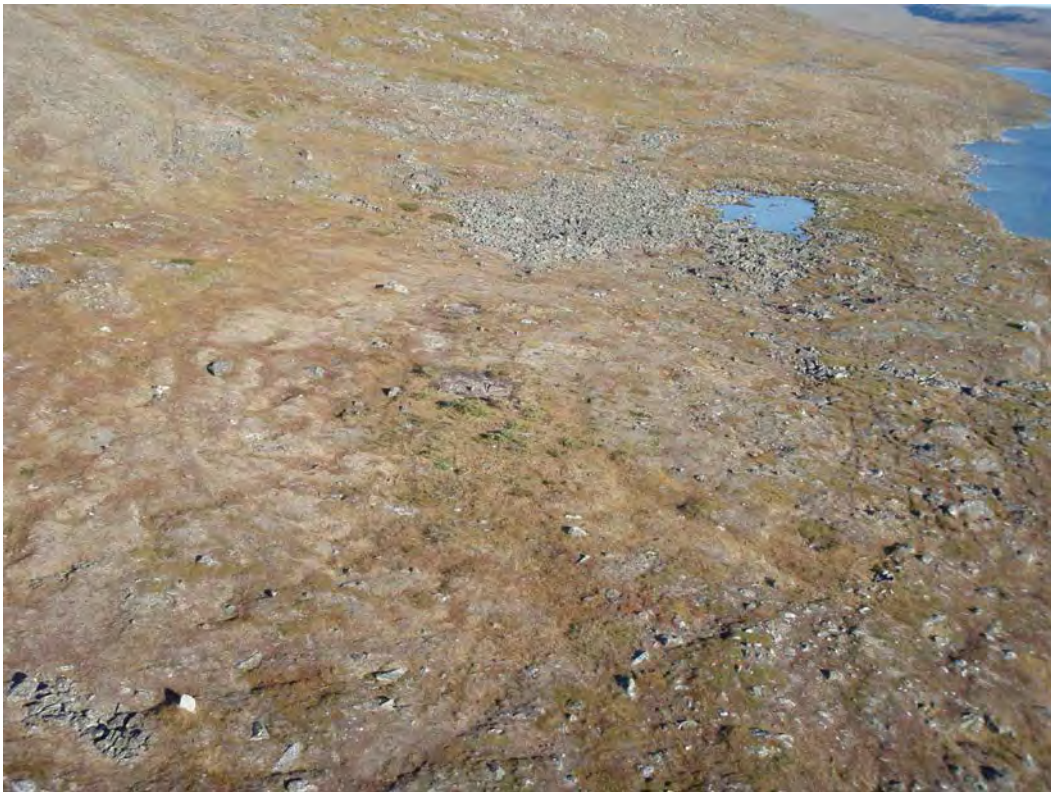
Figure 26: Sector 2 of site SW-27, after cleanup, September 2015
