# REHABILITATION OF ABANDONED MINERAL EXPLORATION SITES IN NUNAVIK

## 2015-2016 ACTIVITY REPORT

**Kativik Regional Government**

**April 2016**

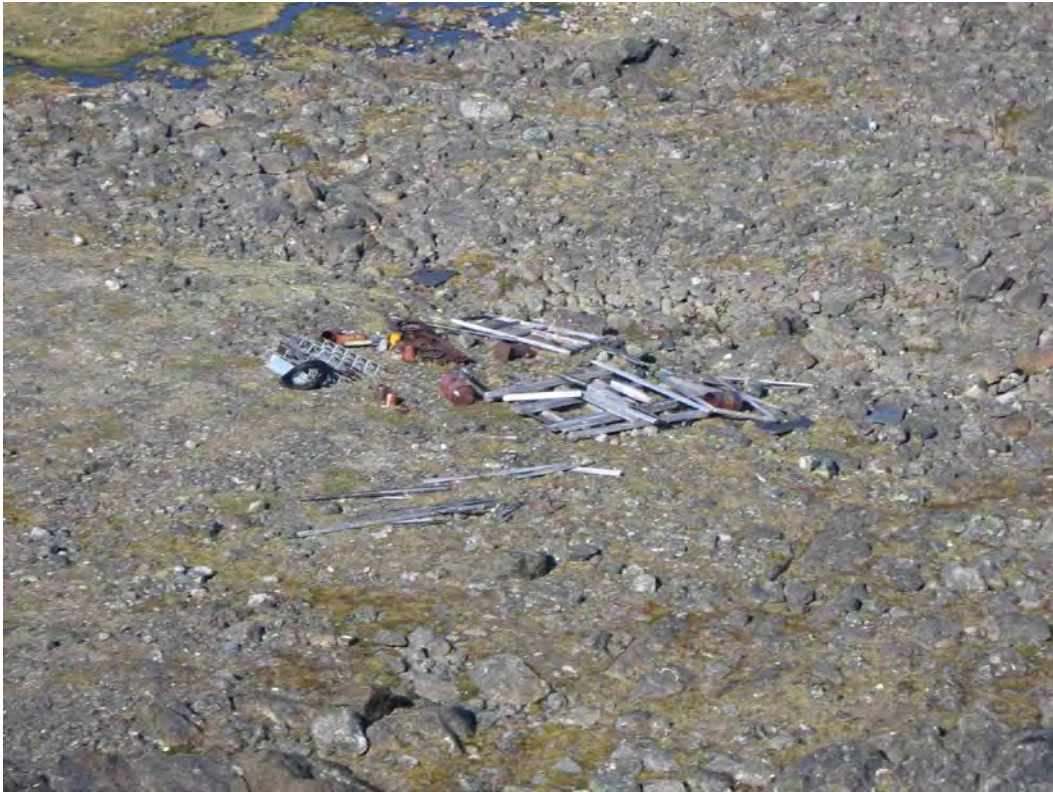
Figure 27: Sector 3 of site SW-27, before cleanup, September 2015

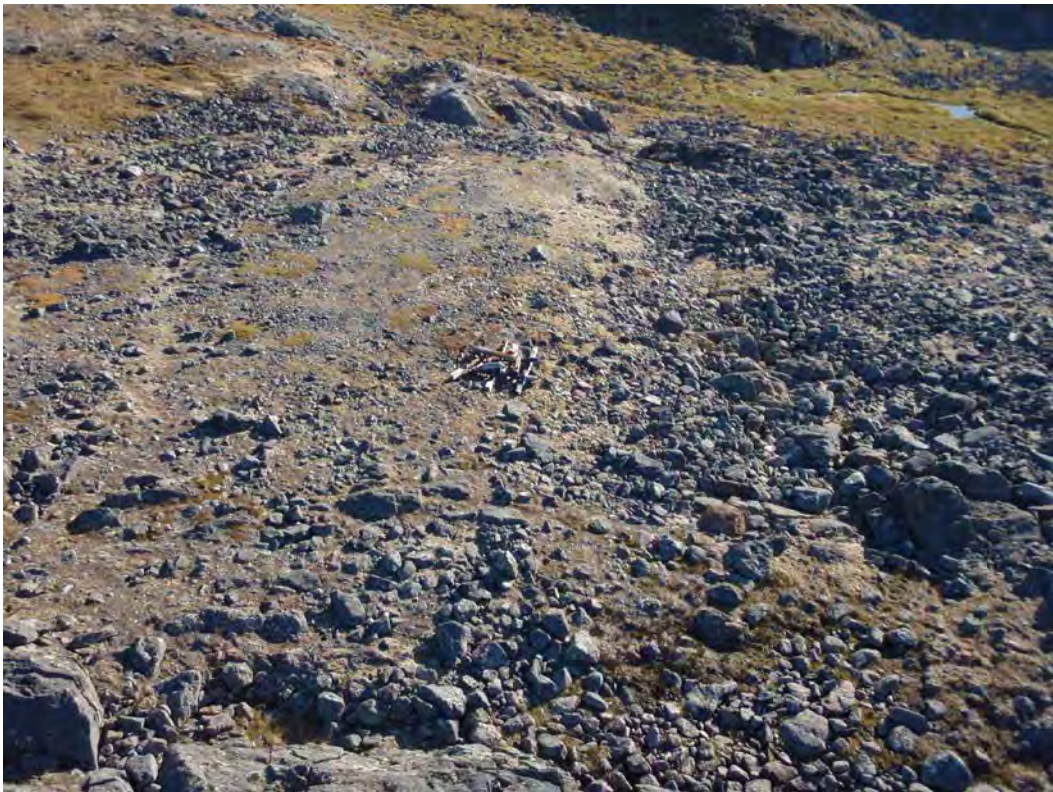
Figure 28: Sector 3 of site SW-27, after cleanup, September 2015

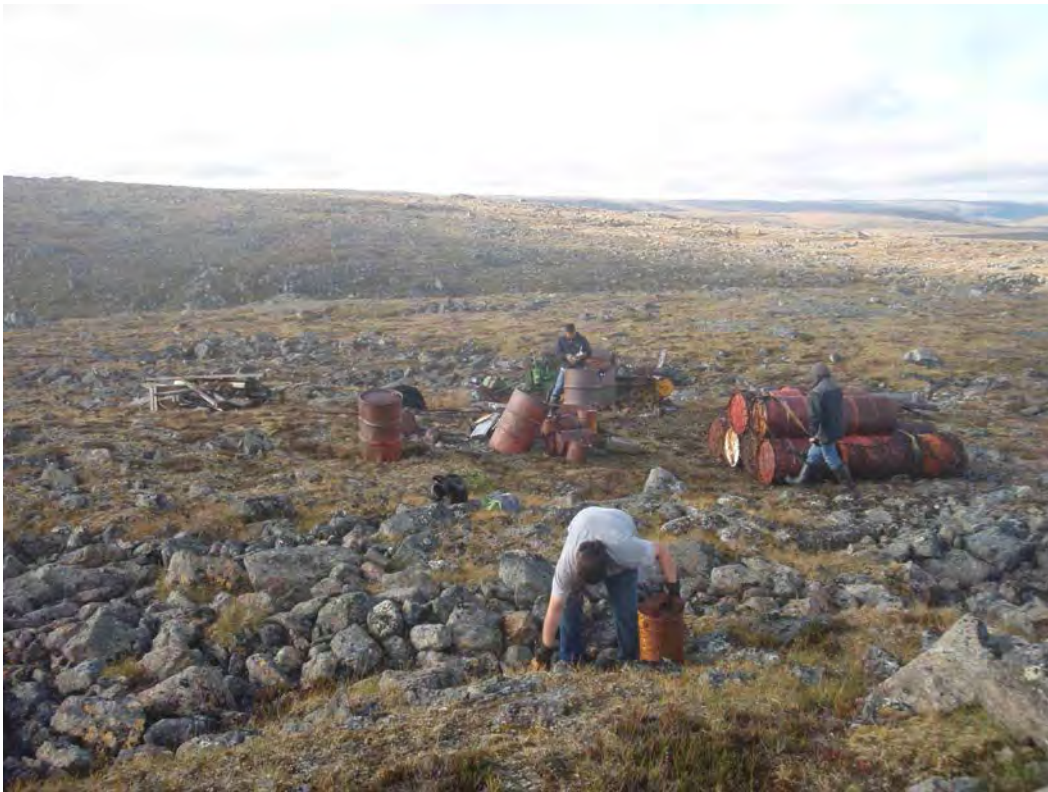
Figure 29: Workers collecting debris on Sector 4 of site SW-27, September 2015

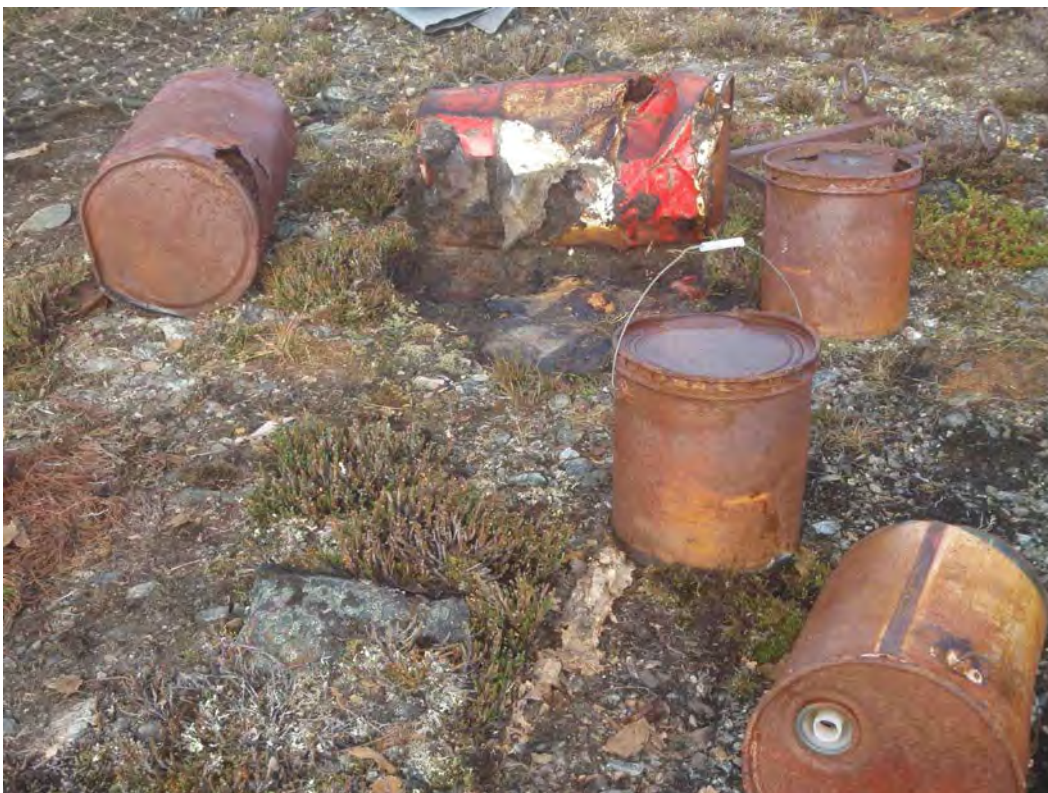
Figure 30: Pails of grease found in Sector 4 of site SW-27, September 2015

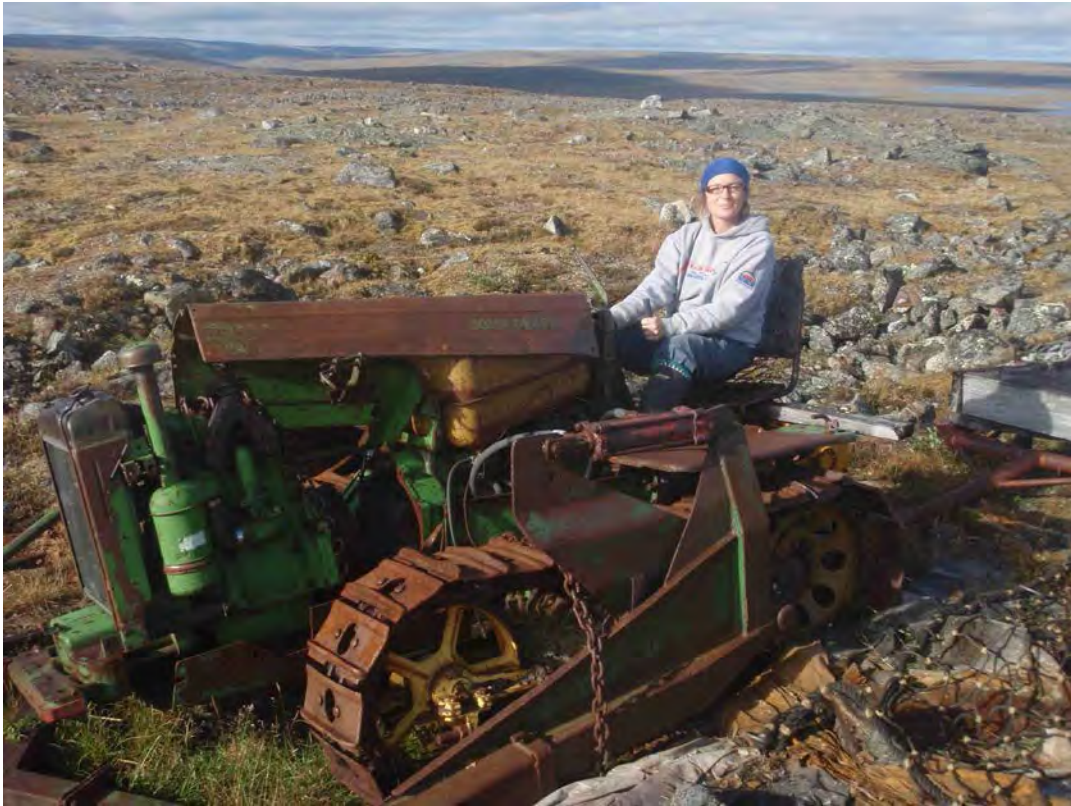
All combustible material was burned in each sector. Due to its weight, a small tractor was left in Sector 4 and will need to be cut up into smaller pieces in order for it to be transportable by helicopter. Sectors 1, 2 and 3 are complete. Pictures of this work can be found in Appendix 2. Work will continue of this site in 2016 and is described in Section 6 of this report.

Figure 31: Tractor remaining in Sector 4 of site SW-27, September 2015

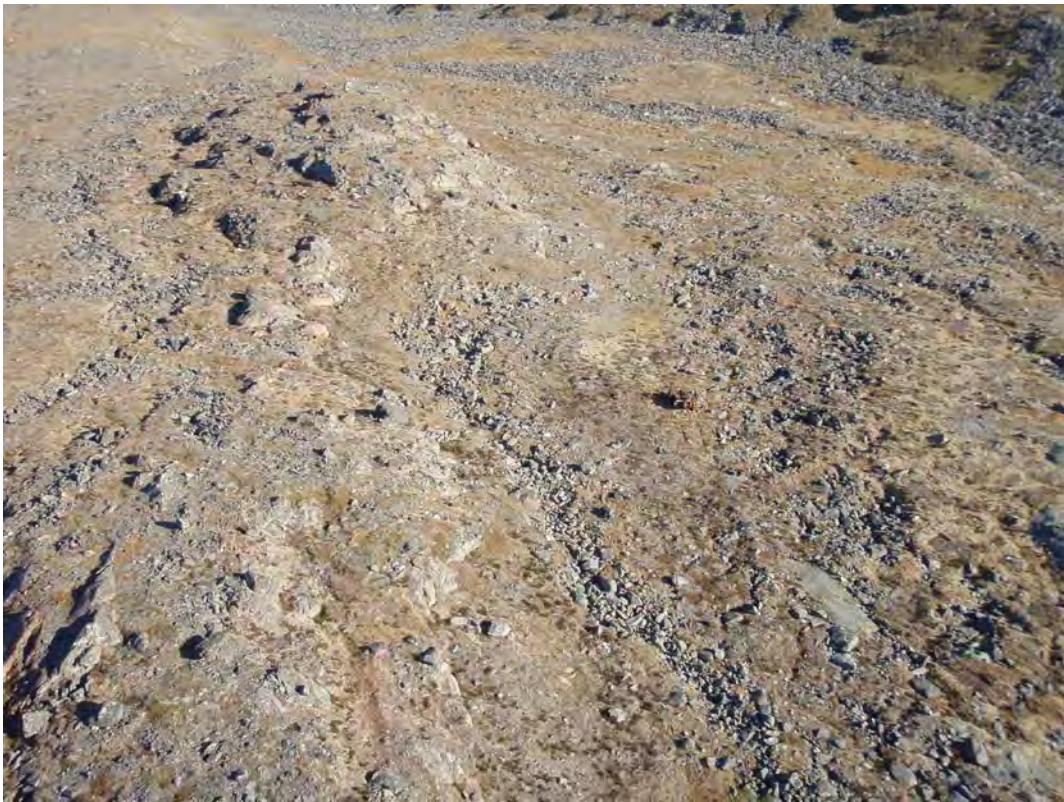
Figure 32: Sector 4 of site SW-27, after cleanup, September 2015

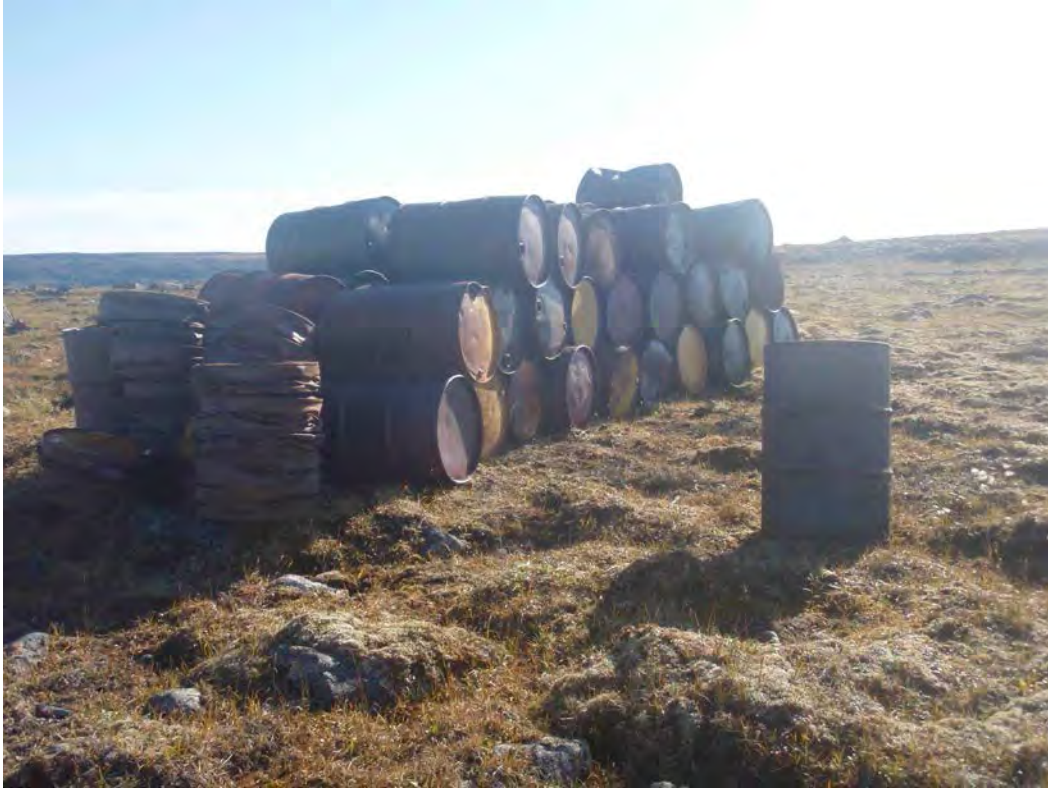
Figure 33: Empty crushed and uncrushed drums at Sector 5 of site SW-27, September 2015

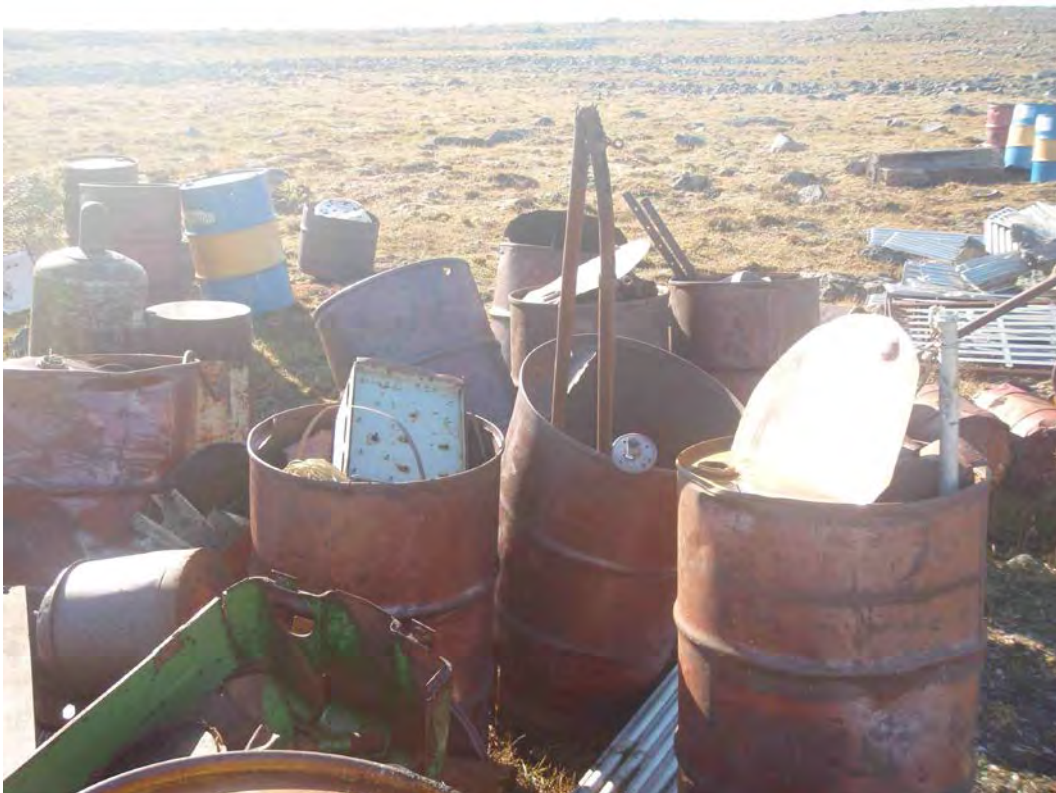
Figure 34: Drums filled with small debris at Sector 5 of site SW-27, September 2015

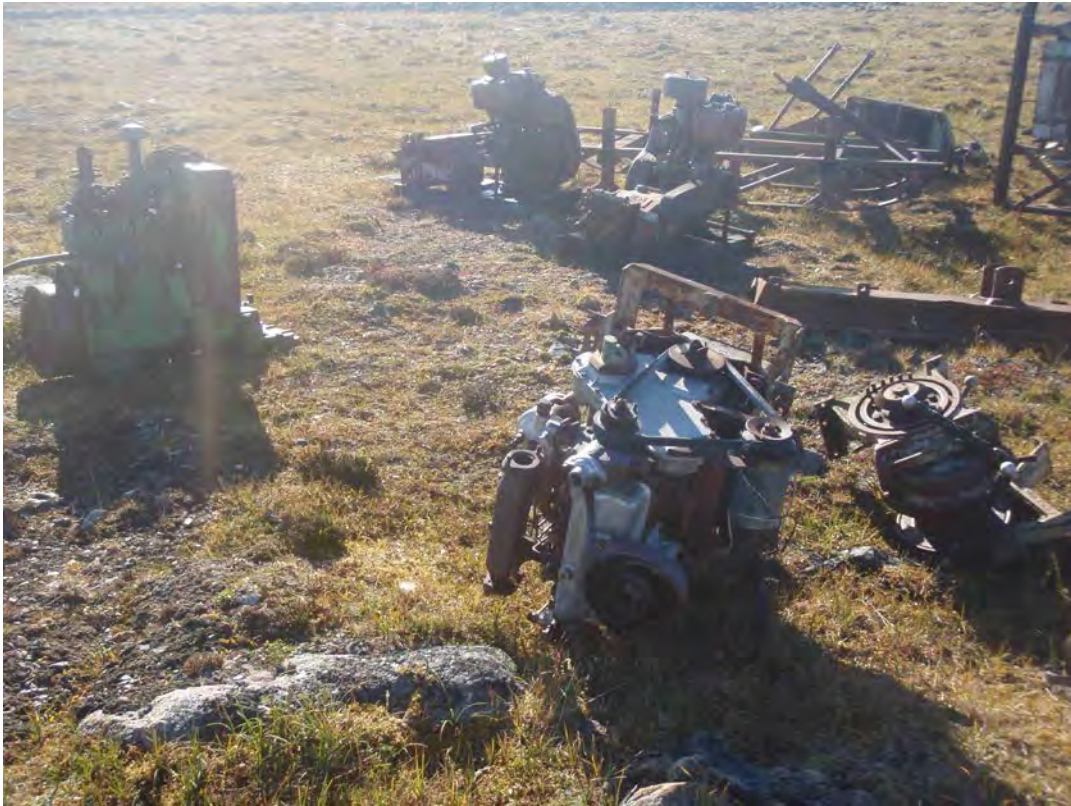
Figure 35: Pieces of machinery at Sector 5 of site SW-27, September 2015

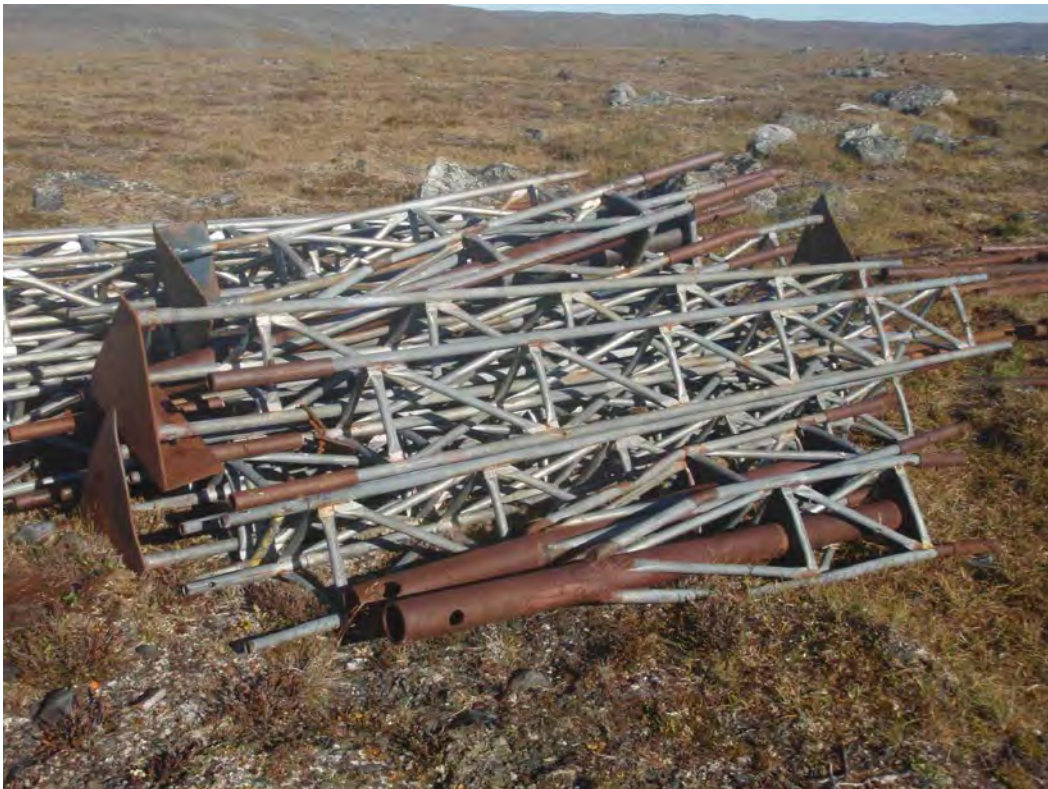
Figure 36: Pieces of aluminum towers at Sector 5 of site SW-27, September 2015

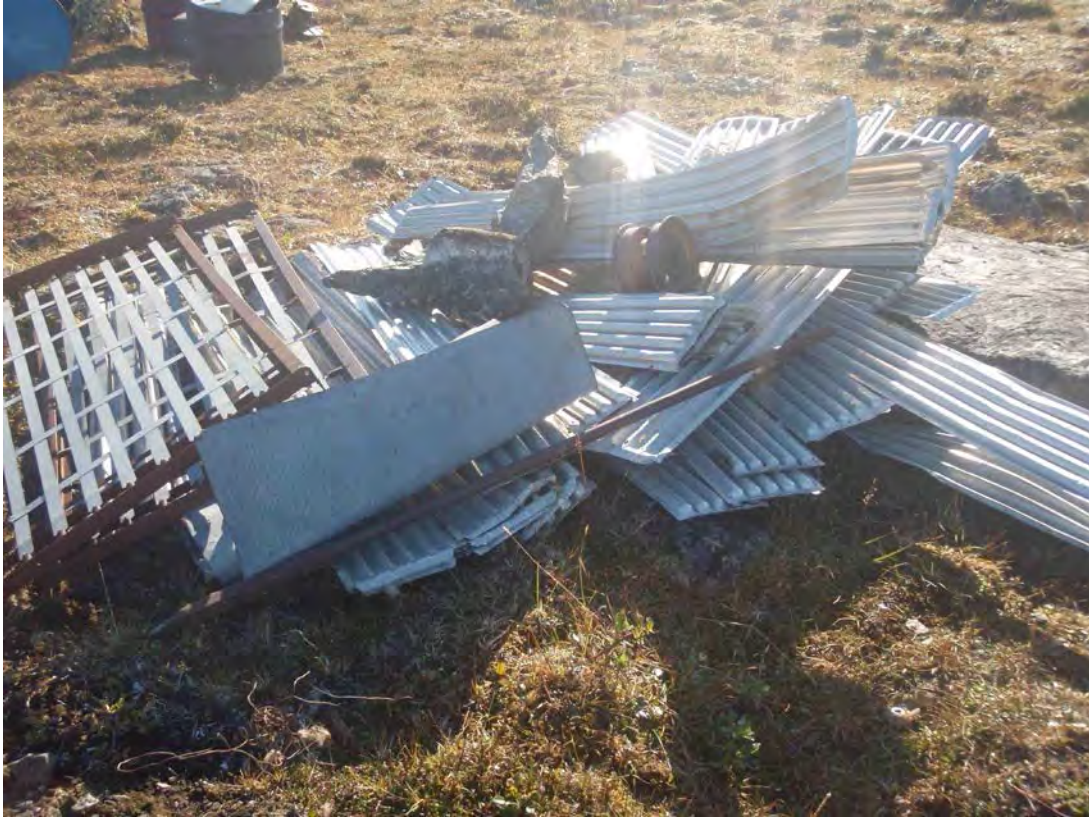
Figure 37: Aluminum core trays at Sector 5 of site SW-27, September 2015

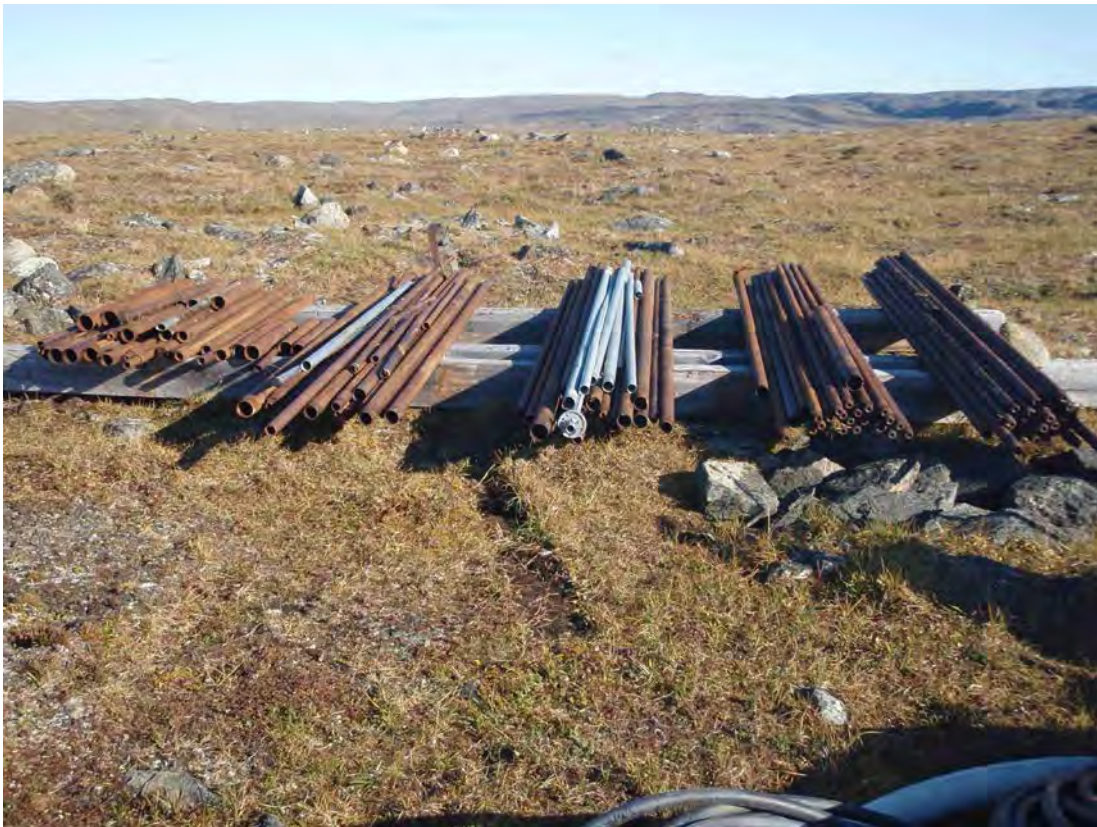
Figure 38: Drill rods at Sector 5 of site SW-27, September 2015

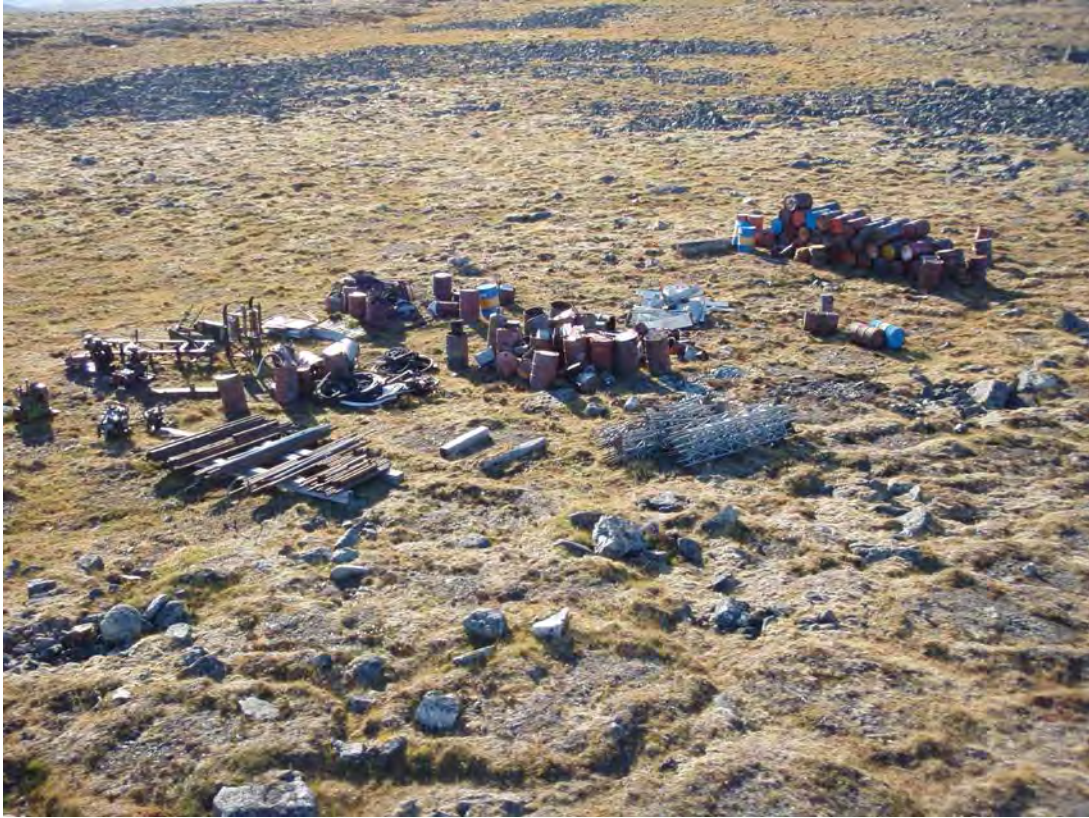
Figure 39: All material remaining at Sector 5 of site SW-27, September 2015

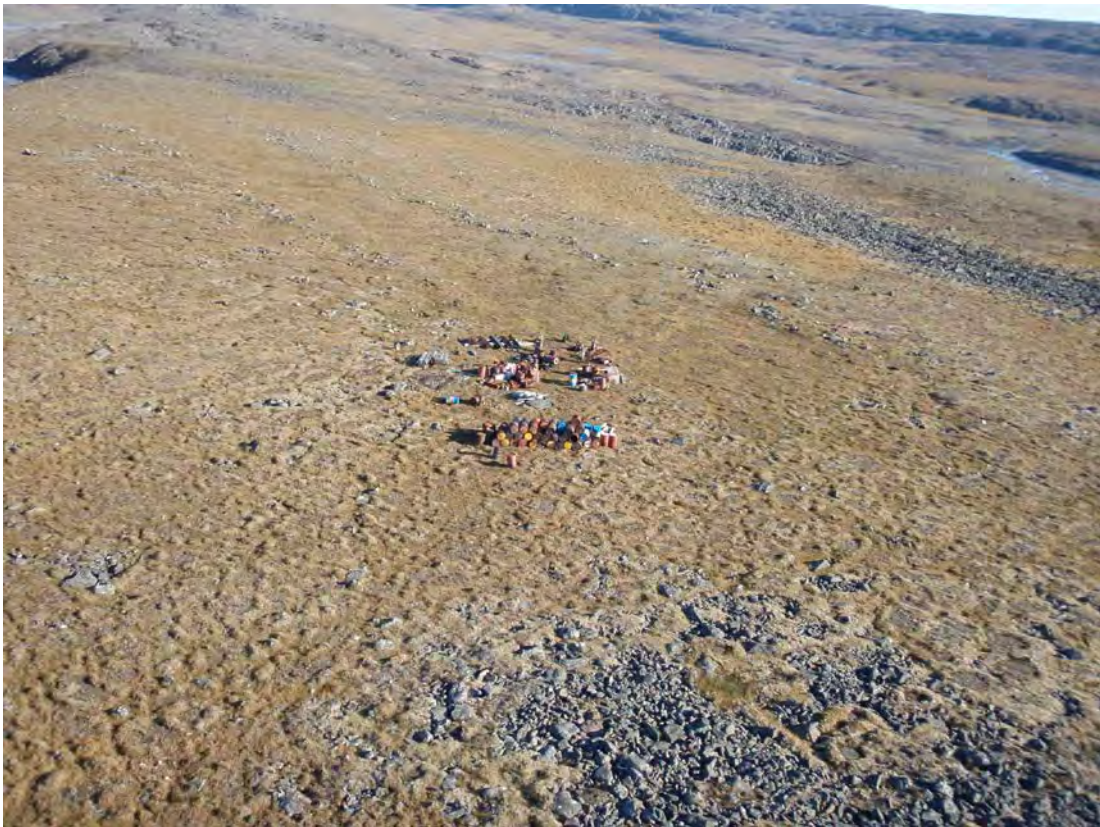
Figure 40: Aerial view of Sector 5 of site SW-27, September 2015

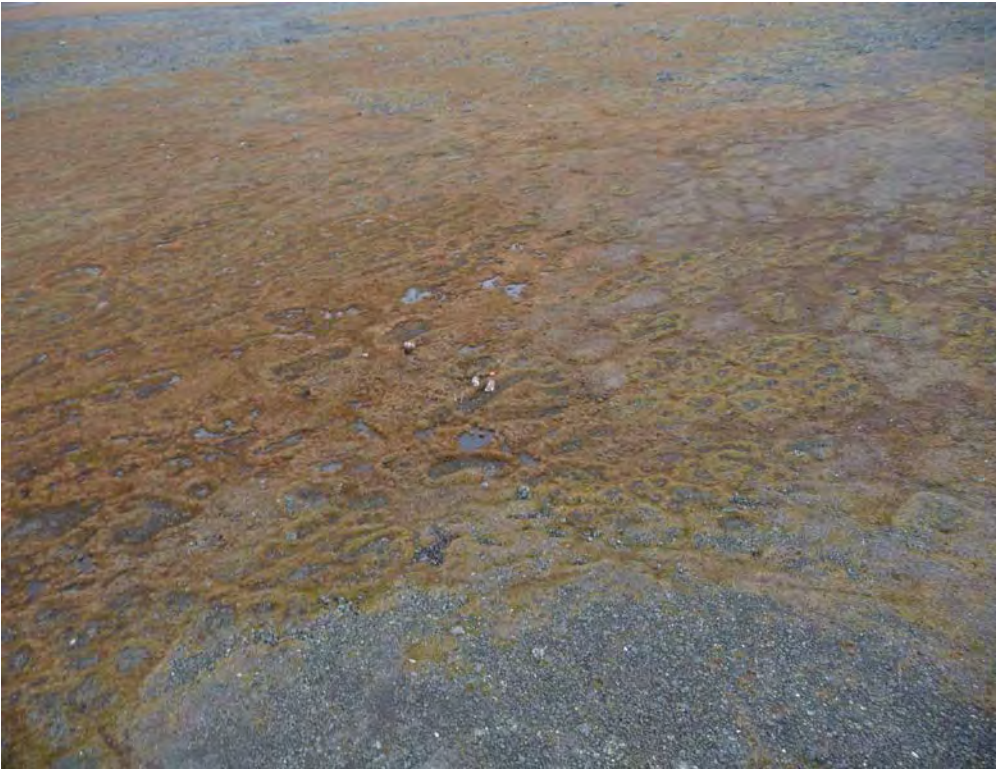
Figure 38: Debris found at site known as Parent Lake, September 2011

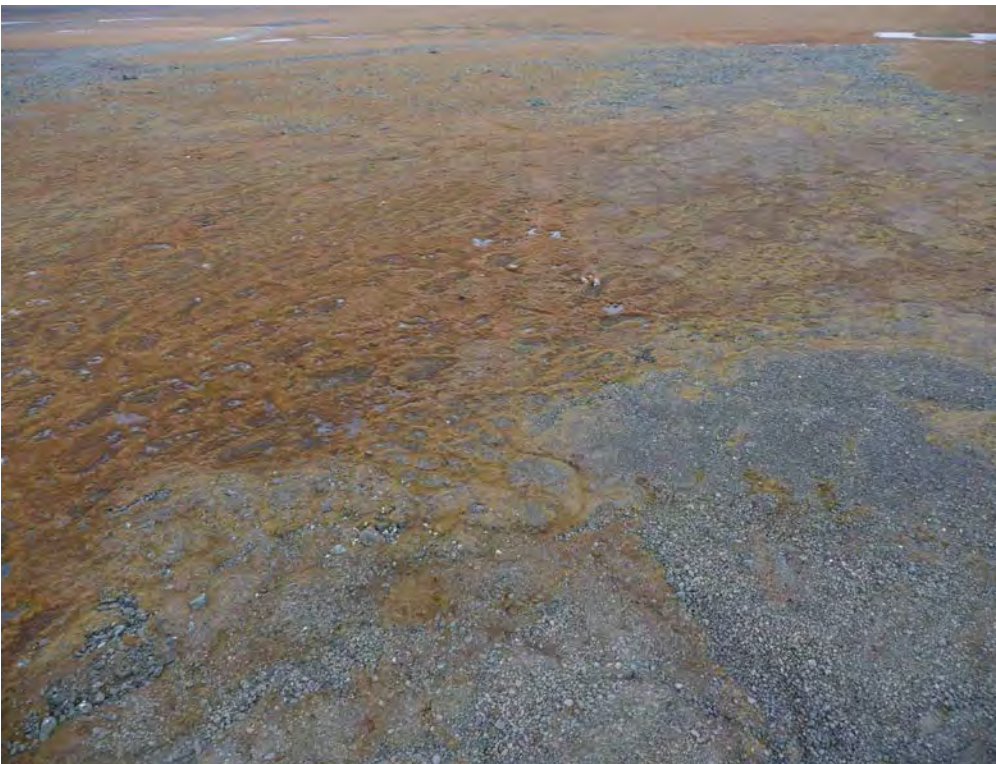
Figure 39: Debris found at site known as Parent Lake, September 2011

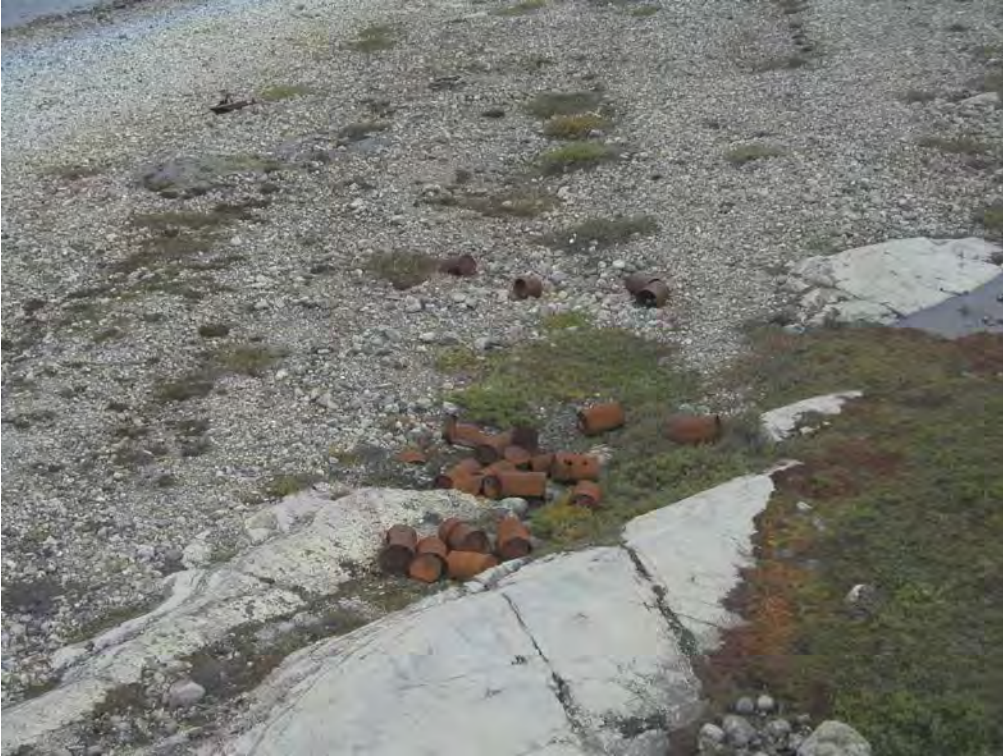
Figure 42: Site GW-8, located on the Hudson Coast, September 2002
