REHABILITATION OF ABANDONED MINERAL EXPLORATION SITES IN NUNAVIK

2017-2018 ACTIVITY REPORT

Kativik Regional Government

April 2018

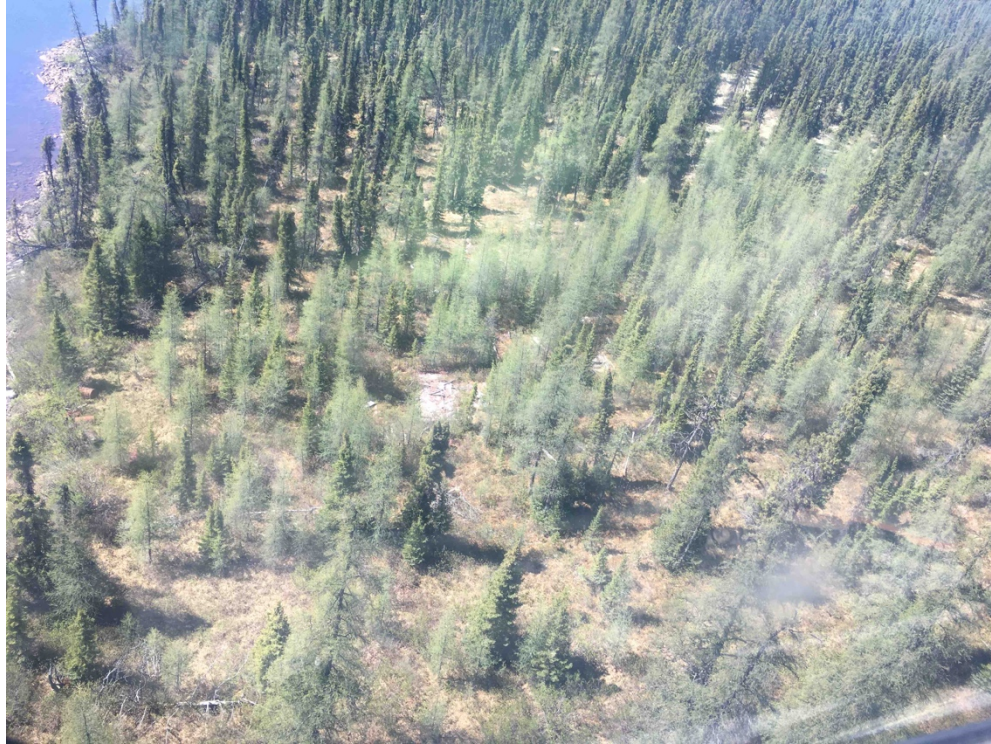
Figure 1: Site PD-1, before rehabilitation, June 2017

In June 2016, the project coordinator and 3 workers from Kuujuaq undertook rehabilitation activities on the site. It was a one-day campaign in which they removed 8 empty drums and 1 heavy-duty bag of small debris. This material was transported to Kuujuaq by helicopter and stored in a marine container, already holding material removed from two other sites the previous year. This container of material will be shipped in 2018. The site is now complete and photos of this work can be found in Appendix 2.

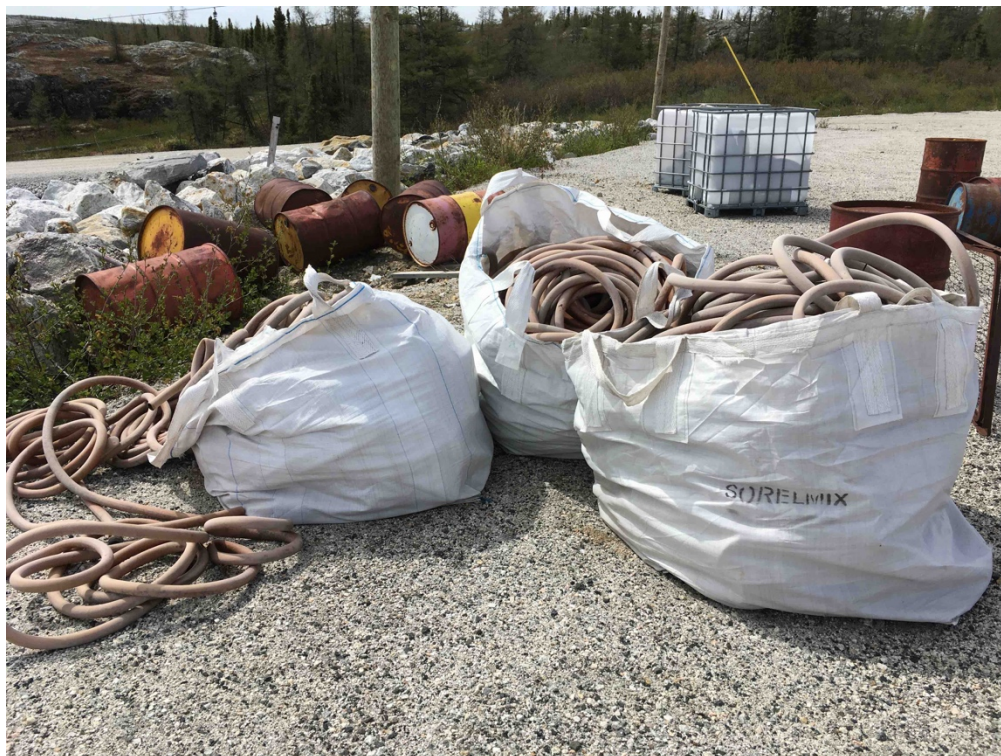
Figure 2: Material at marina in Kuujuaq, June 2017

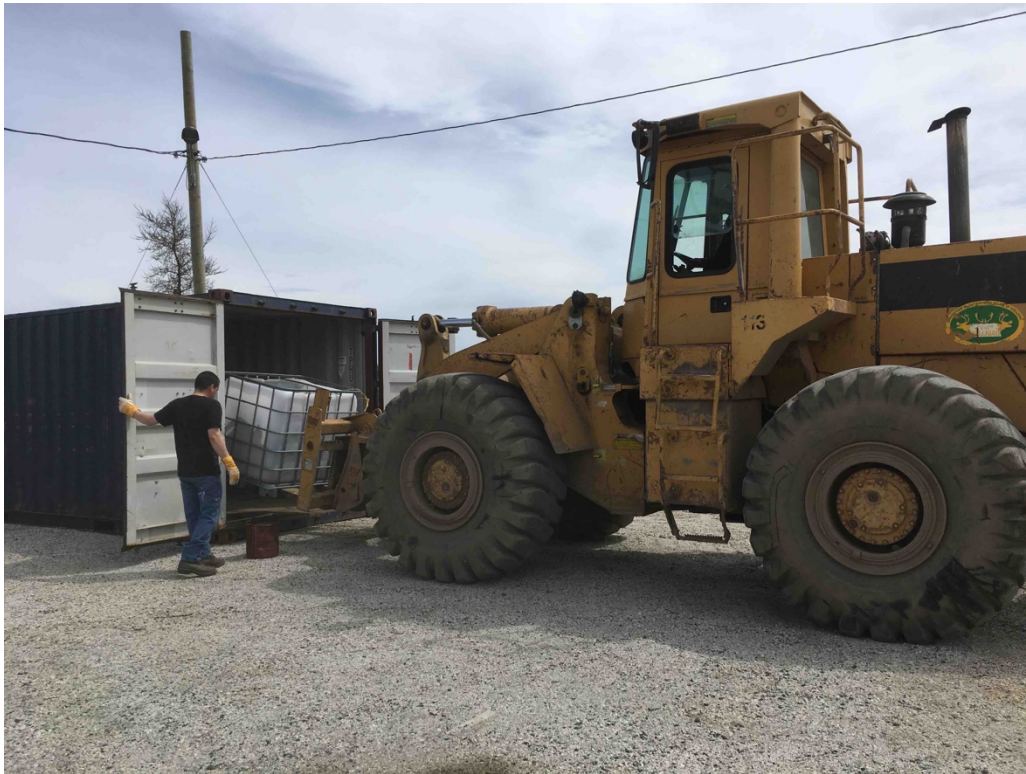
Figure 3: Material being loaded into container at marina in Kuujjuaq, June 2017

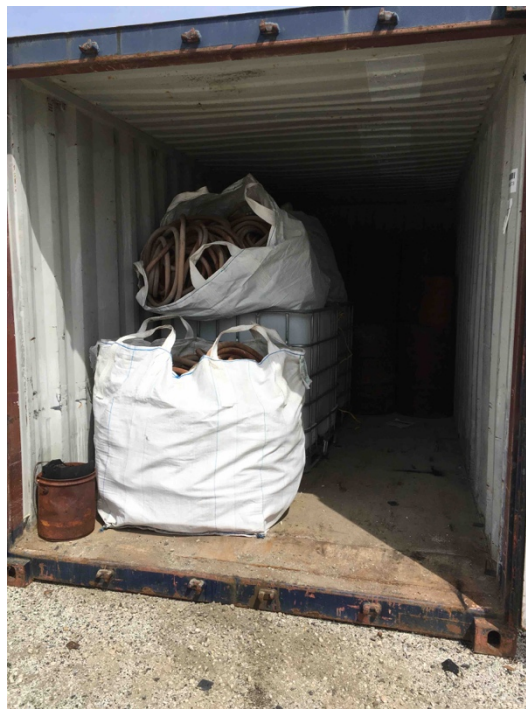
Figure 4: Material inside container, Kuujjuaq, June 2017

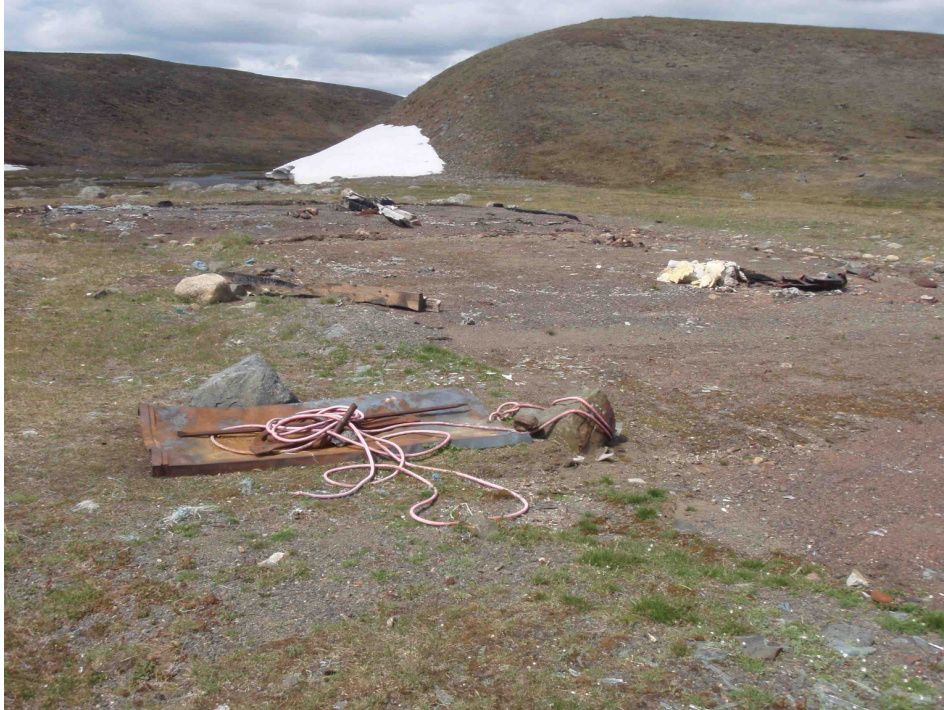
Figure 5: Material on site WB-9 before cleanup, July 2017

Site WB-9, an abandoned mineral exploration site requiring major cleanup, is located next to Kenty Lake, roughly 100 km south-southeast of Salluit (Map 6). After having burned all combustible material at the site in 2015, a final sweep was conducted in August 2017 with the purpose of removing any smaller debris that may have been difficult to see while buildings burned or smoldered. During a one-day campaign, a magnet was used to collect the smaller debris such as nails and screws. In total 3 loads of material, weighing approximately 3,500 pounds, was removed from the site by helicopter and transported to the Kikkialik mine, on the property of Glencore Canada Corporation. There the material was stored in a marine container and will be shipped by the mining company to a proper facility as part of their in-kind contribution to the project. This site is now complete and pictures of this work can be found in Appendix 2.

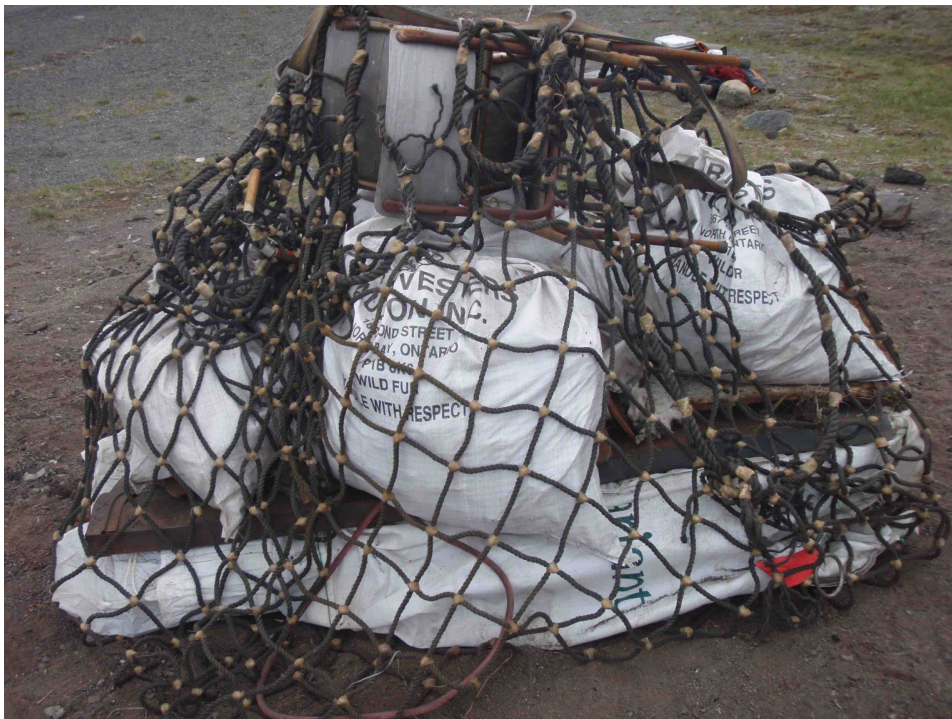
Figure 6: Material on site WB-9 ready for transportation by helicopter, July 2017

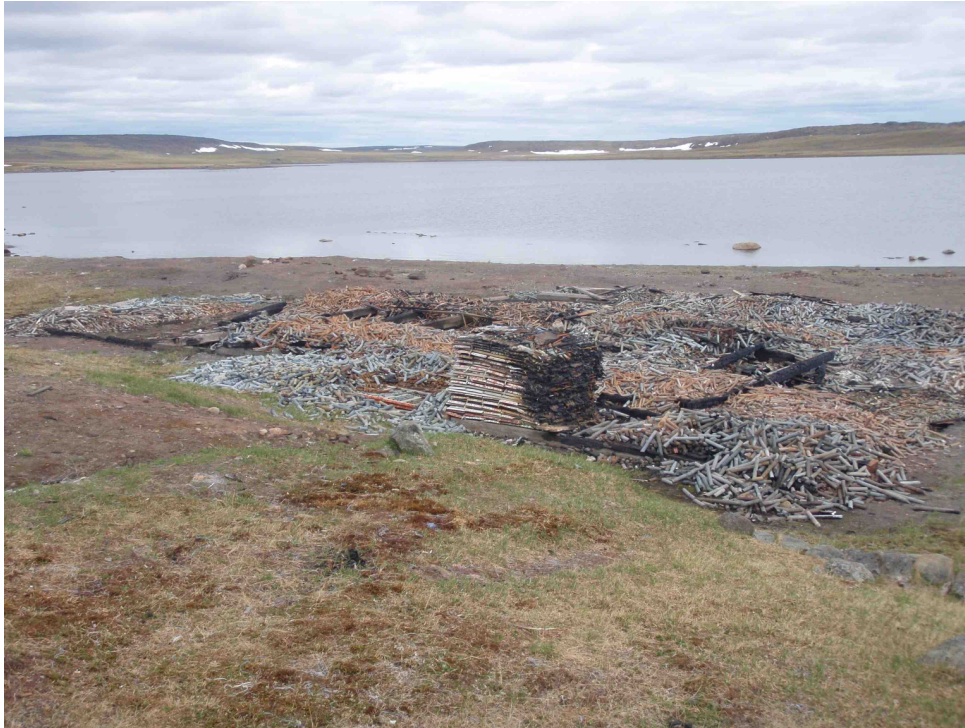
Figure 7: Core remaining on site WB-9, July 2017

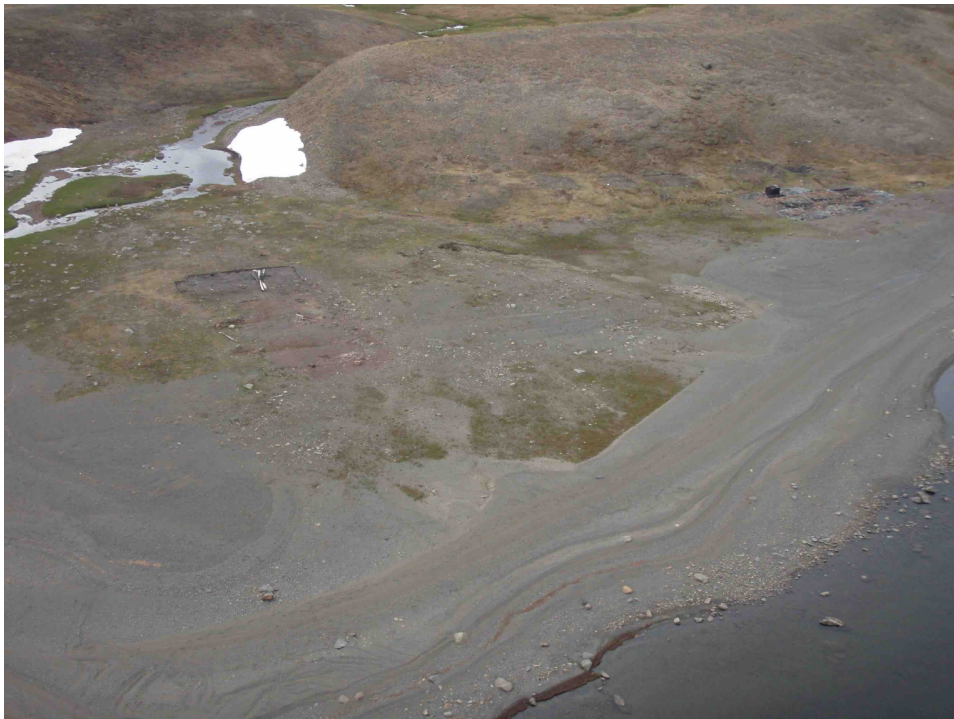
Figure 8: Site WB-9 after rehabilitation, July 2017

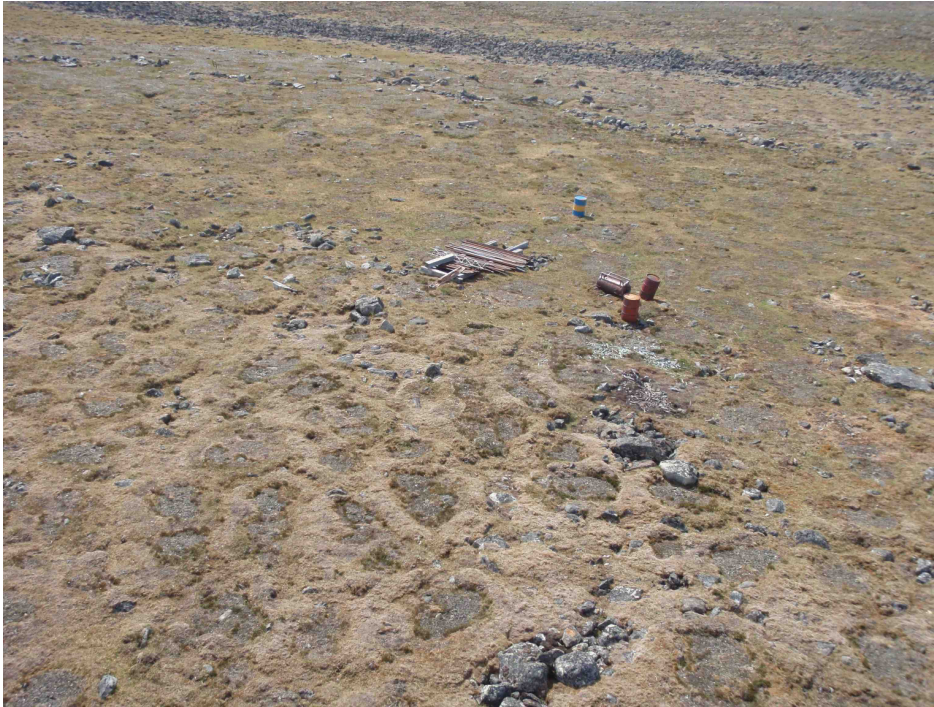
The abandoned mineral exploration site SW-27 (61°28.76' N, 76°22.93' W) is located roughly 90 km south-southwest of Salluit (Map 6). The 2001-2002 inventory ranks this site 12th in importance for major rehabilitation work. The site covers 0.2 km² and although originally thought to comprise four sectors, five sectors were actually found on site. Before rehabilitation activities, SW-27 contained a significant quantity of residual material and hydrocarbons residue.

Figure 9: Material collected at site SW-27, July 2017

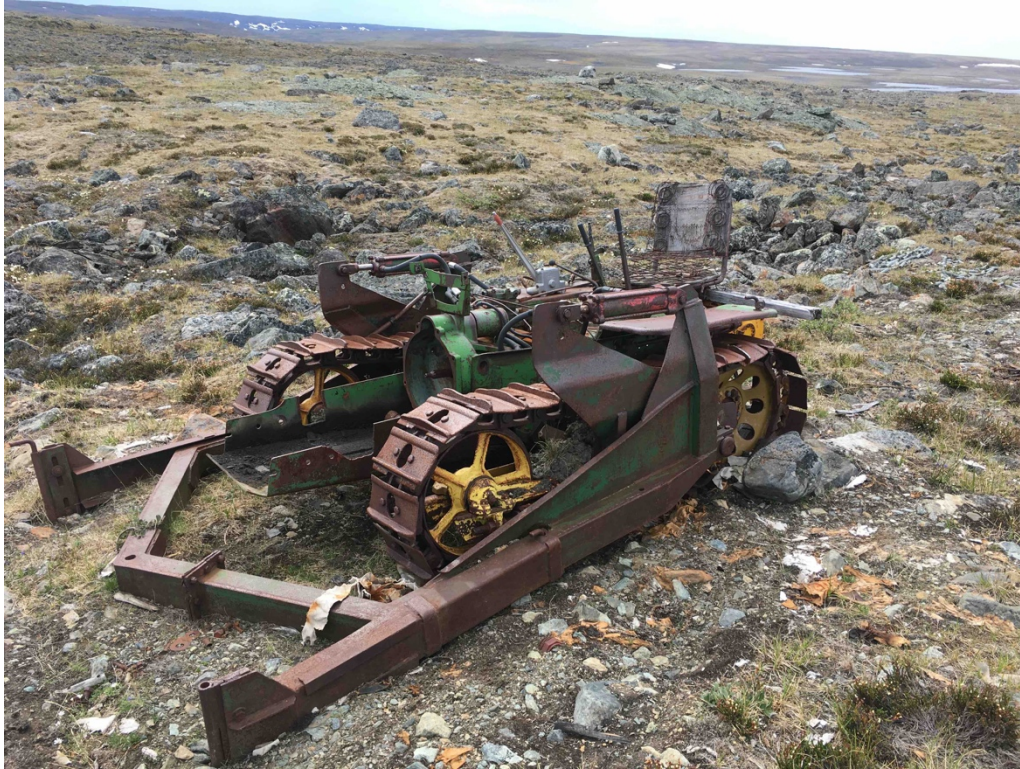
Figure 11: Small tractor remaining at site SW-27, July 2017

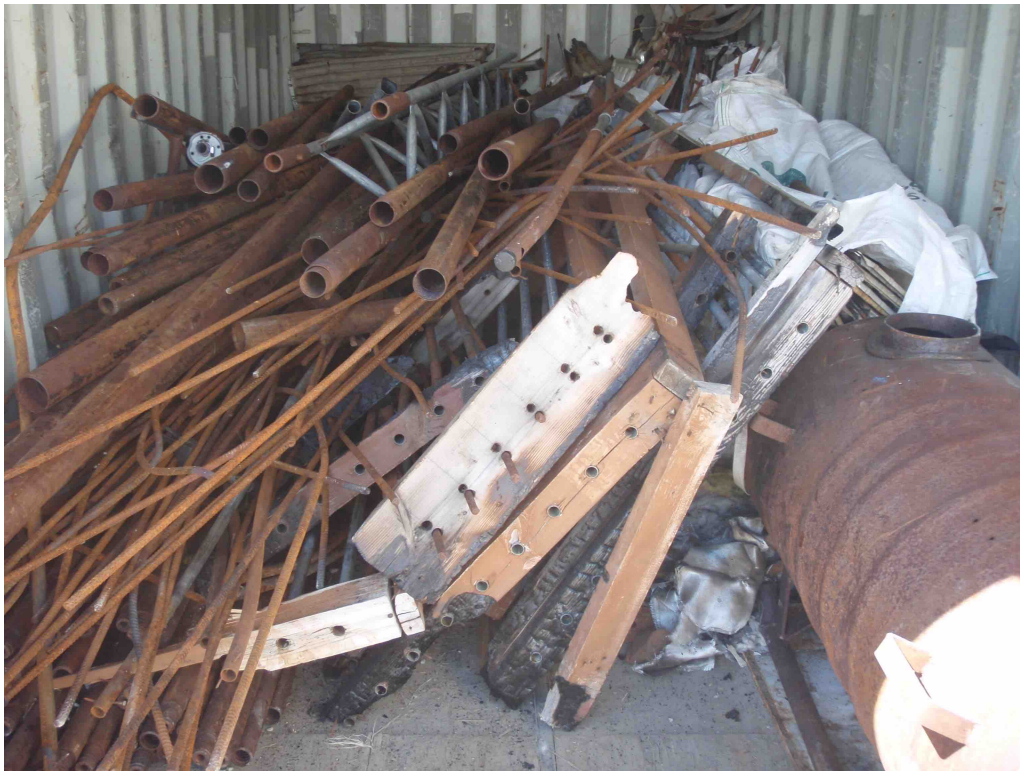
Figure 12: Material inside container at Kikkialik mine, July 2017

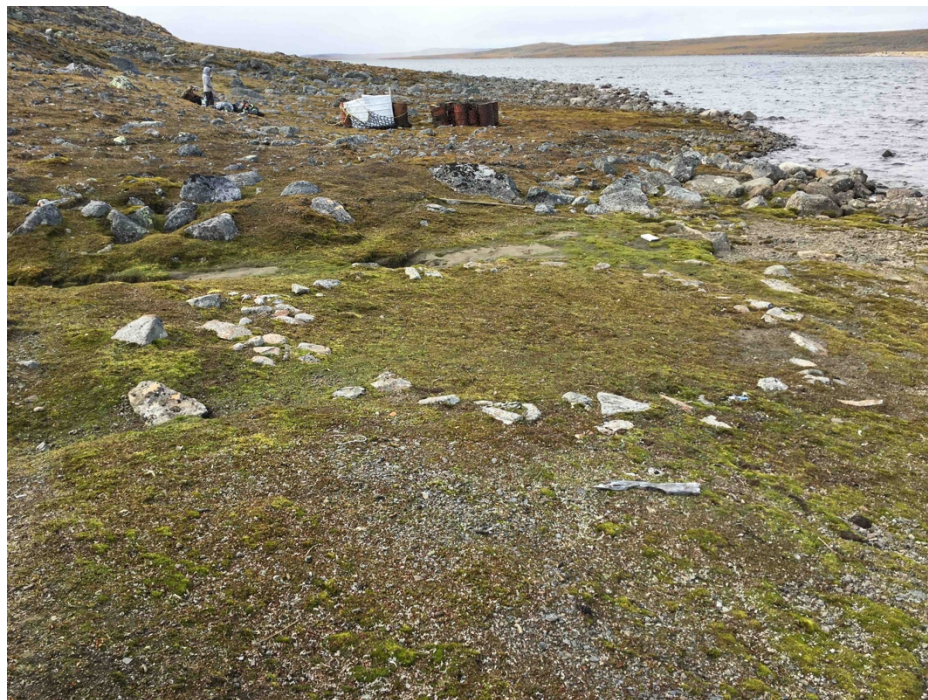
Figure 14: Tent ring found at site SW-24 during rehabilitation activities, August 2017

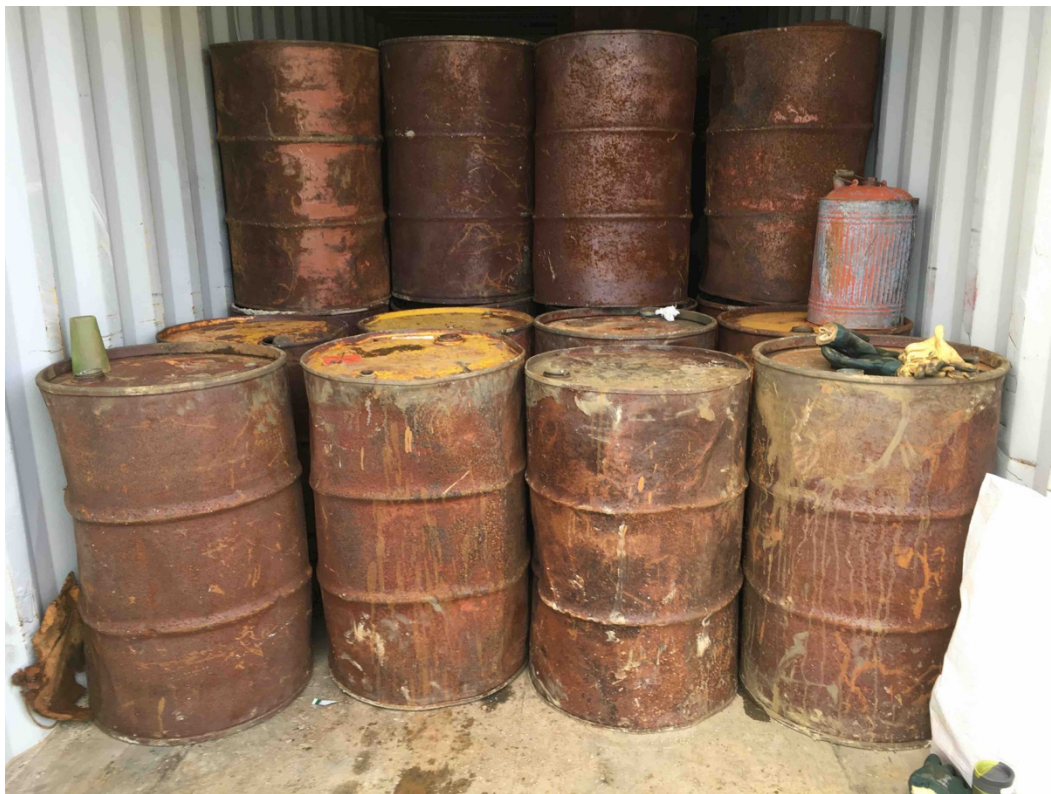
Figure 15: Material transported to Kikkialik by helicopter from site SW-24, August 2017

In August 2017, the Project Coordinator and 4 workers from Salluit undertook and completed the rehabilitation of site SW-24. During a two-day campaign, they collected 52 empty drums, 18 barrels with liquid, 17 propane tanks and a small volume of metal debris. The material was transported by helicopter to the Kikkialik mine, on Glencore Canada Corporation property. There the material was stored in a marine container and will be shipped by the mining company to a proper facility as part of their in-kind contribution to the project. This site is now complete and pictures of this work can be found in Appendix 2.

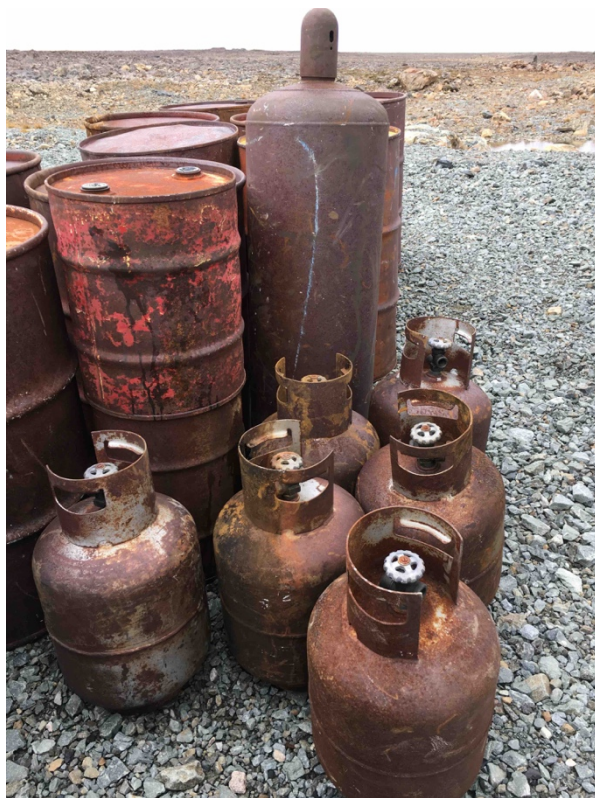
Figure 16: Material transported to Kikkialik by helicopter from site SW-24, August 2017

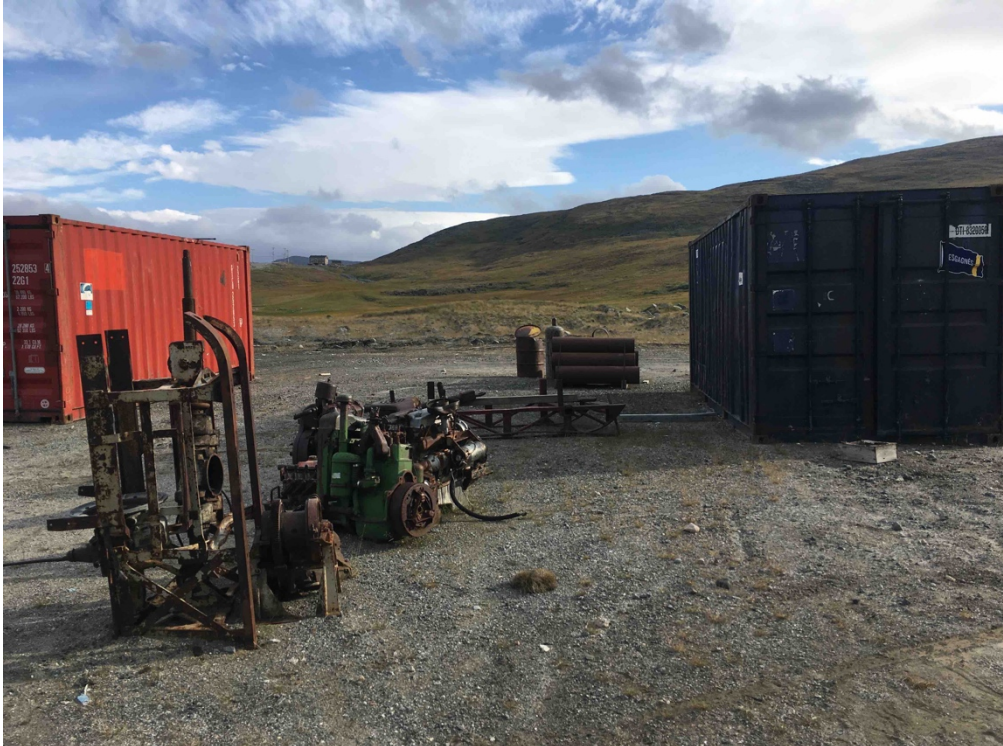
Figure 17: Material transported from Salluit, August 2017

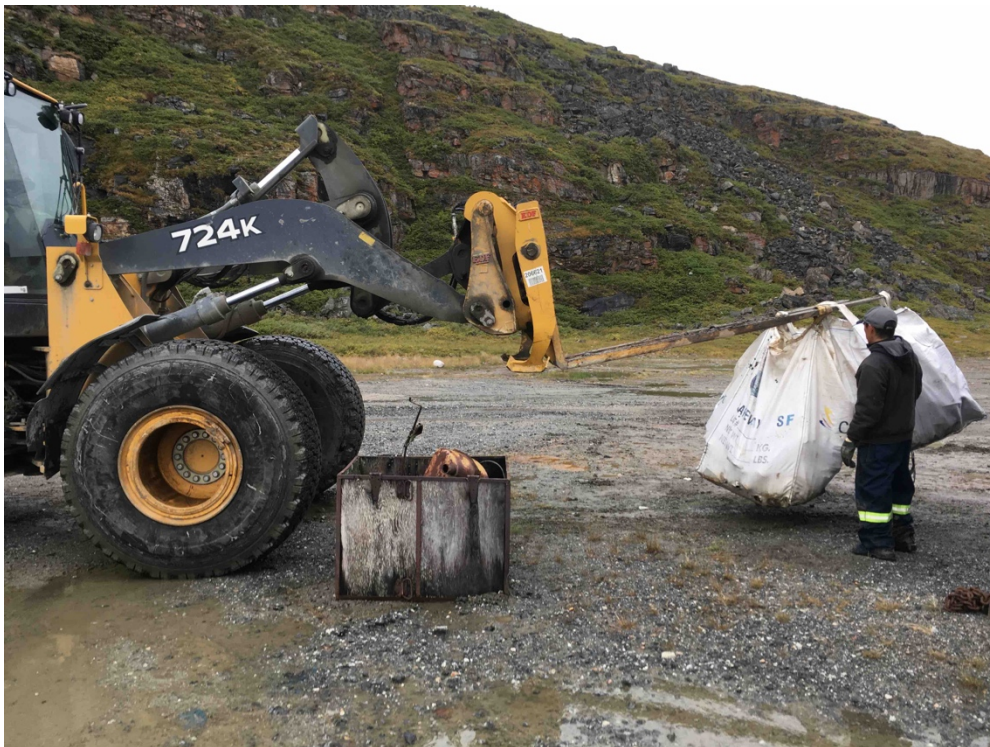
Figure 18: Preparing material for transportation by cargo ship from Salluit, August 2017

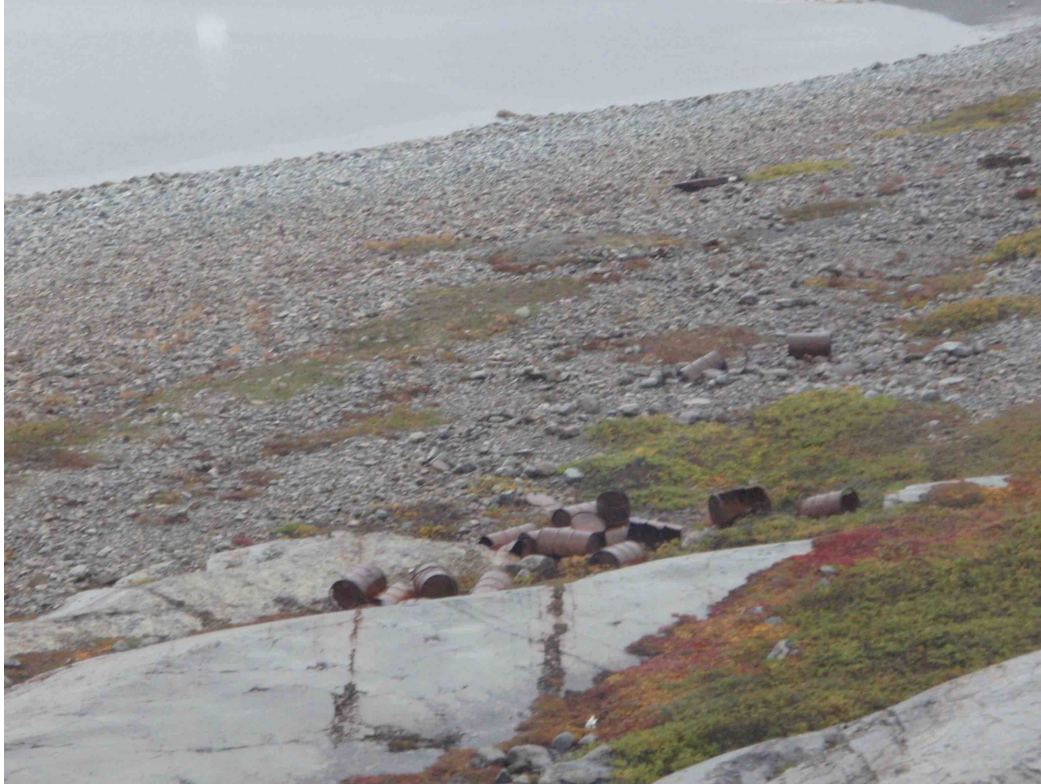
Figure 19: Site GW-8 before rehabilitation, September 2017

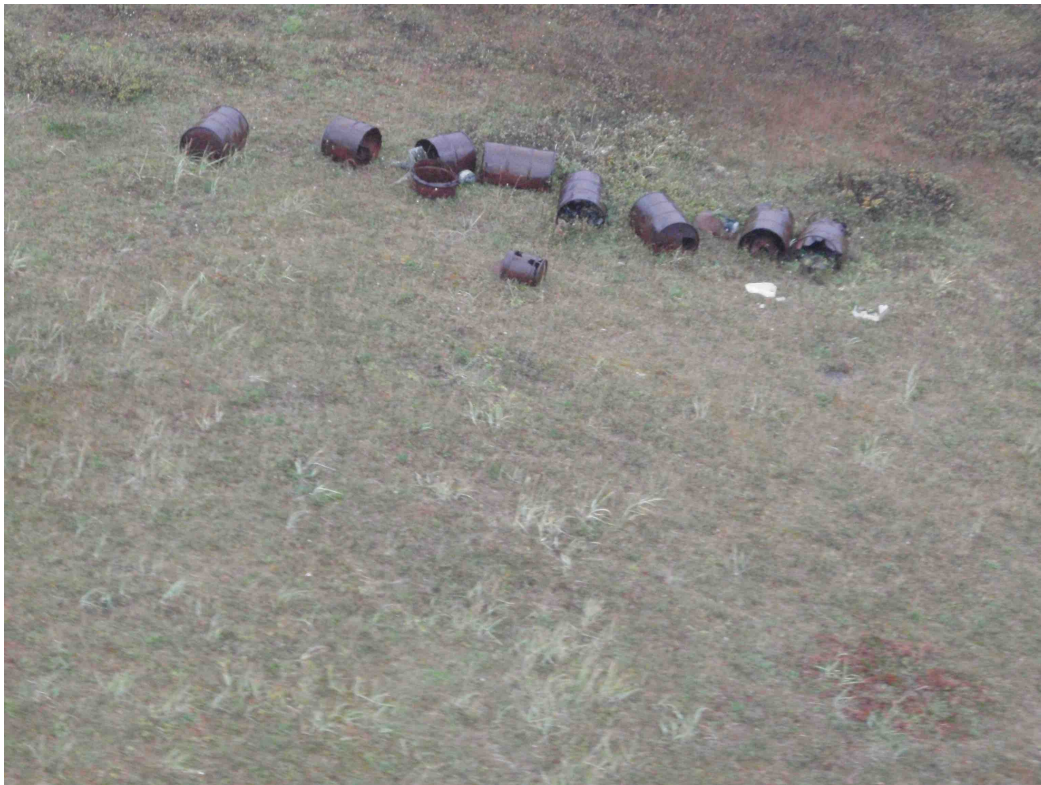
Figure 20: Secondary site found east of GW-8, September 2017

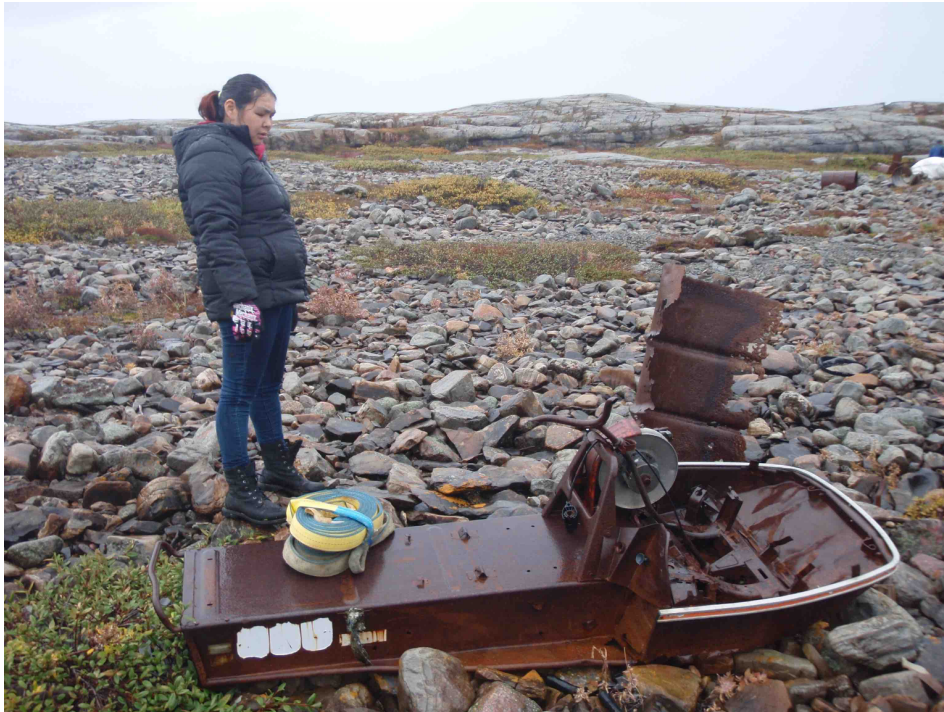
Figure 21: Material at site GW-8, September 2017

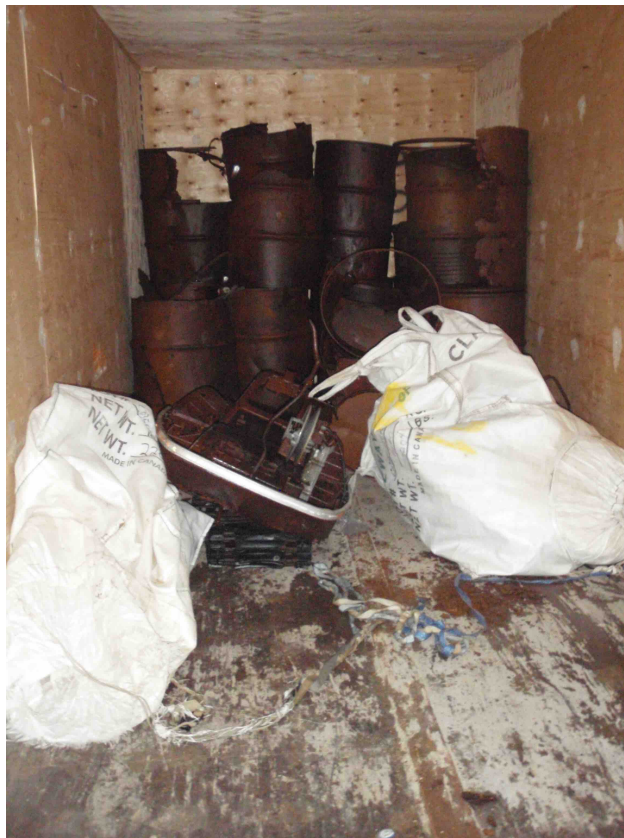
Figure 22: Material from site GW-8 ready for marine transportation in Kuujjuaraapik, September 2017

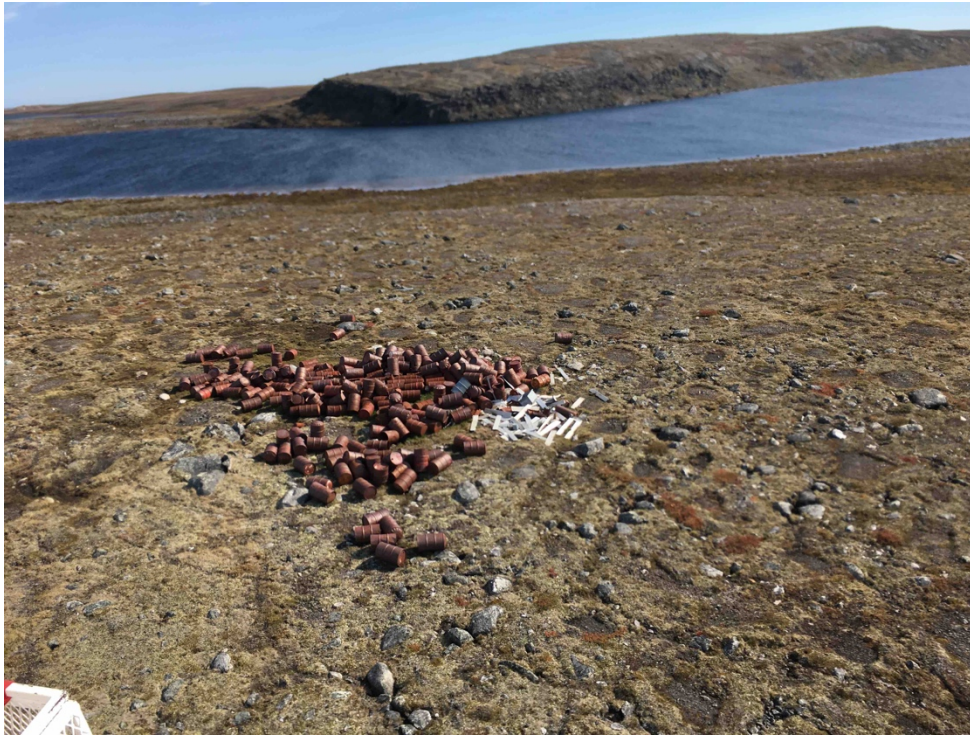
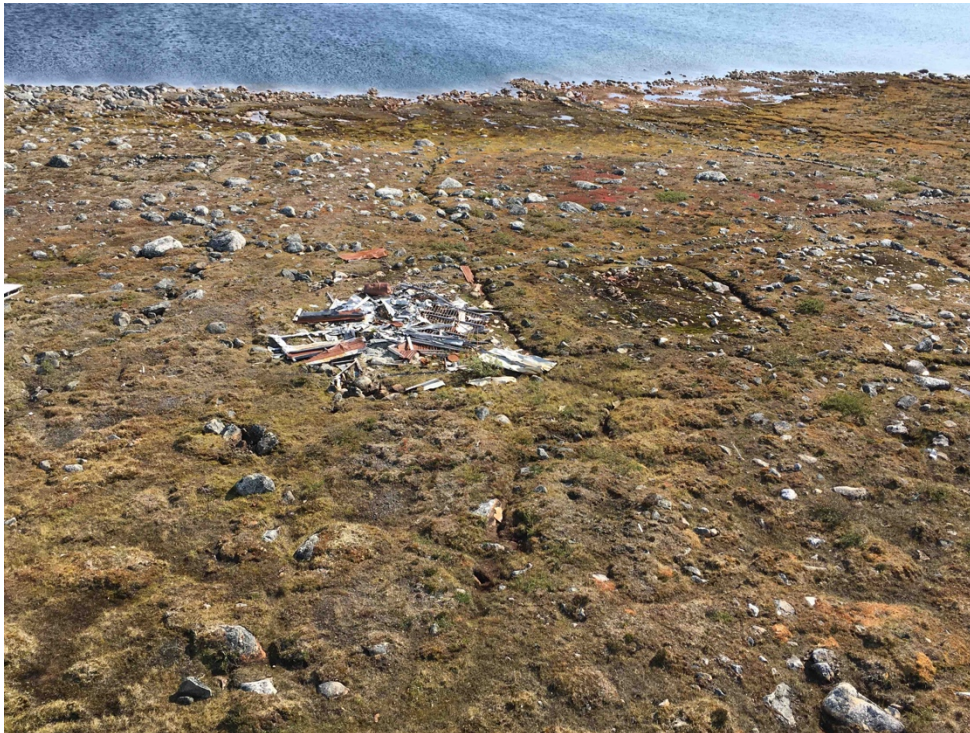
The abandoned mineral exploration site KG-1 (59°46'5"N, 65°59'6"W) is located 28 km southwest from the community of Kangirsuk. The site could be considered as requiring major cleanup due to the volume of material found there: 120 drums, scattered debris, core trays and a dumpsite.

Figure 23: Material seen at site KG-1, August 2017

Figure 24: Material seen at site KG-1, August 2017

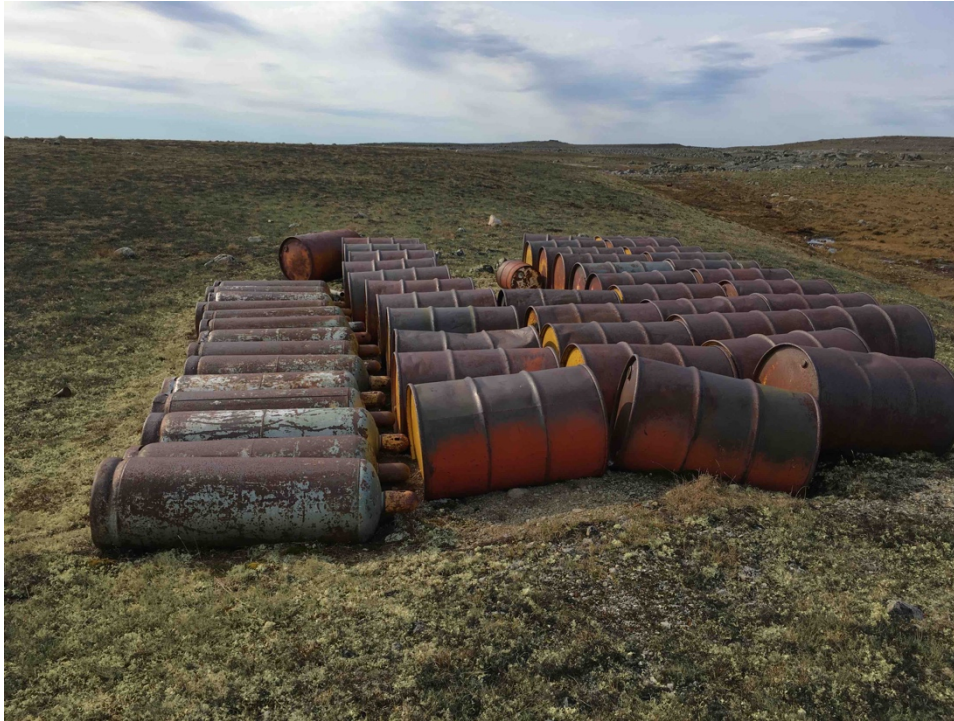
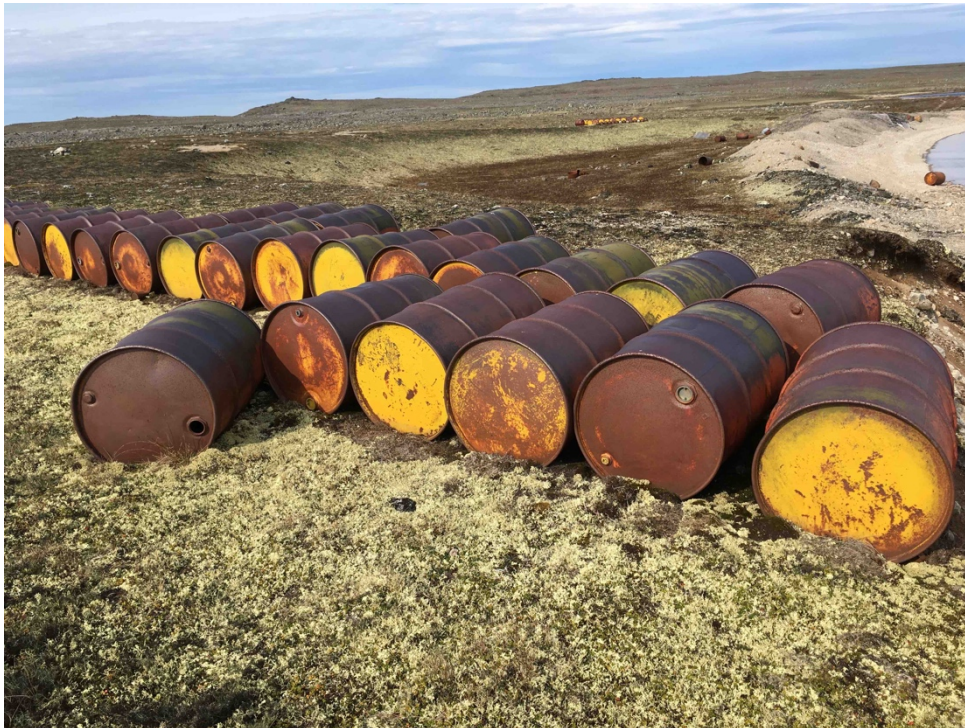
Figure 25: Material seen at site KG-2 (Amaluttuq Lake), August 2017

Figure 26: Material seen at site KG-2 (Amaluttuq Lake), August 2017

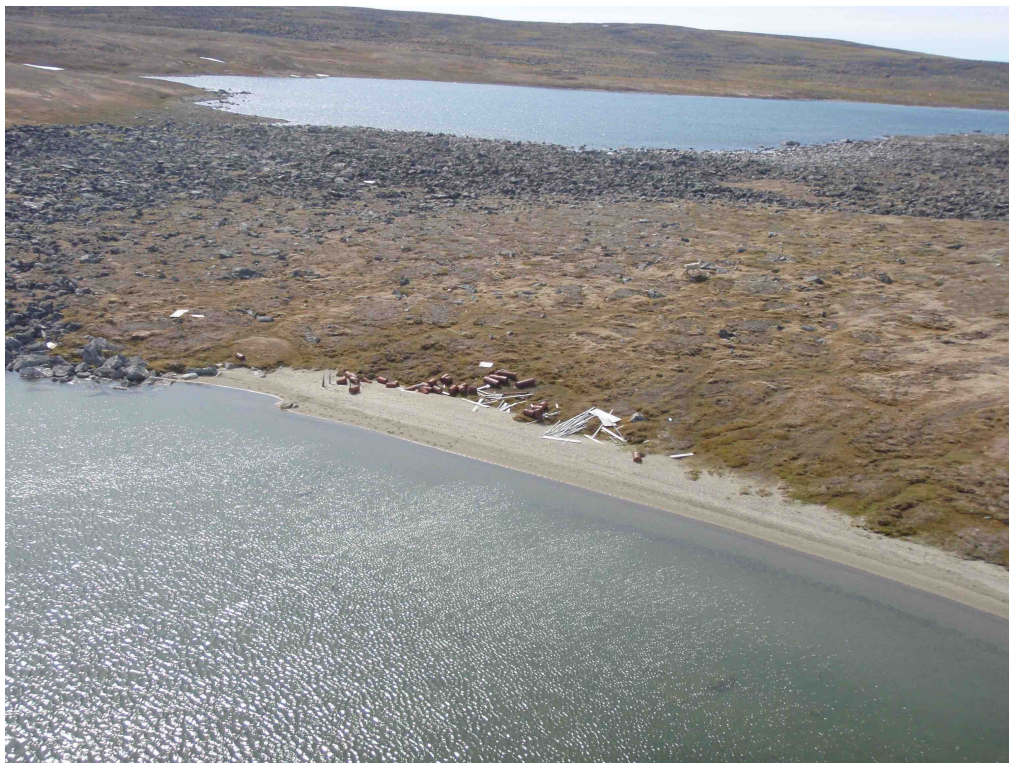
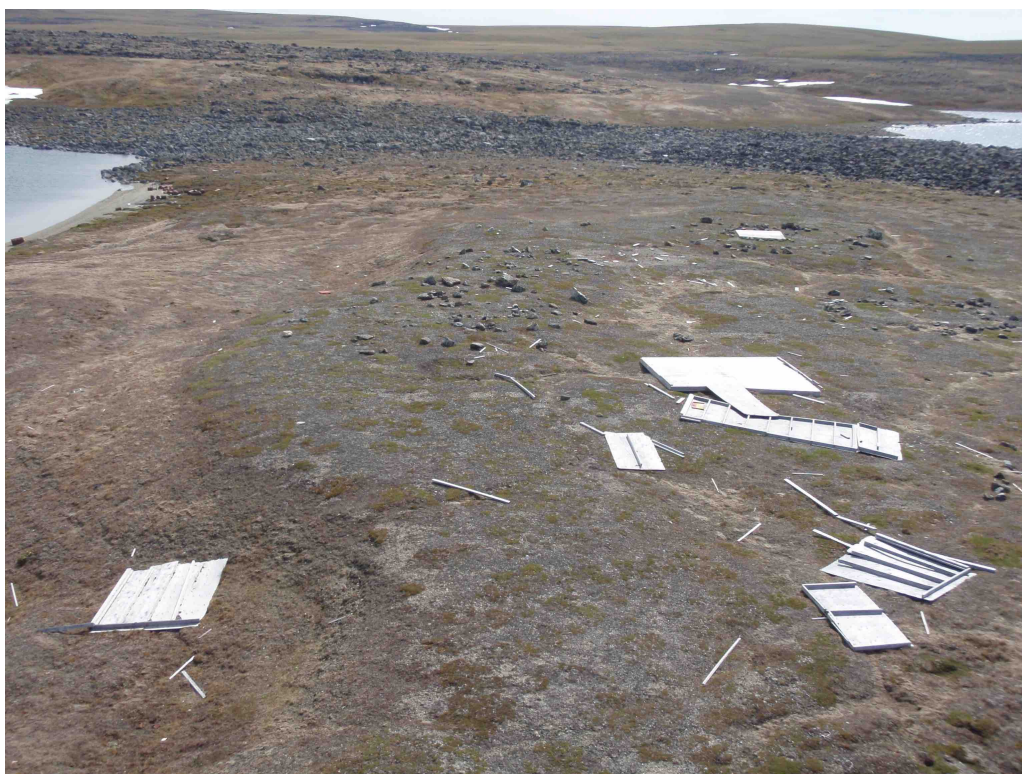
Figure 27: Material seen at site SW-27C, August 2017

Figure 28: Material seen at site SW-27C, August 2017

It should also be noted that this site is located near active claims (one of which contains another new site known as SW-27D) that are currently owned by Orford Mining. The KRG could inform the company of the material found on these sites and ask for their assistance in the rehabilitation process.
