**Northern Village of
Kangihsualujjuaq**

**VULNERABILITY ANALYSIS OF
THE DRINKING WATER
SOURCE**

WATER INTAKE N°X2114288 OF
KANGIHSUALUJJUAQ

Project 21-0053

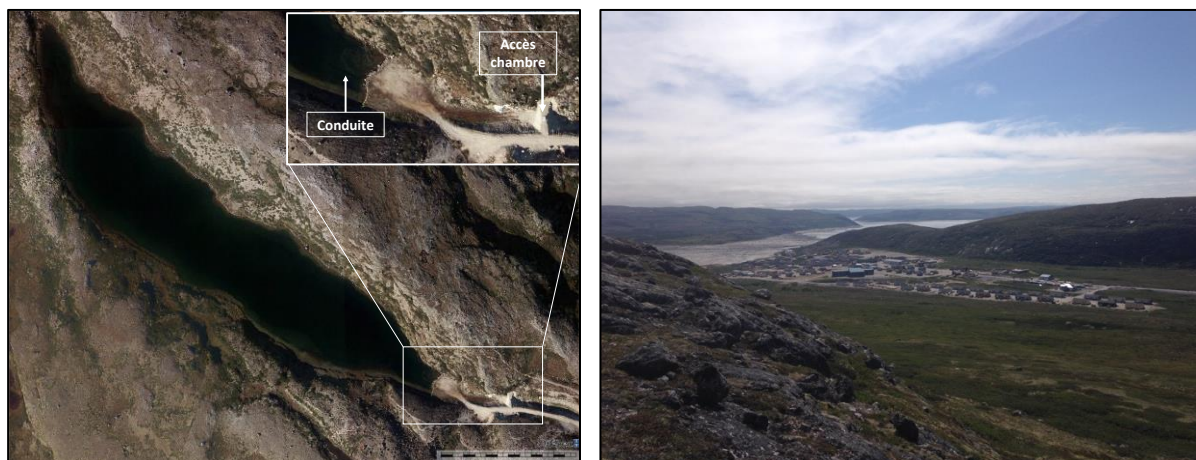
Photo 1. Aerial photography adapted from the images library of the indigenous Northern Villages (MERN). The lake is the drinking water source for the Northern Village of Kangiqsualujjuaq

Photo 2. View of the Kangiqsualujjuaq from higher grounds near the lake from which the village's drinking water is withdrawn (2017, KRG)

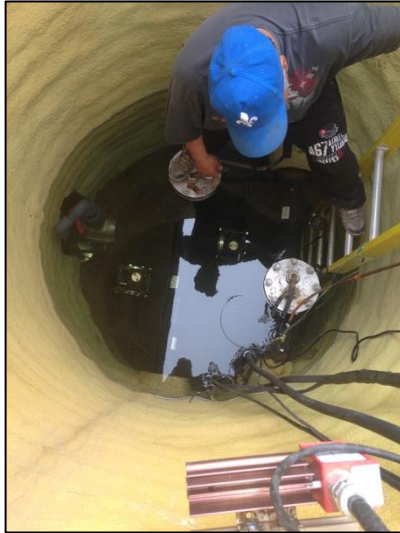
Photo 3. Inside view of the chamber for the air traps and electricity supply for the heating cables (2017, source KRG)

Regarding the manhole located immediately on the shore of the lake (pictures 1 to 4), the latter was also upgraded a decade ago following melting water infiltrations and the electrocution hazards that ensued every spring (600 volts electrical installations in the ground near the manhole). Finally, we noticed that the top of the manhole is closed only by a wooden lid that does not fit the opening (picture 4). We advise to replace this wooden lid by a cover that fits the manhole and isolates the interior of the chamber from any infiltration (rain, snow, dusts or organic debris) or intrusion by the fauna living in the area. Moreover, as the withdrawal site is a public one, it could be pertinent to install a lock on the new cover in order to provide access to the manhole to the relevant personal only.

The on-site evaluation by a professional should also assess the condition of the manhole near the shore and in particular if it needs some adjustments (other than the tight-fitting lid) in order to 1) prevent melt water infiltrations and 2) guarantee the security of the personal working there at all times.

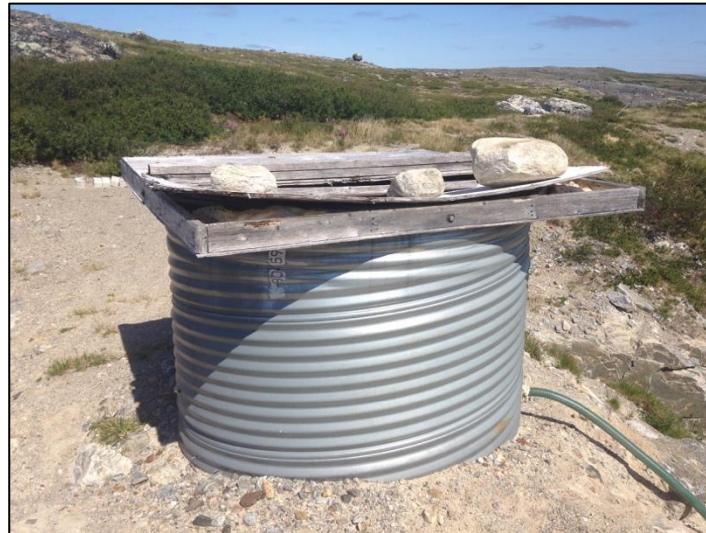
Photo 4. Outside view of chamber for the air traps and electricity supply for the heating cables (2017, KRG)

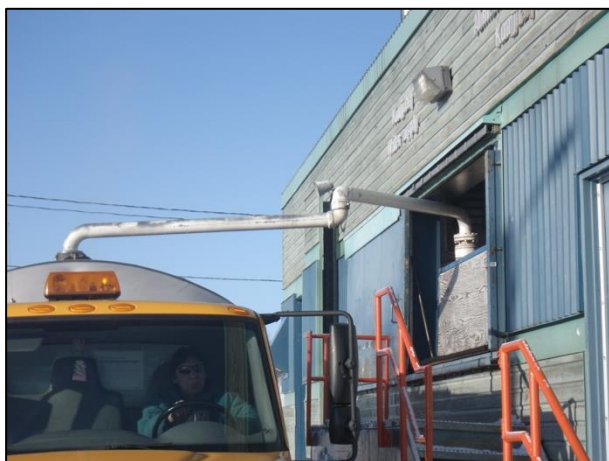
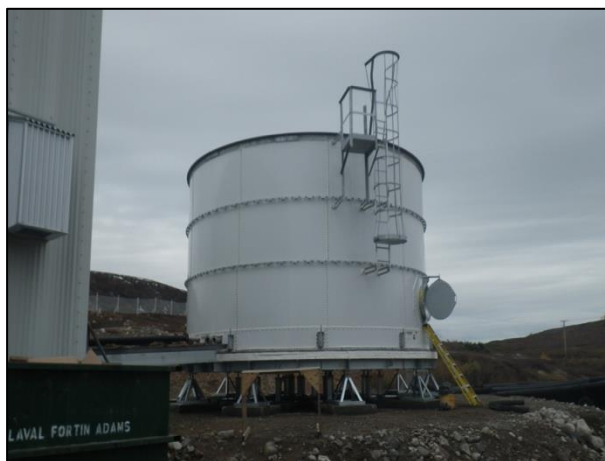
Photo 5. Filling of a water truck at the water treatment plant for distribution in the village (2014, KRG)

Photo 6. Drinking water tank newly installed in 2014 (KRG, 2014)
