Surface water intake vulnerability analysis report for the Northern village of Kangirsuk

Water intake number: X2114293

January 2025

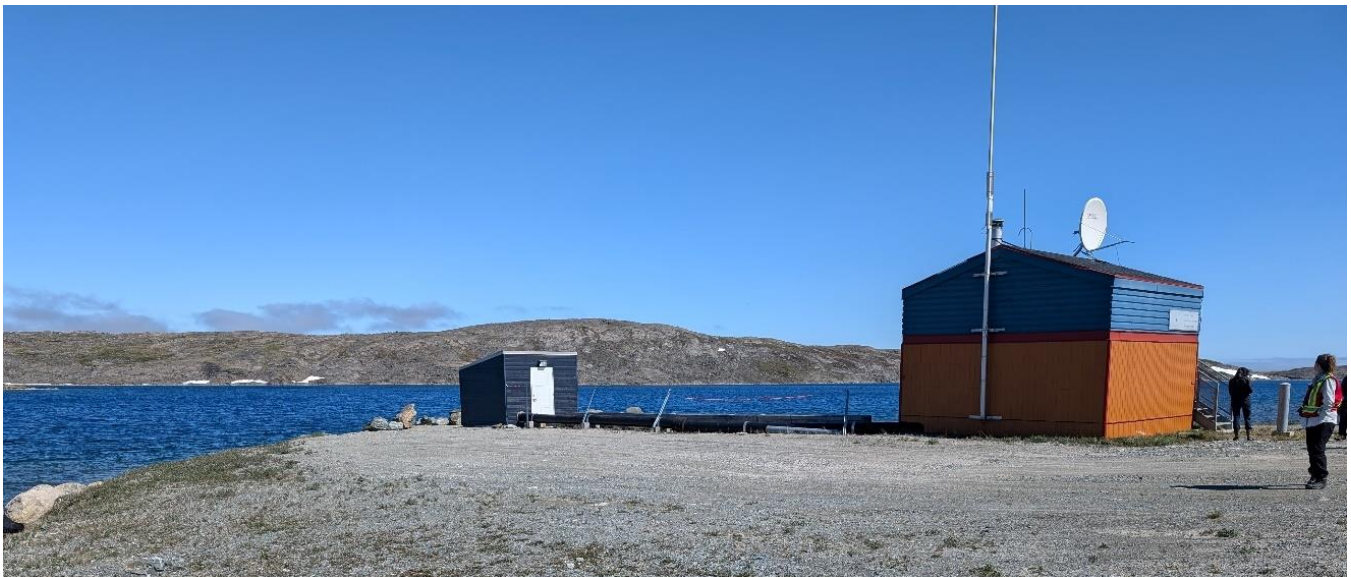
Figure 3. Drinking water withdrawal infrastructure. The navy blue building houses the pumps (Photo taken on July 18, 2024, by Antoine Thibault)

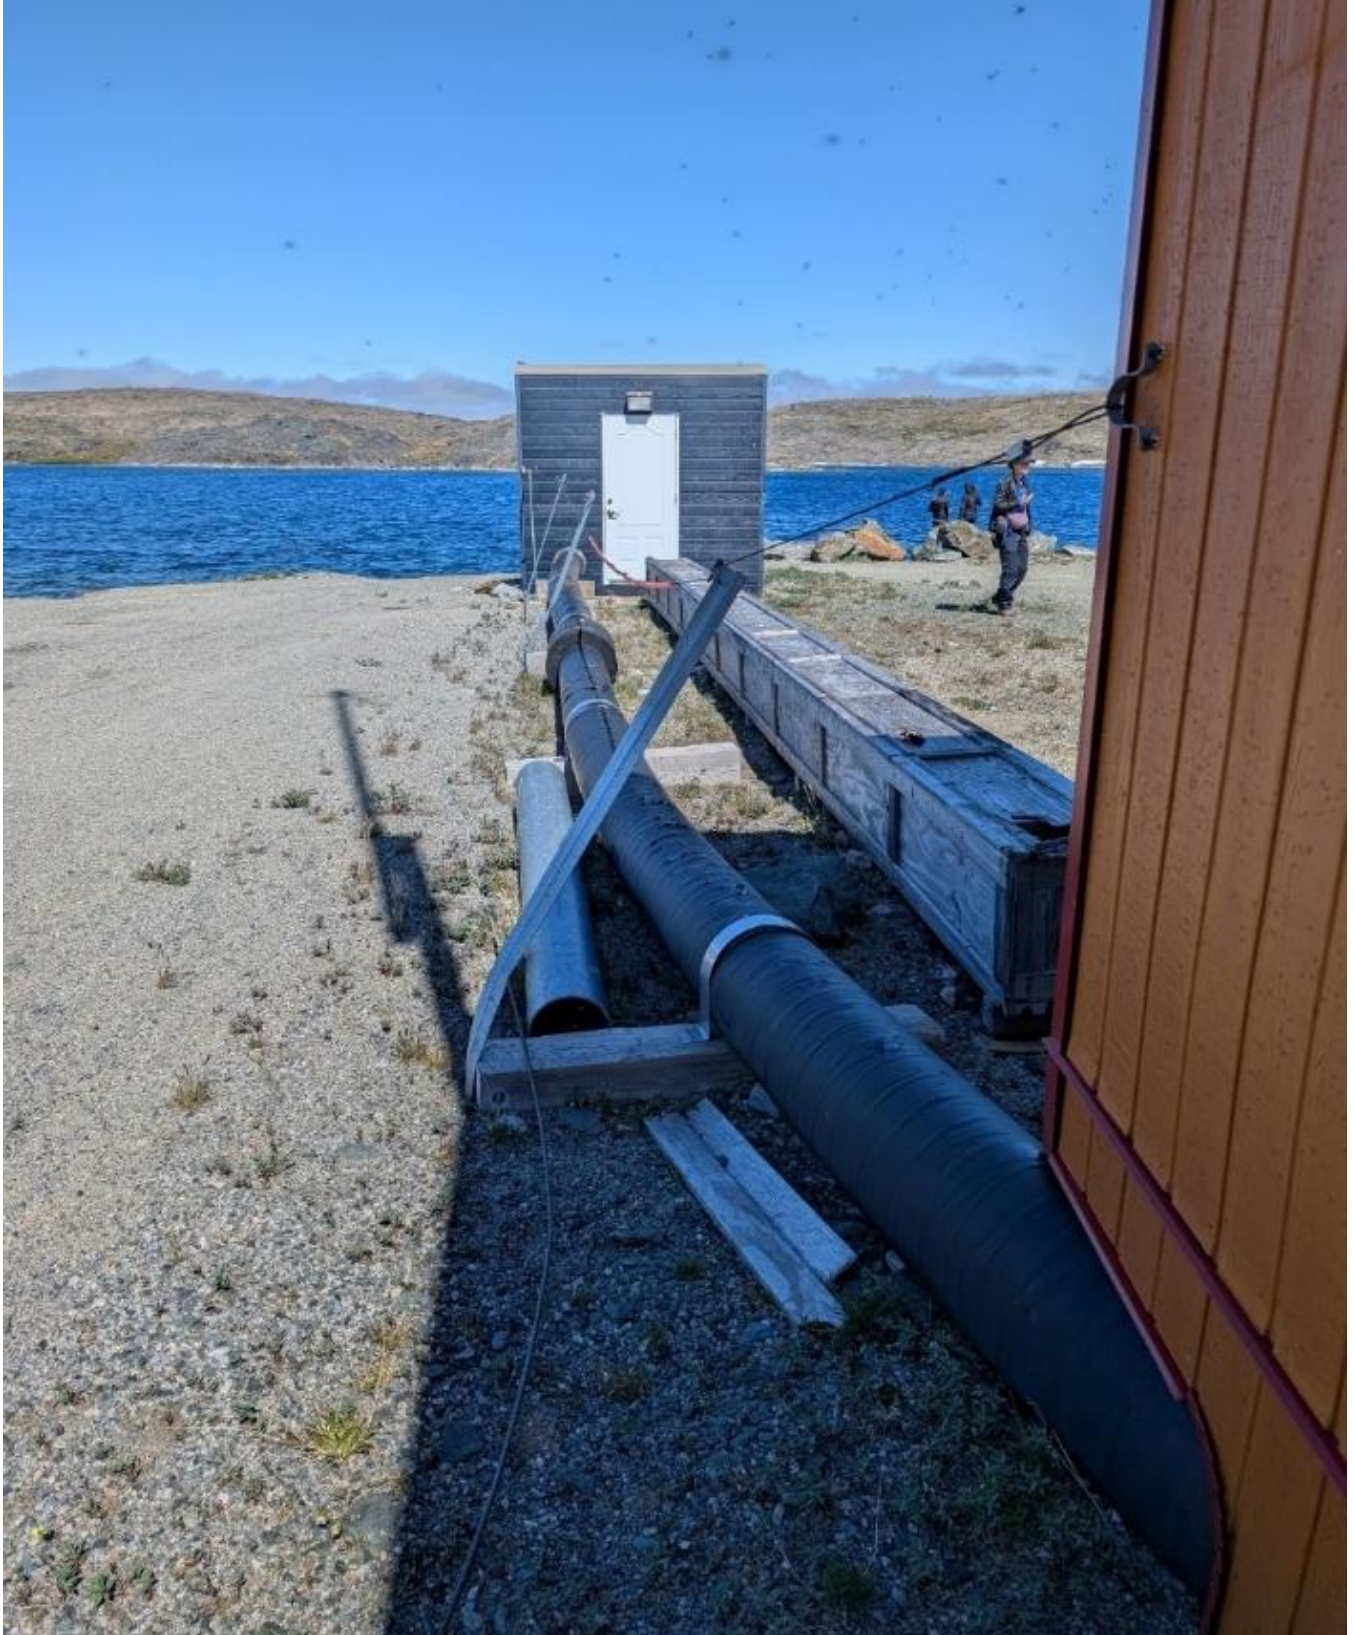
Figure 4. Connection between the building housing the pumps and the pumping station. Photo taken on July 7, 2024 by Antoine Thibault

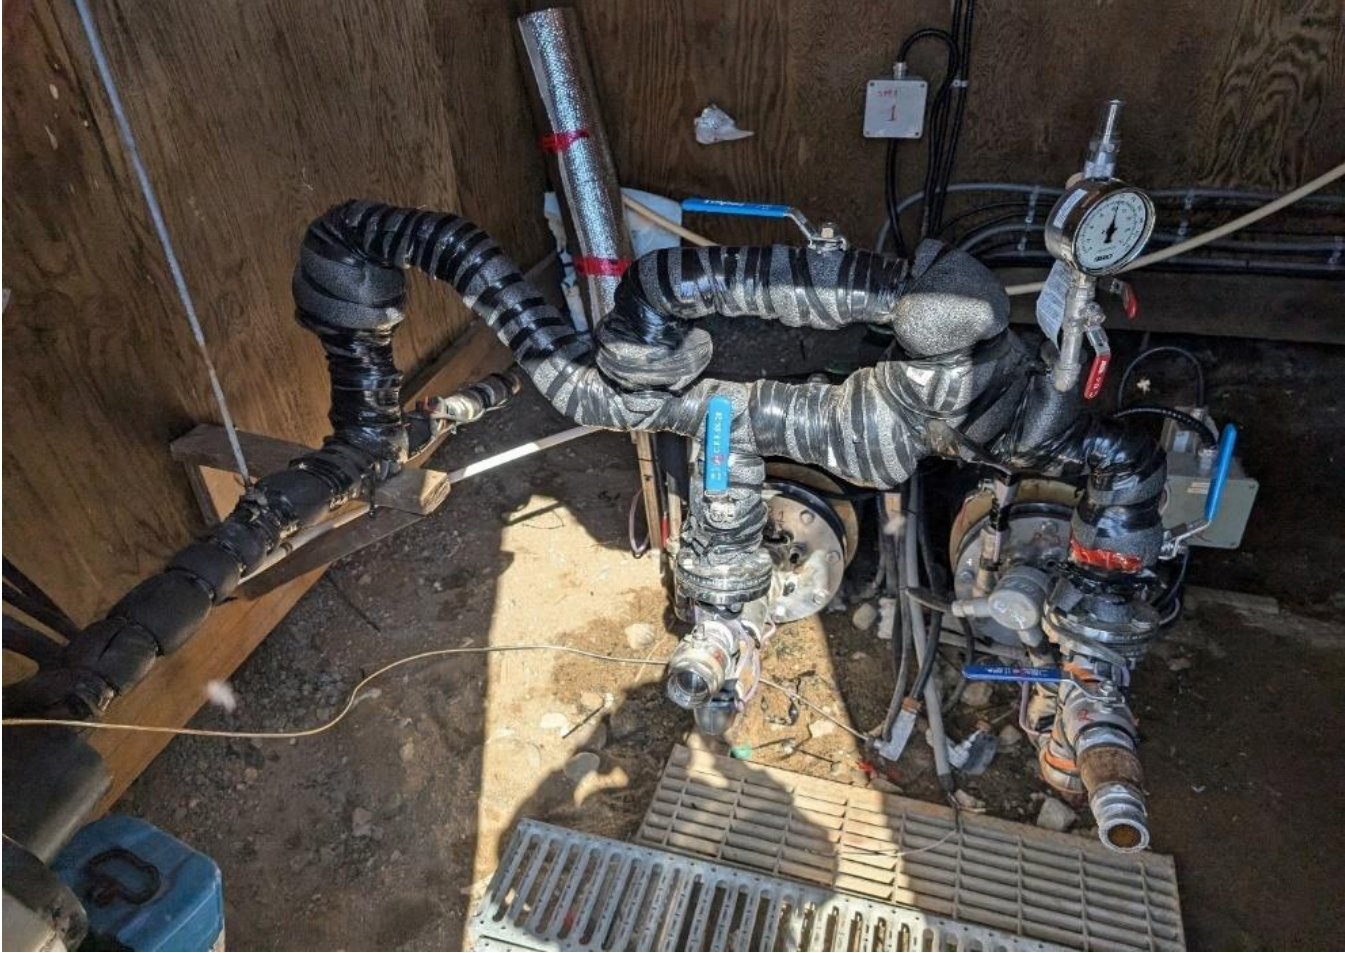
Figure 5. Inside the navy blue building: raw water pumping station (Photo taken on July 7, 2024, by Antoine Thibault)

- There is no event record.
- The supply pipe in the lake froze in 2020.
- Pumps SPP1 and SPP2 have recently stopped working. Repairs took 3 days on each occasion. The technical team pointed out that the service life of the pumps is significantly shorter than the normal expected life. An underwater inspection is scheduled for the summer of 2025 to identify the causes of this problem.
- The withdrawal site’s perforated casing is positioned too close to the shore, which could lead to clogging of the casing and conduits.
- The KRG team stated that communication with the WTP and the withdrawal site is difficult in Kangirsuk. As a result, breakdowns can persist for some time before being detected and reported, exacerbating the overall vulnerability of the site.
- The pumping station has no flooring.

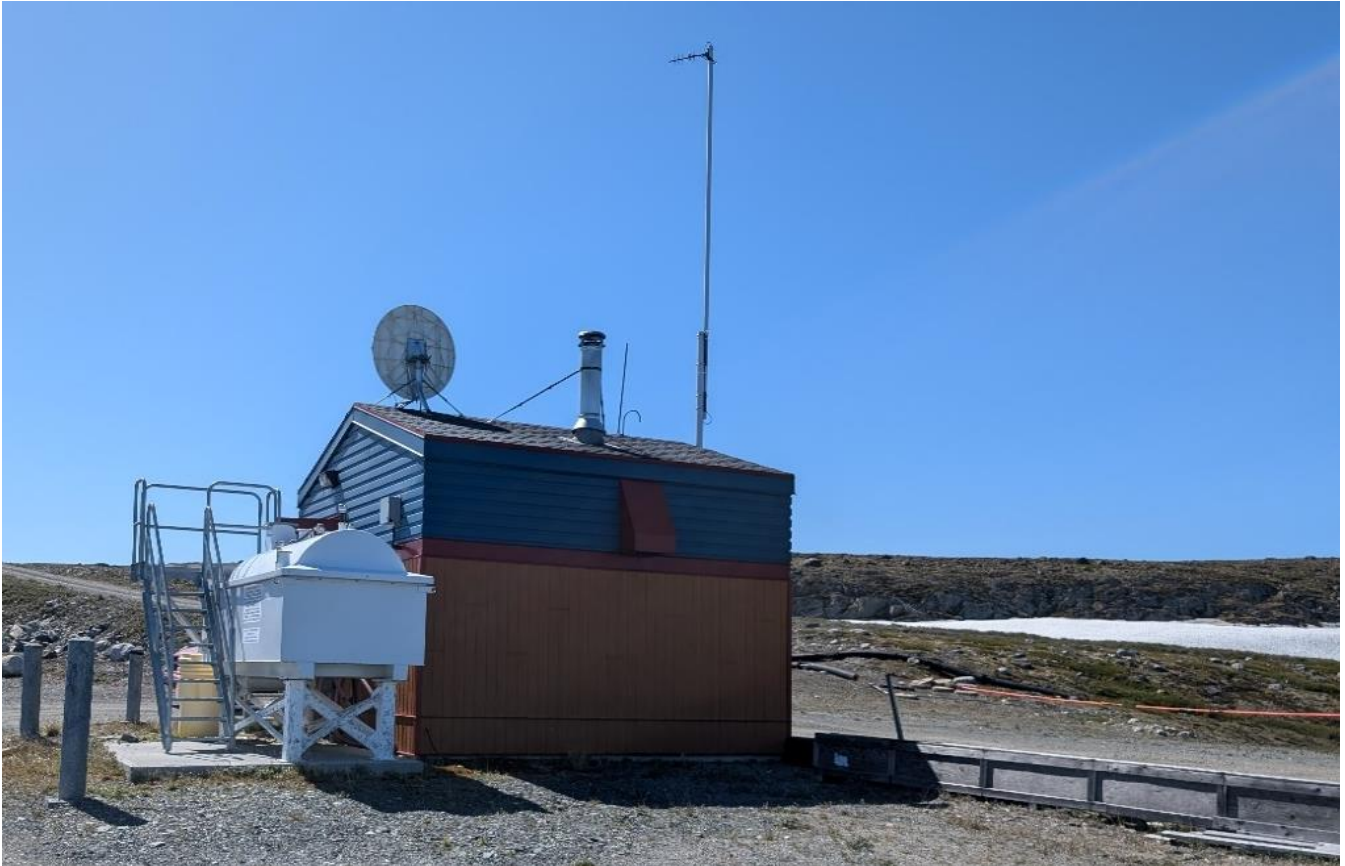
Figure 6. Pumping station on the shore of Lac Hardy. The oil tank is attached to the main building (Photo taken on July 7, 2024, by Antoine Thibault)

Vulnerability to organic substances (F)	Method 2	Medium	The presence of a fuel tank in the inner protection zone poses a potentially high risk of contamination.
---	----------	--------	--

The only building in the intermediate zone is the pumping station. According to the spatial analysis, the percentage of the intermediate protection zone occupied by this building is 0.004%. However, the presence of a fuel tank straddling the inner and intermediate protection zones between the pumping station and Lac Hardy poses a threat to water quality. The tank involves the handling and storage of 10,000 litres of diesel in an area of permafrost that is unstable to thawing and at risk of flash floods, ice jams, and ice break-up (see section 2.2 Results of the inventory of potential events and assessment of the threats they represent for more details, and Appendices Appendix 3 and Appendix 7 for reference maps).

Identified problem	Vulnerability indicator with which this problem is associated	Identification of causes	Type of cause
Fuel storage and handling at the water treatment plant	Vulnerability to organic substances (F)	Presence of water treatment plant in the intermediate zone	Anthropogenic

it) and monitor the recording of events.
2	Fuel storage and handling at the raw water pumping station	<ul style="list-style-type: none"> • Move the fuel tank away from the inner zone; • Offer targeted training to Fédération des coopératives du Nouveau-Québec (FCNQ), WTP, and Northern village employees, combined with the installation of a spill containment station with the equipment needed to contain the spill and limit the risk of contamination at source.
3	Short service life for pumps SPP1 and SPP2	<ul style="list-style-type: none"> • Carry out an underwater inspection of the condition of the intake conduit and the perforated casing; • If the blockage in the conduits is not the cause of the short service life of the pumps, continue investigating.
4	Communication difficult	<ul style="list-style-type: none"> • Implement solutions to improve the quality of communication; • Identify possible problems in the event of poor communication and develop solutions that are independent of problematic technologies.

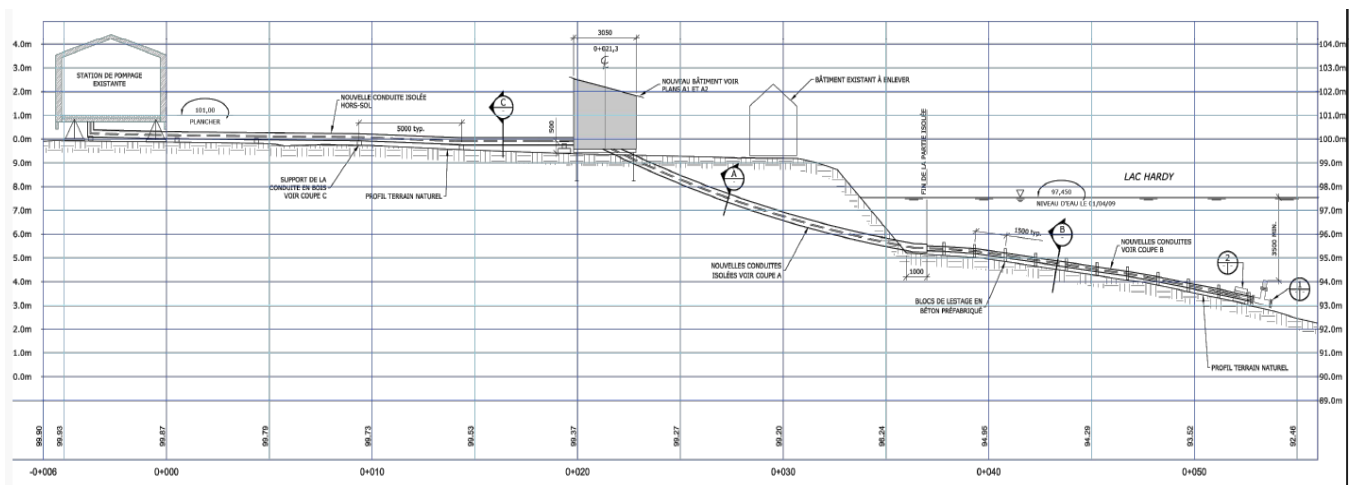
Figure 7 shows a cross-section of the pumping infrastructure on the shore of Lac Hardy. The two buildings illustrated in the diagram are shown in Figures 3 to 6.

Figure 7 Diagram of water withdrawal infrastructure
