Nunavik Abandoned Mineral Exploration Sites Rehabilitation Project

2020-2021 Activity Report

Kativik Regional Government

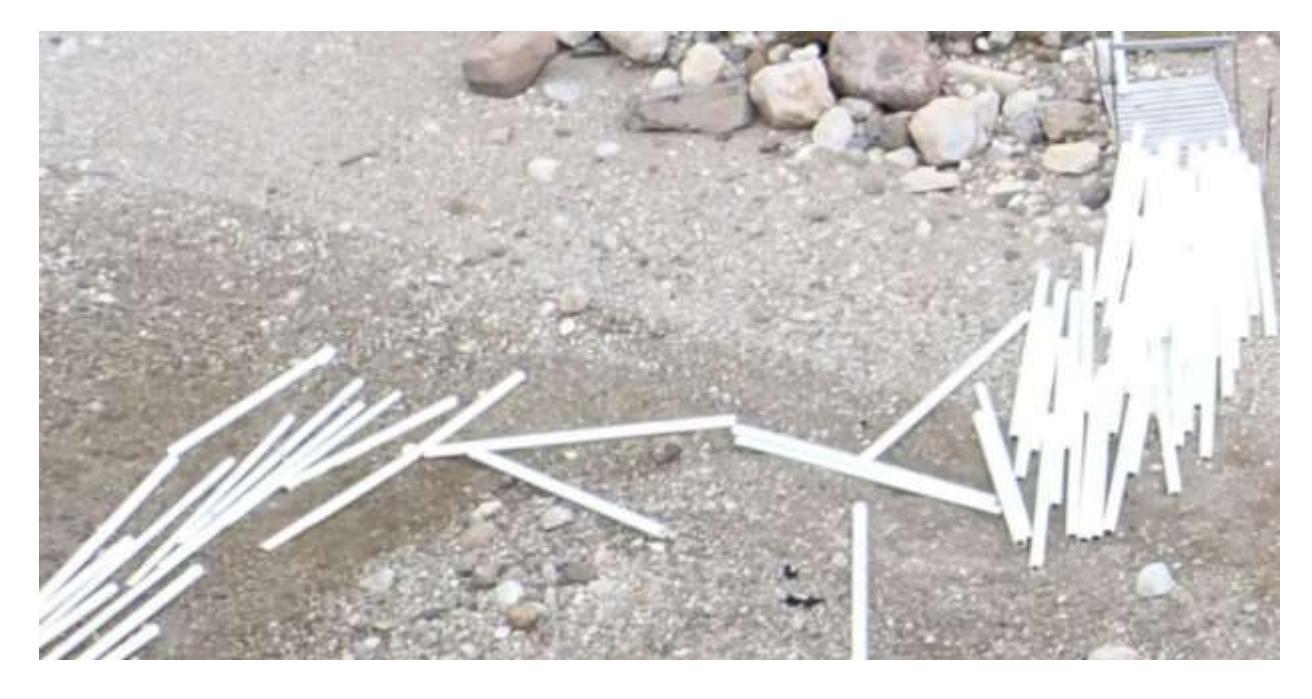
Figure 18 PVC pipes at GR-6, 2020

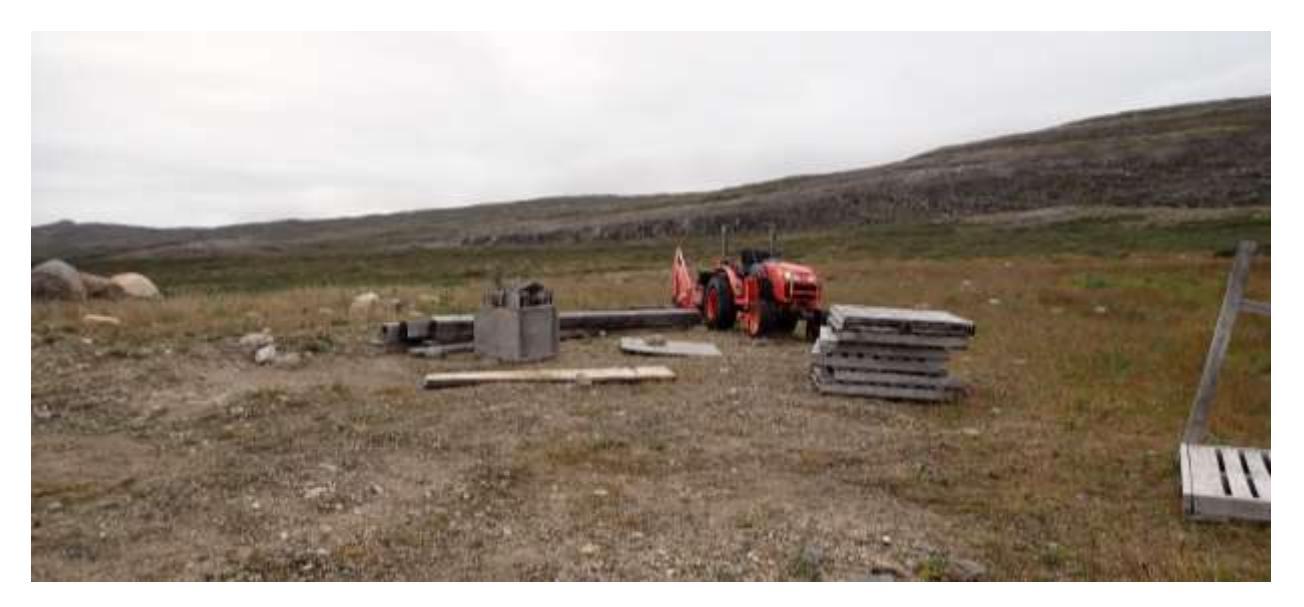
Figure 20 GR-6 site, with only the tractor and the wood remaining, 2020

A small piece of heavy equipment (Kubota tractor) was also removed from the site and donated to the local community. The total weight of the removed material is approximatively 8,000 lbs. The site is considered as complete and photos of the work can be found in Appendix 2.

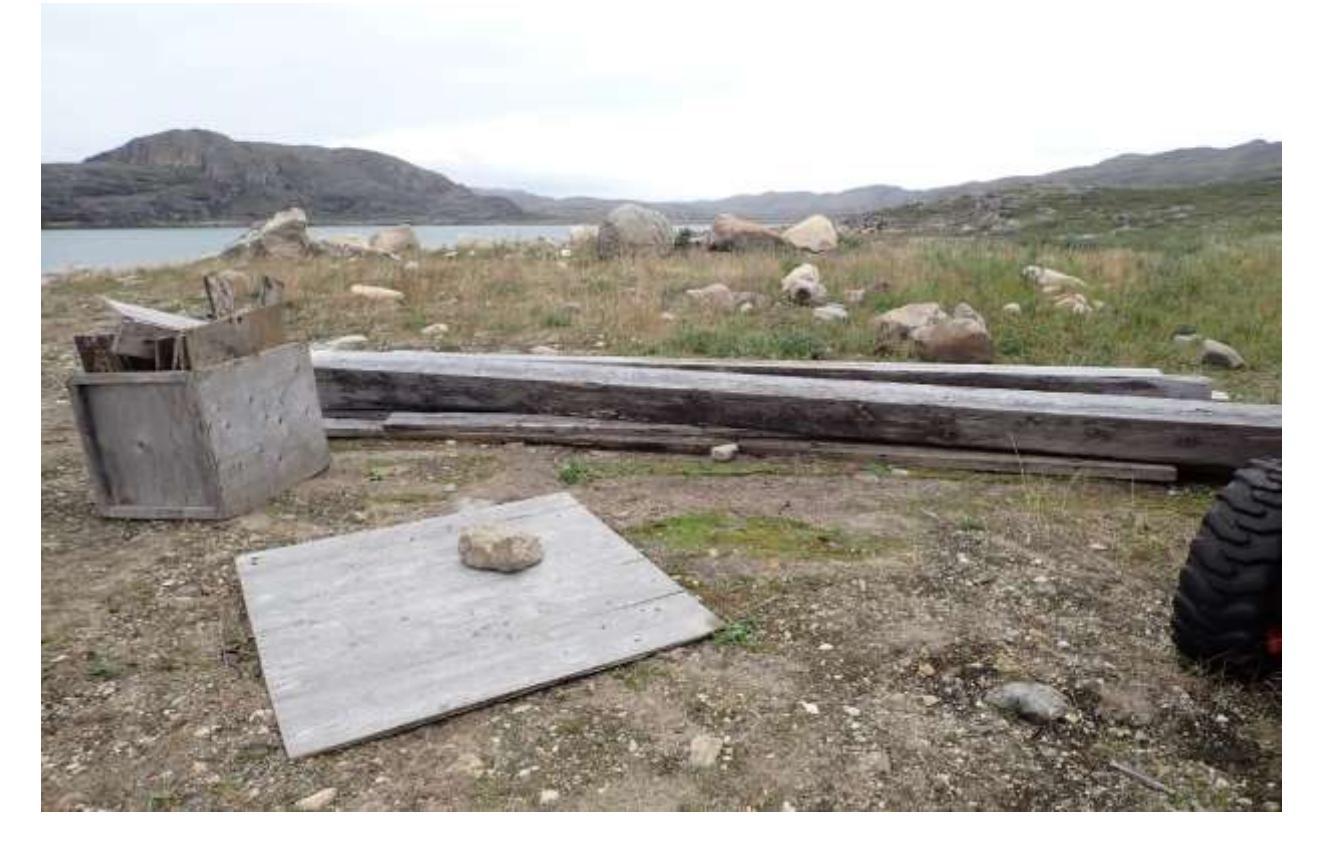
Figure 21 Wood remaining at GR-6 site, 2020

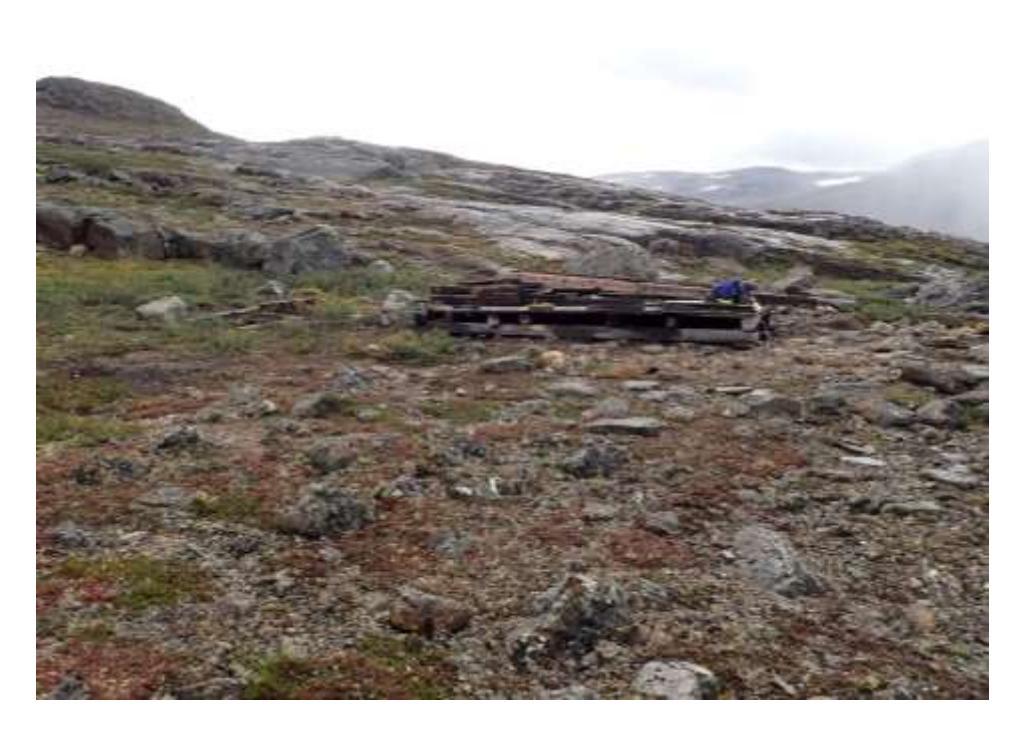
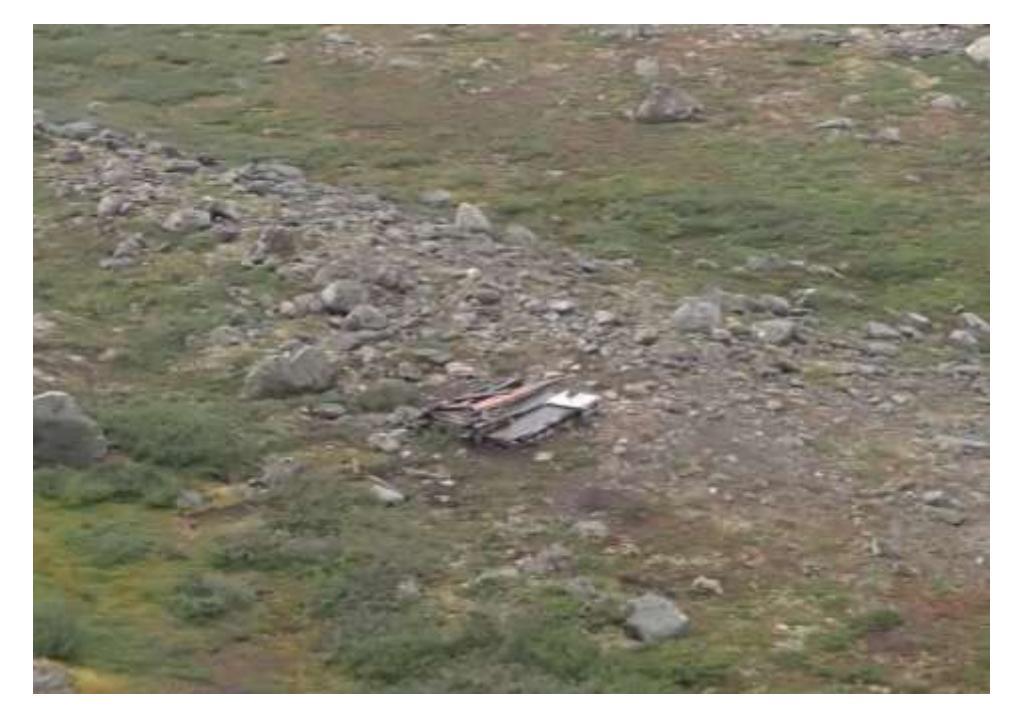
Figure 28 GR-3 Drill site completed with only wood remaining on site, 2020

Figure 29 GR-3 Drill site completed with only wood remaining on site, 2020

The total weight of the removed material is approximatively 9,000 lbs. There is a wooden platform remaining at the site, but should time not permit for its burning in 2021, the site should be considered as complete. Photos of the work can be found in Appendix 2.

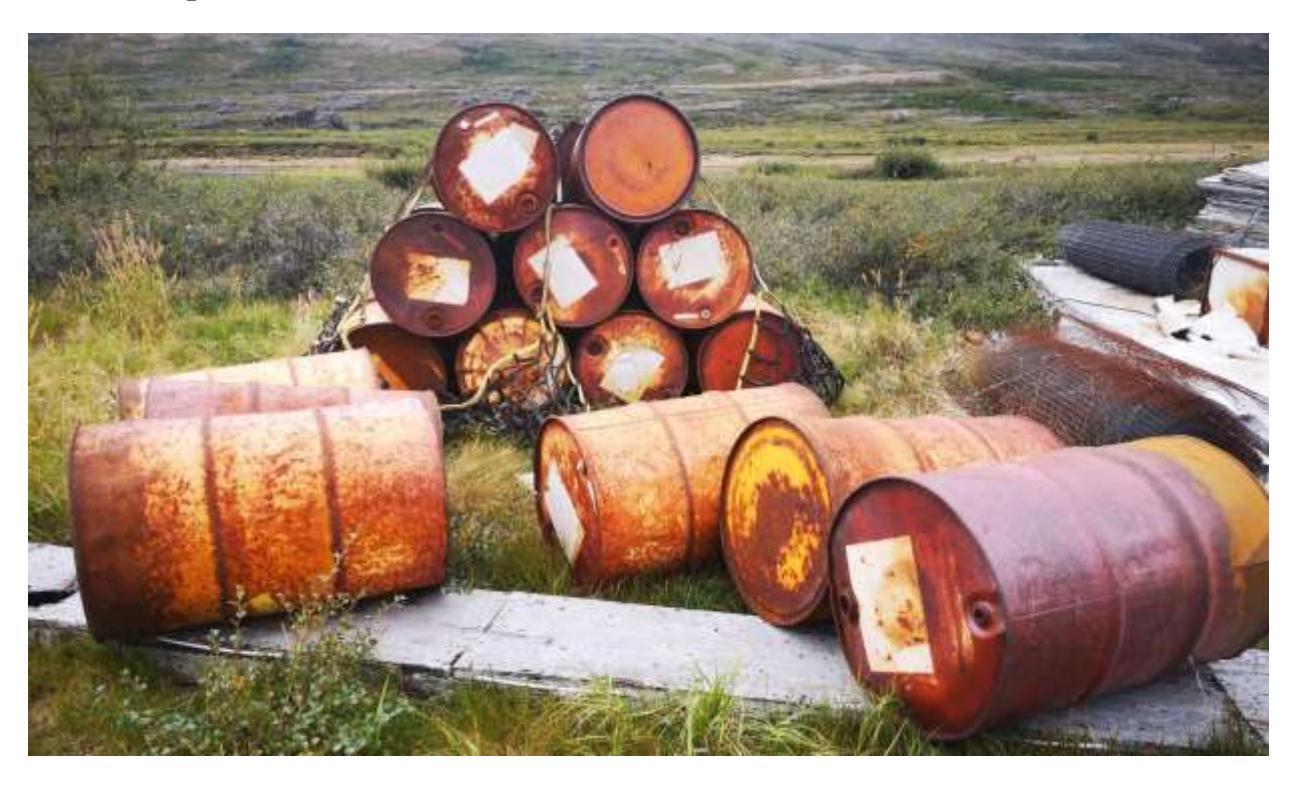
Figure 31 Drums prepared for transportation, 2020

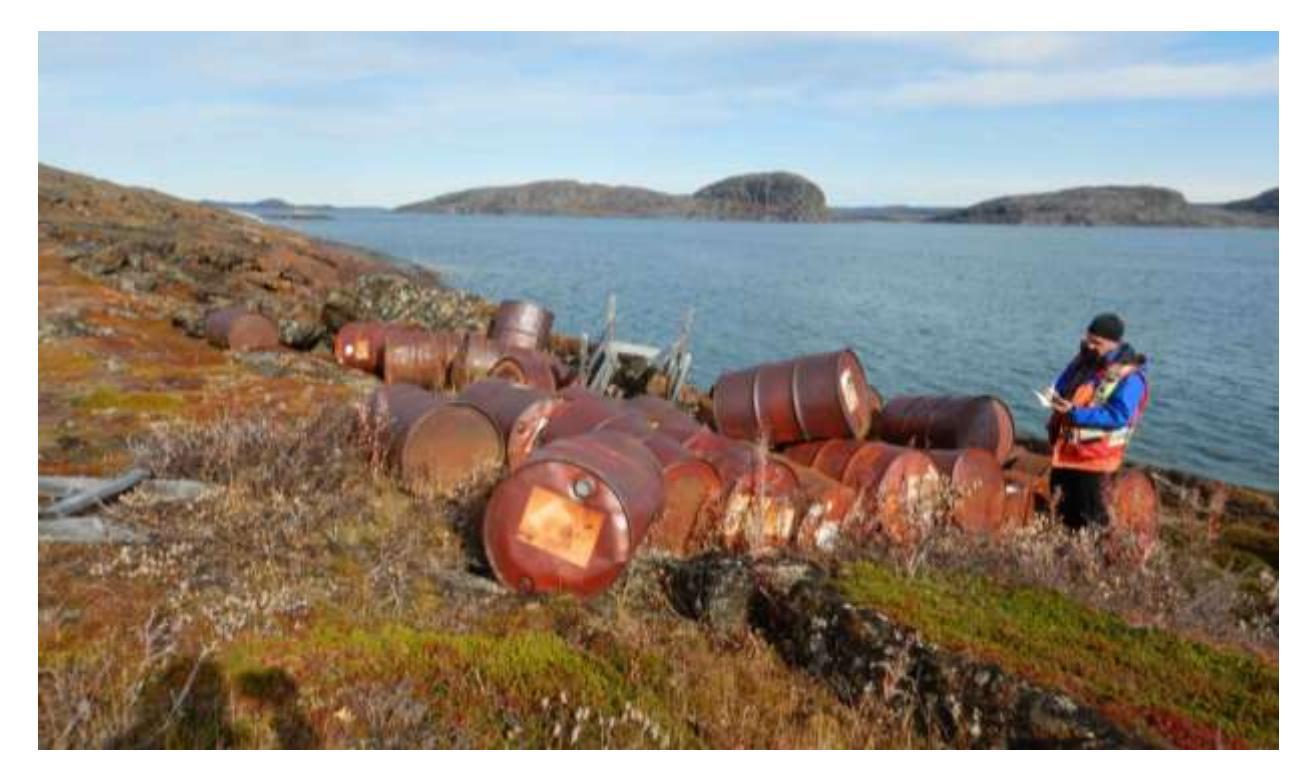
Figure 34 Pile of drums left by the shore of the Weymouth site, 2019

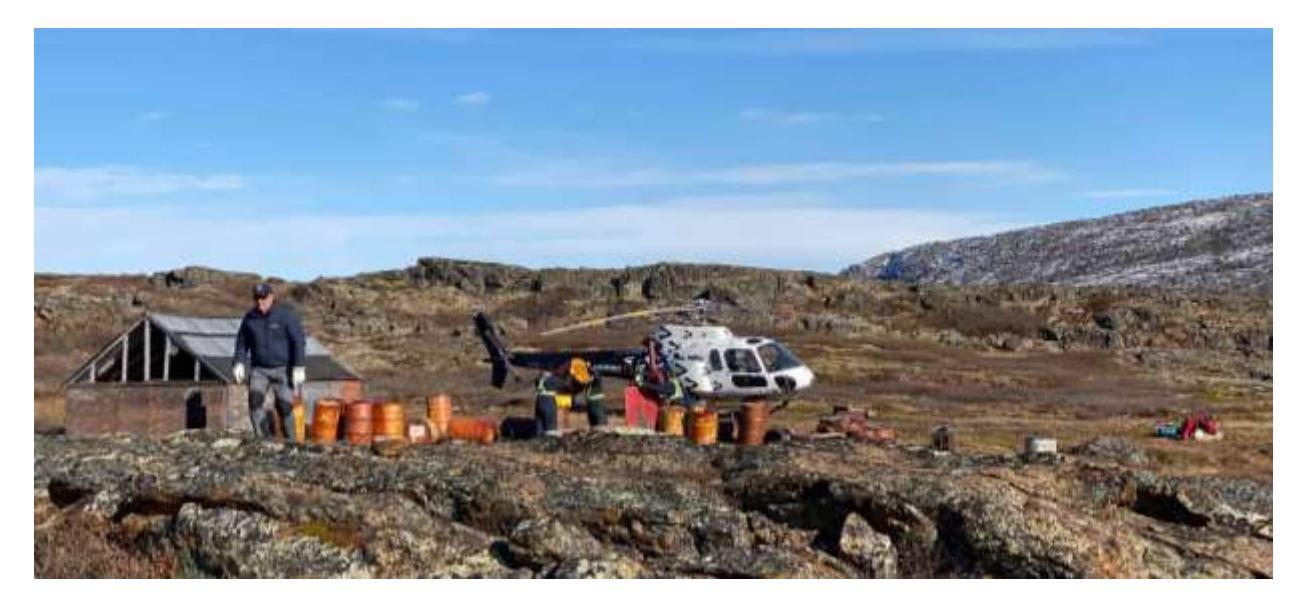
Figure 42 Team crushing drums, 2020

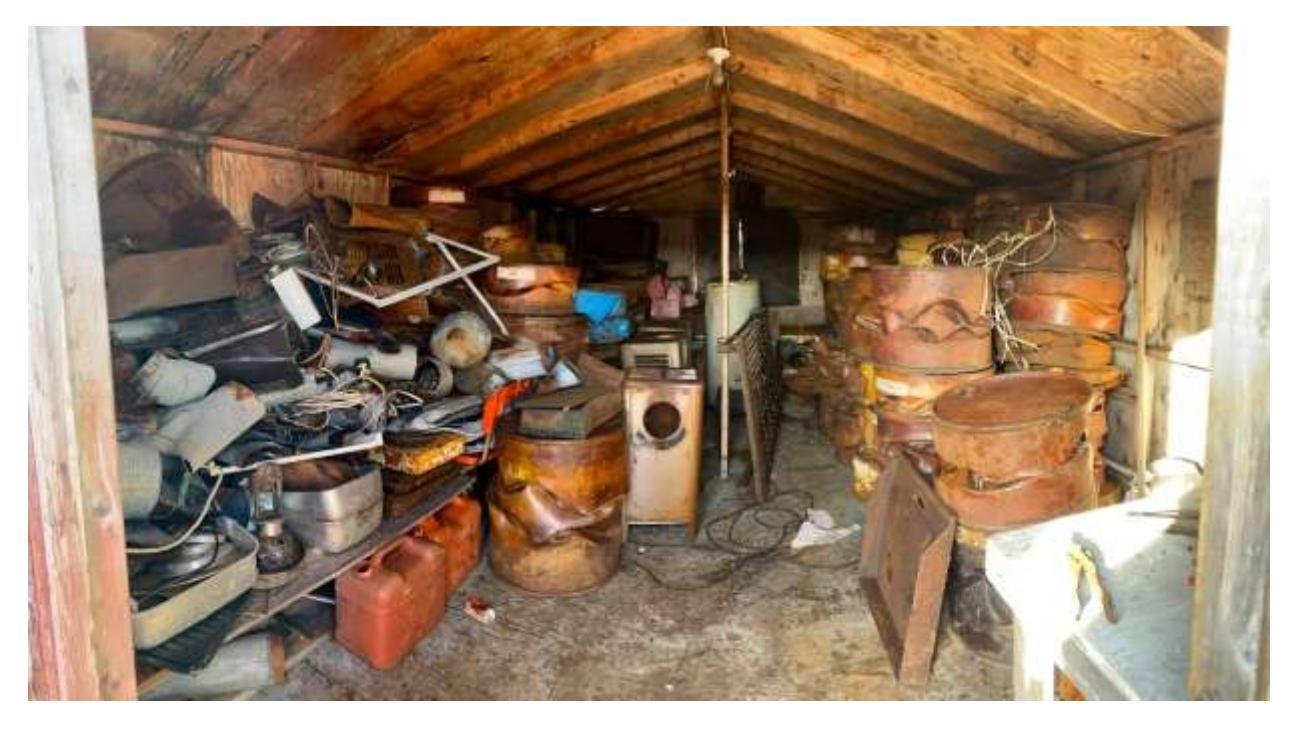
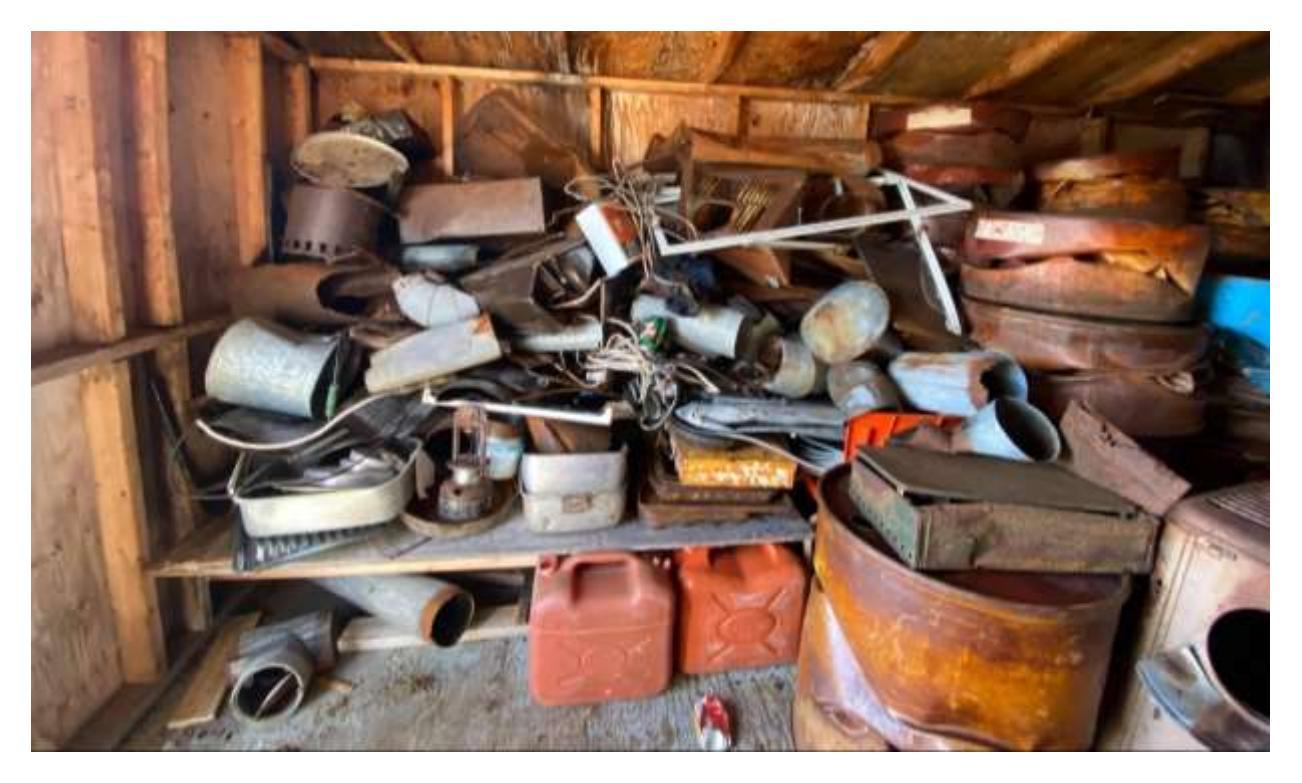
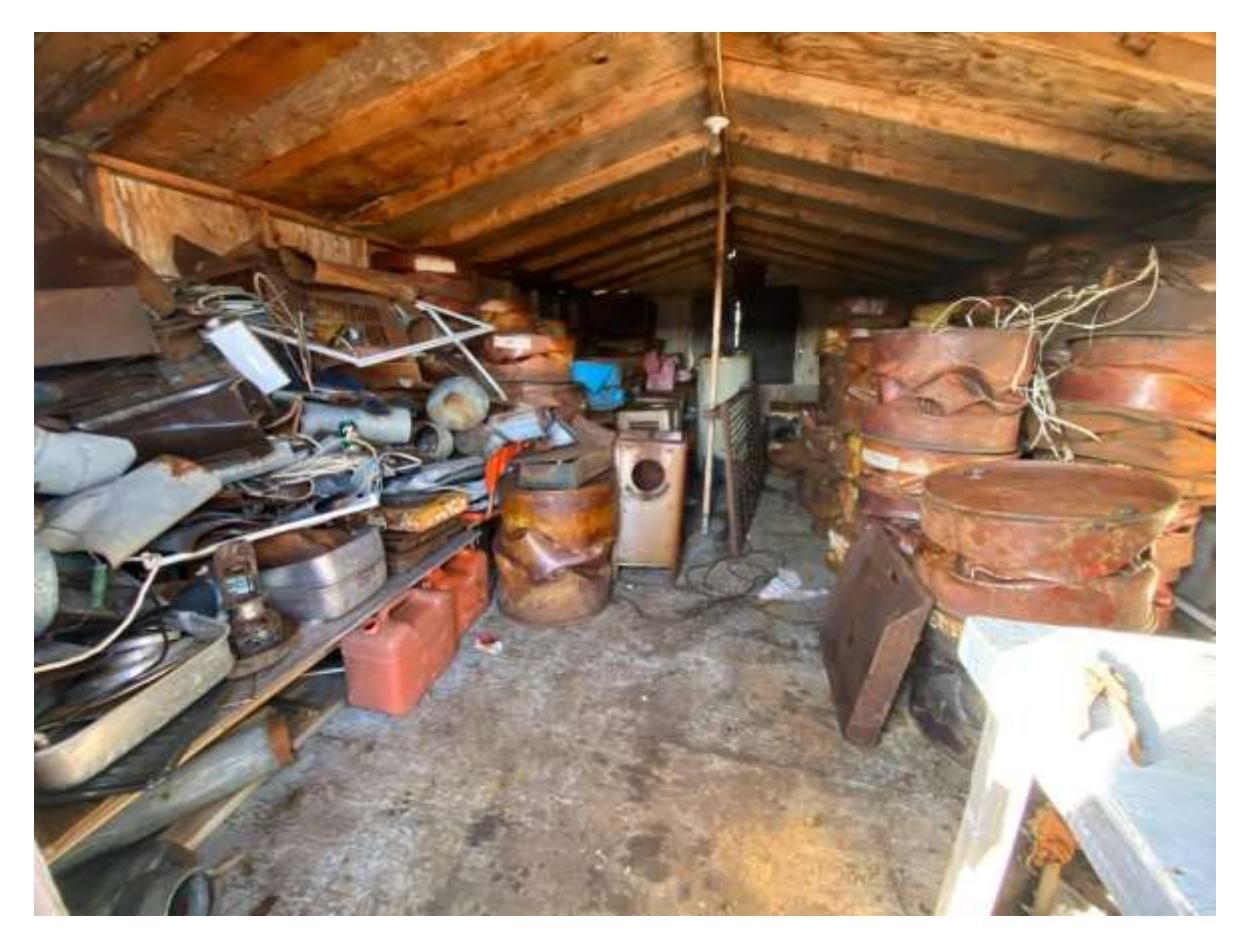
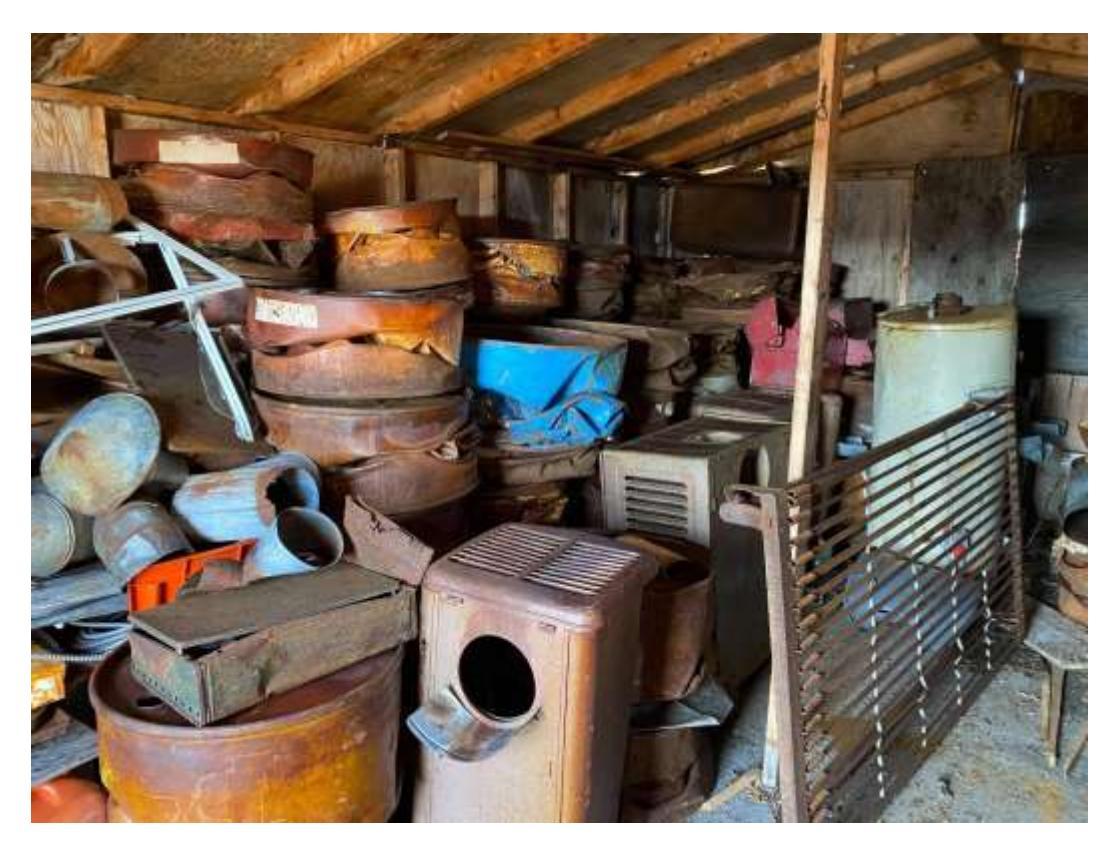
Figure 43 Stored debris for snowmobile pick-up, 2020

Figure 44 Stored debris for snowmobile pick-up, 2020

Figure 45 Stored debris for snowmobile pick-up, 2020

Figure 46 Stored debris for snowmobile pick-up, 2020

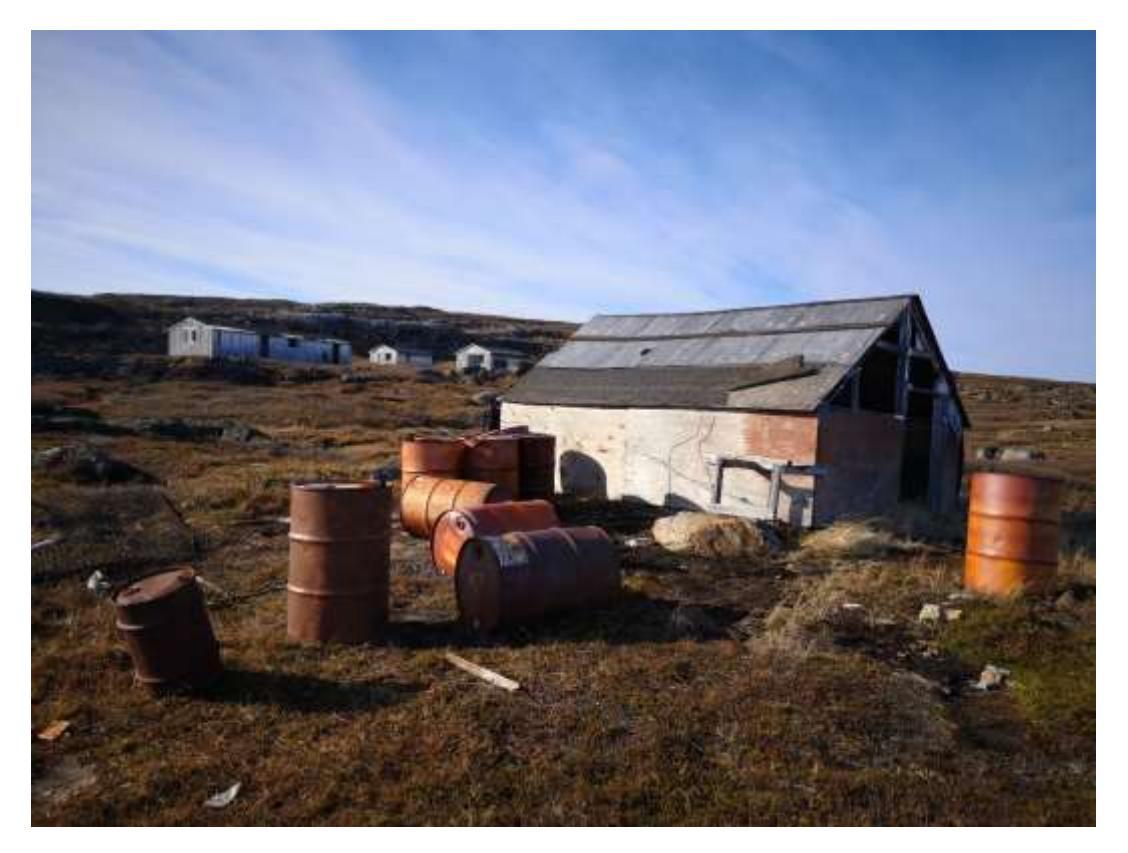
Figure 47 Full drums left by the central cabin, 2020
