**Northern Village of Kuujjuaq**

**VULNERABILITY ANALYSIS OF  
THE DRINKING WATER  
SOURCE**

WATER INTAKE N°X2114283 OF NV  
KUUJJUAQ

Project 21-0054

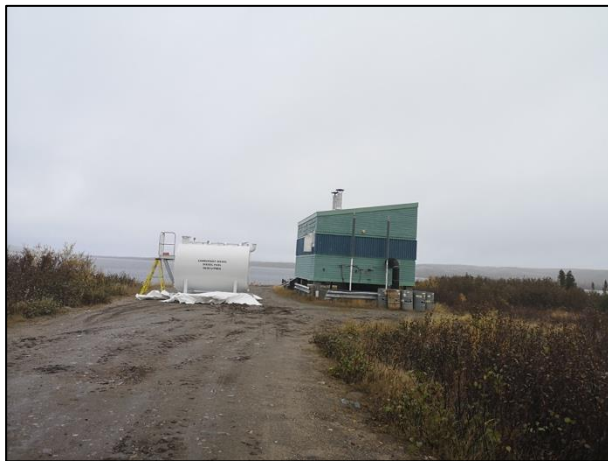
Photo 2. Pumping station on the shore of Lake Stewart (September 2019, KRG)

An oil spill at the raw water pumping station located on the shore of the lake immediately beside the water intake, is a potential event that could contaminate the exploited waters. A potential spill following either the filling/ maintenance of the oil tank associated to the pumping station or some instruments malfunctions associated to the oil tank (due to a freezing event, defective/ old parts, etc.) could have **serious** consequences on water quality (aesthetic or organoleptic water quality problem that is not acceptable for the consumer; MELCC 2018). Moreover, it is possible that such an event will occur in the next 5 years. Following the guide's criteria, the associated risk potential is therefore **low**. It should be noted that such an event occurred in Autumn 2019 (see section 2.4.1 and section 4 for more details).

Following an oil spill incident on the pumping station site (see section 2.4.1, method 1), the physical vulnerability indicator of the water sampling site was set at medium level. The probable cause of this spill is related to the displacement of the oil tank. Normally, this tank is placed on a concrete slab and surrounded by low walls, acting as a retention basin in the event of any spills. However, the tank having been moved for works, the oil spill took place directly on the ground. Thus, this exceptional situation should not occur again. Should such events be a recurring problem, we recommend that the facilities be assessed by a professional so that they can suggest solutions to this problem.
