# ASSESSMENT AND REMEDIATION OF ABANDONED MINING EXPLORATION SITES IN NUNAVIK

# PROGRESS REPORT FOR YEAR 2006-2007 OF THE PROJECT

Kativik Regional Government

March 2007

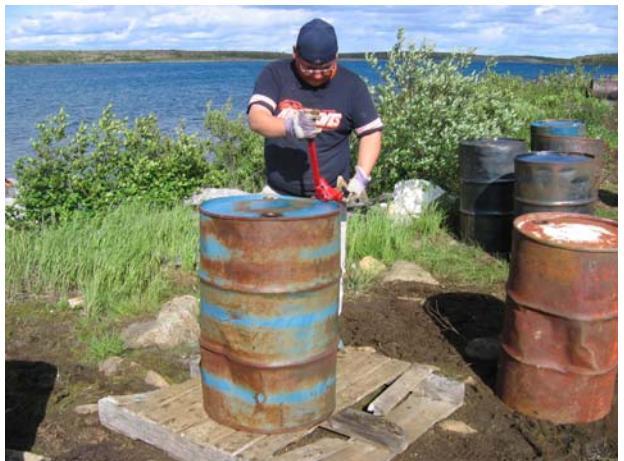
Picture 3: Barrels "deheading" station.

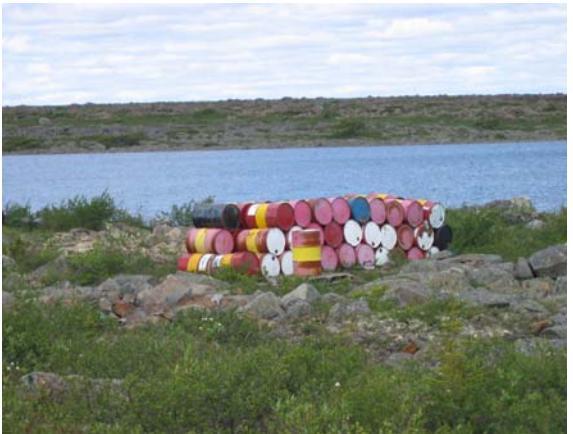
Picture 2: Barrels piled on site in 2005

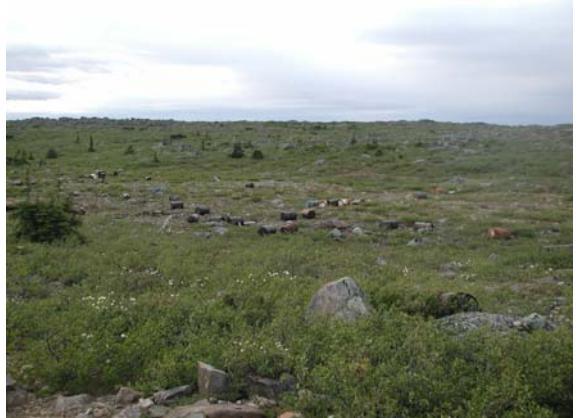
Picture 5: Scattered barrels (sector 2)

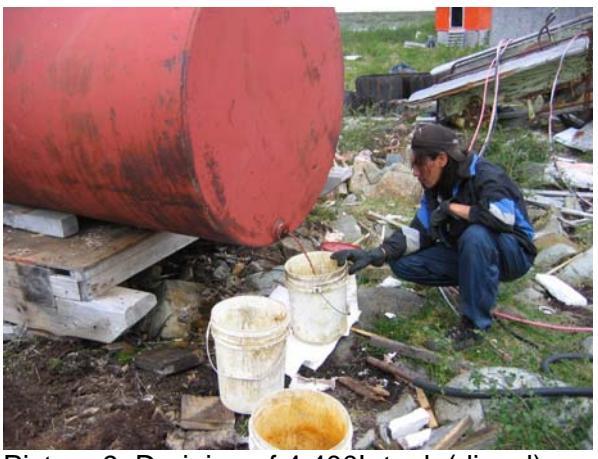
Picture 9: Draining of 4,400L tank (diesel)

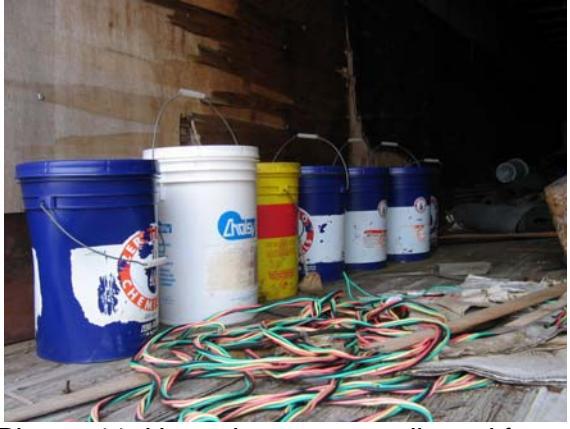
Picture 11: Hazardous waste collected from sector 3

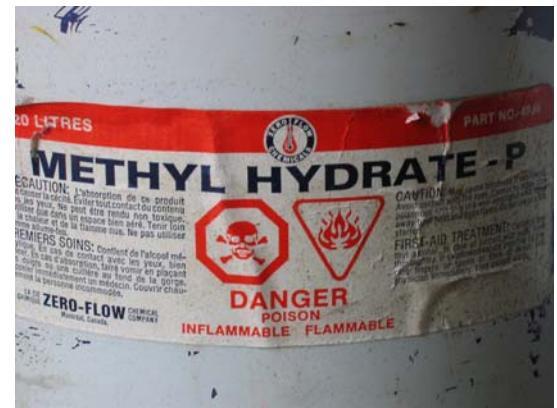
Picture 12: Chemical product "methylhydrate" collected from the site

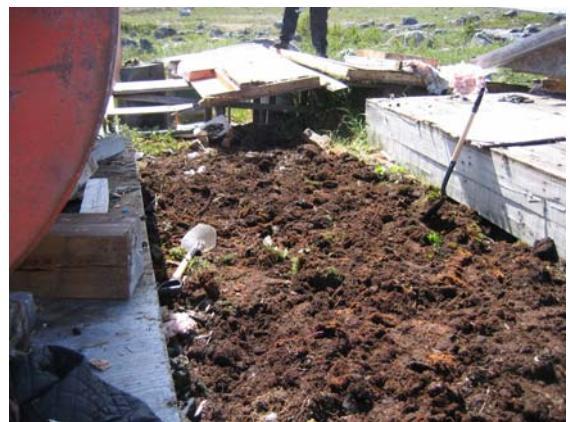
Bio-remediation was not applied on the contaminated zone (samples S-2, S-3) identified during the 2005 field campaign. The zone corresponded to the area under the generator reservoir where the assay results showed concentrations exceeding the  $C_{10}$ - $C_{50}$  concentrations limit for residential land use (Rf.:*Règlement sur la protection et la réhabilitation des terrains*, Gouvernement du Québec). The soil was less than 15 cm over the bedrock or stony substrate. The soil was also rocky (50% stone and rock) and too difficult to manipulate without machinery.

Picture 15: Contaminated area identified in 2005

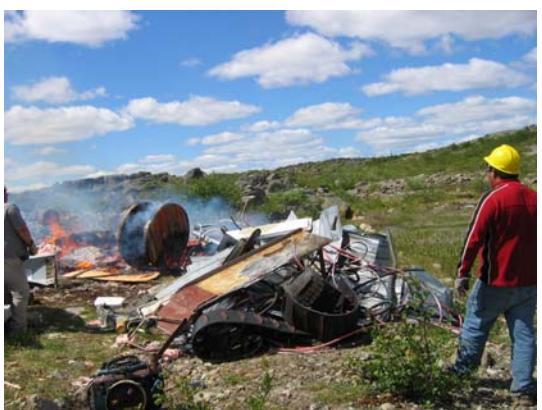
Picture 16: Combustible debris piled and burned on site

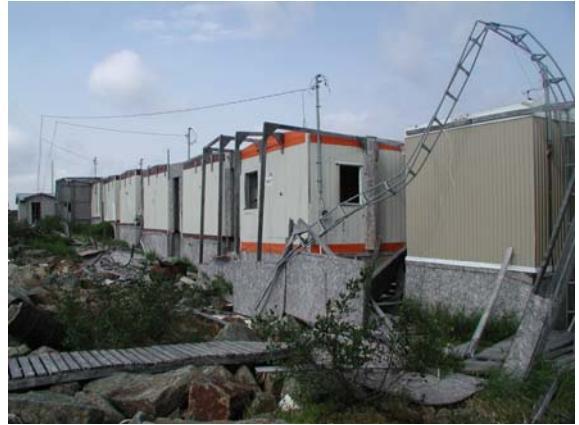
Picture 17: Dangerous structures identified in 2005

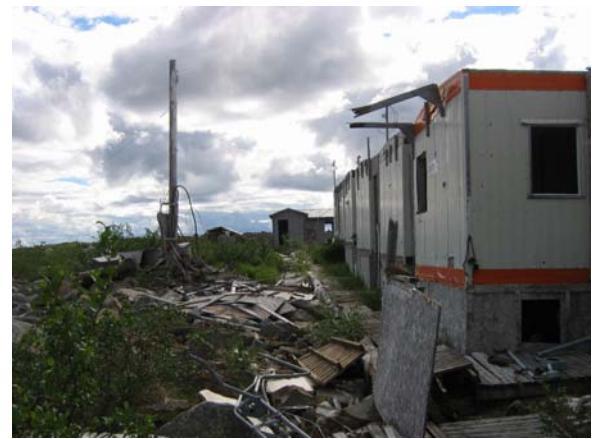
Unstable or dangerous components, such as metallic antennas, suspended wires and stairs were demolished. These structures were almost all part of the housing trailers located in sector 1 of the site. They no longer pose a threat for public safety.

Picture 18: Structures dismantled in 2006

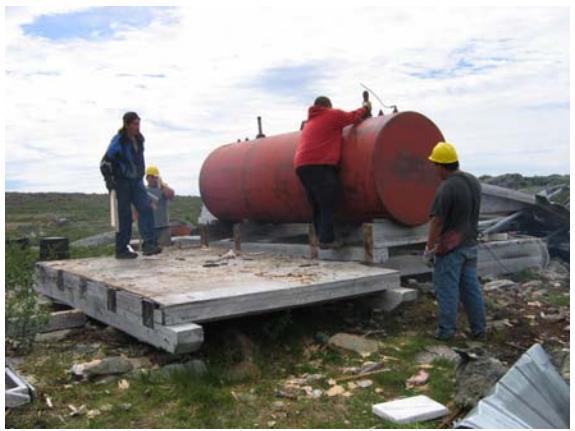
Picture20: Generator structures dismantled

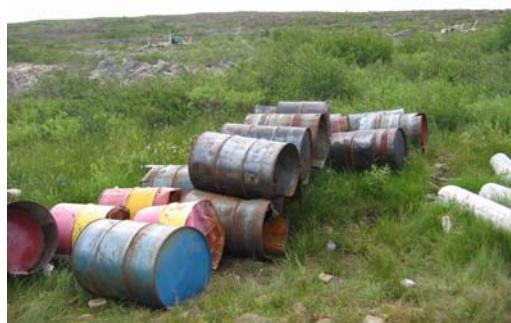
Picture 1: Remaining clean barrels on site (sector 1)

There are presently 20 barrels filled with barrel tops, ready to be taken out by floatplane or moved to the non-combustible material deposit. Some barrels (+/- 30) can be found scattered on site as their removal would not have been safe. These barrels potentially contain a certain amount of hydrocarbon residues. Any additional hazardous products found on site would have to be taken out and sent to a treatment centre.

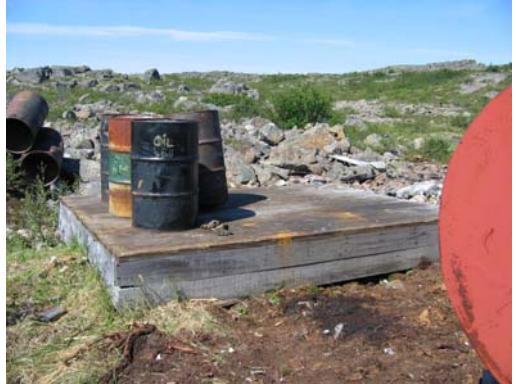
Picture 2: Remaining barrels on site (generator tank, sector 1)

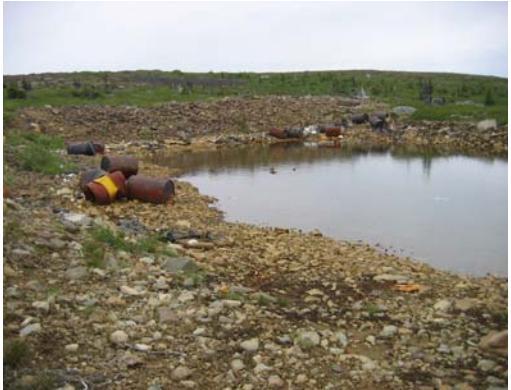
Picture 3: Scattered barrels (towards sector 3)

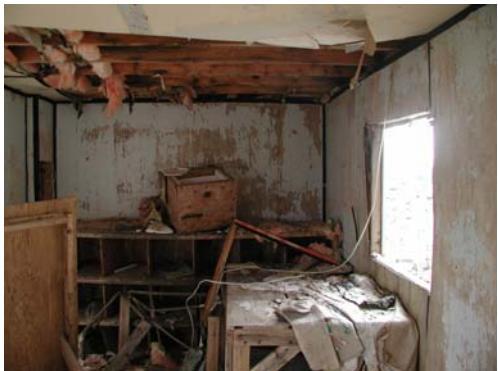
The condition of the buildings on-site is still poor, in deterioration and could eventually lead to issues of public safety. A future phase of clean-up measures on this site could involve the stabilization and/or demolition of these structures. All metallic and non-combustible debris could also be collected and placed in the non-combustible material deposit. Finally, any remaining combustible debris could be burned on site according to Environment Québec regulations. Pictures showing remaining materials and structures on site are presented in Appendix B.

Picture 5: View inside a trailer

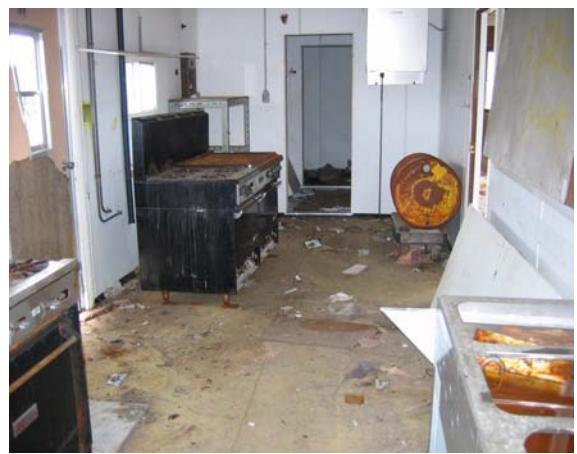
Picture 4: Kitchen trailer (first day)

The main kitchen trailer was cleaned and repaired at the beginning of the fieldwork. Broken windows and doors were repaired or replaced while waste collected inside was piled neatly outside with other debris. The trailer was used during the field campaign as a lunch room area. Appendix C of this report presents pictures of the fieldwork.

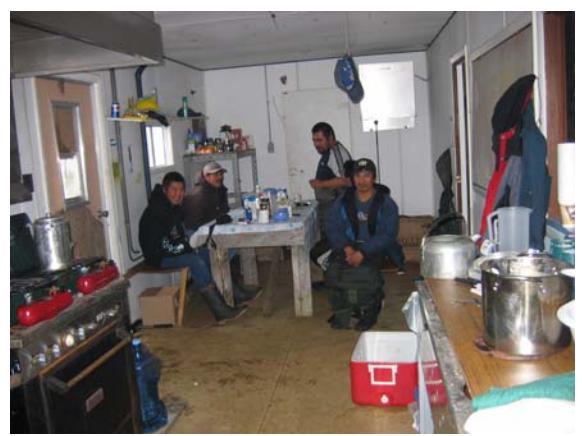
Picture 5: Kitchen after cleaning

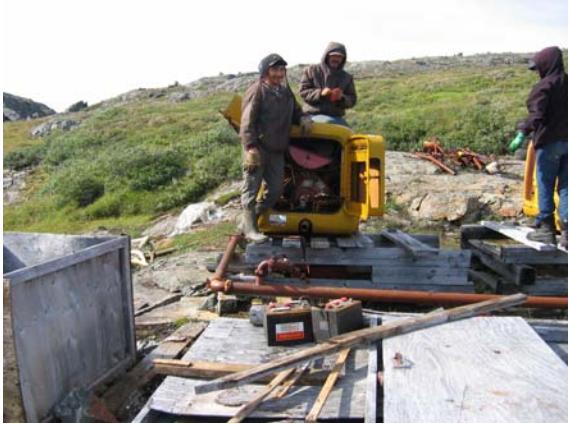
Picture 12: Batteries collected from generator units, sector 4

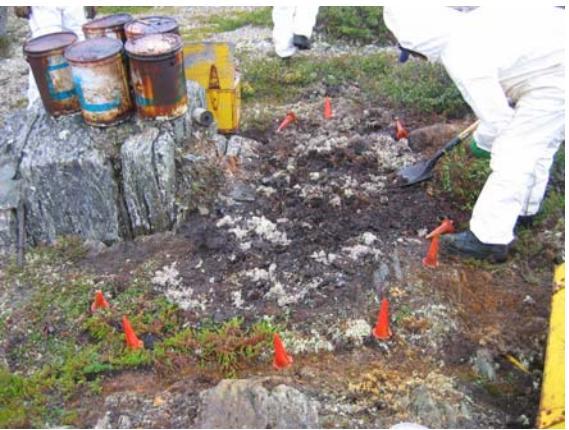
Bio-remediation efforts were conducted on two contaminated zones (PJ1-13, PJ1-20) which were identified during the 2001-2002 assessment. These two areas presented high levels of hydrocarbon ( $C_{10}$ - $C_{50}$ ) and APH (aromatic polycyclic hydrocarbons) concentrations. The work consisted in turning the contaminated soil with a shovel, and adding and mixing into the soil substances that accelerate the breakdown of the hydrocarbons. The substances employed were fertilizers, dolomite lime and organic material consisting of vegetation or moss found on site. The quantities employed were approximately 0,1 kg/m<sup>2</sup> of fertilizer, 0,5 kg/m<sup>2</sup> of dolomite and approximately 1kg/m<sup>2</sup> of sphagnum or moss. (Appendix C, photo 18, 19).

Picture 18: Soil remediation project (PJ-13 area, sector 6)

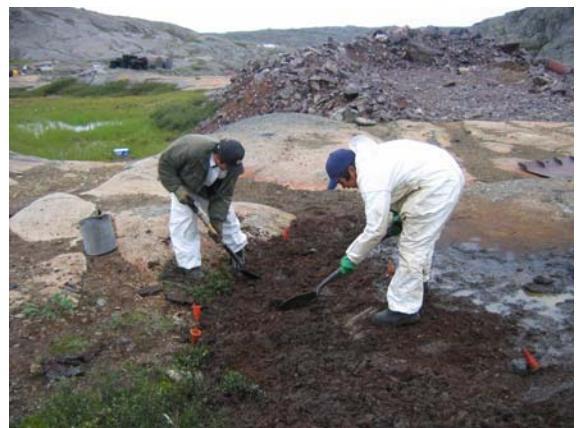
Picture 19: Soil remediation project (PJ-20 area, sector 4)

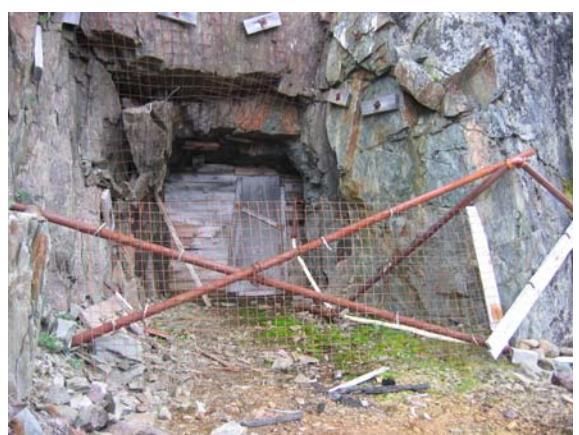
Picture 20: Metal fence installed for main gallery (sector 4)

Three mine shafts, located in sector 1 and leading to the main mining gallery, were closed with temporary fences. Two of the shafts were closed with steel and wood structures founded on site. The main gallery was completely closed off with wood and secured with a steel fence.

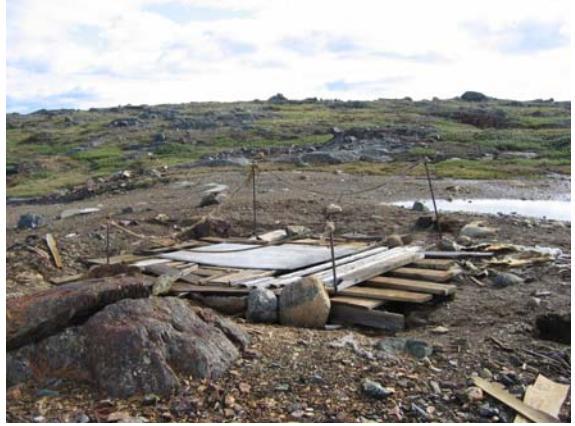
Picture 21: Mine shaft fence and cover installed

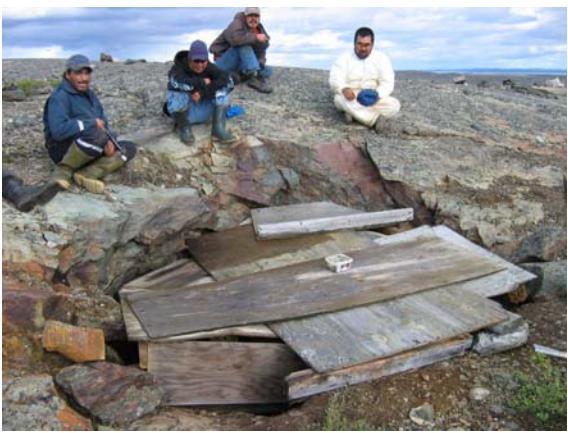
Picture 22: Mine shaft cover installed

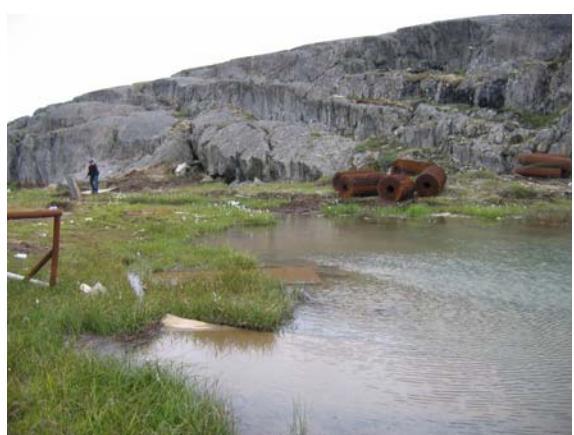
Picture 23: Rusted metal pieces retrieved from pond; sector 4

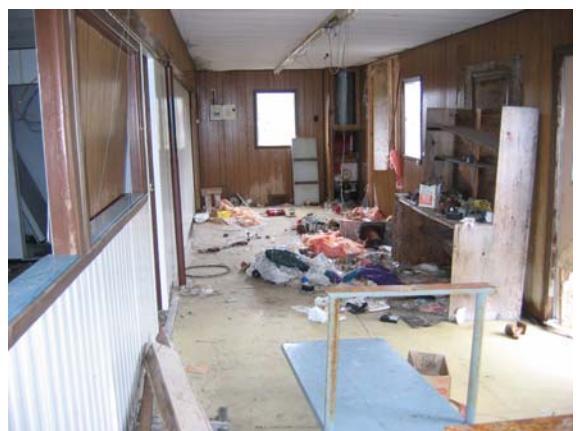
The condition of the buildings and dwellings is also still poor. The structures will continue to deteriorate and could pose problems in terms of safety. The next phases of the project should also include the stabilization and/or demolition of these buildings. All metallic and non-combustible debris should be collected and assembled together in a non-combustible material deposit. The disposal site will have to be established according to government regulations (*L.R.Q. c. Q-2, r.3.2*). Soil remediation should be continued on the PJ1-13 and PJ1-20 areas, as well as the other contaminated areas identified in the KRG 2001-2002 report. Finally, any debris burning on site must be done in accordance with MDDEP regulations.

Picture 1: Trailer, sector 5

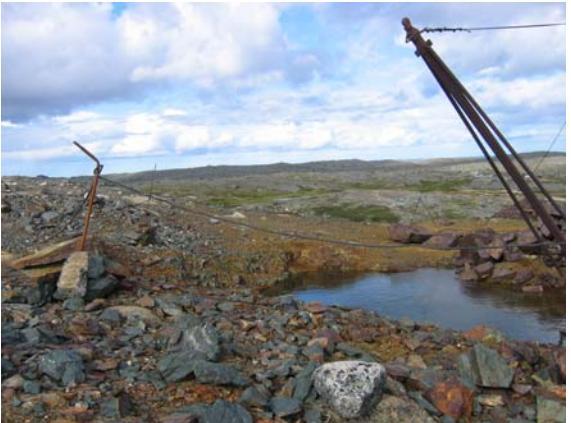
The condition of the three shafts leading to the main gallery is still poor but no longer presents any serious hazard for public safety. The fences and structures installed during the fieldwork

Picture 2: Temporary fence installed around mine shaft

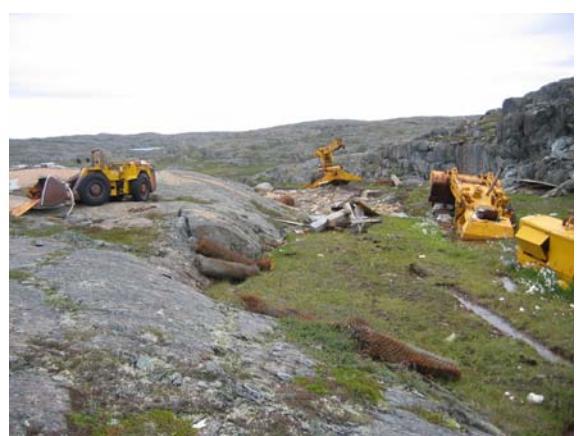
Picture 4: Remaining heavy equipment, sector 4

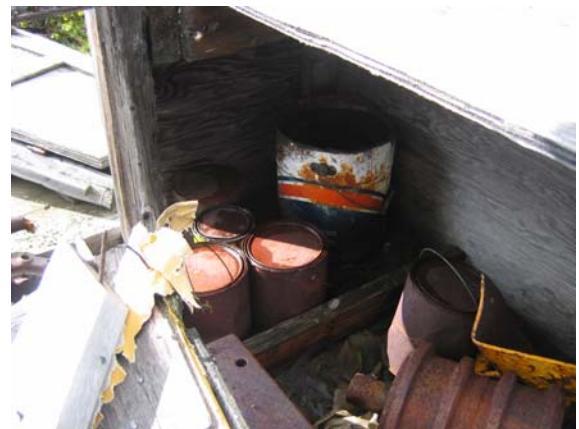
Picture 5: Remaining hazardous materiel; sector 2

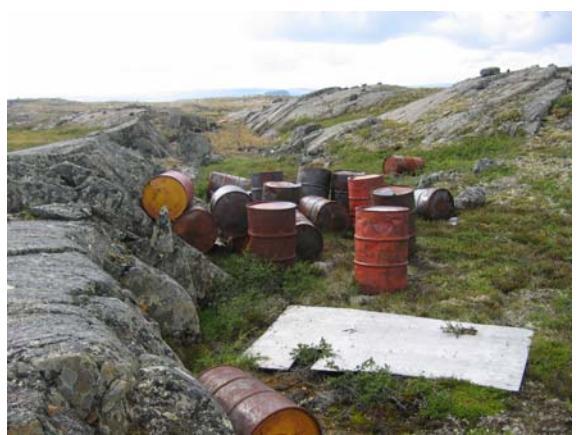
Picture 6: Scattered barrels; sector 2
