ABANDONED MINERAL EXPLORATION SITES IN NUNAVIK REHABILITATION PROJECT

2005-2012 Summary Report
and
Update of the General Reponse Plan

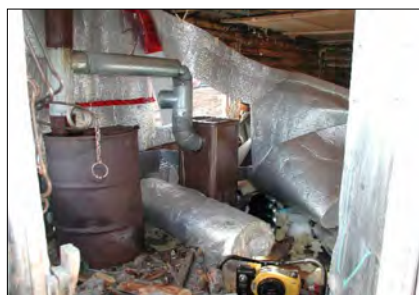
Photo 25 Inside of Cabin 1

1 brand new ice drill,
1 furnace, 1 barrel, traps,
Al insulating sheets, various debris

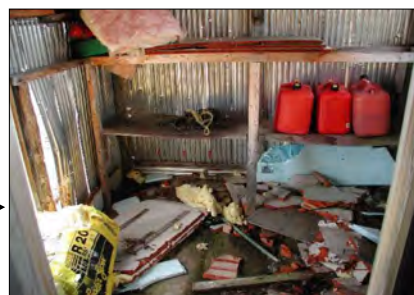
Photo 28 Inside of Cabin 2

Al cores (cover walls), fiberglass,
3 x 20-L gas containers full of gas,
traps, 1 Coleman stove, debris of
insulating foam (rust color)

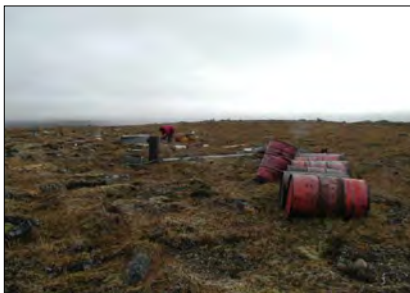
Sector 3 *Photo 159*

8 empty barrels,
4 barrels with diesel (200 L),
1 barrel X 100 L diesel,
core trays,
metal debris (30m³),
wood debris,
canvas, few pipes,
2 pickaxes (geologist hammers)

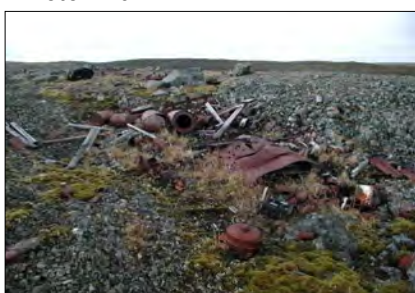
Photo 240

Scattered: wood debris (3m³),
metal debris (3m³).
2 muskeg tracks (caterpillars),
electronic parts,
1 communication antennae,
radio equipment,
many broken glass bottles
(chemicals products ?),
3 batteries,
scattered barrels

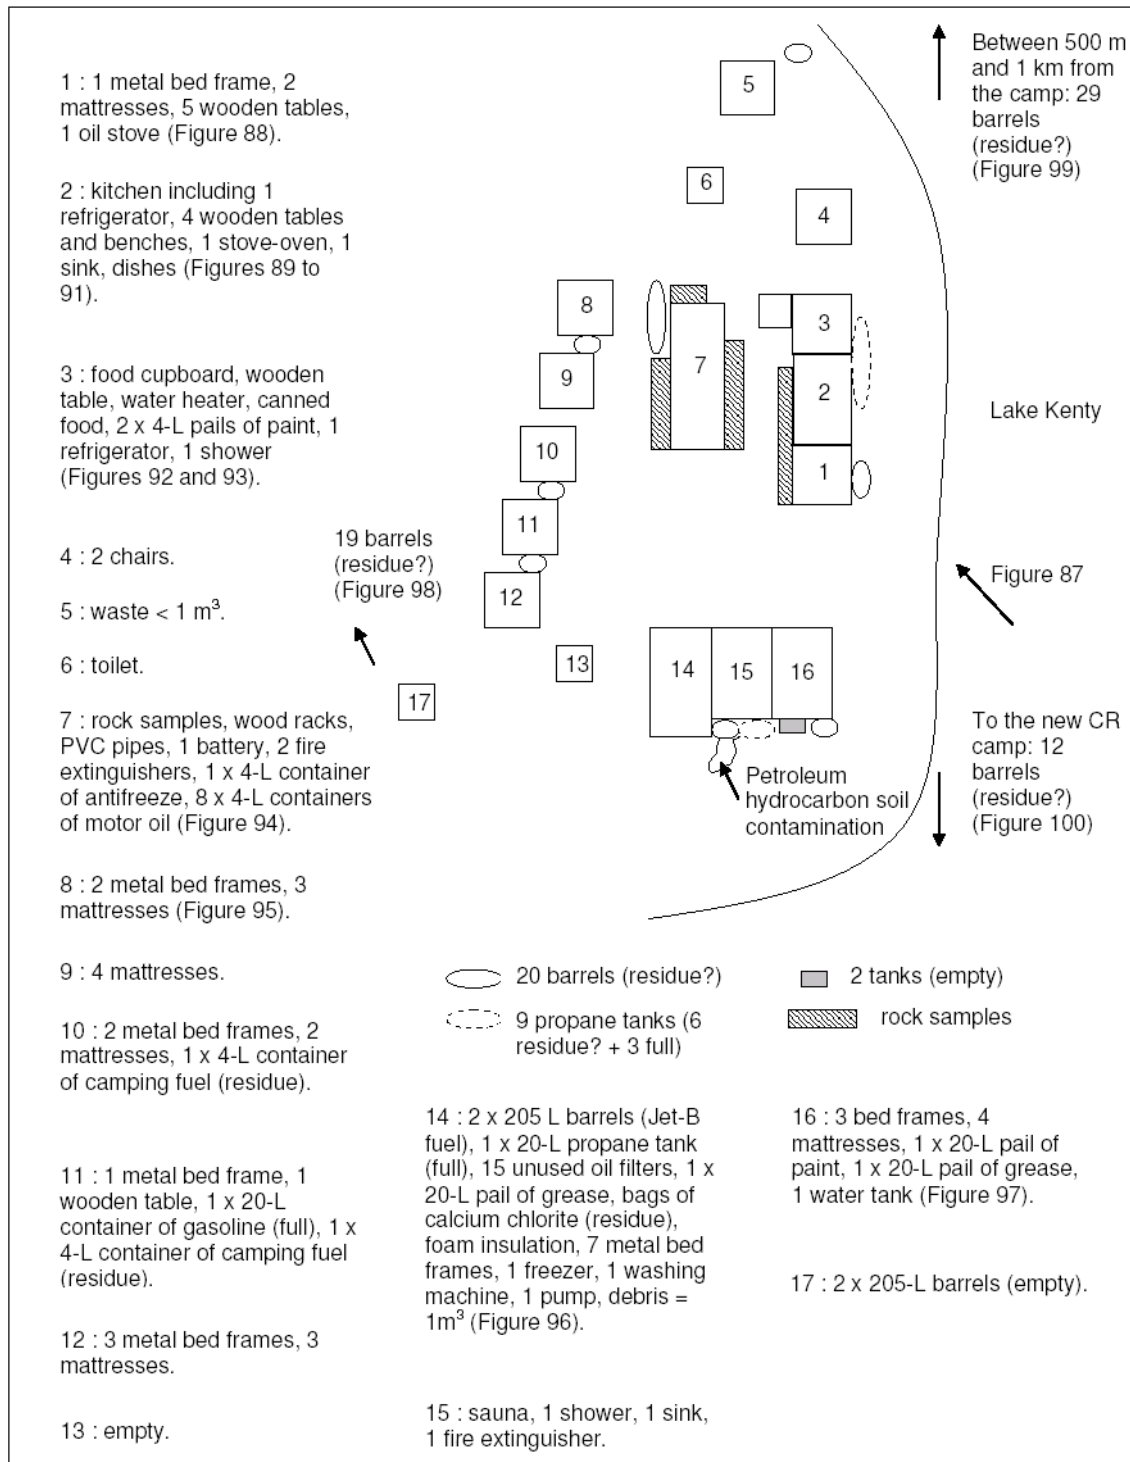
Layout of site WB-9 prepared during the 2007 inspection.

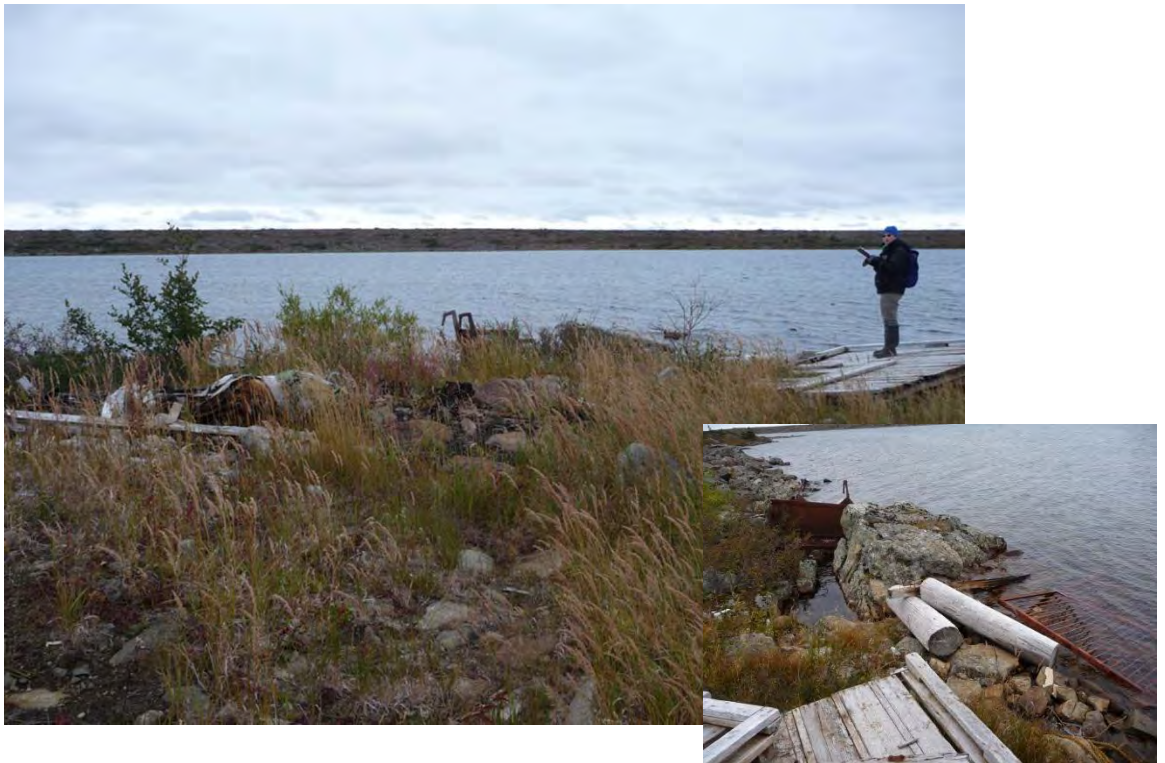
Photo 11 Barrels and small cabin near the shore of Retty Lake during the of 2001-2002 inventory, September 10, 2002

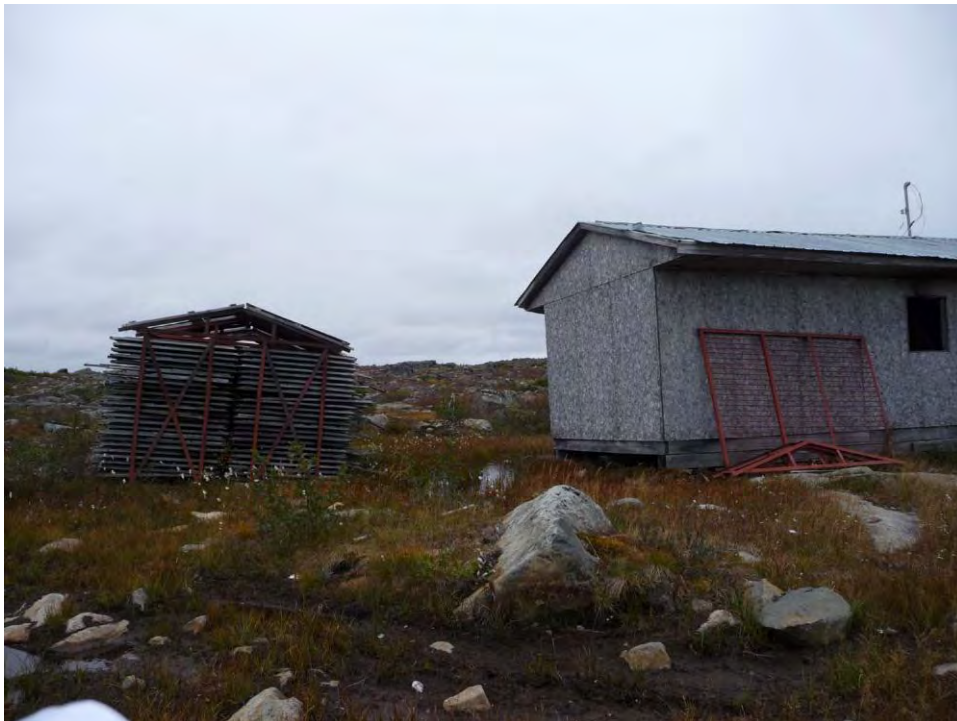
Photo 15 Buildings and shelter containing samples of rocks and various debris during 2001-2001 inventory, September 10, 2002

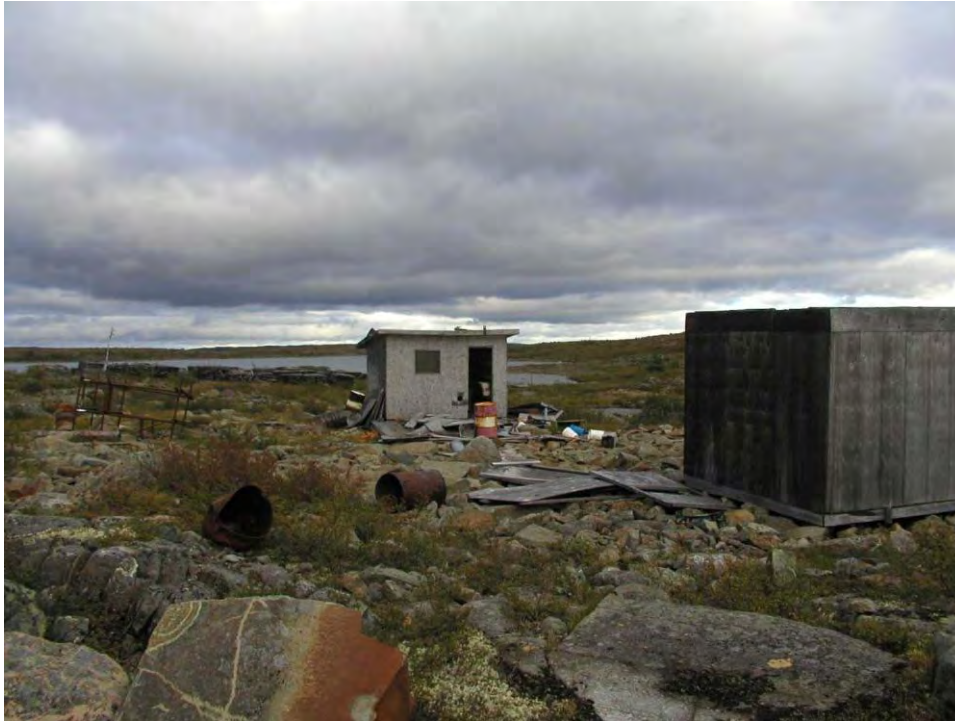
Photo 16 Shelter containing samples of rocks, debris and main building during the inspection visit on September 15, 2011. It should be noted that the two small buildings in the background in the previous photo, pole and electrical wires, and some debris have been removed.

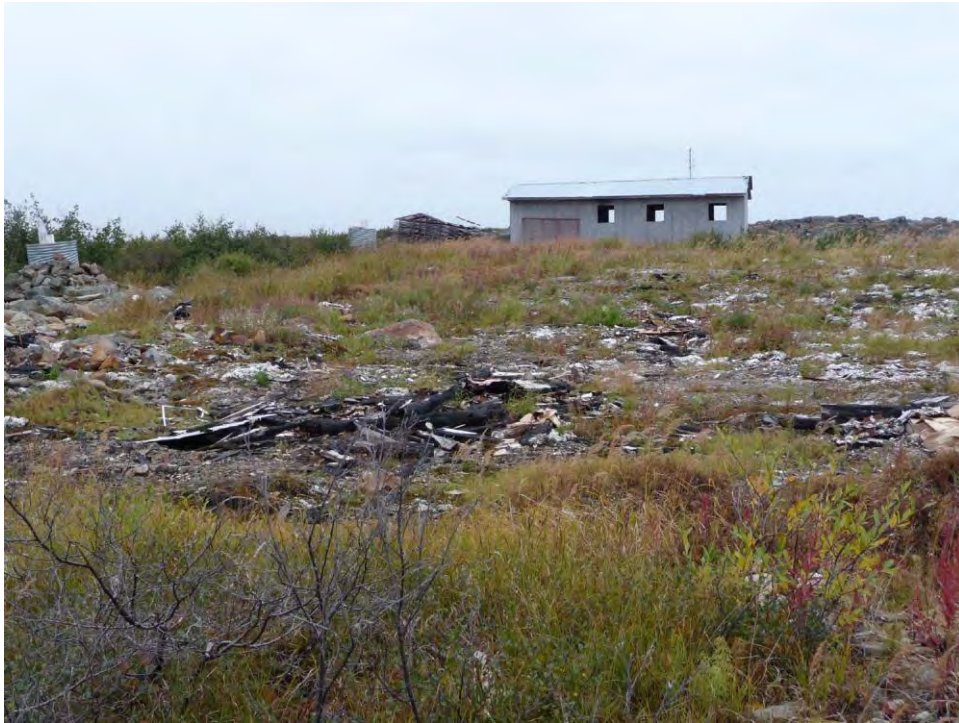
Photo 22 Pile of debris at the site KAW-35 (September 15, 2011)

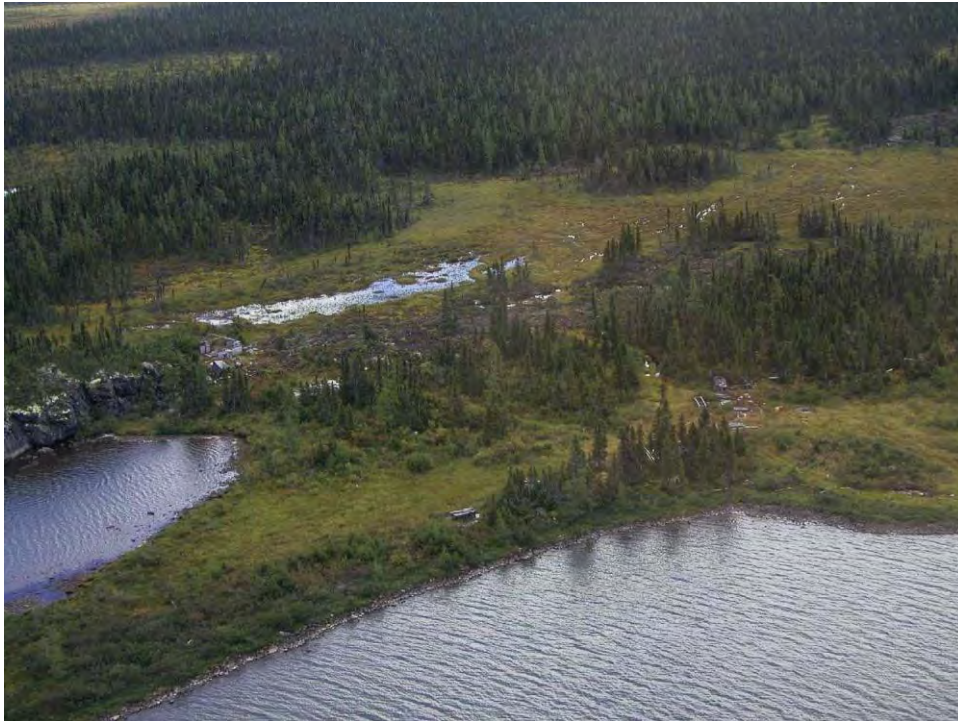
Photo 24 Overview of the site KAW-45 during 2001-2002 inventory, September 11, 2002

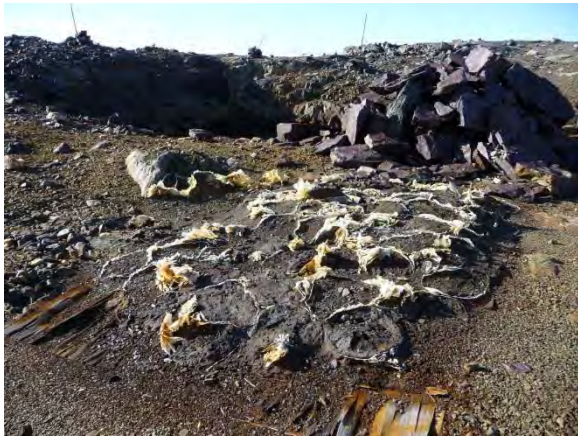
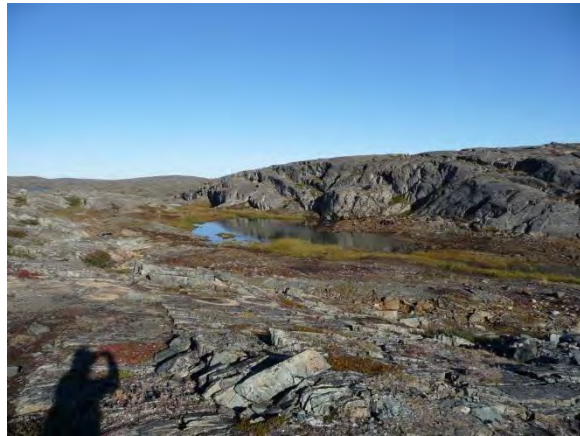
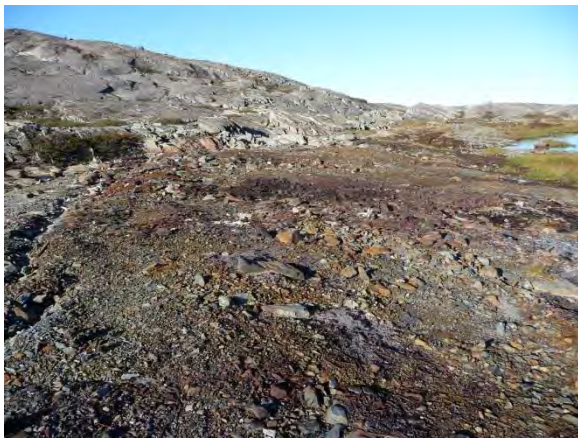
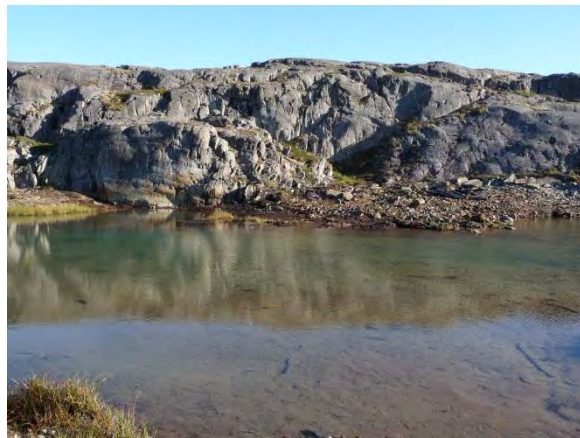
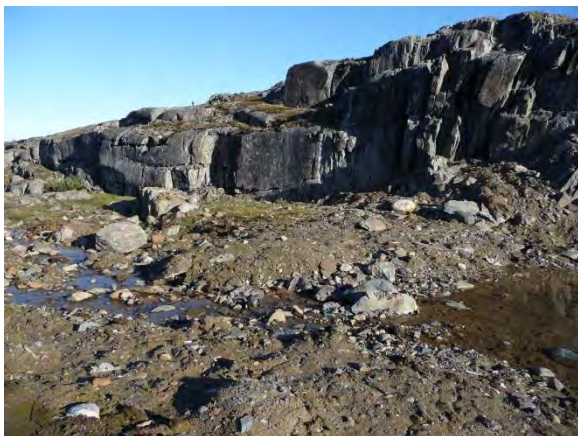
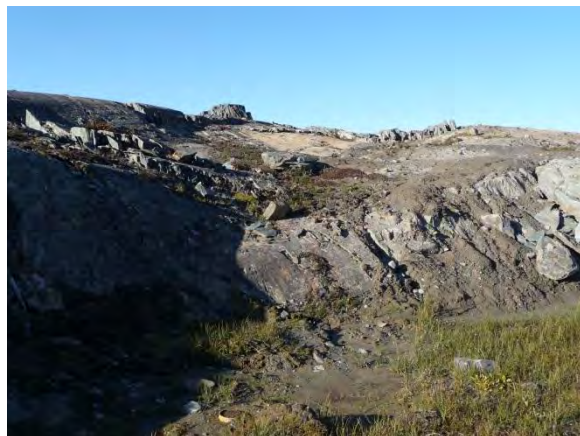
Photo 40 Sector 4 after cleanup: The various debris, reservoirs, tires were removed from the site PJ-1 (September 16, 2011)

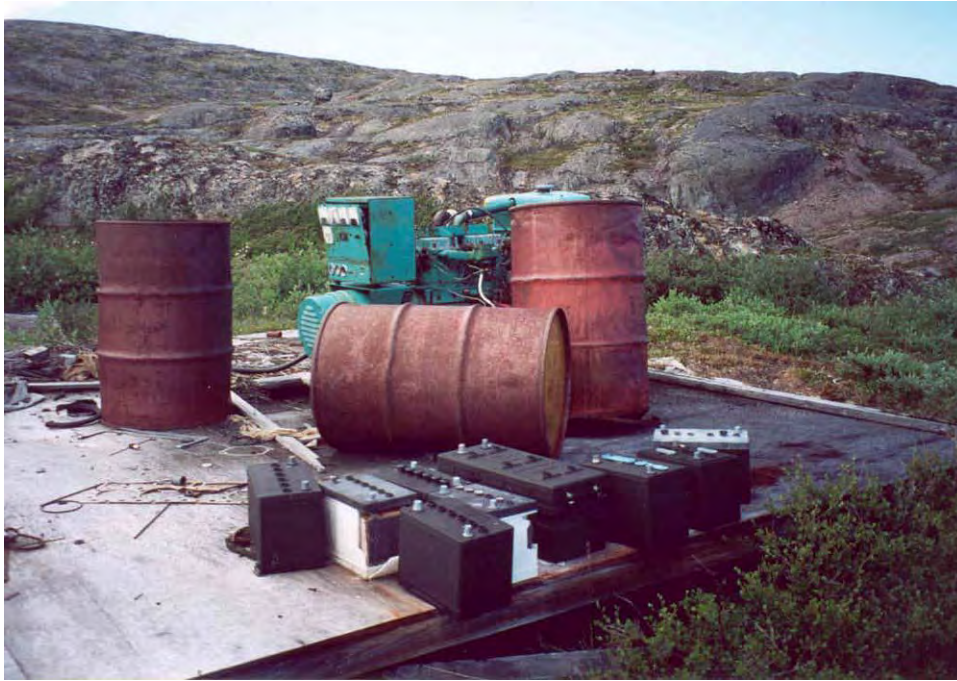
Photo 41 Sector 4 of PJ-1 site after cleanup: All machinery, barrels, reservoirs, and miscellaneous debris were removed from the site and combustible materials were burned (September 16, 2011)

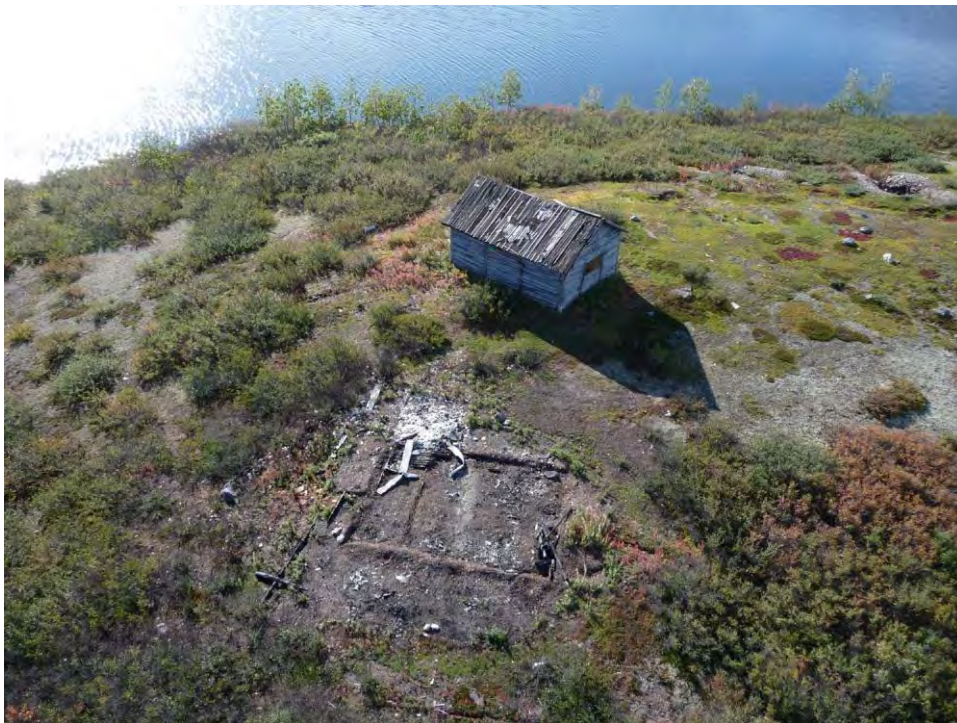
Photo 66 Overview of site TQ-4 after cleanup (September 16, 2011)

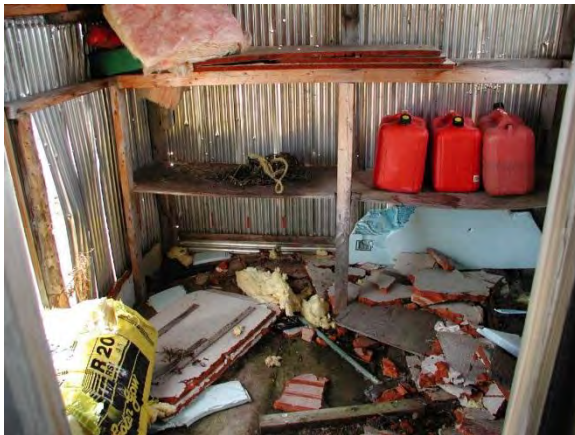
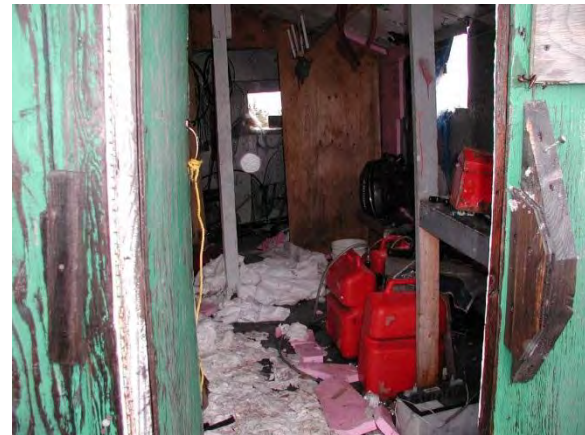
Photo 71 Sector 2 after cleanup: Rubber bladders in ditches, drums and debris
were removed from site TQ-4 (September 16, 2011)

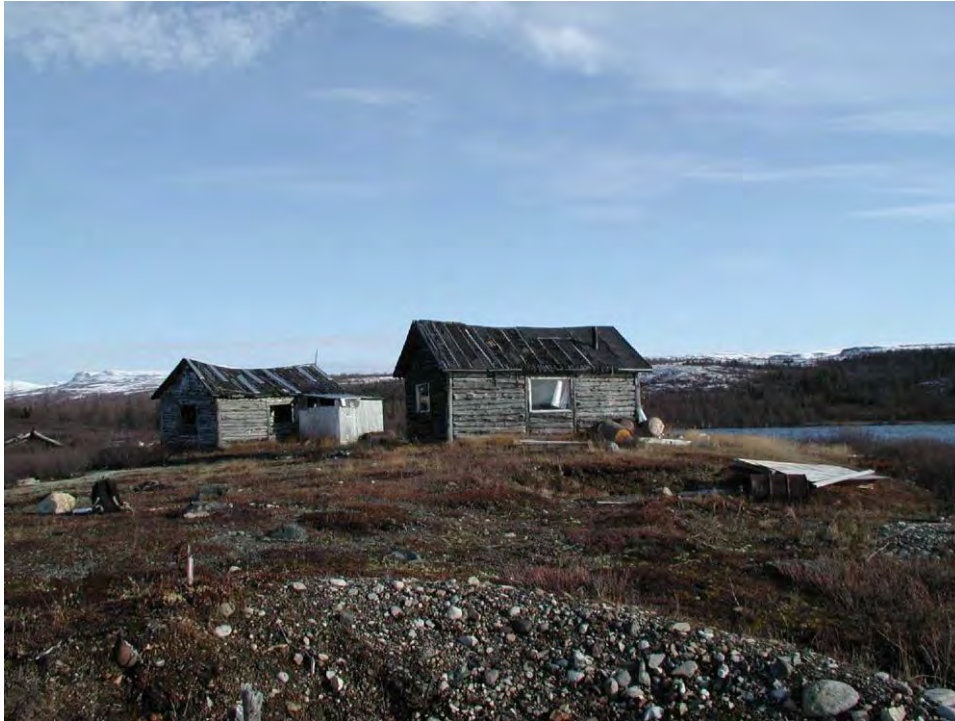
Photo 72 Content of the cabins that were on site, October 19 2001. All debris was
removed from site TQ-4 and combustibile materials were burned

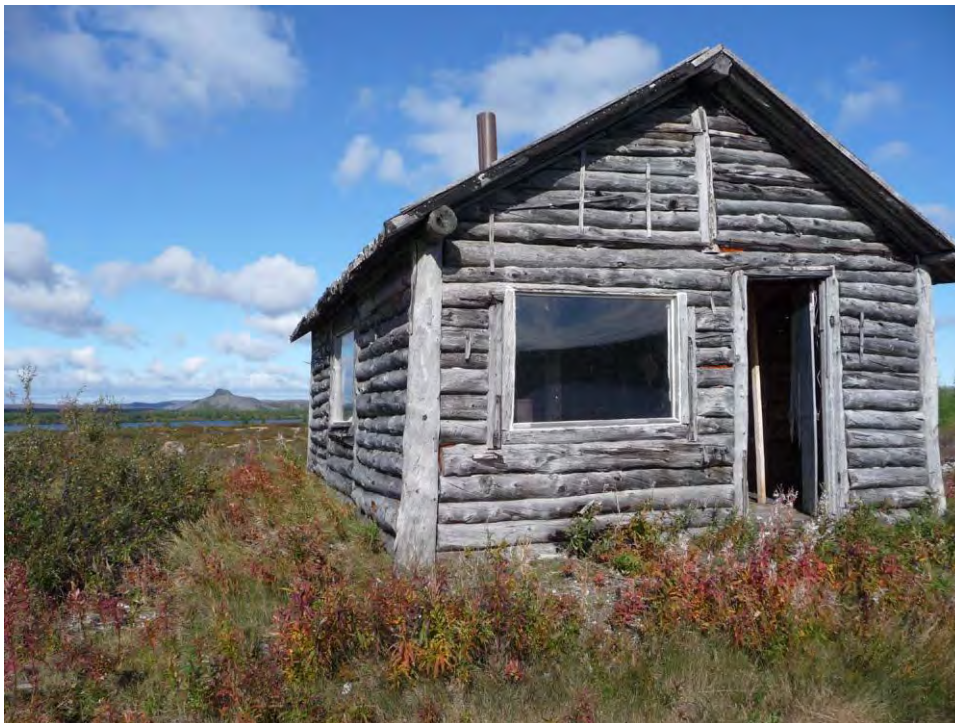
Photo 73 Sector 1: Log cabins and debris at the site before cleanup TQ-4, October 19, 2001

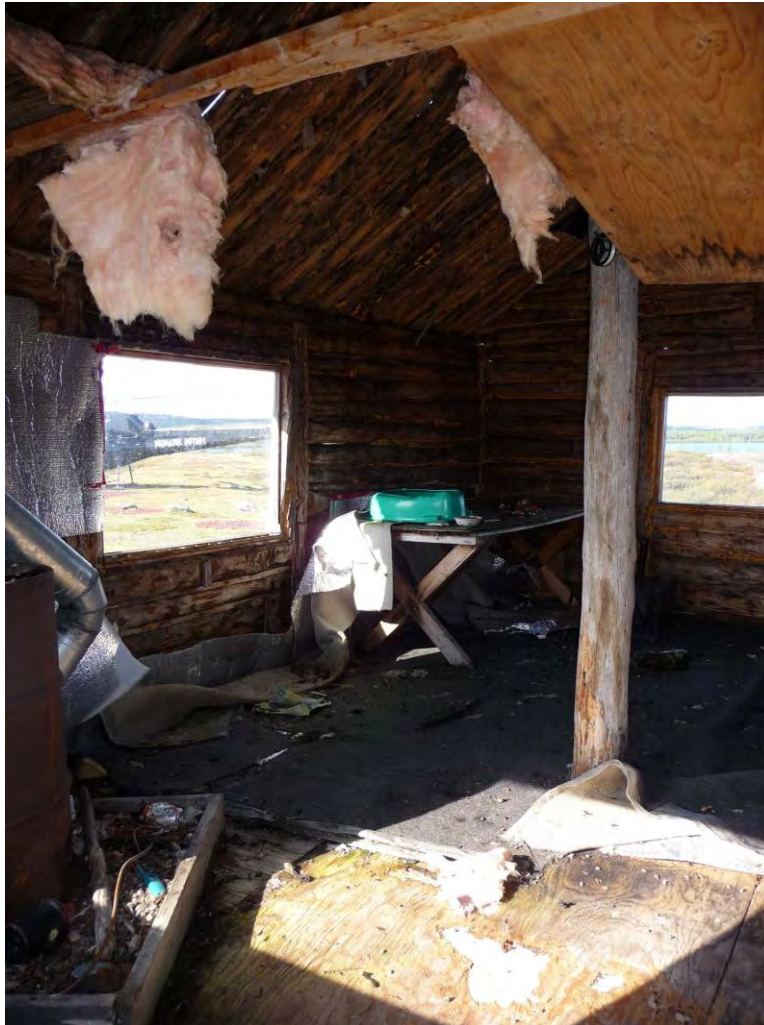
Photo 74 Sector after a cleanup: The log cabin left on site TQ-4 is as shown in the foreground in the previous picture. The other two were emptied and burned (see picture 67) (September 16, 2011).

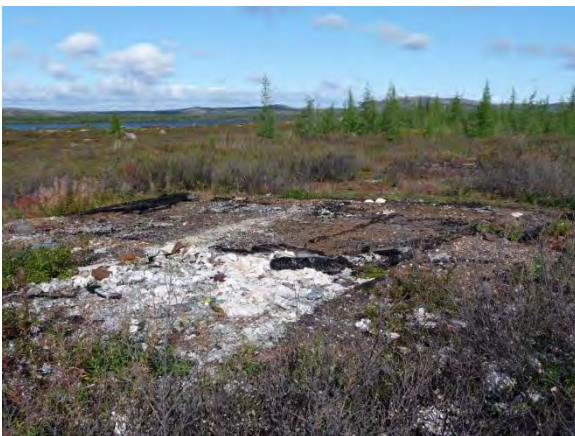
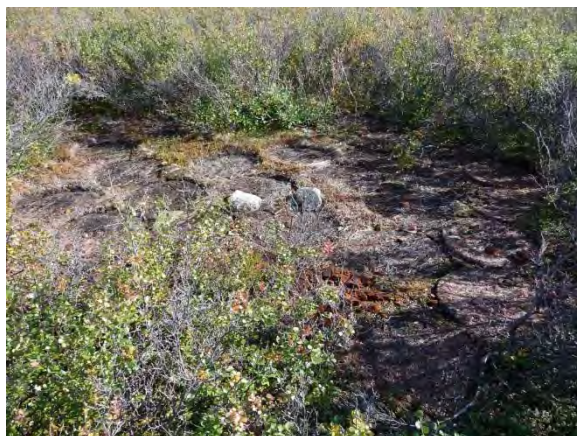
Photo 75 Inside the log cabin that was left on the site TQ-4 (September 16, 2011)

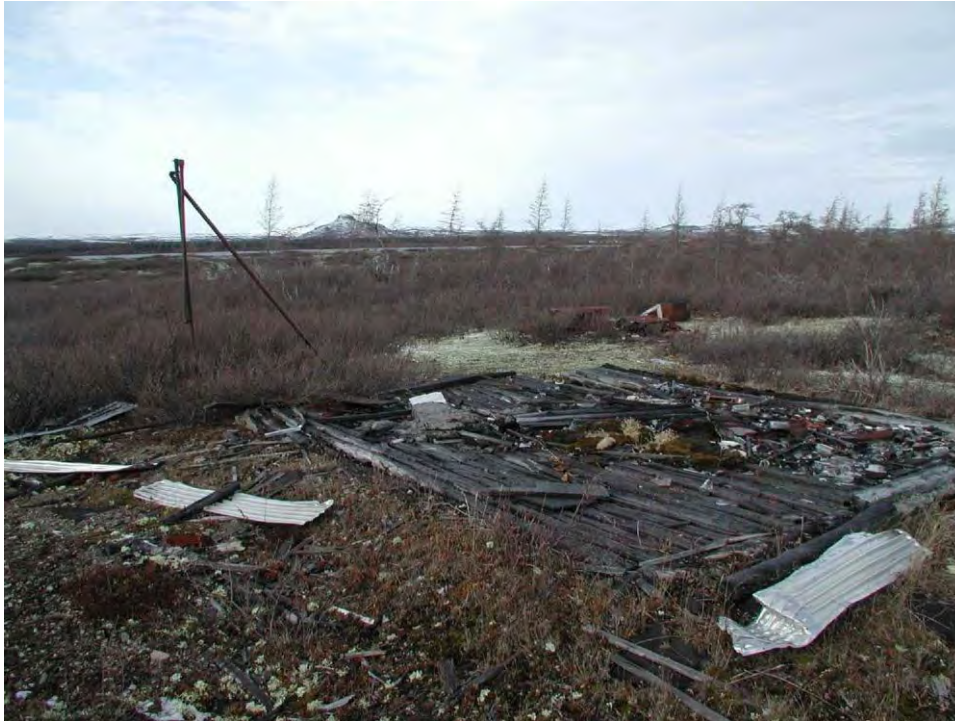
Photo 76 Sector after a cleanup: Debris from burned cabins and traces left by old barrels, site TQ-4 (September 16, 2011)

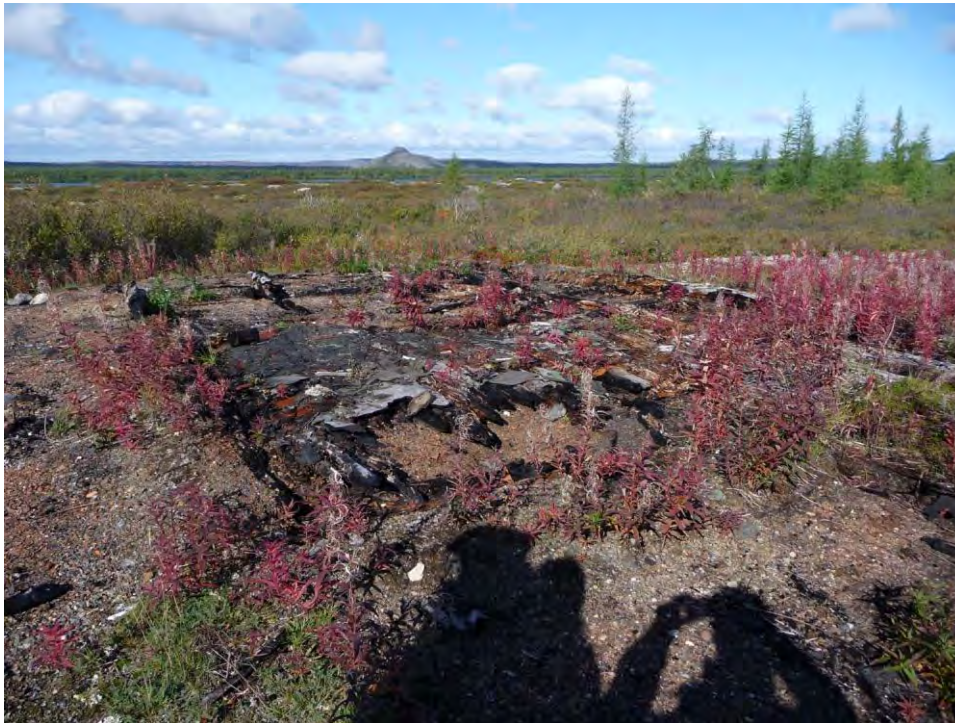
Photo 77 Sector 1: Cabin collapsed, metal tripod and various debris, site TQ-4, October 19, 2001

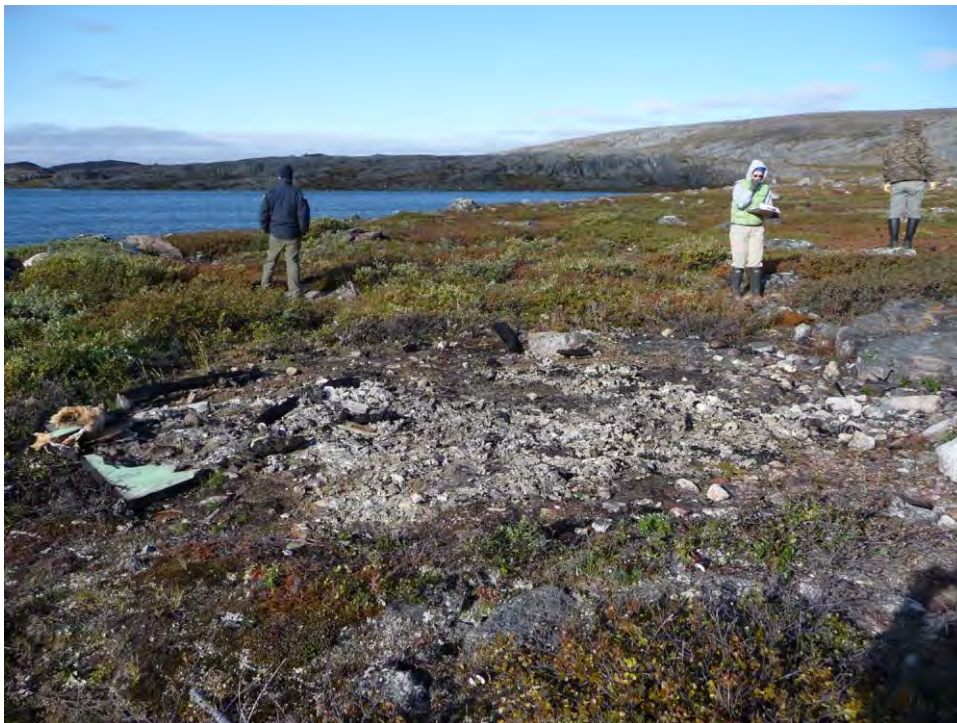
Photo 79 Overview of the site PJ-10 after cleanup. To the left you can see the traces of the old platforms (September 17, 2011)

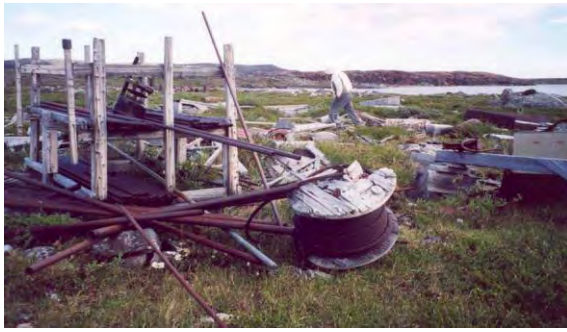
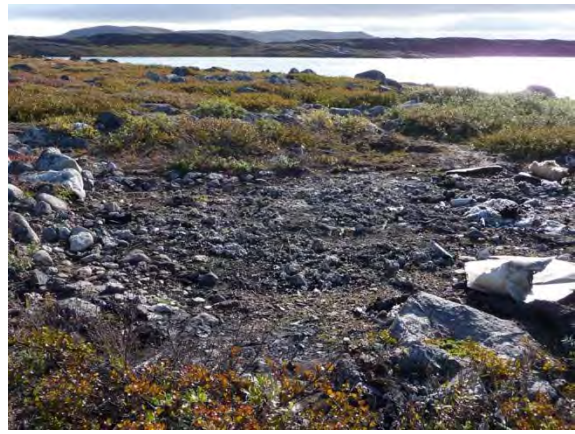
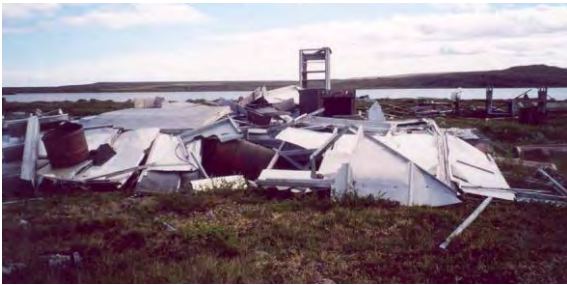
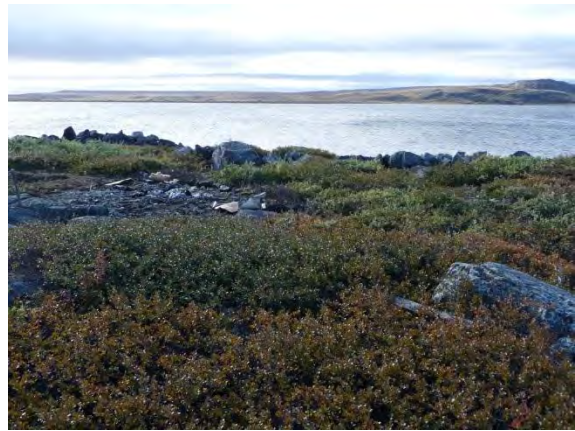
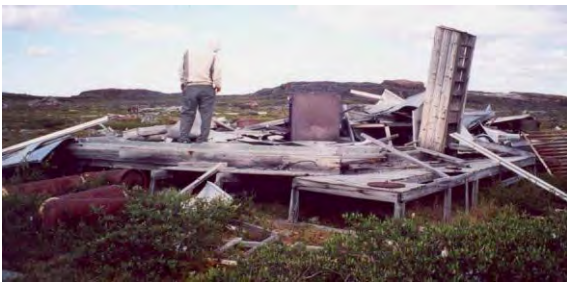
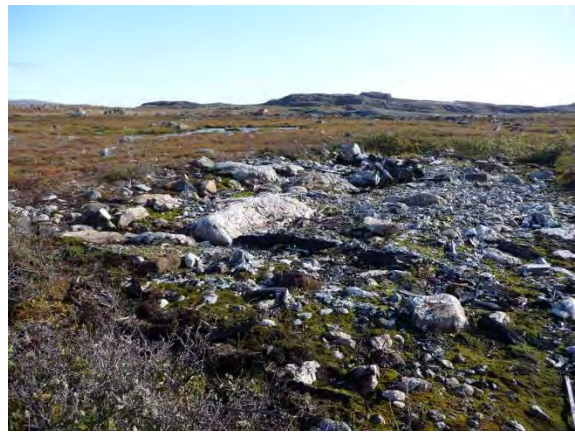
Photo 81 Comparative photographs before (left) and after cleanup (right) at the site PJ-10 (September 17, 2011)

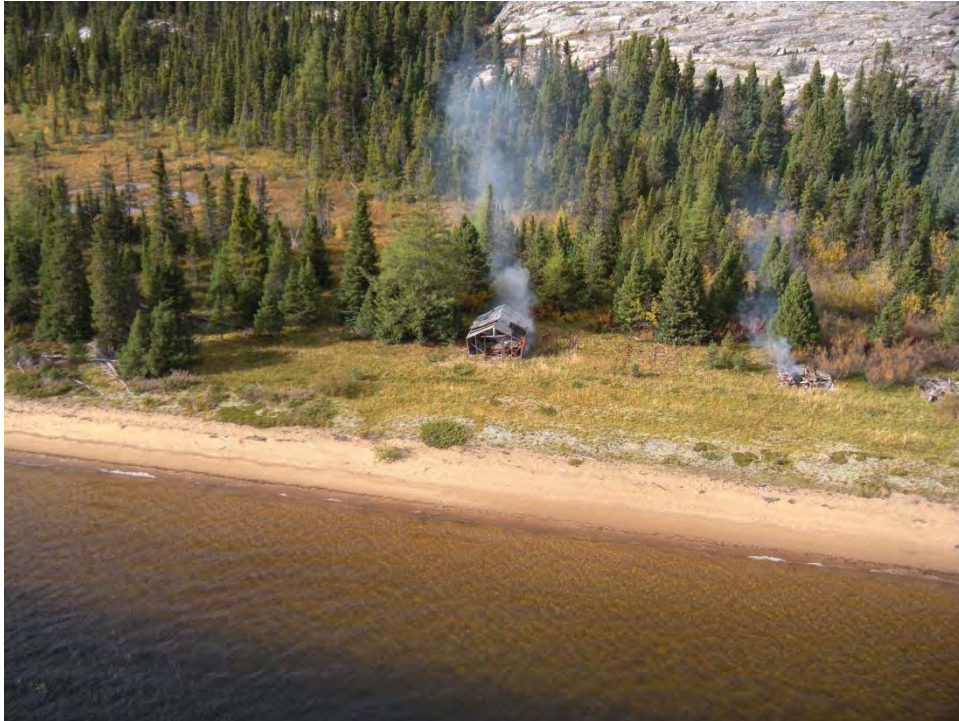
Photo 132 Site WHA-1 during an inventory conducted September 25, 2002. The site had 10 cabins (one upright and 9 collapsing), many barrels and debris

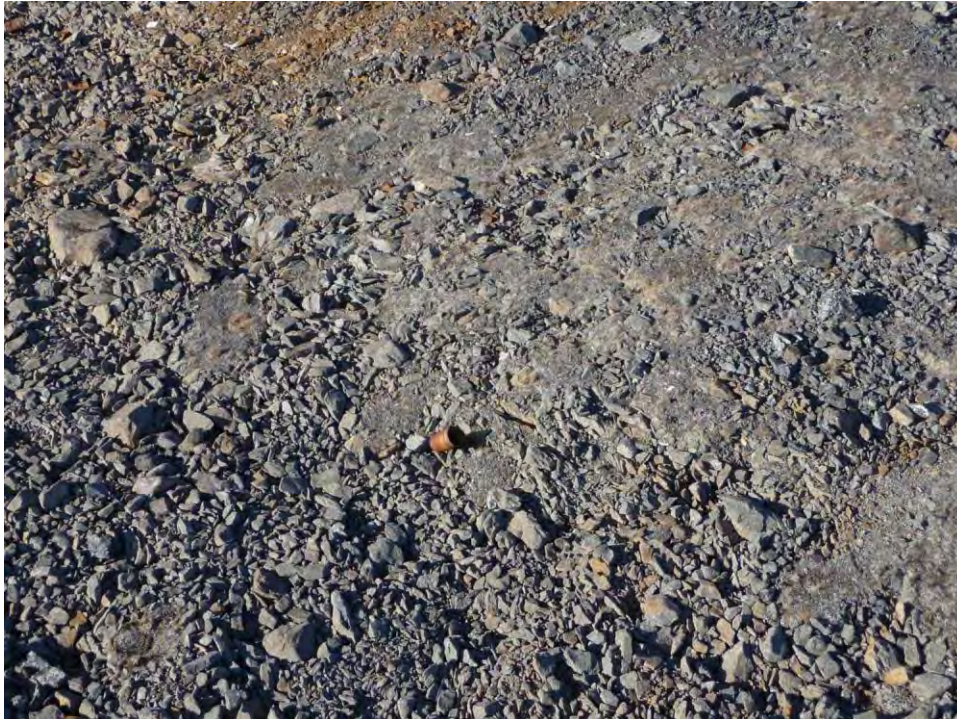
Photo 70 One of seven barrels observed at site "Unknown-3", near KAN-1 (September 17, 2011)

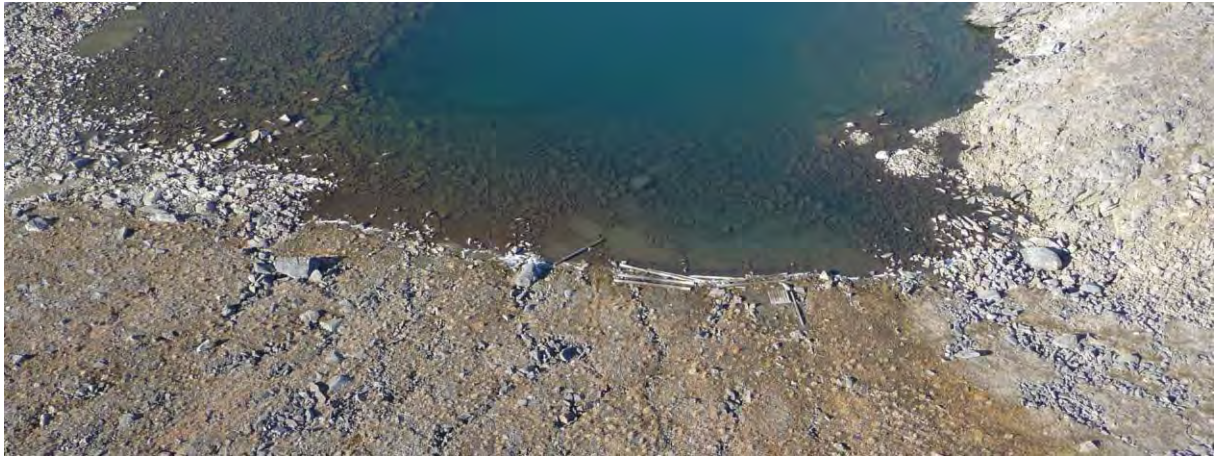
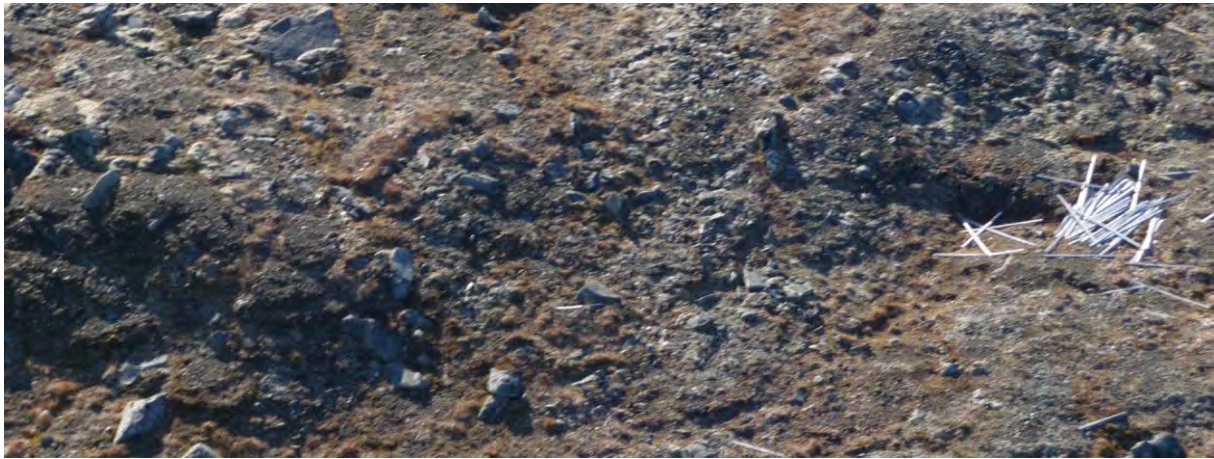
Photo 71 Debris (pipes, planks of wood, metal rods) observed at the site "Unknown-3", located near a Goldbrook Ventures drilling site around the site KAN-1 (September 17, 2011)

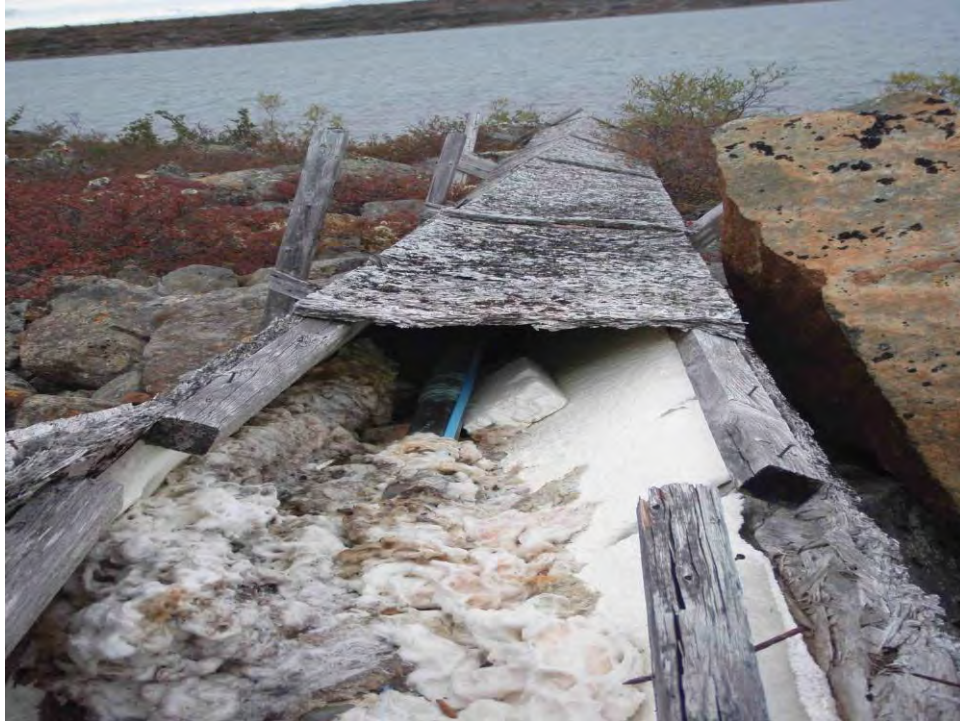
Photo 9 Wood covered pipeline found on site KAW-35

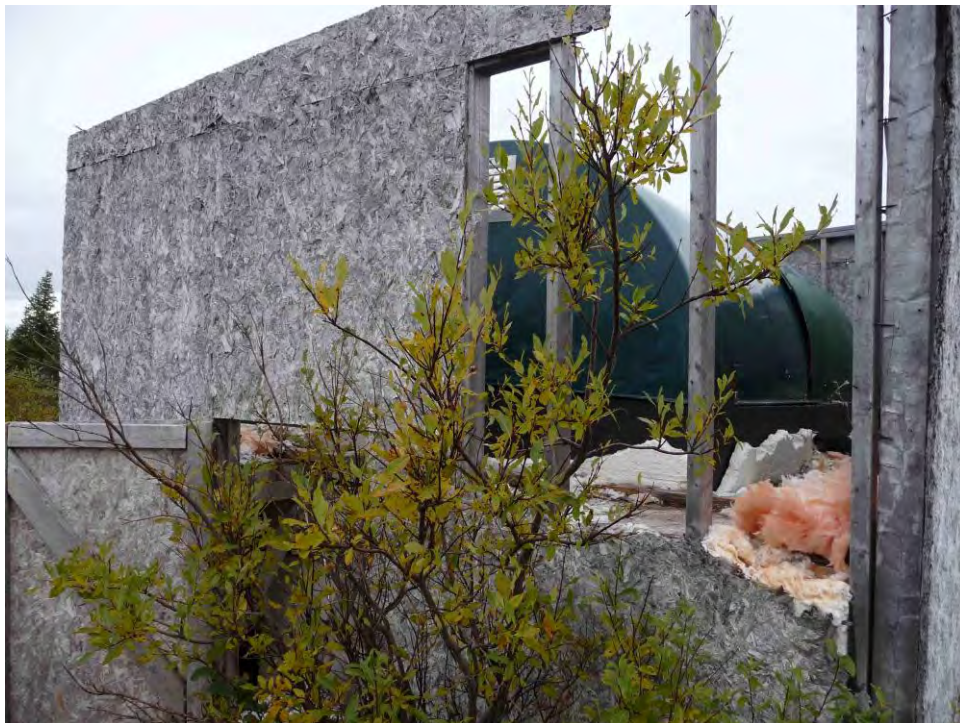
Photo 10 Building with large reservoir inside on site KAW-35
