NUNAVIK ABANDONED MINERAL EXPLORATION SITES REHABILITATION PROJECT

2013-2014 ACTIVITY REPORT

Kativik Regional Government

April 2014

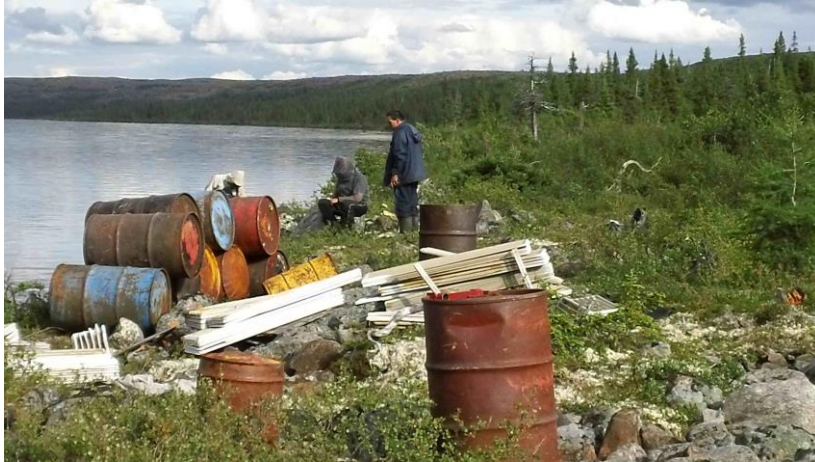
Figure 1: Workers on site KAW-36, August 2013

In collaboration with the Naskapi Nation of Kawawachikamach and the Innu Nation of Matimekush-Lac John, an initial inspection of the site was undertaken in June and a cleanup session was carried out in August 2013. 40 barrels, drill rods, core boxes, and various metal waste were removed from site. Photographs of the material transported from the site are found in Appendix 2.

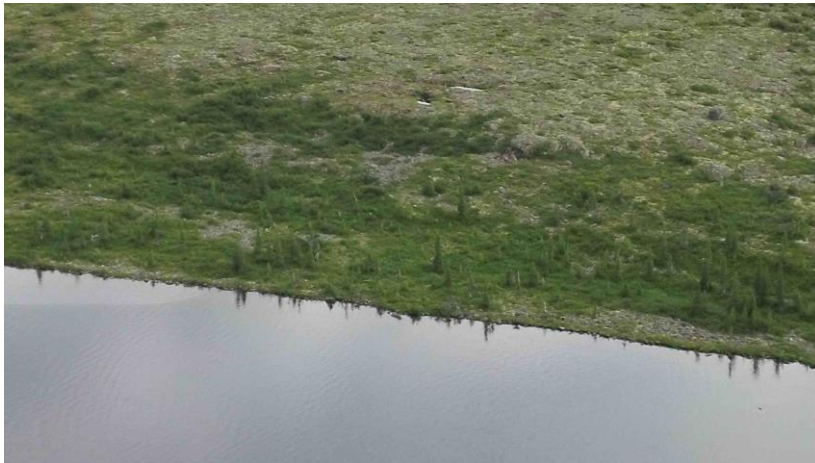
Figure 2: Aerial view of site KAW-36 after cleanup, August 2013

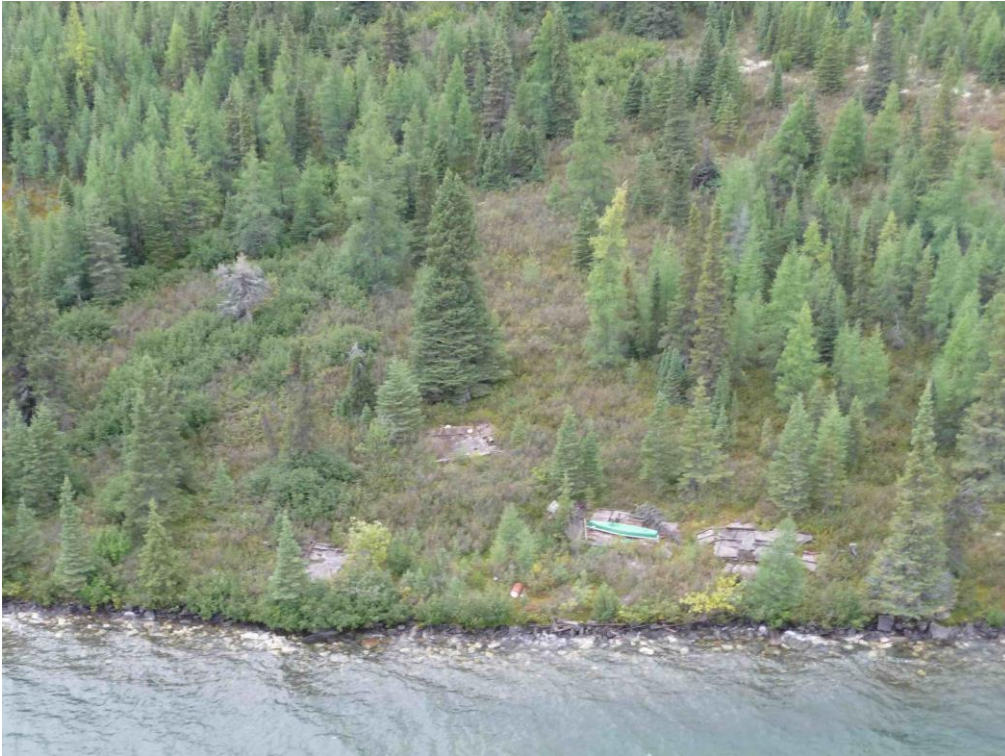
Figure 3: Site KAW-59 during 2011 inspections

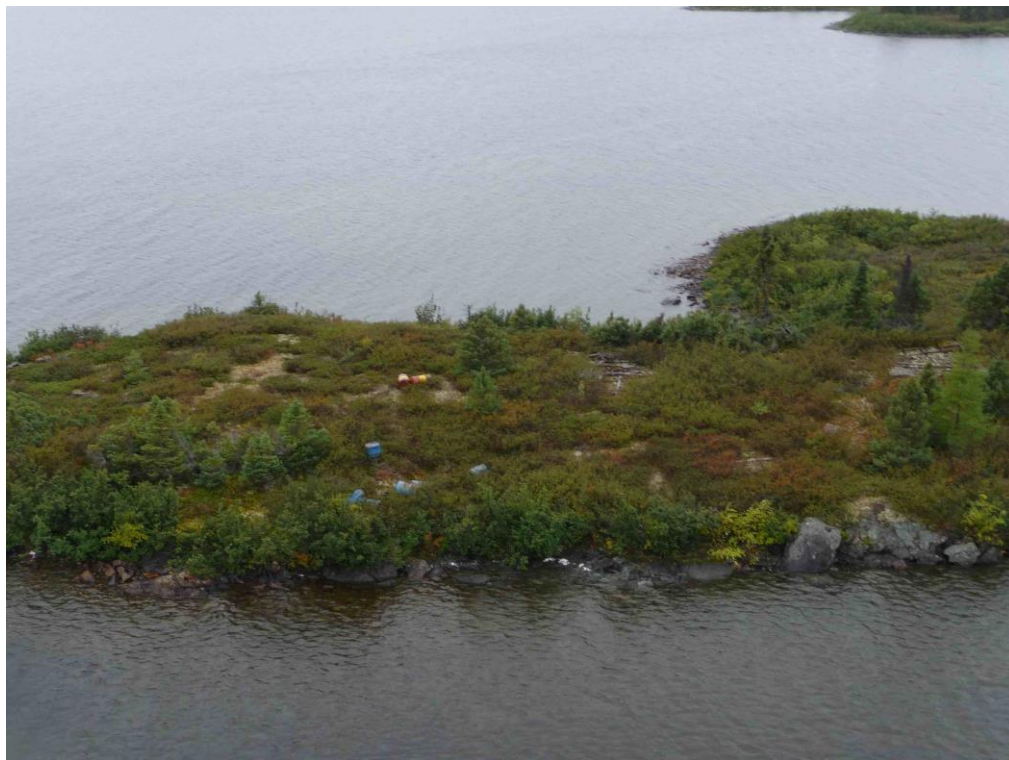
Figure 4: Site KAW-119, during 2011 inspections

An initial inspection of the site was undertaken in June and the cleanup was completed in September 2013. Mostly metal debris was removed from the site and included 60 barrels, 30 propane tanks, stove and small metal cans. This material was transported to Kuujuaq by helicopter where it was stored in marine containers and shipped to a recycling facility by ship in October. Wooden debris was either burned or left to rot on site. The site is now considered as rehabilitated.

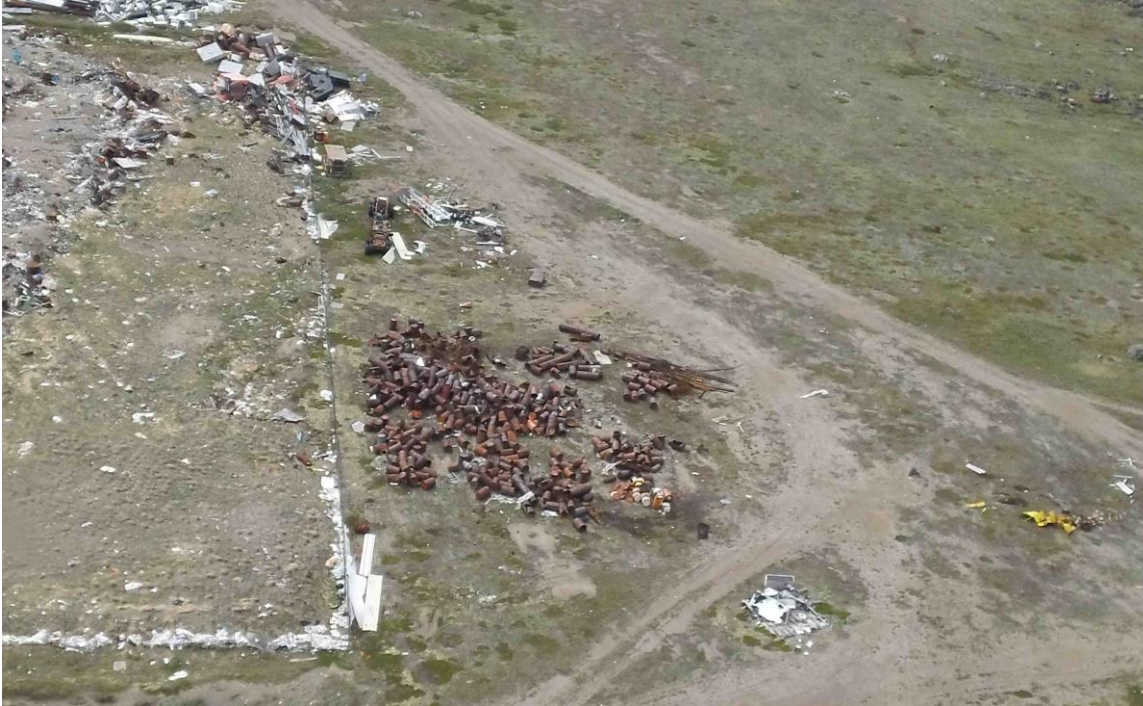
Figure 5: Barrels located at the Aupaluk disposal site, August 2013

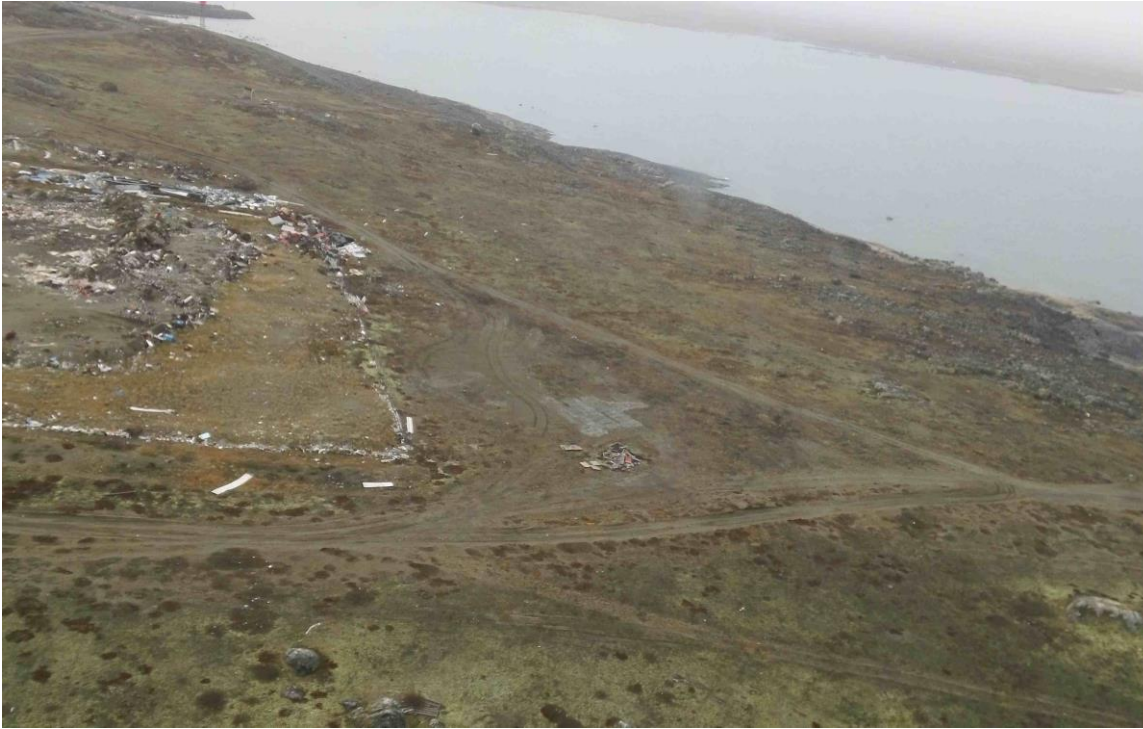
Figure 6: Aupaluk disposal site after removal of barrels, October 2013

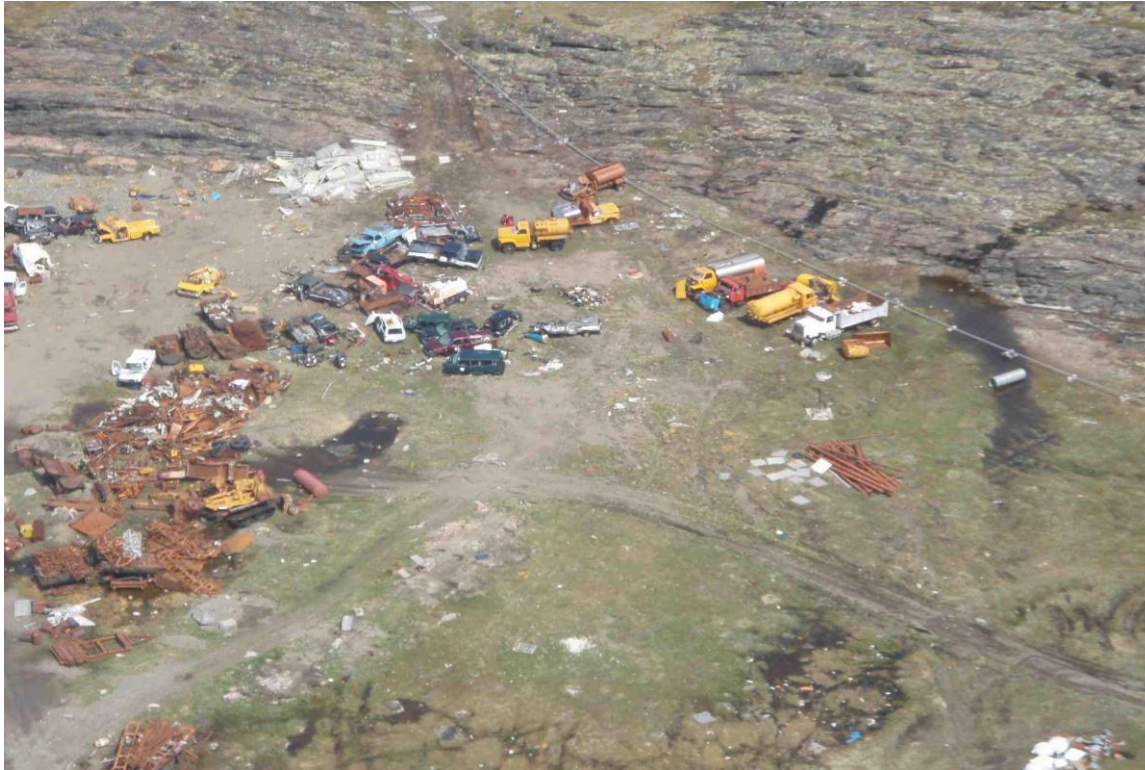
Figure 7: View of material stored next to municipal garage in Aupaluk, October 2012

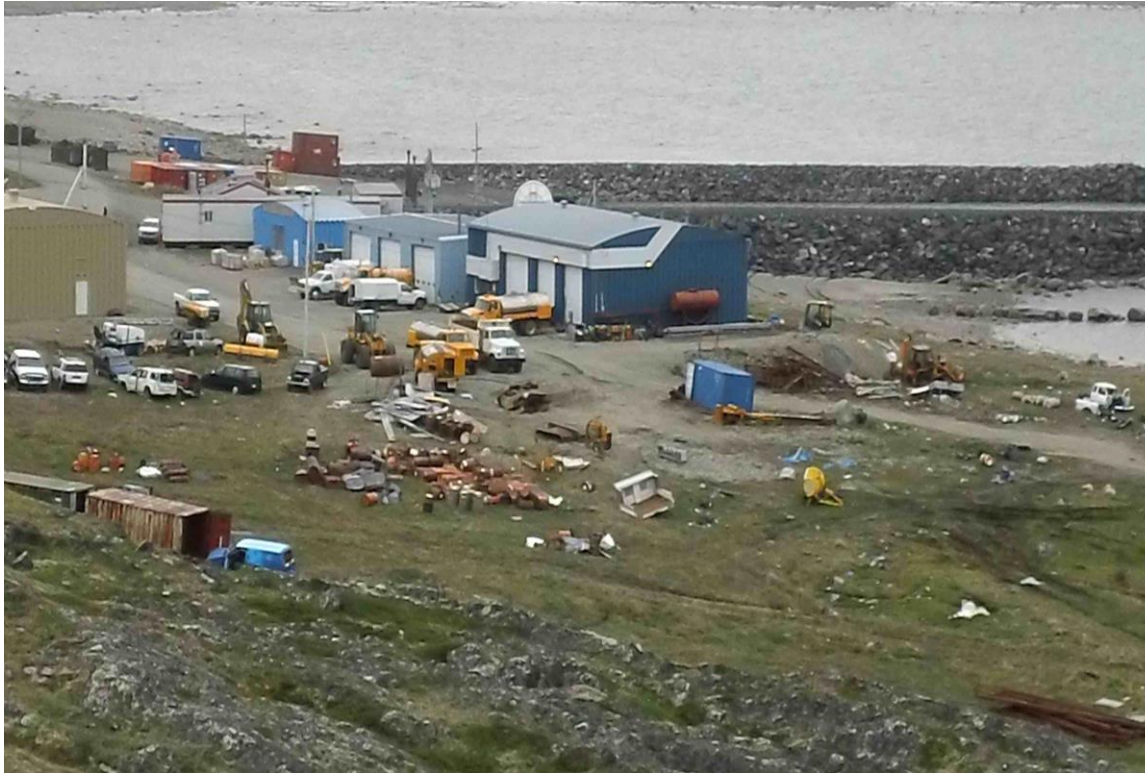
Figure 8: View of municipal garage area after material was removed, August 2013

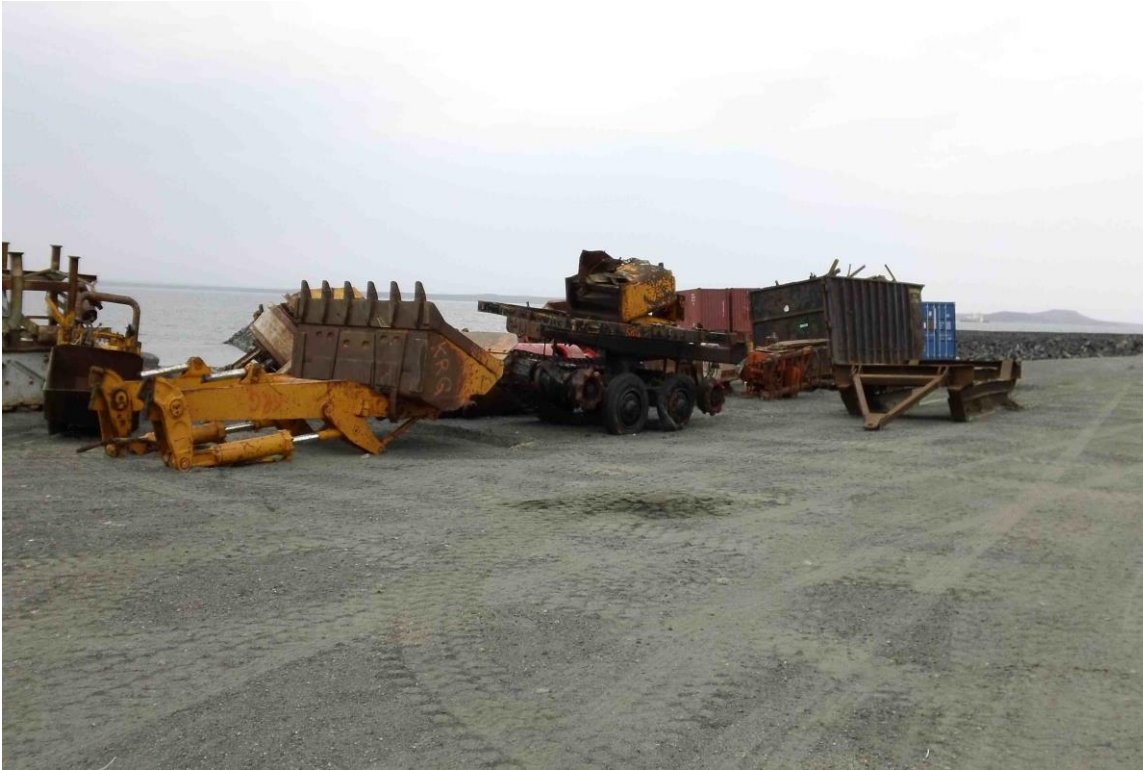
Figure 9: Material at dock in Aupaluk, October 2013

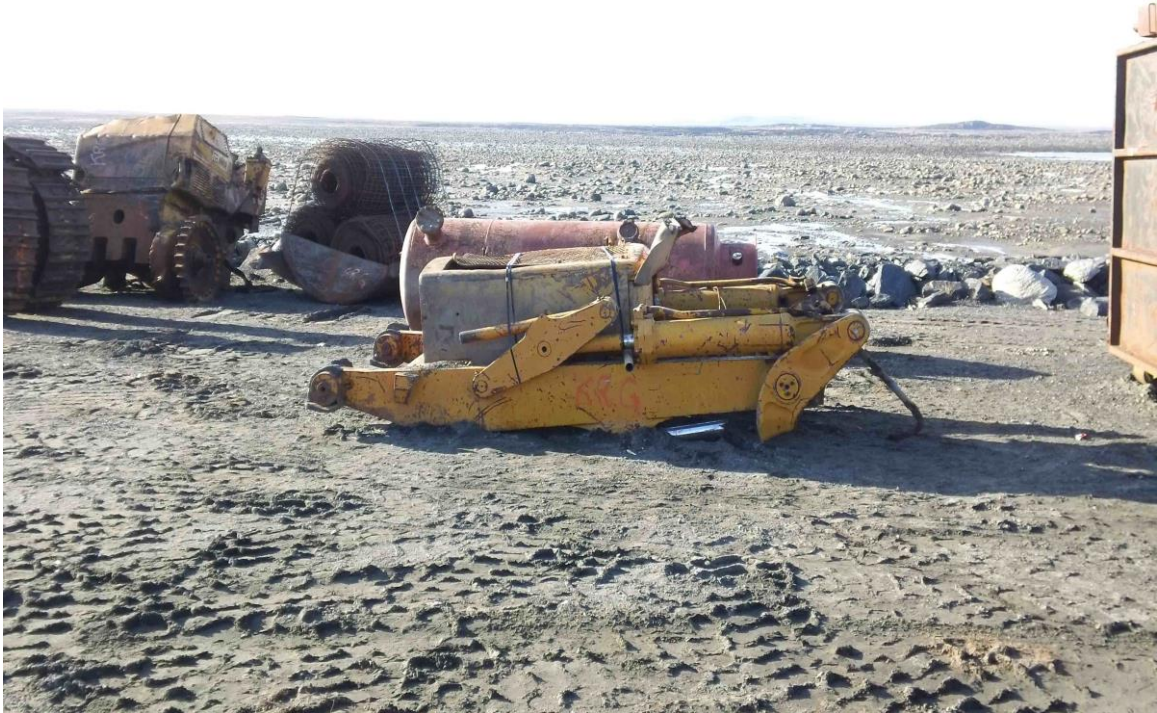
Figure 11: Example of remaining material in Aupaluk, October 2013

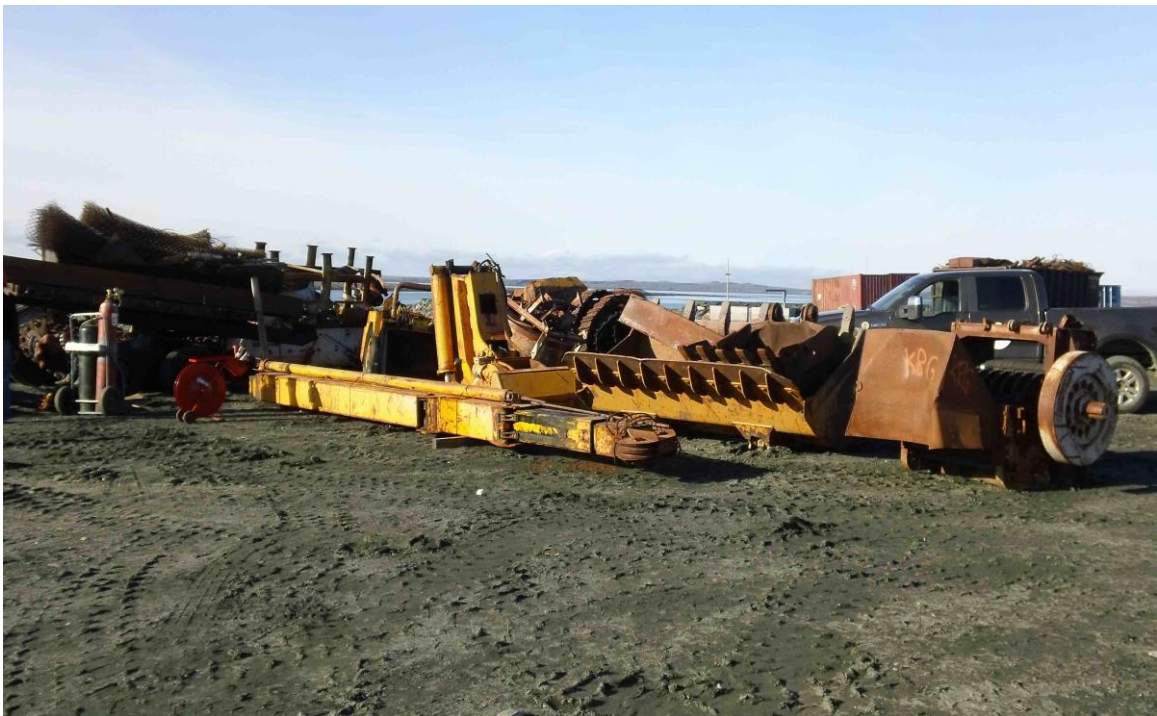
Figure 12: Example of remaining material in Aupaluk, October 2013

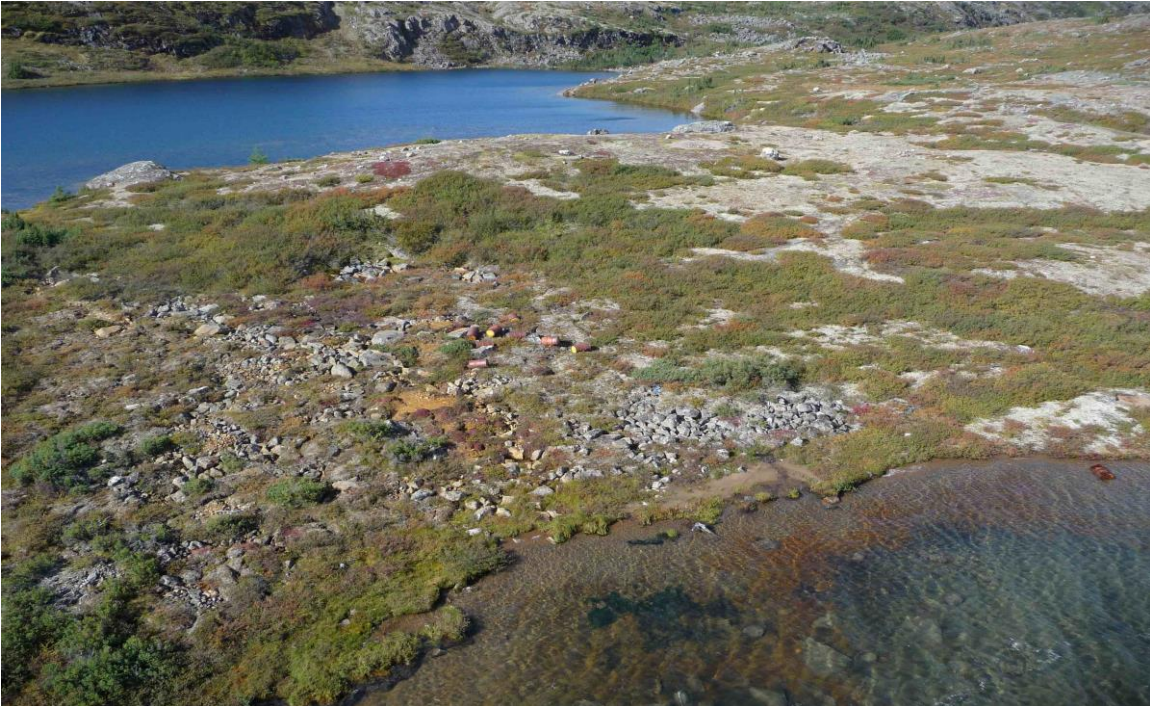
Figure 13: Aerial view of site TA-1, September 2011

Metal waste, including the drums, as well as the miscellaneous debris, can be transported by helicopter to Kuujjuaq where it will be stored in marine containers and transported by ship. Wood debris can be burned on site.

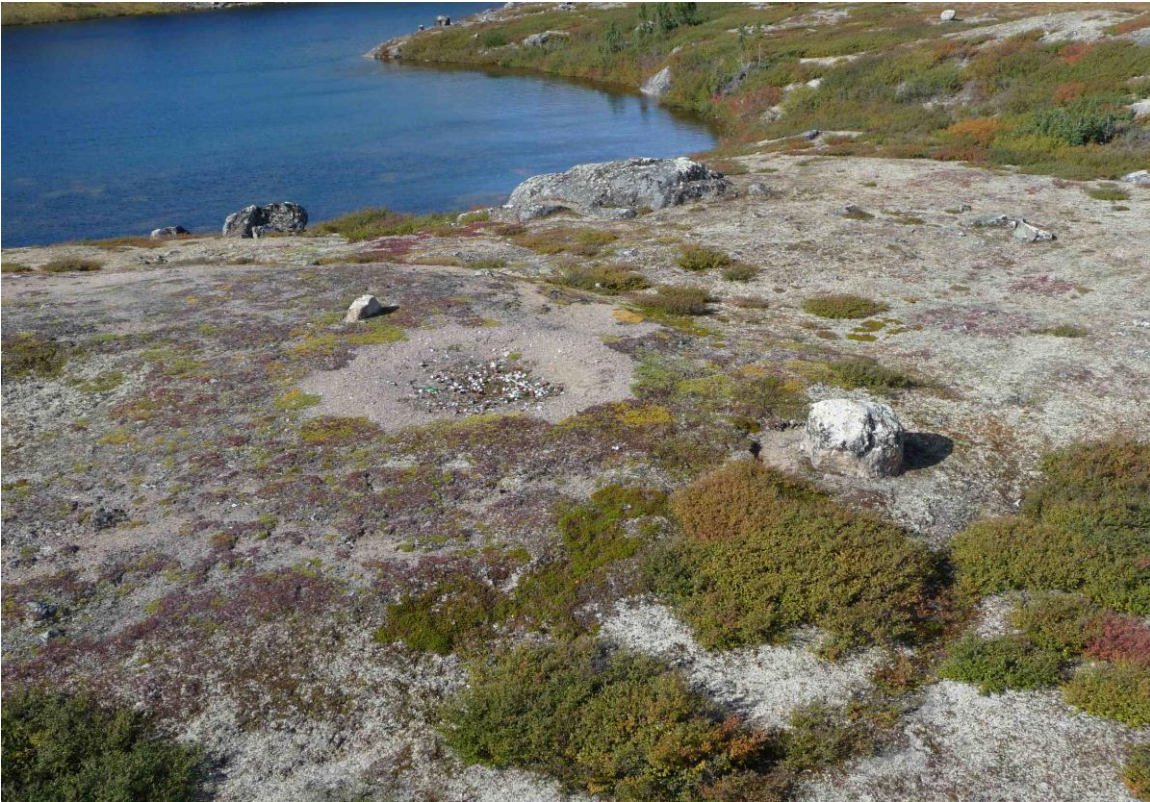
Figure 14: Small disposal site at site TA-1, September 2011

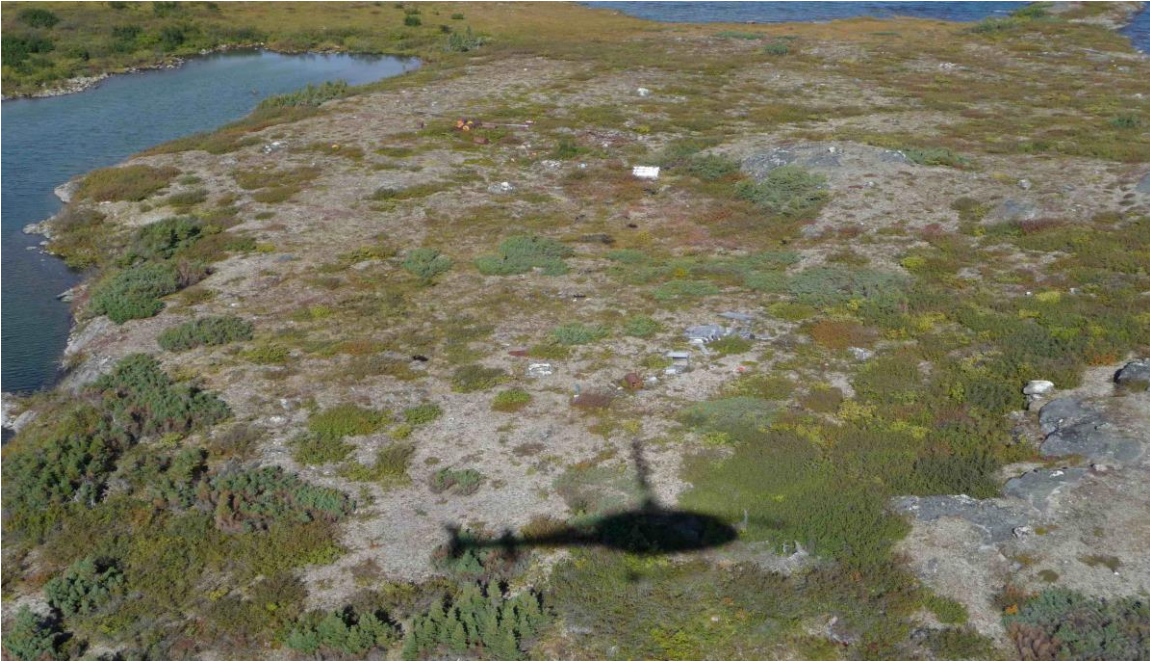
Figure 15: Aerial view of site TQ-6, September 2011

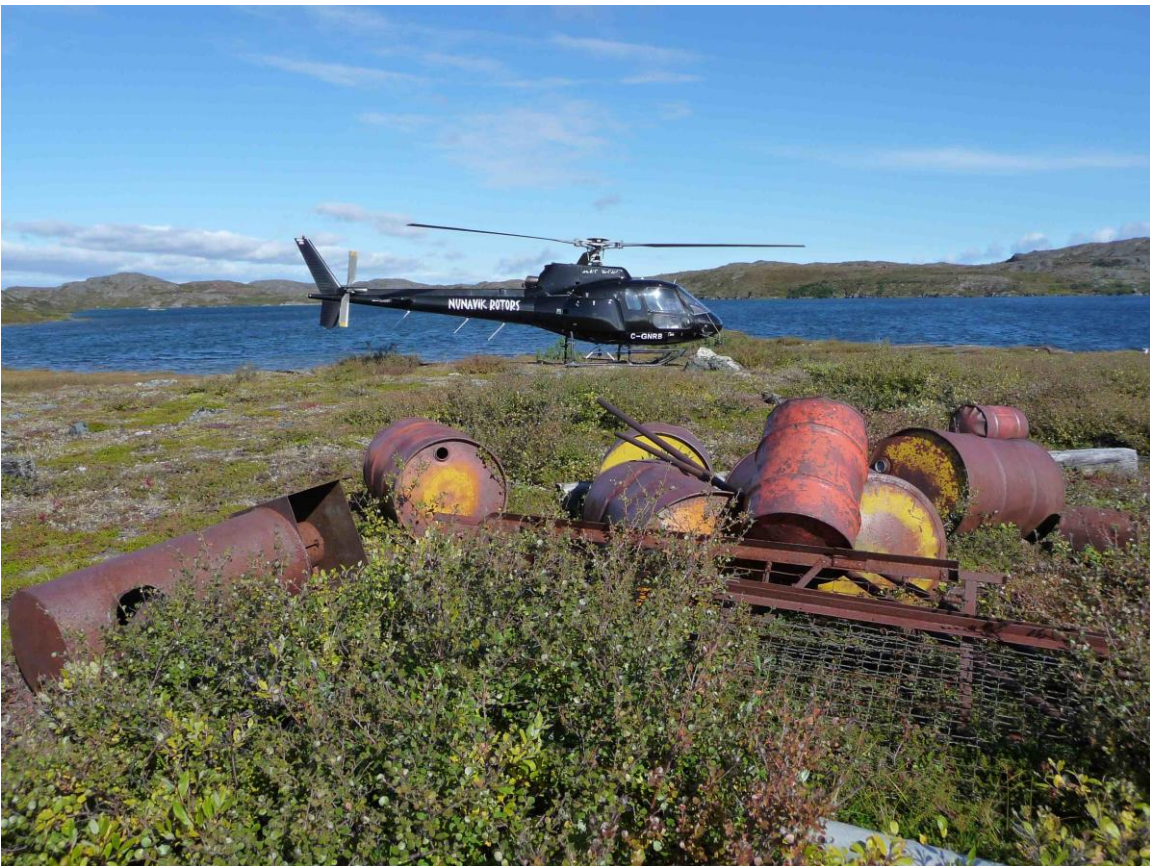
Figure 16: Material found on site TQ-6, September 2013

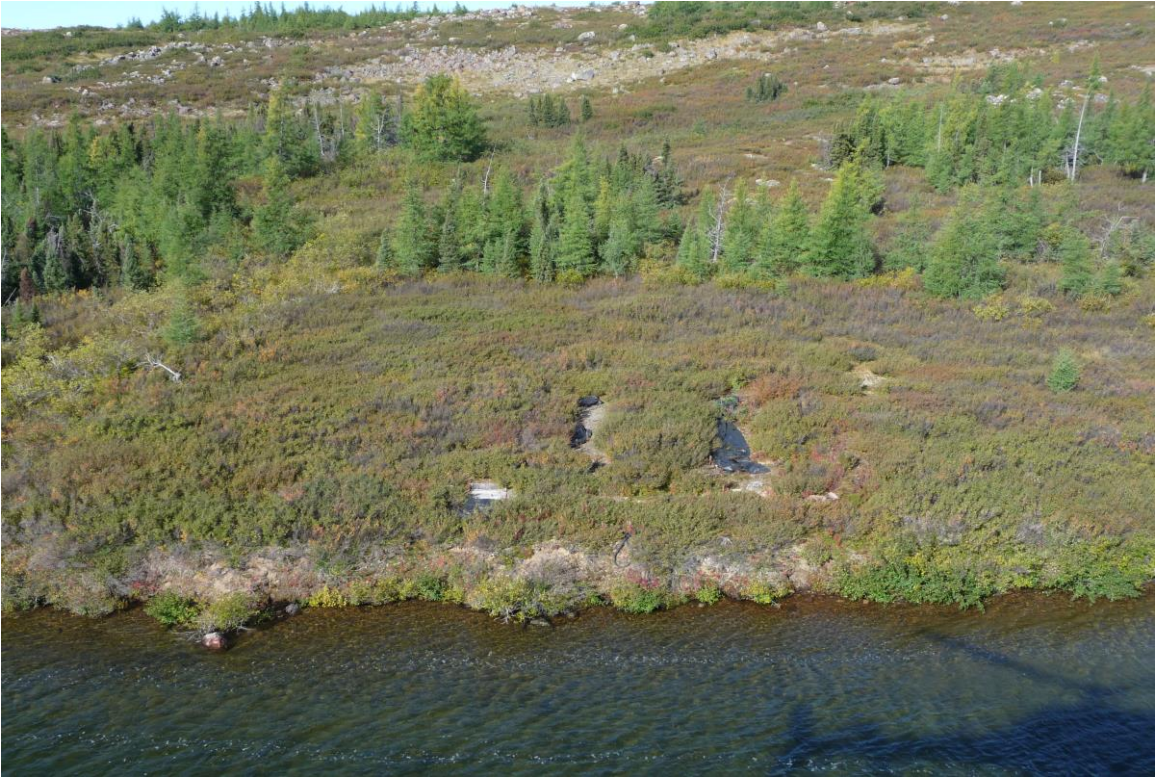
Figure 17: Aerial view of site TQ-10, September 2011

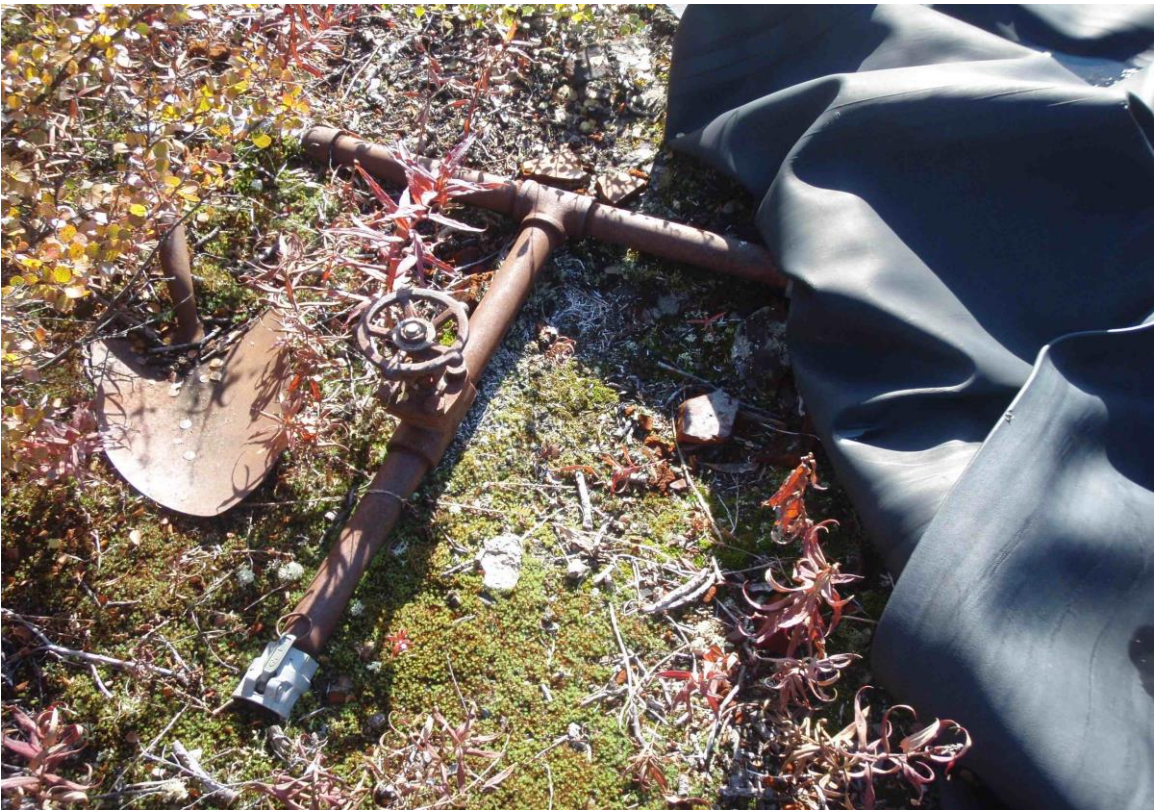
Figure 18: Material found on site TQ-10, September 2011

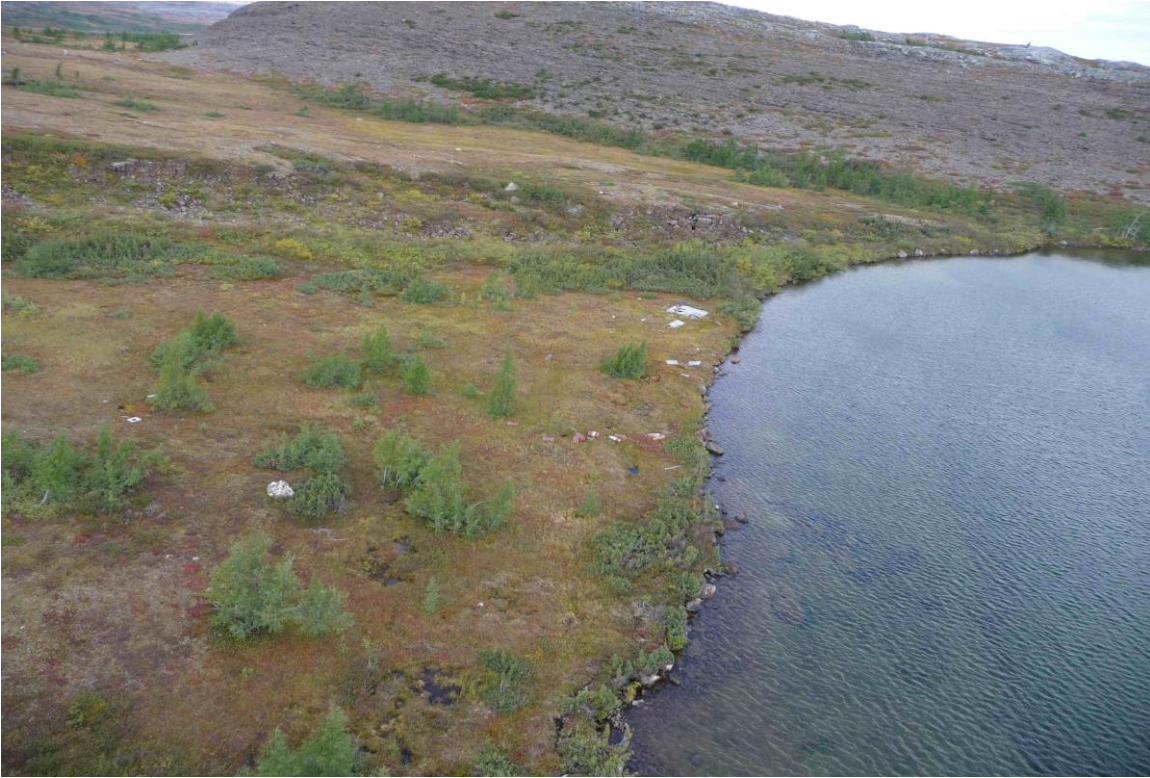
Figure 19: Aerial view of site TQ-14, September 2011

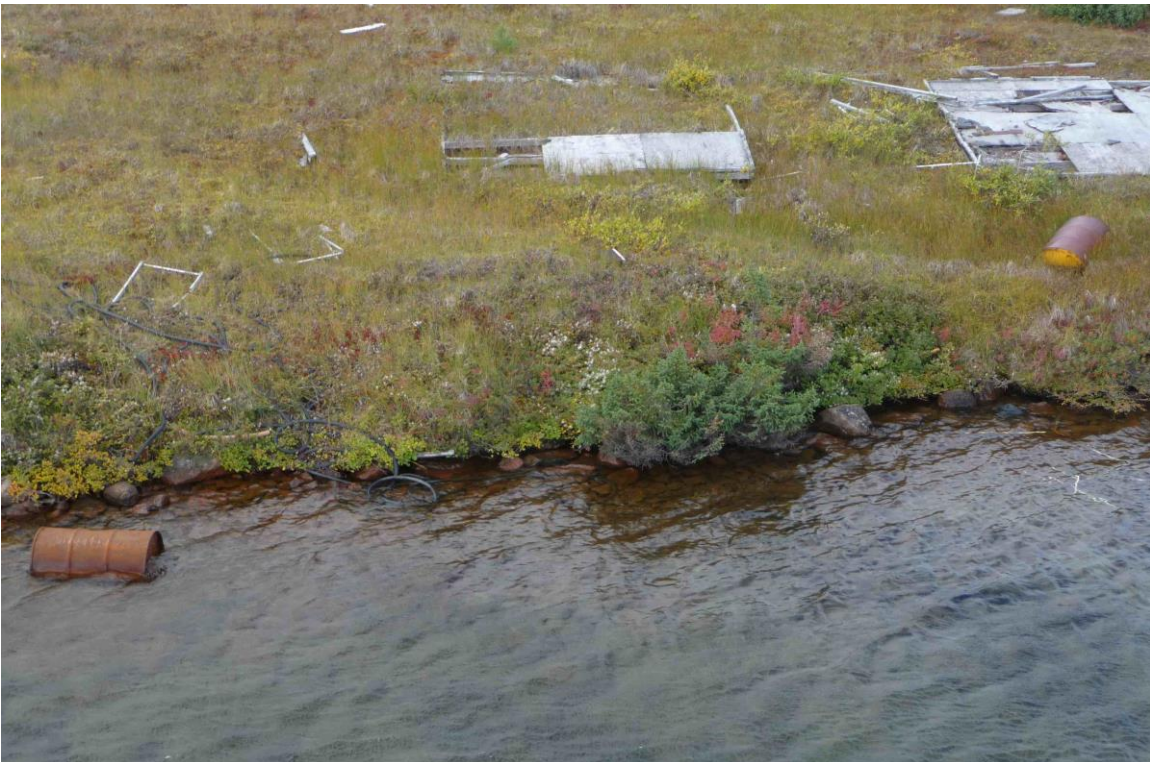
Figure 20: Material found on site TQ-14, September 2011

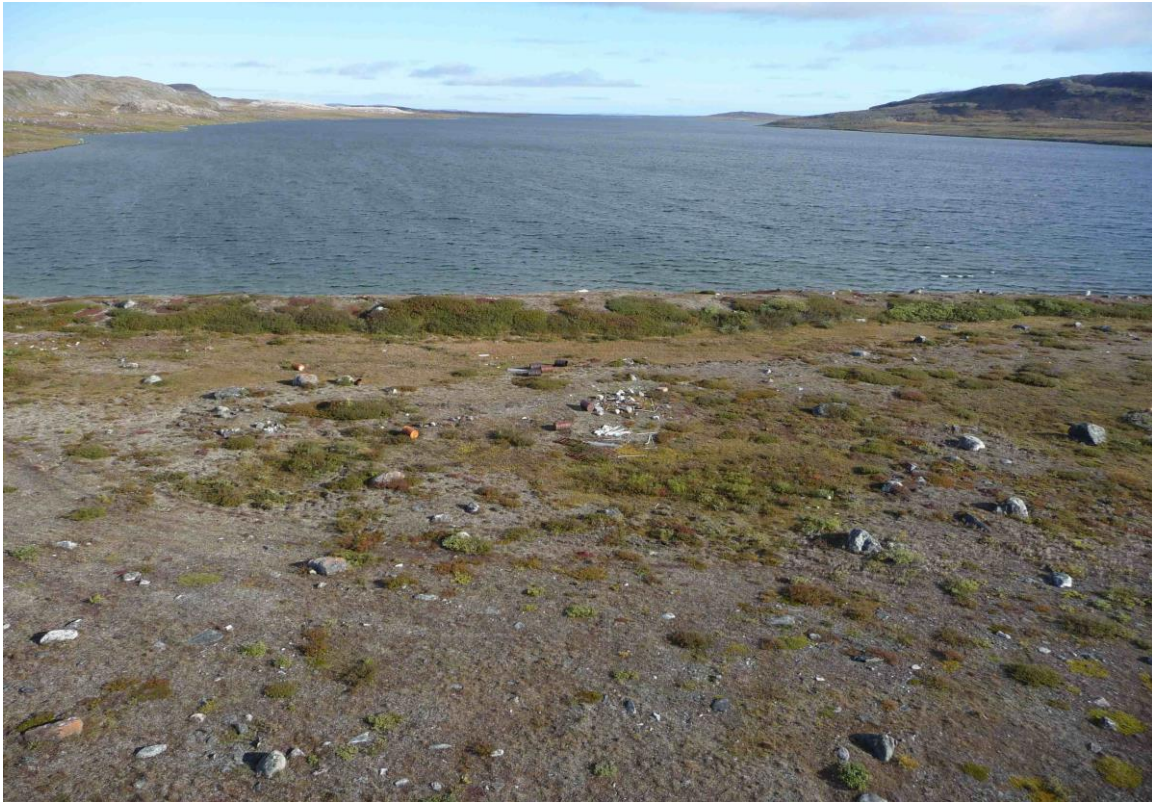
Figure 21: Aerial view of site G-24-N4-3, September 2011

In 2014, KRG will need to mobilize a team from Aupaluk to remove the material from these 2 sites. All metal debris can be transported to Aupaluk by helicopter where it can be stored in the marine containers already containing debris from other sites. It can then be transported by ship. Wood debris can be burned on site.

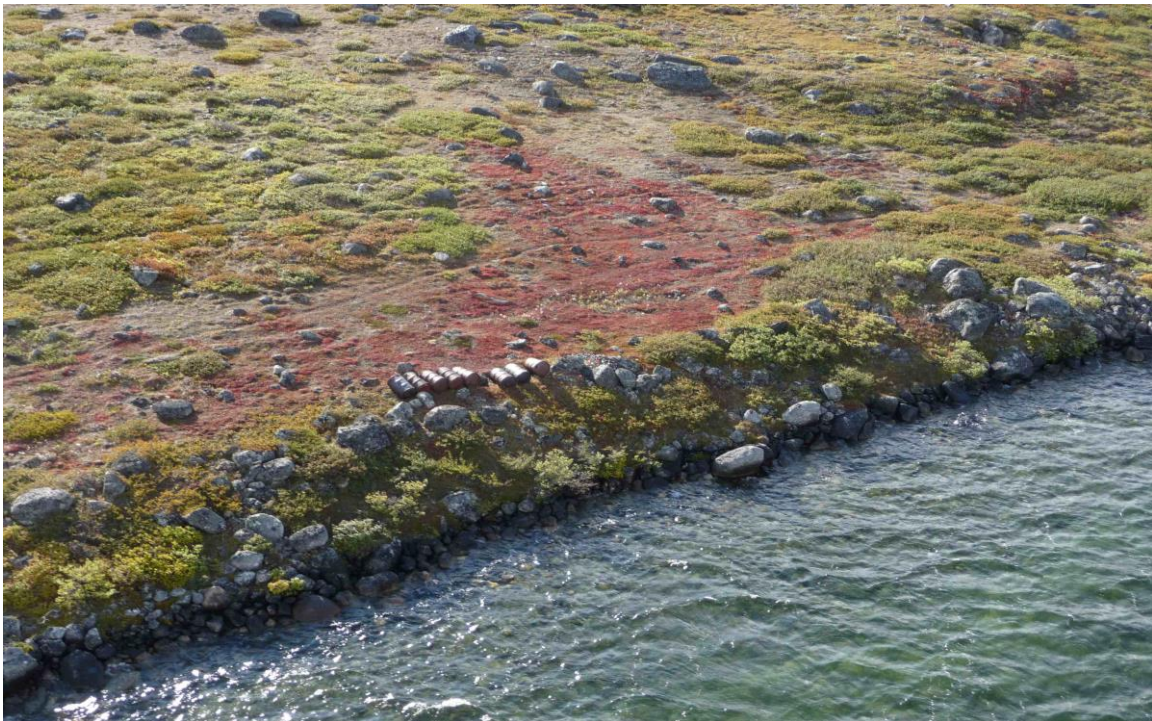
Figure 22: Aerial view of barrels found on site G-24-N4-3, September 2011

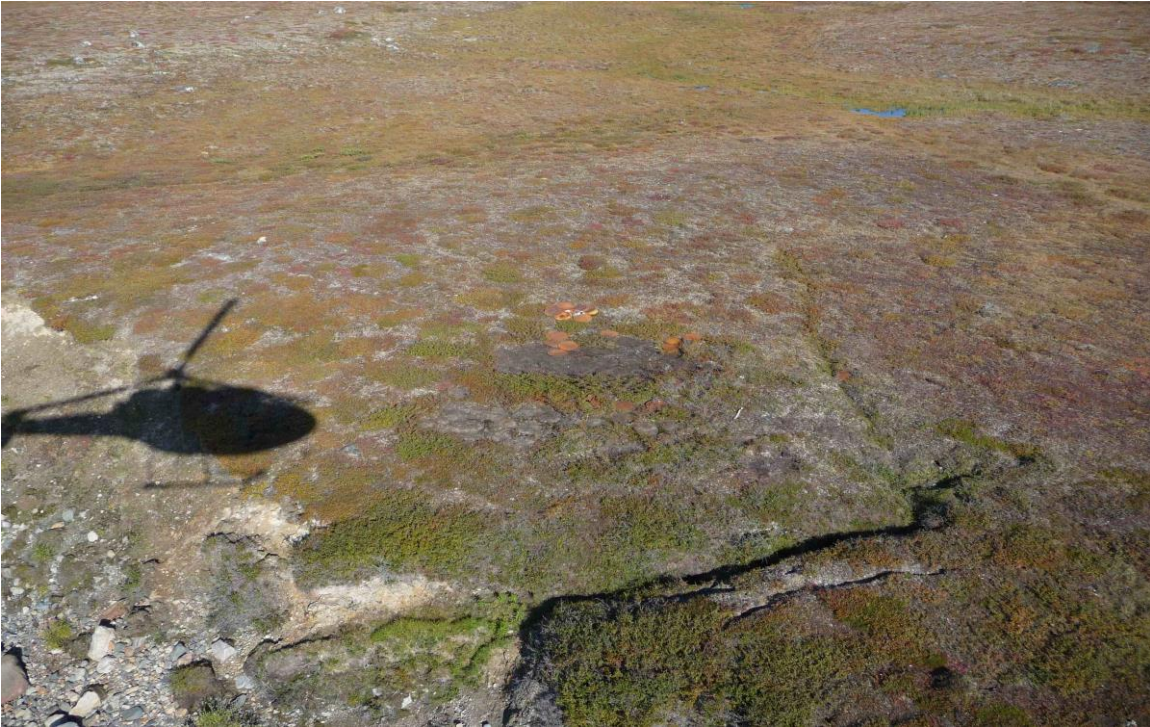
Figure 23: Aerial view of site PJ-19, September 2011

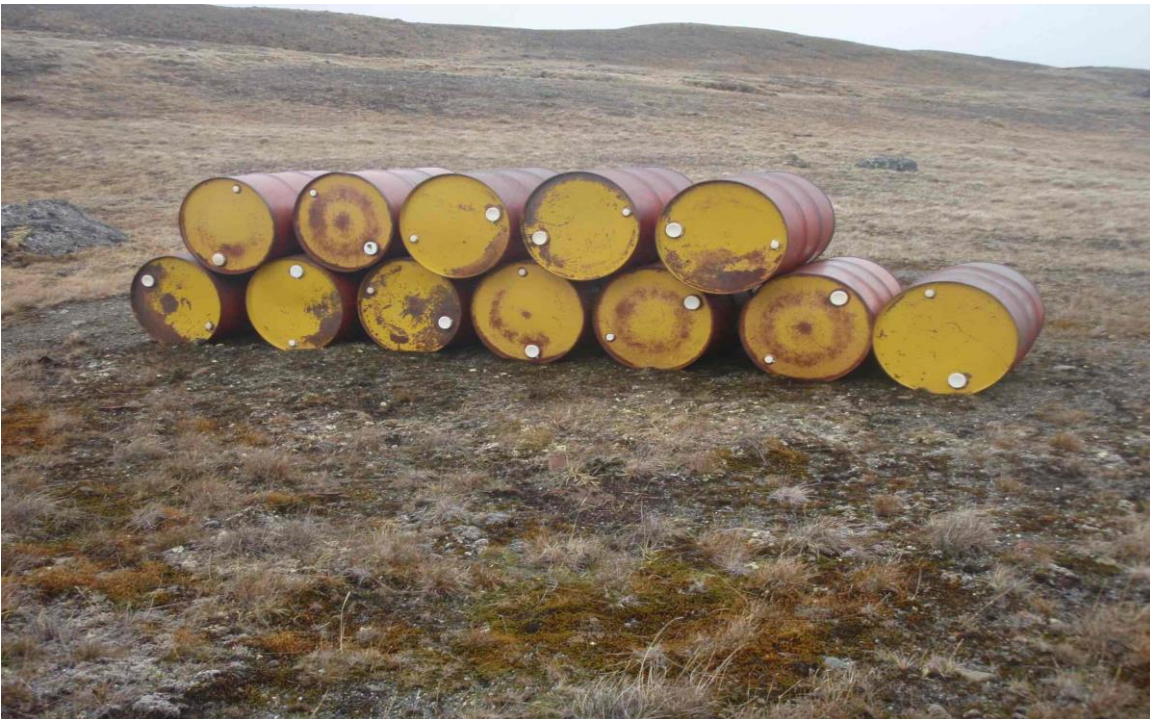
Figure 24: One group of barrels found at site WB-9, June 2012

A follow-up inspection was undertaken in June 2012. The site possesses 10 buildings and three small wooden cabins. The condition of the facilities has deteriorated since the original inventory. The site contains a large quantity of non-hazardous waste, such as bed frames, rotten mattresses, a stove-oven, a washing machine, refrigerators etc. Hazardous waste is nonetheless present on site and includes paint, motor oil, propane tanks, fire extinguishers, oil filters and a battery. Several thousand rock/core samples are still housed in a wooden structure on the site. There are approximately 20 barrels stacked close to the buildings, about half of which contain hydrocarbon residue. The soil contamination observed in 2001 underneath two barrels is still present. As well, within a one-kilometre radius of the camp, two groups of drums were observed. The first group, to the west of the site contain approximately 30 full and 10 empty barrels. The second group, located on a hill next to the site contains 18 empty drums. Photographs of the debris and buildings present at the site in 2012 are found in Appendix 4.

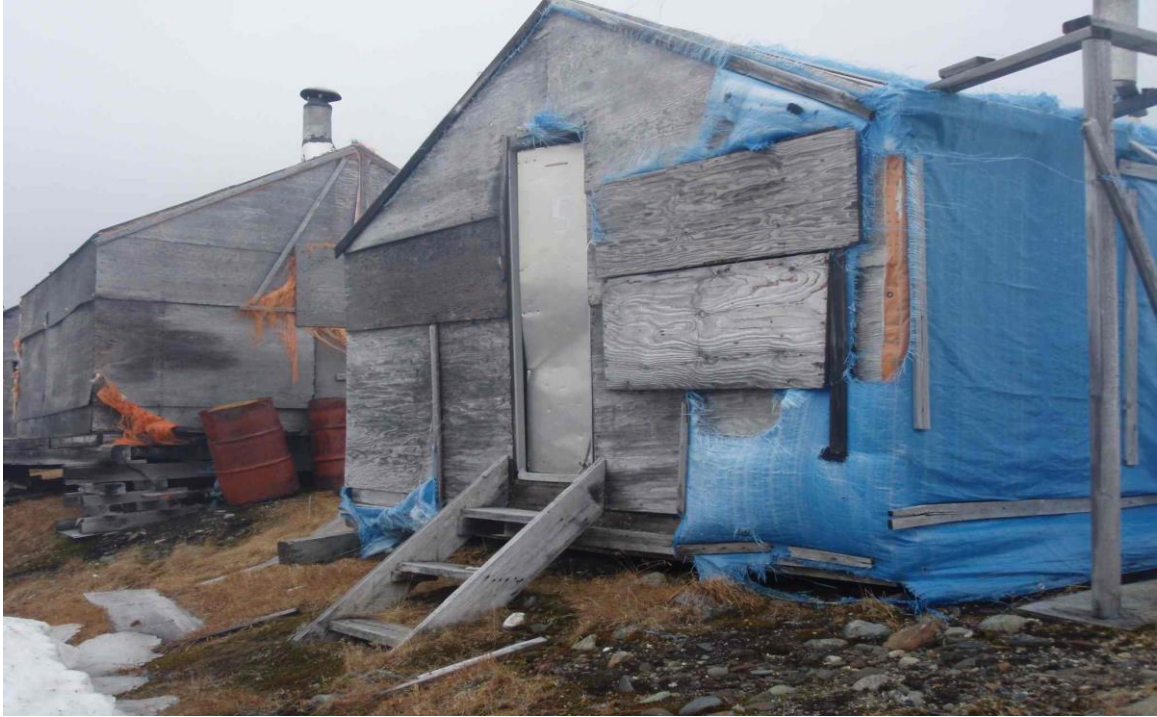
Figure 25: Two of thirteen buildings found on site WB-9, June 2012

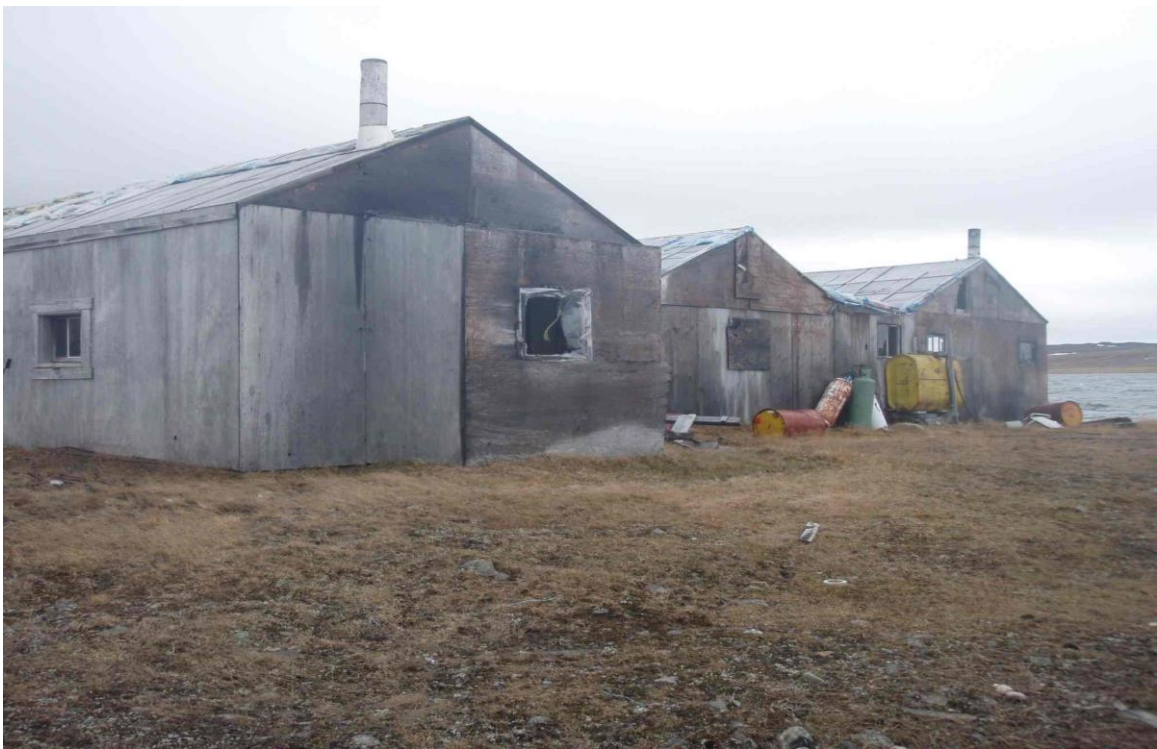
Figure 26: Example of wooden structures and debris found on site WB-9, June 2012

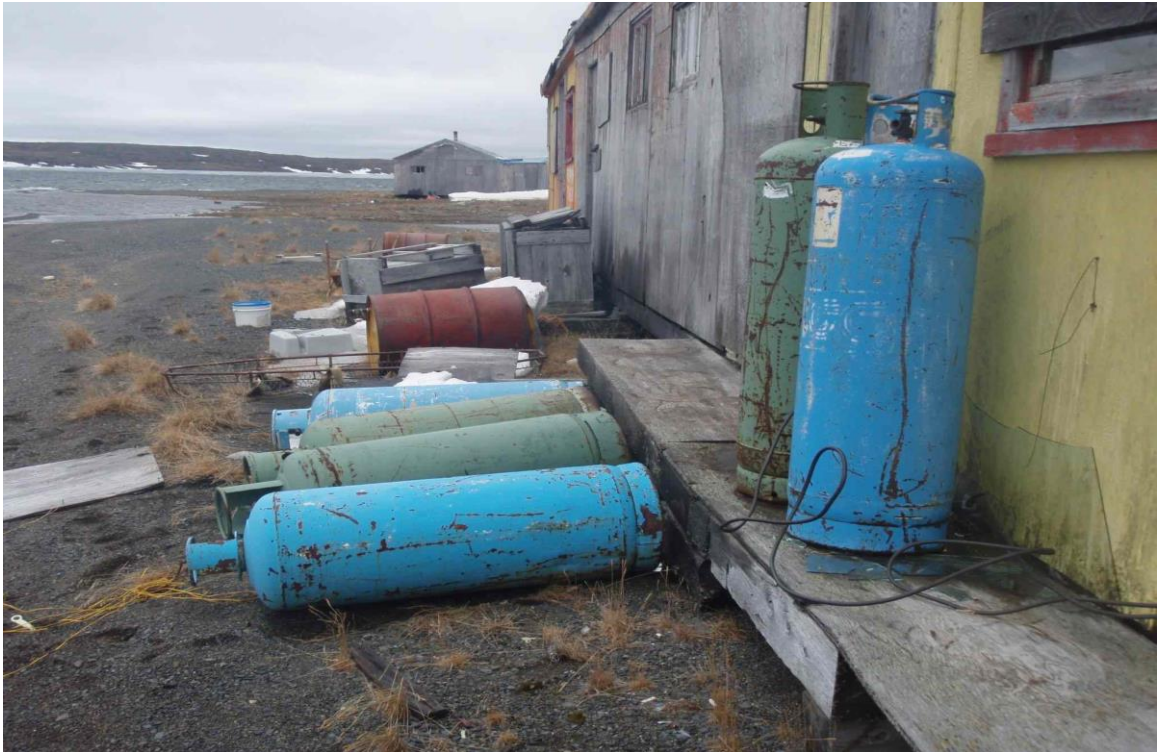
Figure 27: Propane tanks found at site WB-9, June 2012
