NUNAVIK ABANDONED MINERAL EXPLORATION SITES REHABILITATION PROJECT

2013-2014 ACTIVITY REPORT

Kativik Regional Government

April 2014

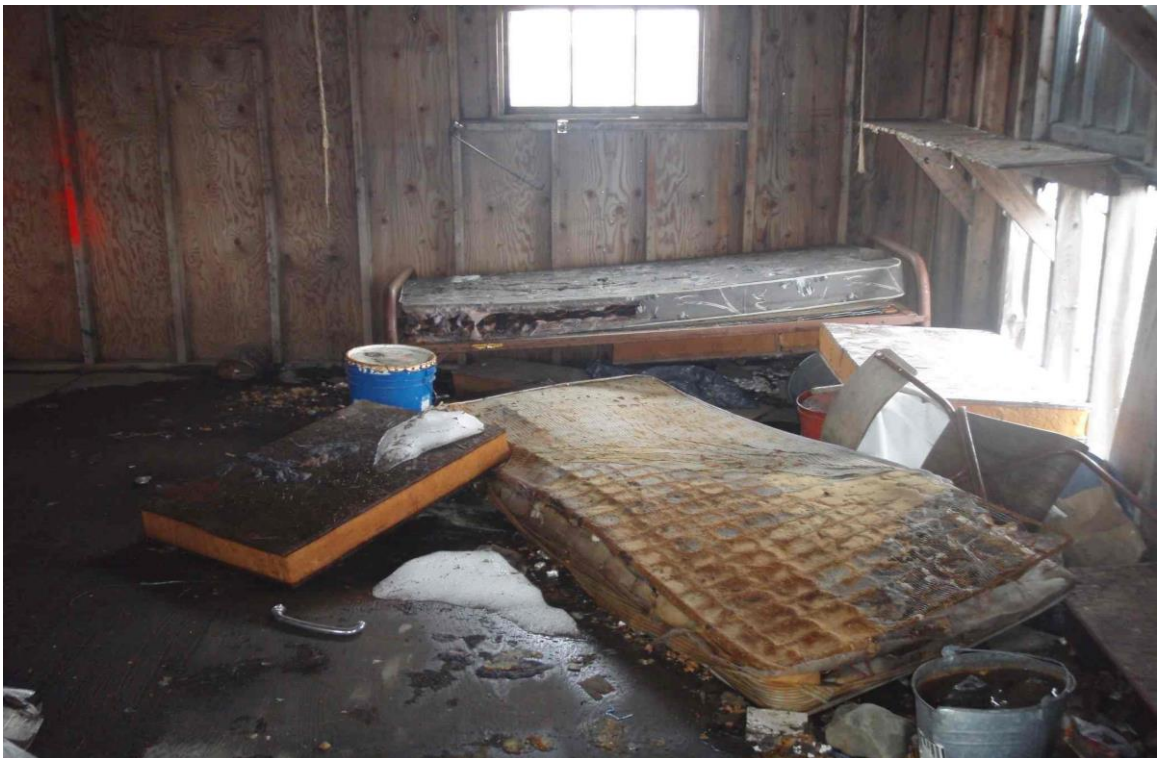
Figure 28: General debris and waste found inside buildings on site WB-9, June 2012

A follow-up inspection was undertaken in June 2012. The site possesses 10 buildings and three small wooden cabins. The condition of the facilities has deteriorated since the original inventory. The site contains a large quantity of non-hazardous waste, such as bed frames, rotten mattresses, a stove-oven, a washing machine, refrigerators etc. Hazardous waste is nonetheless present on site and includes paint, motor oil, propane tanks, fire extinguishers, oil filters and a battery. Several thousand rock/core samples are still housed in a wooden structure on the site. There are approximately 20 barrels stacked close to the buildings, about half of which contain hydrocarbon residue. The soil contamination observed in 2001 underneath two barrels is still present. As well, within a one-kilometre radius of the camp, two groups of drums were observed. The first group, to the west of the site contain approximately 30 full and 10 empty barrels. The second group, located on a hill next to the site contains 18 empty drums. Photographs of the debris and buildings present at the site in 2012 are found in Appendix 4.

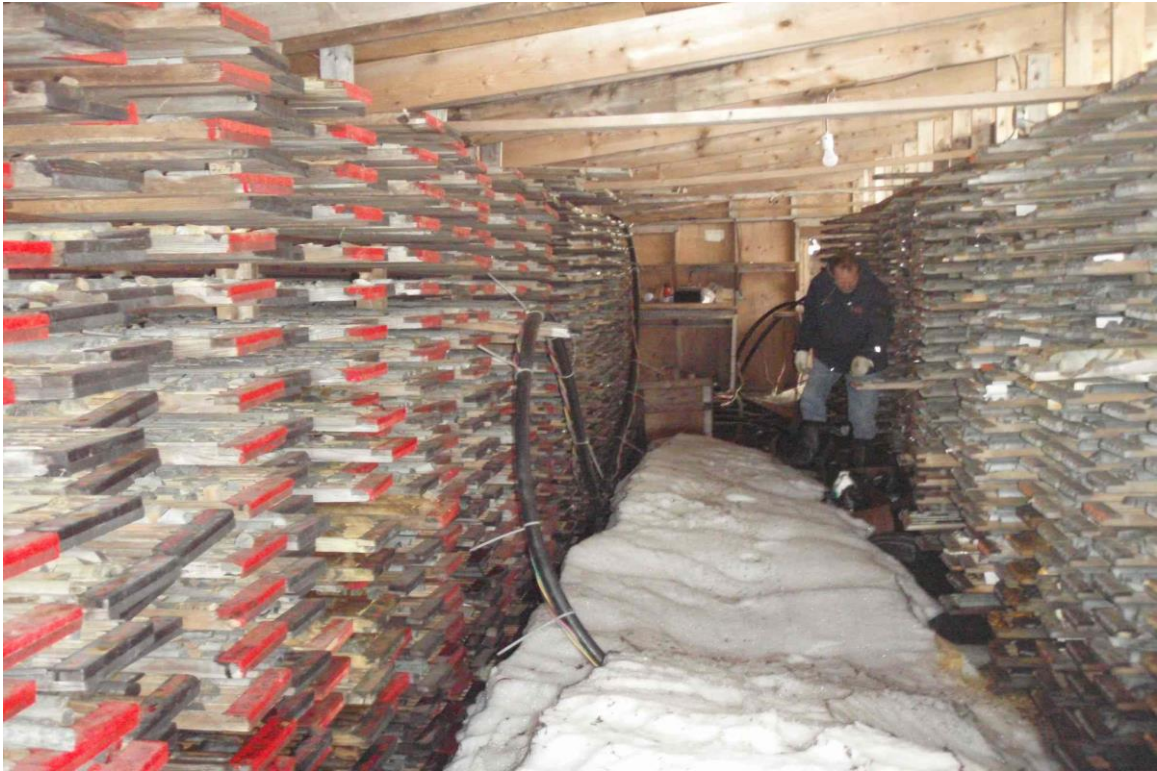
Figure 29: Core sample from previous mining exploration activities found at site WB-9, June 2012

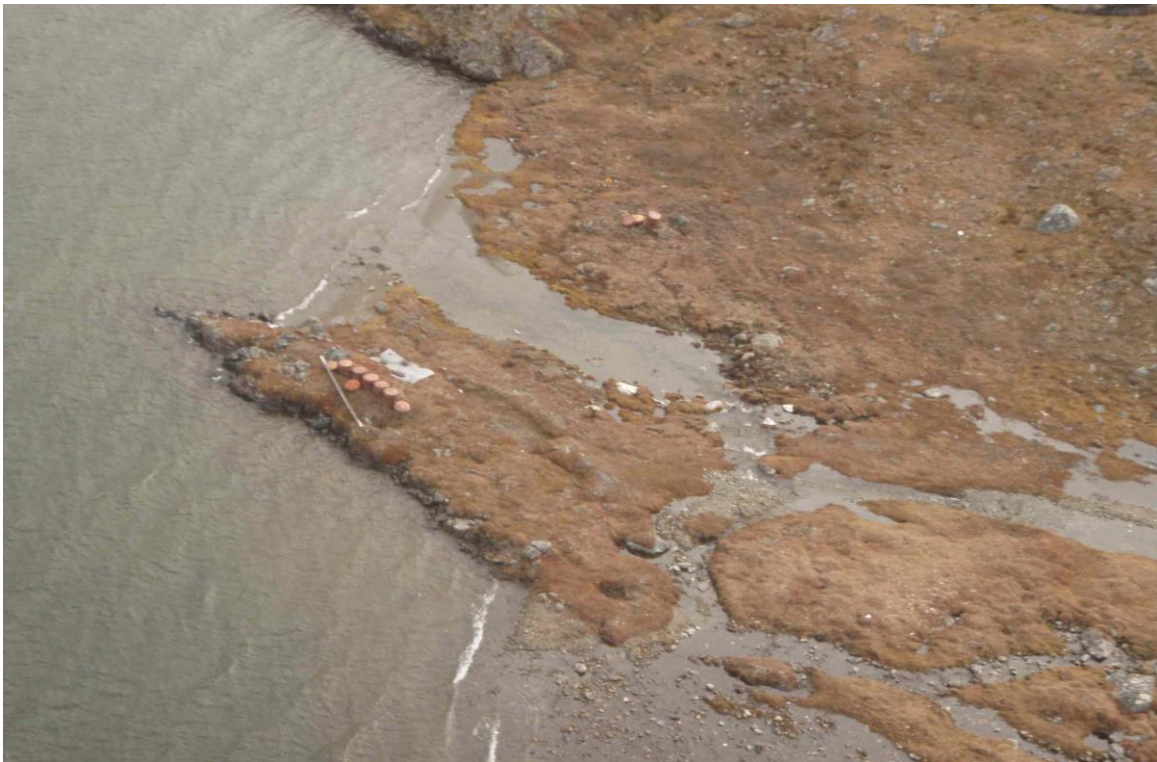
Figure 30: Sector 2 of site KV-1 containing crushed drum and wood, September 2012

Work will consist of gathering barrels and other debris to be removed from the site by helicopter. The combustible material can be burned on location. The site was inspected in September 2012 and photographs are found in Appendix 4.

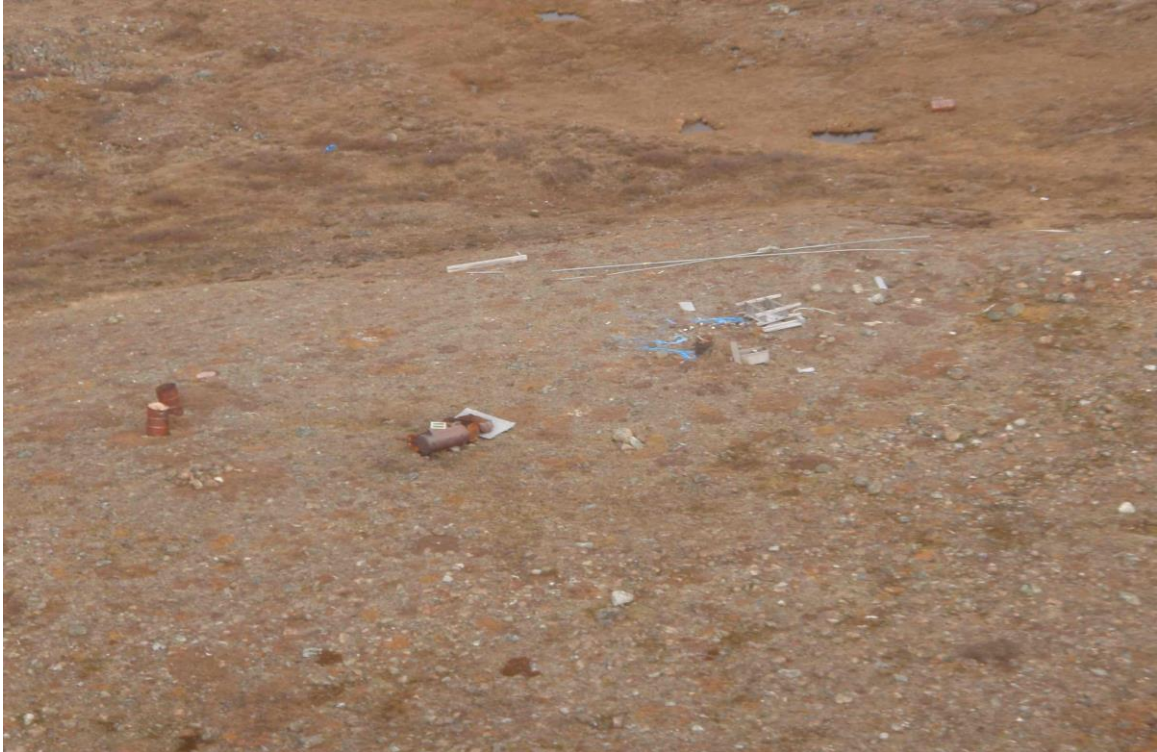
Figure 31: Sector 1 of site KV-1 containing various debris and wood, September 2012

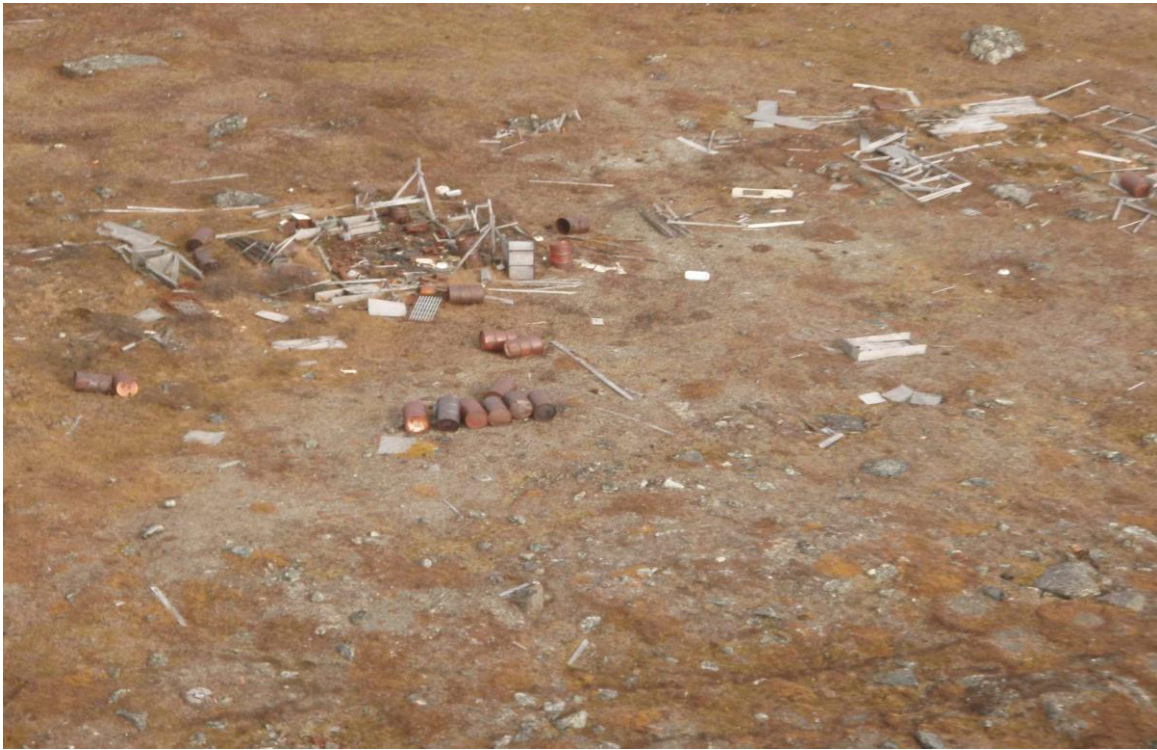
Figure 32: Sector 1 of site SW-27, containing wood debris, barrels, propane tanks and hazardous waste, September 2012

Of all the abandoned mineral exploration sites still requiring clean-up, site SW-27 contains the greatest quantities of residual material and hydrocarbons residue: roughly 1650 L of diesel, 260 L of grease and 26 L of oil. Although covering only 2.5 m², hydrocarbon soil contamination is still very evident. Open or damaged barrels of grease were also observed. The site was inspected in September 2012 and photographs are found in Appendix 4.

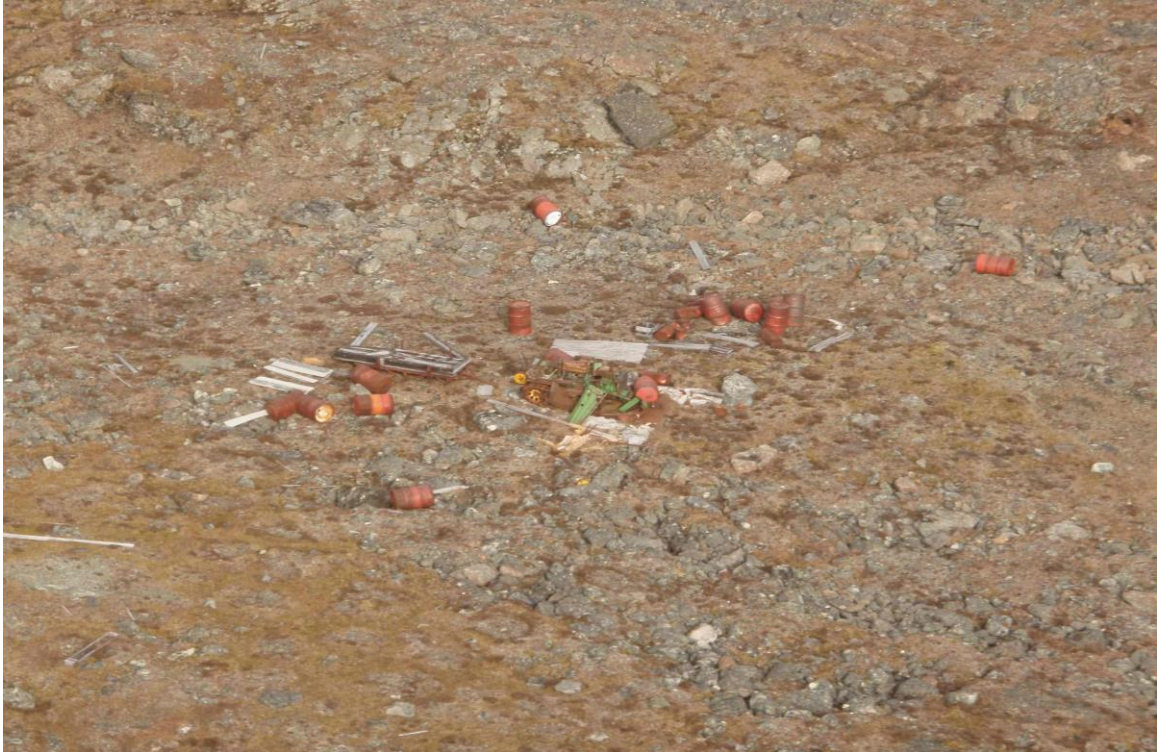
Figure 33: Sector 2 of site SW-27, containing barrels, muskeg, trailer, debris and hazardous waste, September 2012

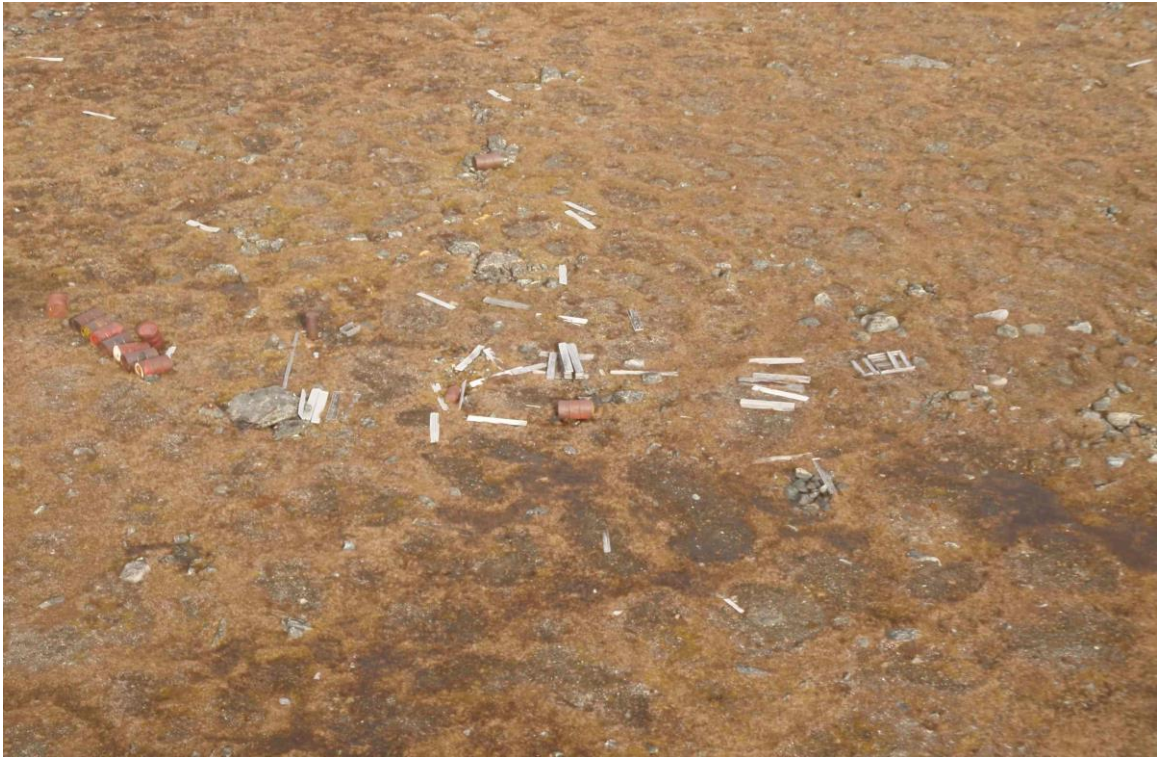
Figure 34: Sector 3 of site SW-27, containing barrels, wood and debris, September 2012

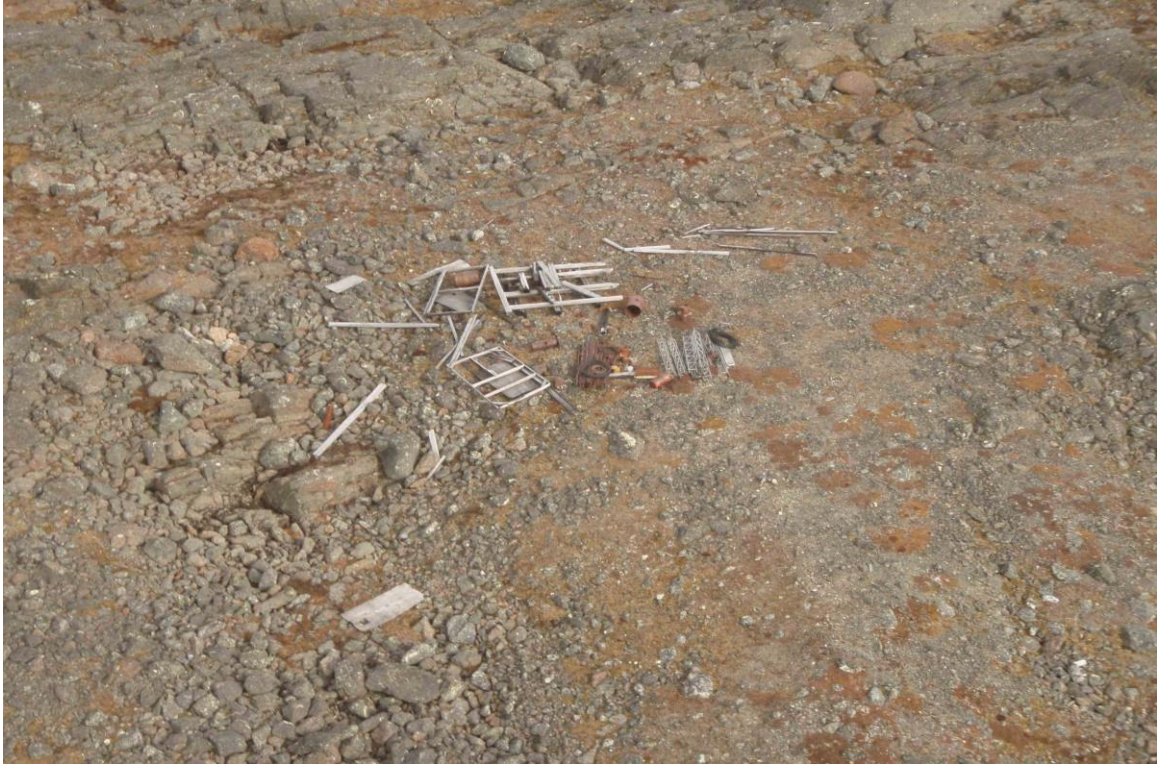
Figure 35: Sector 4 of site SW-27, containing barrels, debris and hazardous waste, September 2012
