Northern Village of Puvirnituk

**VULNERABILITY ANALYSIS OF
THE DRINKING WATER
SOURCE**

WATER INTAKE N°X2114321 OF
PUVIRNITUQ

Project 21-055

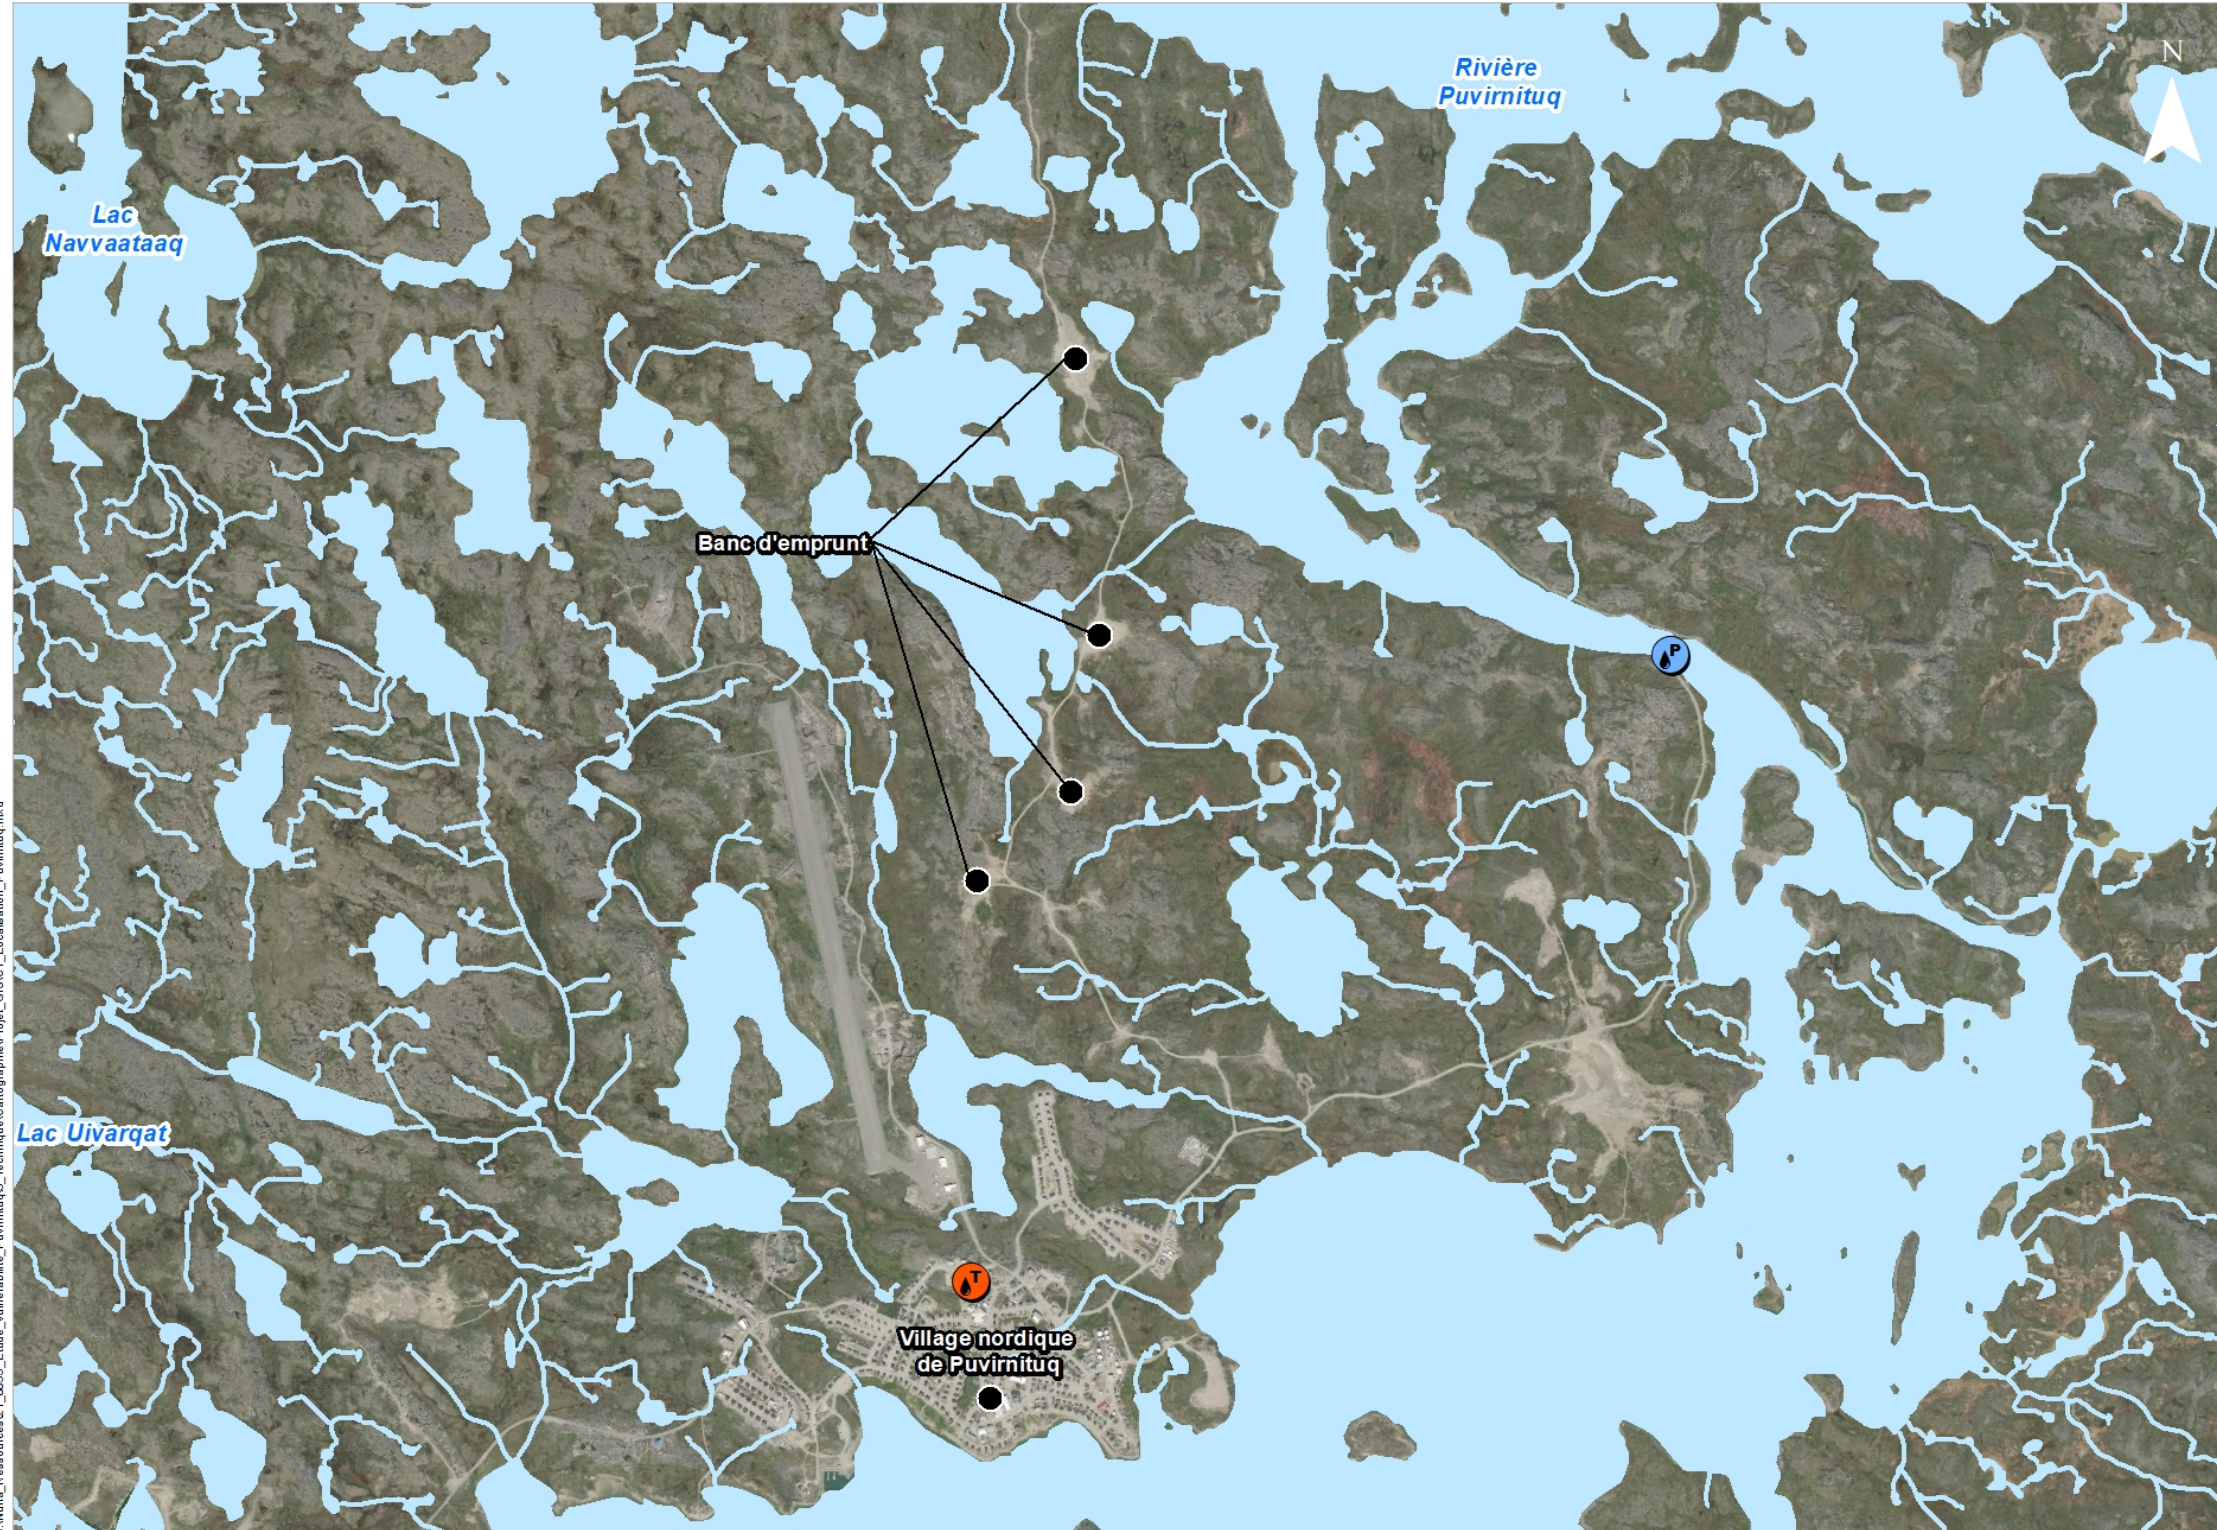
CARTE 1
Localisation de l'aire d'étude

-   Prise d'eau
 -   Station de traitement
- Hydrographie**
-   Cours d'eau
 -   Plan d'eau

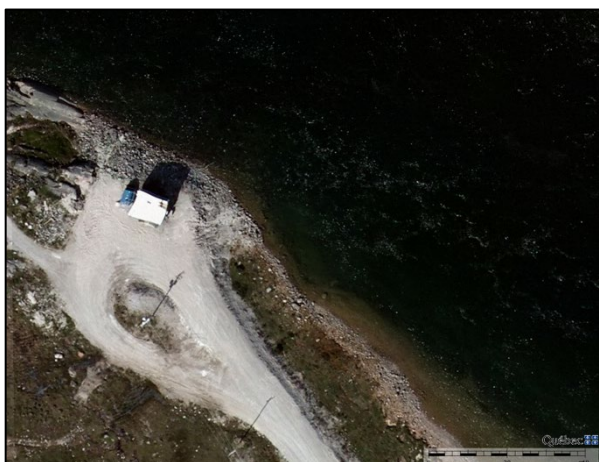
Photo 1. Pumping station and water intake seen from the sky (from MERN online imagery)

The Puvirnituk water intake is located away from the village, at the end of a road that ends in a dead end after a little less than 5 km (location map 1). The current water intake was built in 1991 and consists of a 26 m long and 400 mm diameter polyethylene supply line, with 50 mm thick polyurethane insulation. In this pipe are also installed two copper pipes of 25 mm in diameter each; connected by a copper ring in a closed loop in which a glycol solution circulates, to prevent the pipe from freezing or prevent the formation of frazil (Annex 2). The supply line is connected to a pumping station located immediately on the shore (photos 1 and 2). The latter is then itself connected to the drinking water treatment and distribution plant by two separate pipes: a polyethylene supply pipe 150mm in diameter and insulated with a 75 mm layer of polyurethane

and a recirculation pipe of 100 mm in diameter. The water circulates there continuously to prevent freezing. Heating cables are also used to prevent winter freezing.

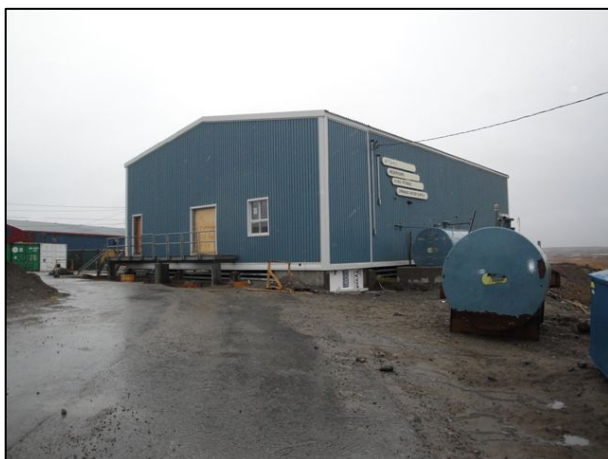
Photo 3. The drinking water treatment and distribution plant in Puvirnituq during its renovation in 2009 (Source: KRG)

The water treatment plant in the Northern Village of Puvirnituk is located in the village, near the hospital (photo 3 and map 1), at the following geographical coordinates :

The building, as well as the water treatment and distribution facilities, were upgraded in 2009 and 2013.

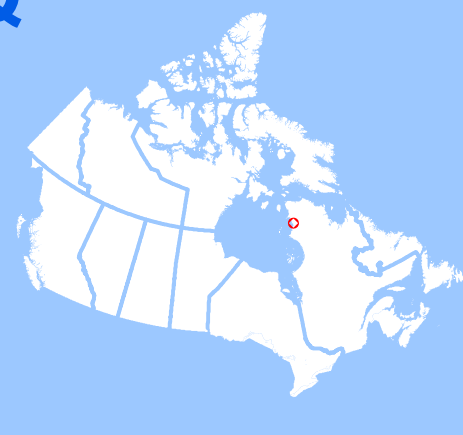
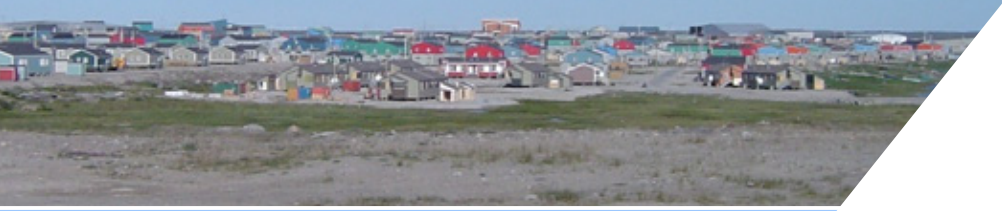
CONDITIONS DE PERGÉLISOL PUVIRNITUQ Québec, Nunavik 1 : 12 000

Dépôts stables au dégel : roc et dépôts meubles contenant très peu ou pas de glace

- 1a** Socle rocheux. La couche active atteint une épaisseur comprise entre 4,5 et 6 m. Seule sa structure de joints et de diaclases est susceptible de contenir une faible quantité de glace.
- 1b** Dépôt de sable et gravier en couverture mince (< 2 m) sur socle rocheux. La couche active atteint une épaisseur comprise entre 1,5 et 2,5 m. Contient de la glace interstitielle poreuse dont le contenu volumique en glace est généralement inférieur à 10 %.
- 1c** Dépôt de sable et gravier stratifié épais (> 2 m). La couche active atteint une épaisseur comprise entre 1,5 et 2,5 m. Contient de la glace interstitielle et possiblement de la glace sous forme de lentilles dans les couches de matériau à granulométrie fine. Présence probable de réseaux de polygones à coins de glace bien développés.

An analysis carried out by the Center for Northern Studies of Laval University (St-Amour et al. 2020) presents the permafrost conditions according to the surface deposits on which the various infrastructures of the village were built (Annex 1). Although a significant portion of the village sits on thaw-unstable deposits, the pumping station was erected on a thick, layered sand and gravel deposit with little ice and therefore deemed thaw stable. The same goes for the land on which the drinking water treatment plant is built. Built on the bedrock, the building is not at risk of structural damage following freeze/thaw permafrost.

However, the access road of a little less than 5 km connecting the location of the drinking water intake to the rest of the village crosses land made up of unconsolidated deposits containing a lot of ice, deposits considered unstable during the thaw. Thermokarstic subsidence has already caused minor damage in the village, so it is not excluded that such an event could affect the access road to the pumping station and the supply and recirculation pipes that connects it to the pumping station. However, the amplitude of such movements is unlikely to be sufficient to cause a serious pipe break in the foreseeable future. It would be useful to reassess the situation in 5 years with the data (permafrost temperatures) that will be available for analysis at that moment.

Finally, still according to the report of St-Amour and co-authors, neither the area of the village which hosts the water treatment facilities nor the location of the water intake at the edge of the river is subject to natural and apprehended hazards that were identified by the team of scientists as part of their research (Annex 1).

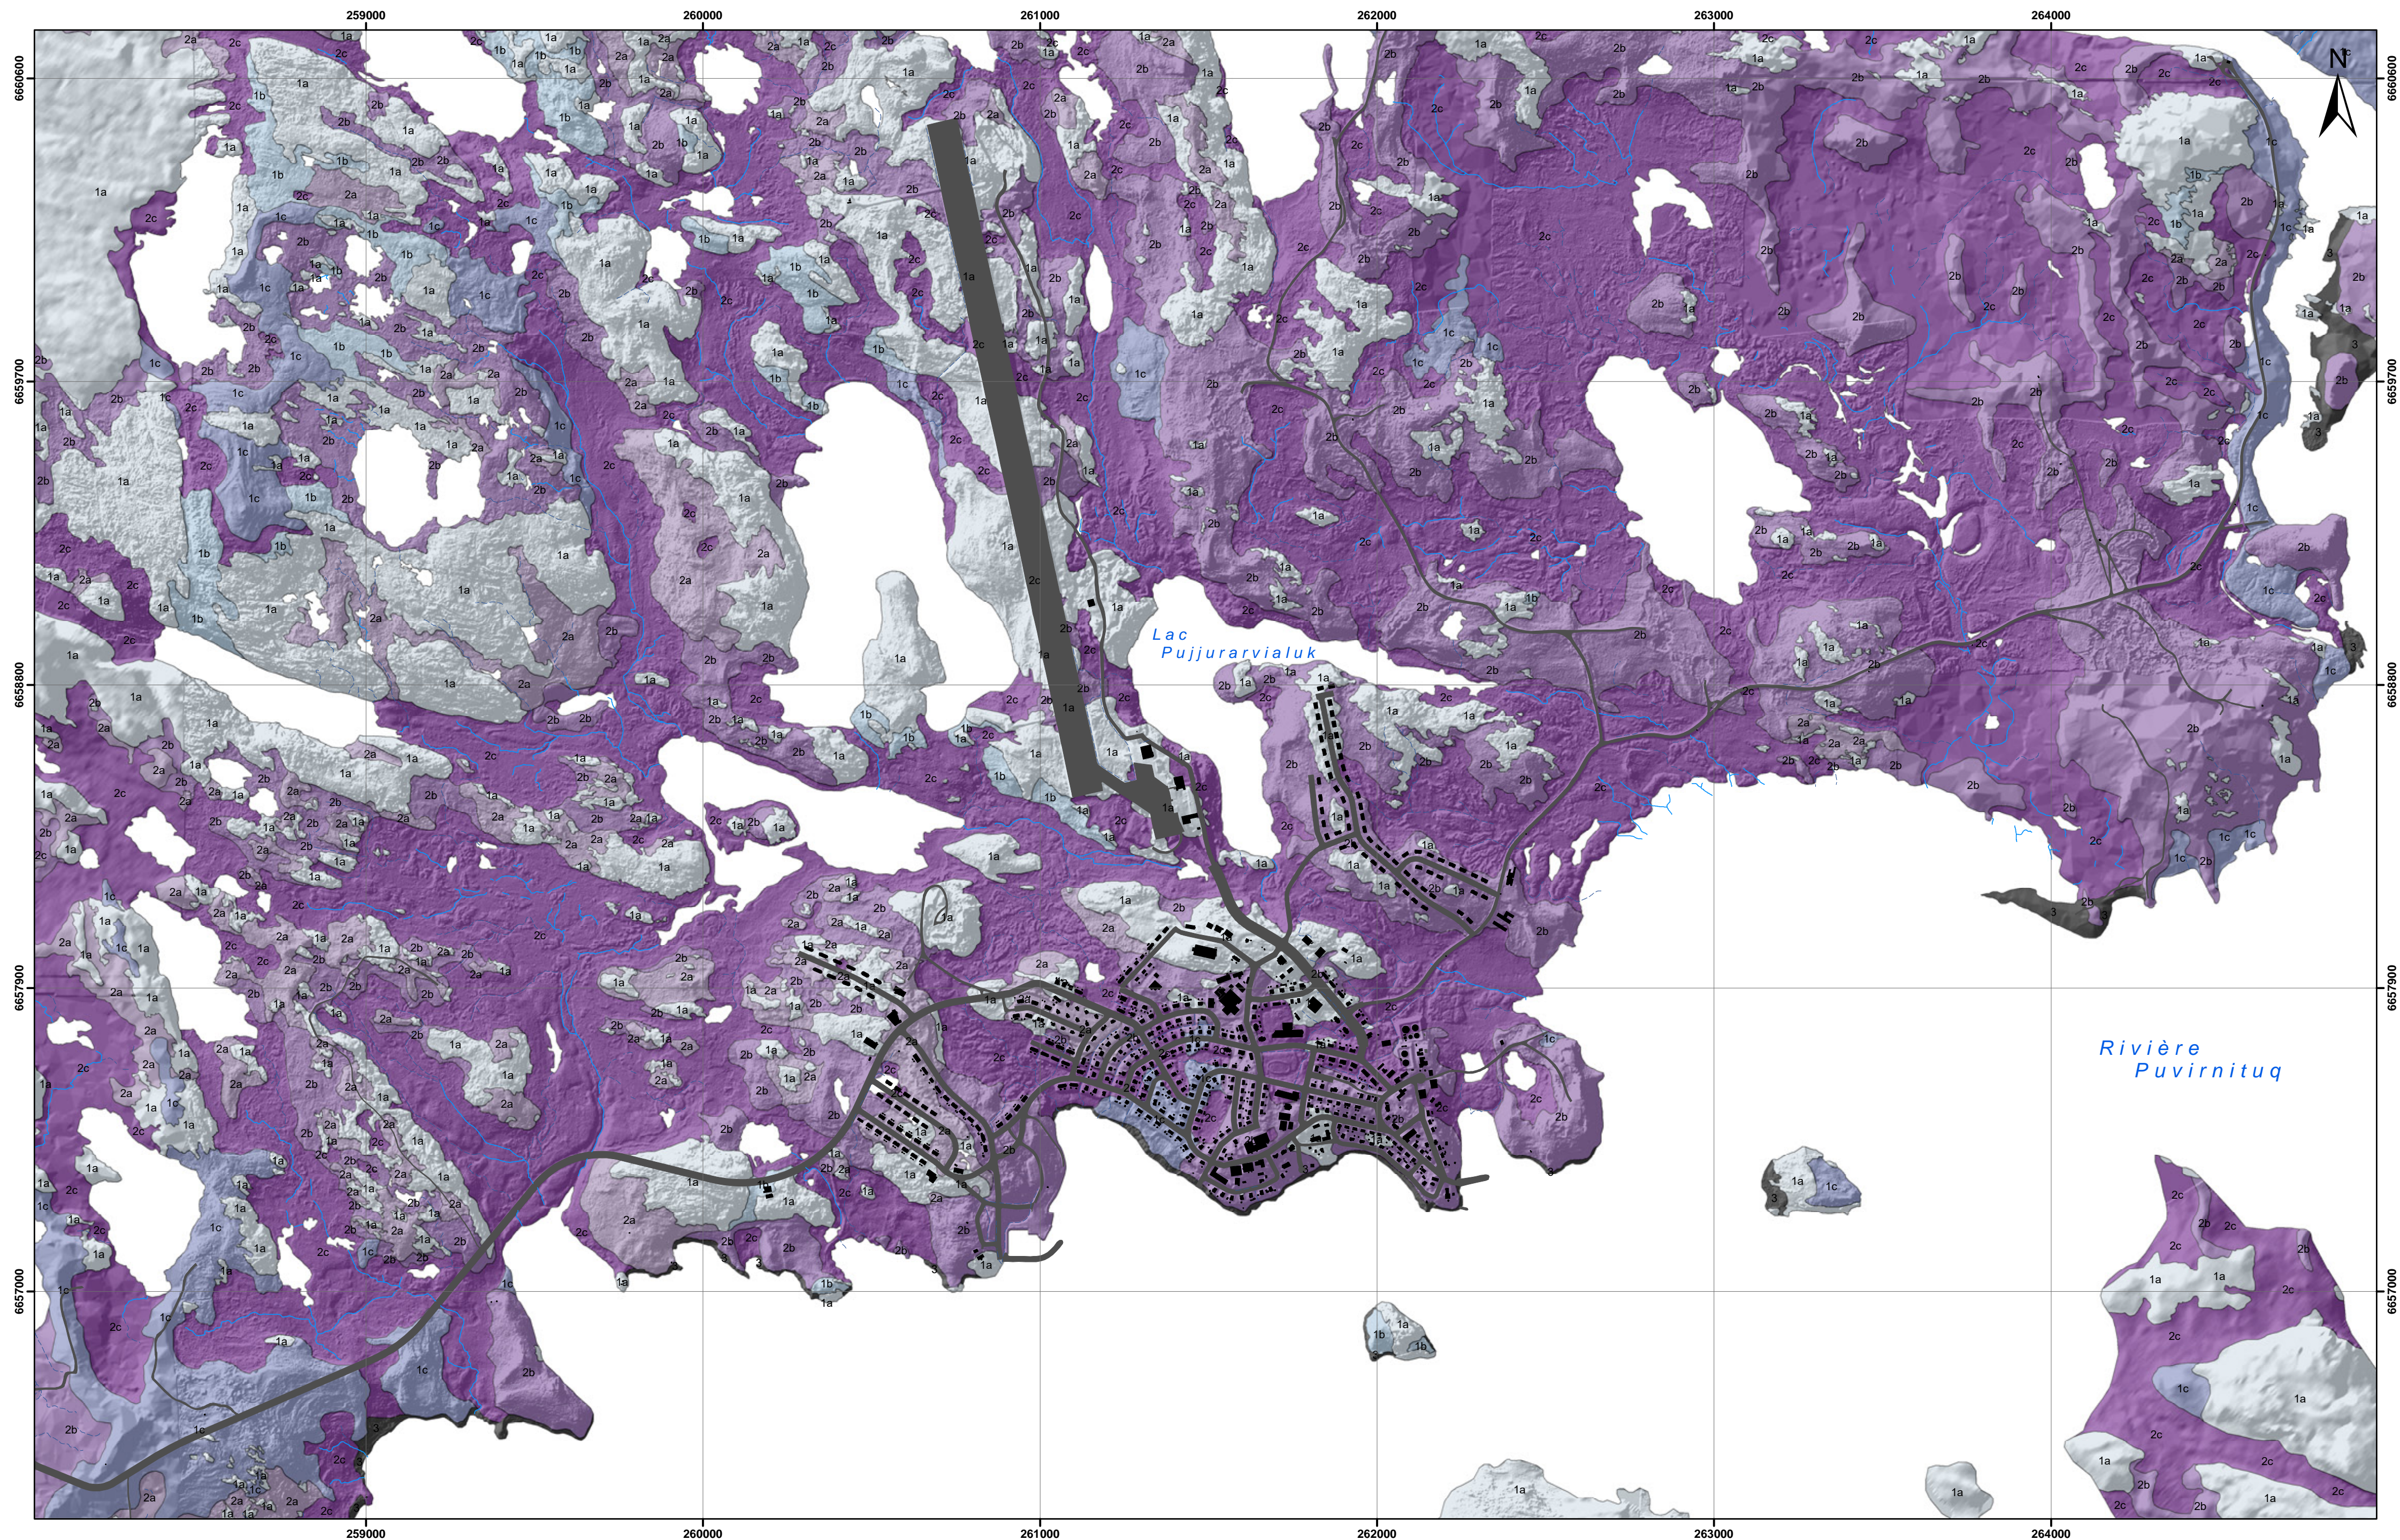
This map shows the permafrost conditions of the Puvirnituq region. This Nunavik village is located on the east shore of the Hudson Bay at the mouth of the Puvirnituq River (60.05° N ; 77.32° W).

This map was compiled mainly by air photo interpretation and validated by a limited number of terrain observations, probing and drill holes in the permafrost. Any information leading to an improvement of precision and, eventually, an update of the map will be received with thanks.

- 2c** Couvertures minces de sols organiques, de sédiments alluviaux, de sédiments littoraux ou de sédiments lacustres sur des sédiments marins fins d'eau profonde (sable fin, silt et argile). Dépôts mal drainés pouvant atteindre plus de 7 m d'épaisseur. La couche active atteint une épaisseur comprise entre 0,5 et 1,5 m. Contient beaucoup de glace de ségrégation dont le contenu volumique dépasse régulièrement 30 % et peut atteindre près de 100 %. Surface fréquemment recouverte d'ostioles. Matériau sujet à des tassements différentiels importants et à des ruptures de pente sur les versants lors de sa fonte.
