Northern Village of Salluit

**VULNERABILITY ANALYSIS OF
THE DRINKING WATER
SOURCE**

WATER INTAKE N° X2114282 OF
SALLUIT

Project 21-0056

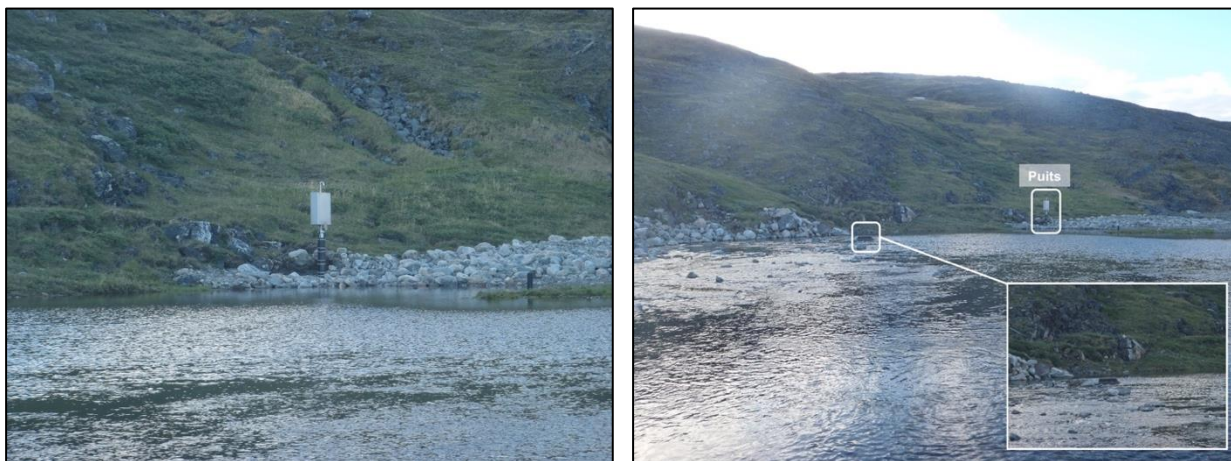
Photo 1. Dated July 26, 2013. Vertical well in the Kuuguluk river, at the level of the artificial basin (Source: KRG)

Photo 2. Dated July 26, 2013. Closed piezometer well in the water retention basin (adapted from KRG's photos)

The installations at the water intake are as follows: a vertical well with a total length of 24 m and a diameter of 15 cm allows water to be taken from under the riverbed, at a depth of 6.84 m using a submersible turbine pump (Berkeley SL70G4). In the well, the pump is located just before the fracture in the rock that connects the groundwater table to the river retention basin. A second closed well is located nearby in the retention basin of the river and serves as a piezometer (photo 2) to monitor the level of drawdown of the exploited water table. The end of the well ends with a rectangular box to accommodate the electrical connections, then with a waterproof cover and a swan neck vent itself covered by an anti-vermin screen (photo 1 and annex 3).

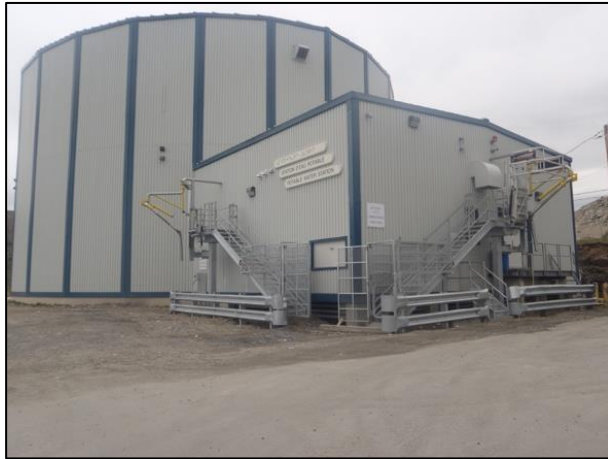
Photo 3. Dated July 26, 2013. Salluit drinking water treatment and distribution station (Source: KRG)

The Salluit water pumping and treatment station is located on Aqutikutak Street (map 1 and photo 3), 2.2 km from the intake in the Kuuguluk River, at the following geographic coordinates :

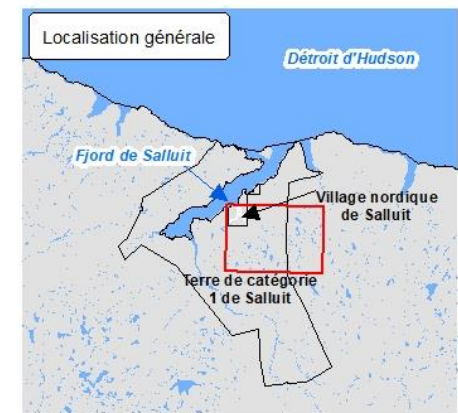
CARTE 2
Aires de protection de la prise d'eau

- Prise d'eau
 - Usine de traitement des eaux
 - Bassin versant
 - Limite des municipalités
- Zone de protection**
- Zone de protection immédiate
 - Zone de protection intermédiaire
 - Zone de protection éloignée
- Hydrographie**
- Cours d'eau
 - Plan d'eau
 - Sens d'écoulement

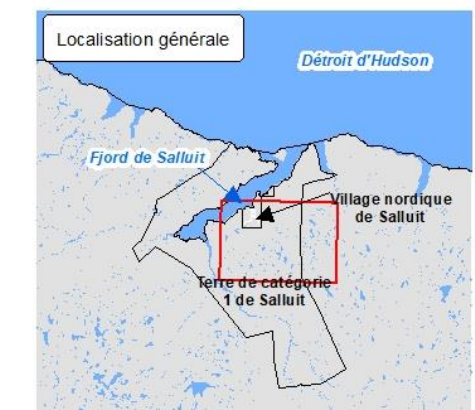
CARTE 3
Vue d'ensemble du bassin
versant de la rivière Kuuguluk

- Prise d'eau
 - Usine de traitement des eaux
 - Banc d'emprunt
 - Bassin versant
 - Limite des municipalités
 - Zone de protection intermédiaire
 - Zone de protection éloignée
- Hydrographie**
- Cours d'eau
 - Plan d'eau
 - Sens d'écoulement
