Surface water intake vulnerability analysis report for the Northern village of Akulivik

Water intake number: X2114284

January 2025

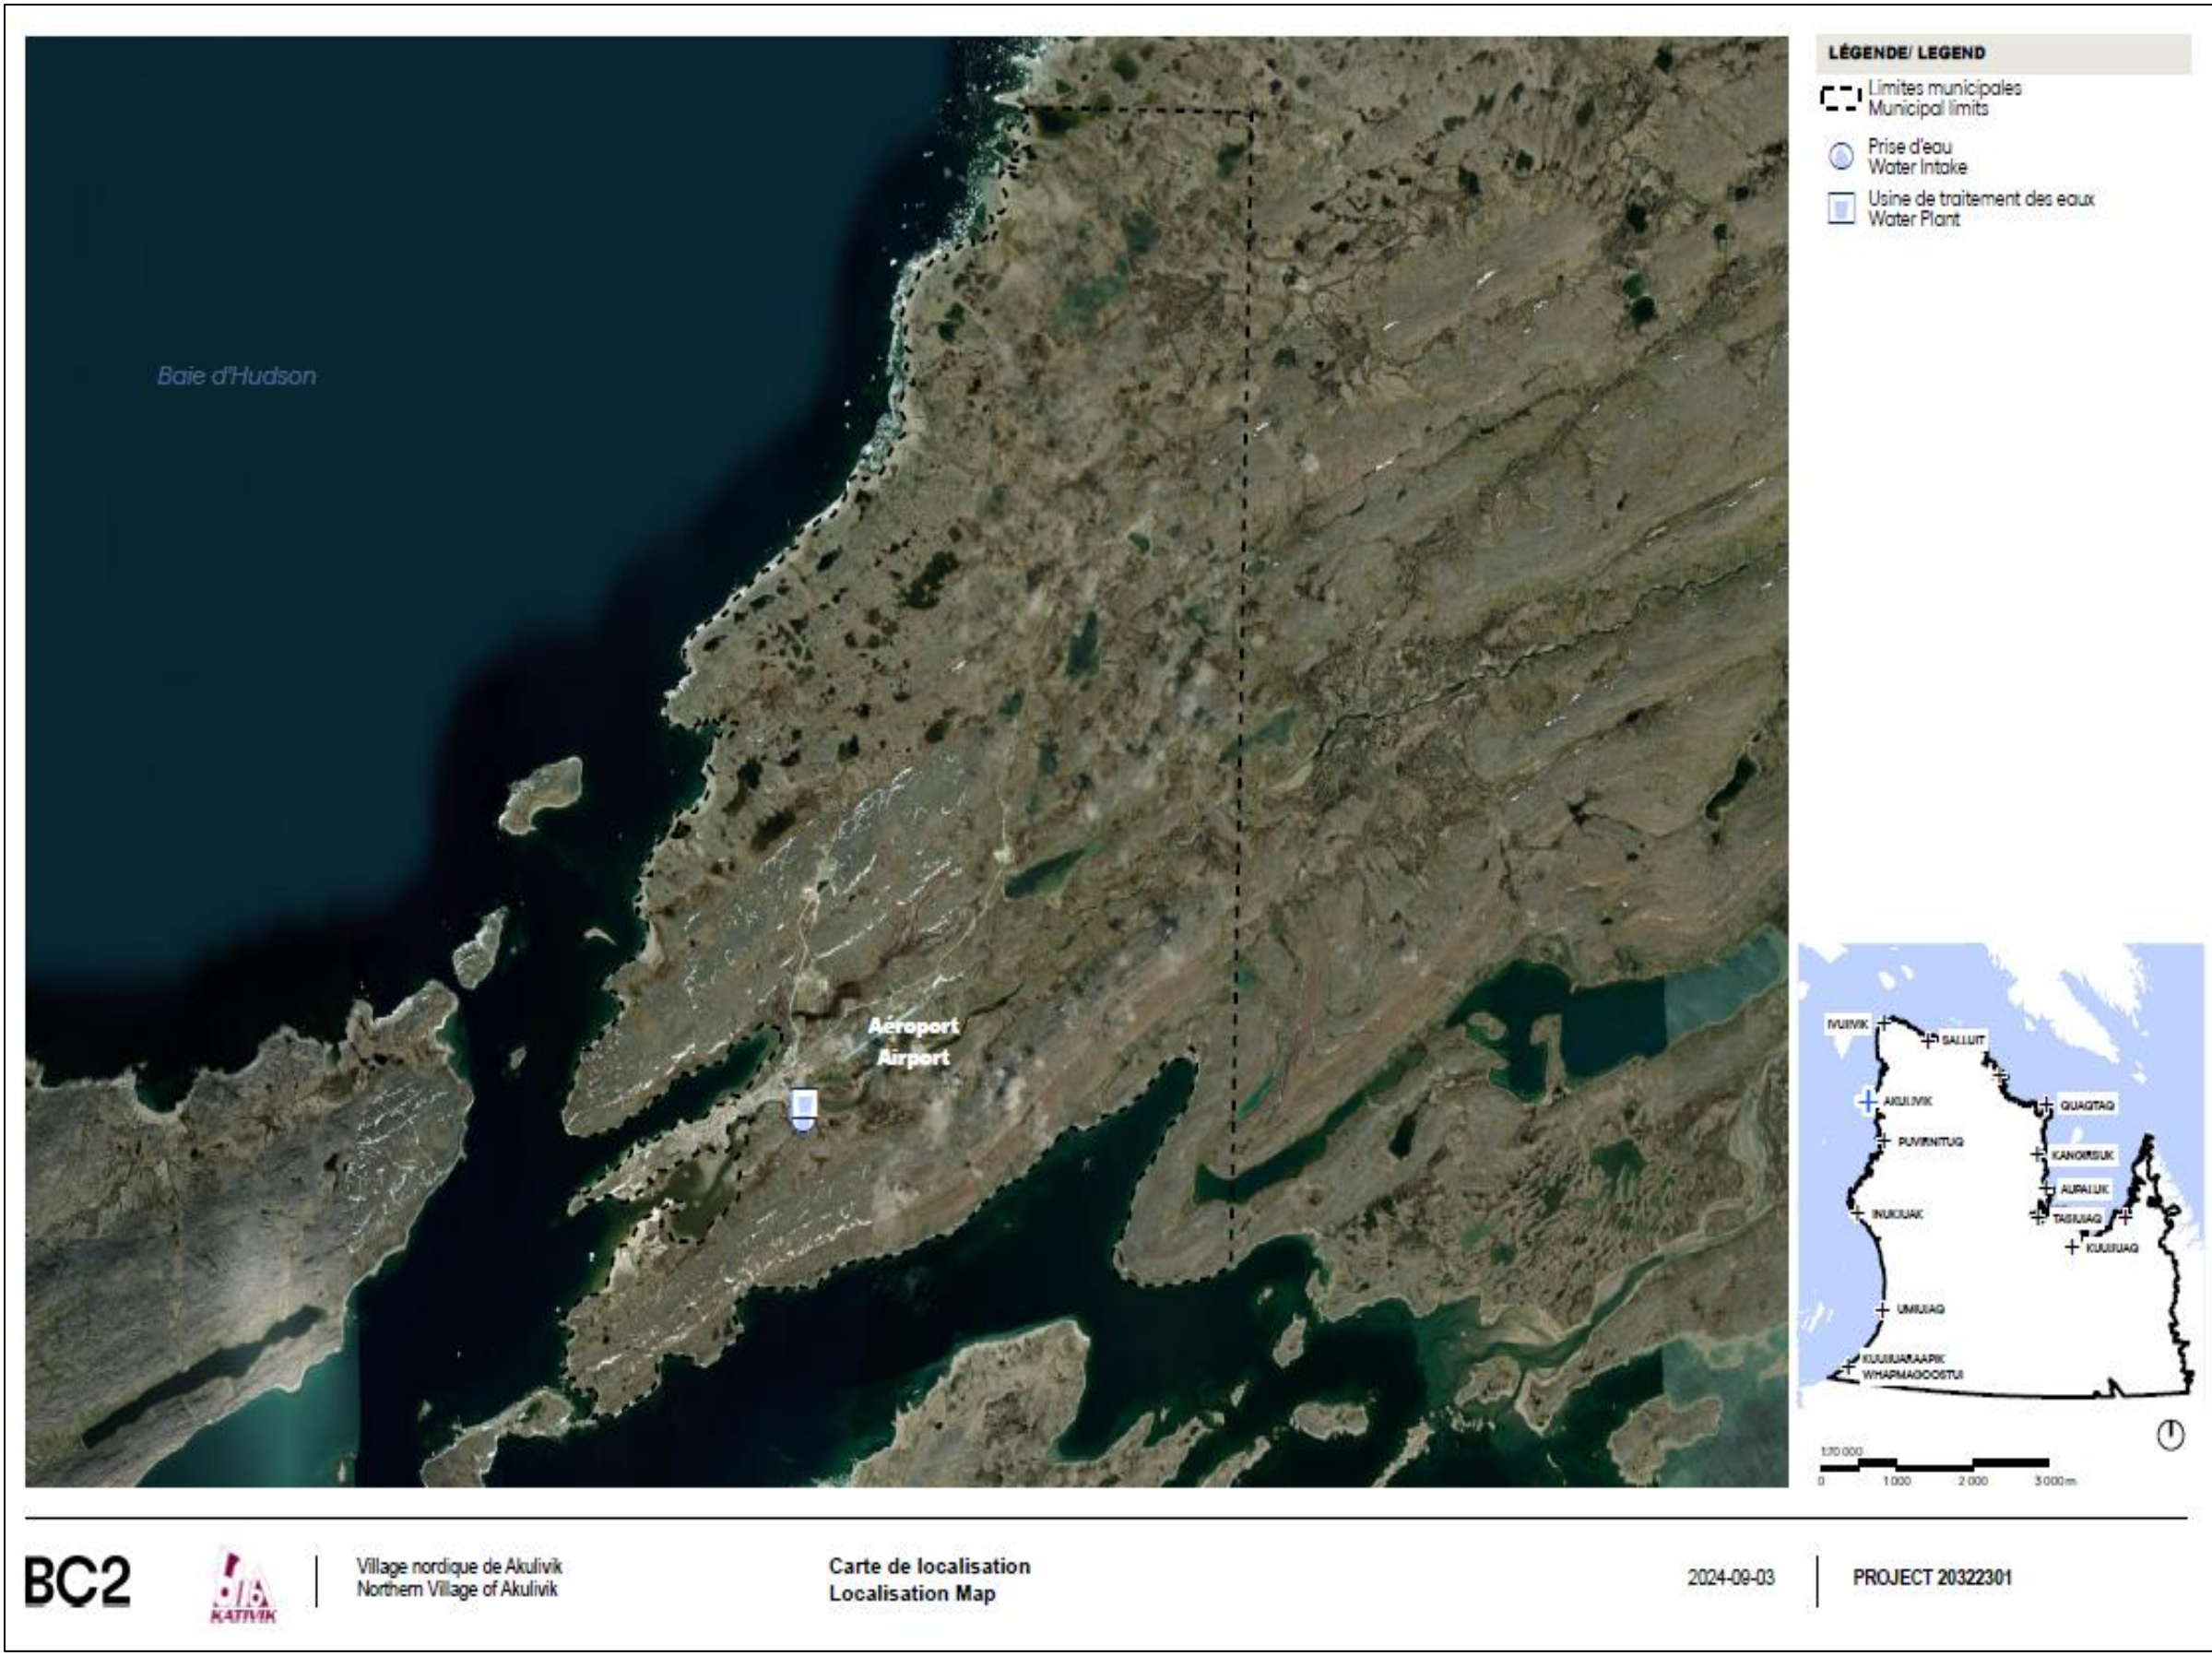
Figure 2. Localisation map for the Northern village of Akulivik

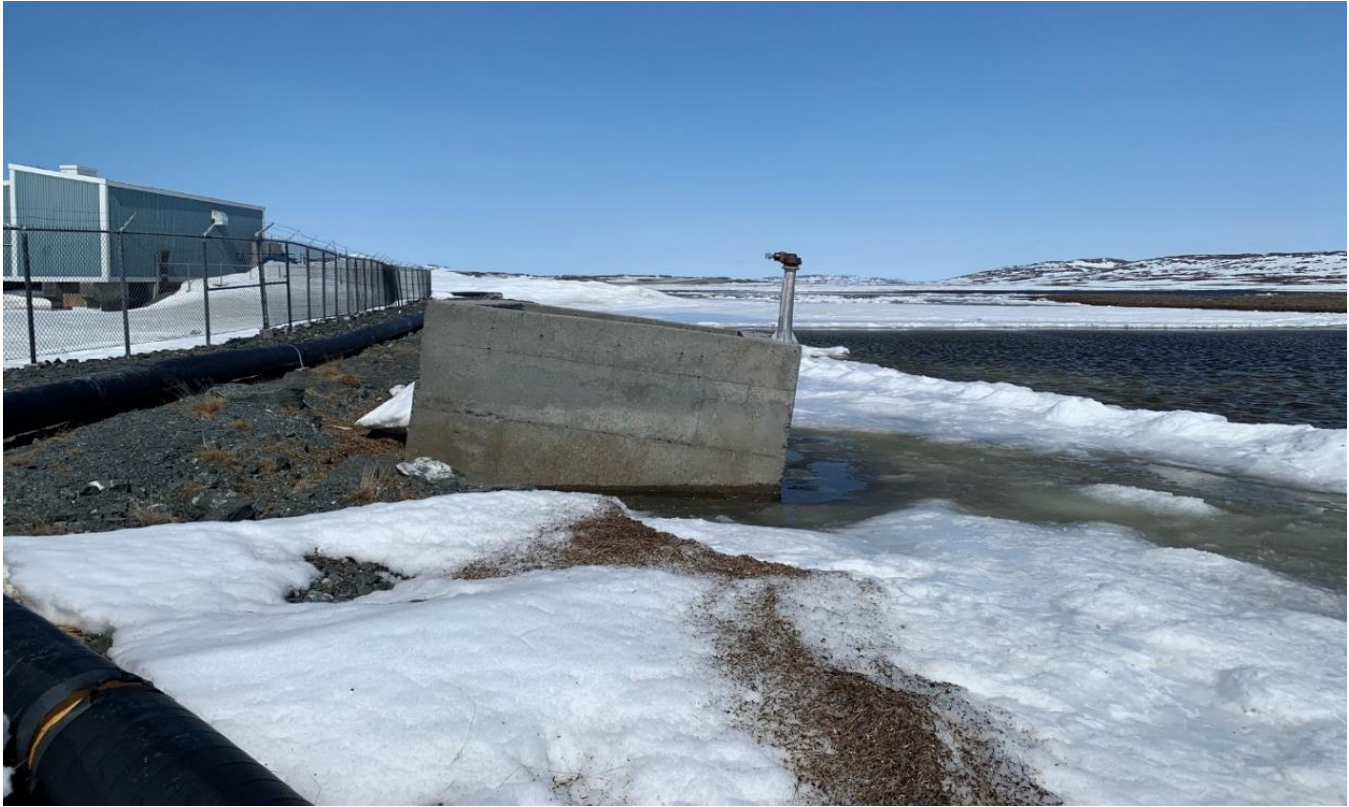
The Northern village of Akulivik draws its drinking water from the Illuktotat River. Water is pumped directly from the river into an outdoor reservoir. Figure 3 shows the caisson housing the water intake pipe that carries raw water from the river to the outdoor reservoir. In the same photo, the reservoir can be seen on the left, with the drinking water treatment plant behind it. The raw water reservoir is continuously filled via the water intake valve. A culvert connects the reservoir to the river, regulating the water level when the reservoir reaches full capacity.

Figure 3. Protective caisson for the water intake pipe on the bank of the Illukotat River. Photo taken on May 19, 2024.

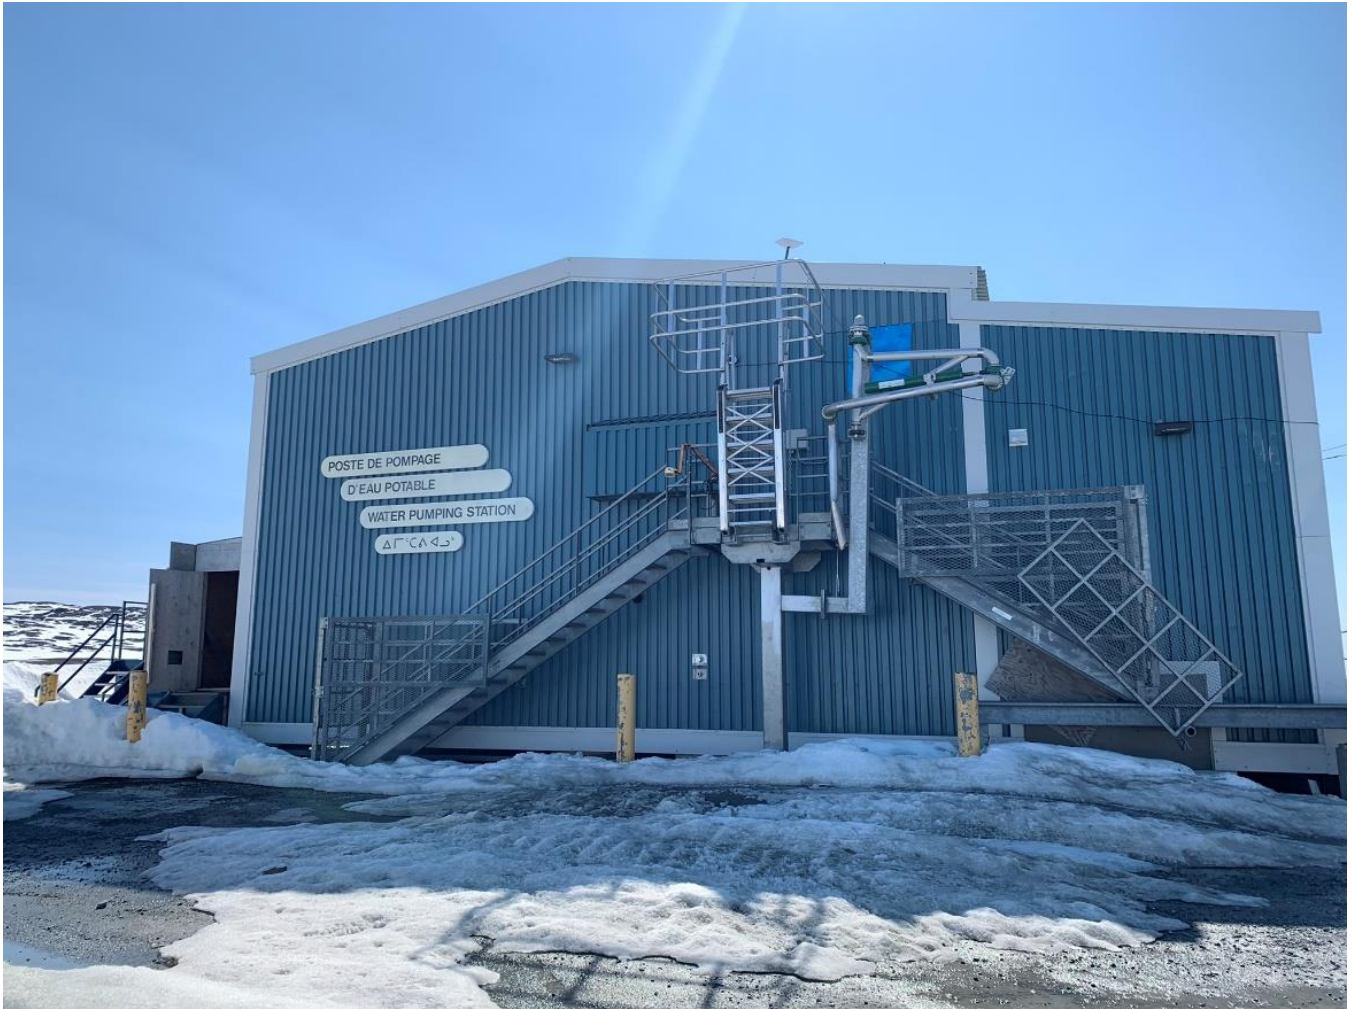
The Akulivik drinking water treatment plant was built in 1988 and completely upgraded in 2011 (see Figure 4). The water is conveyed from the outdoor reservoir (Appendix 4) to a 5-stage treatment process. The first stage consists of a multimedia filtration system, followed by a 5 µm (micron) filter cartridge. The filtered water is disinfected by chlorination (upstream of the reservoir) and then treated with UV radiation before being stored in an 80 m³ tank. A second chlorination is carried out at the reservoir outlet, just before entering the filling pipe of the tank trucks that distribute the water.

Figure 4. Exterior view of the drinking water treatment plant. Photo taken on May 19, 2024.

Current reservoir capacity does not meet fire prevention requirements. The installation of a larger reservoir is scheduled for 2026.

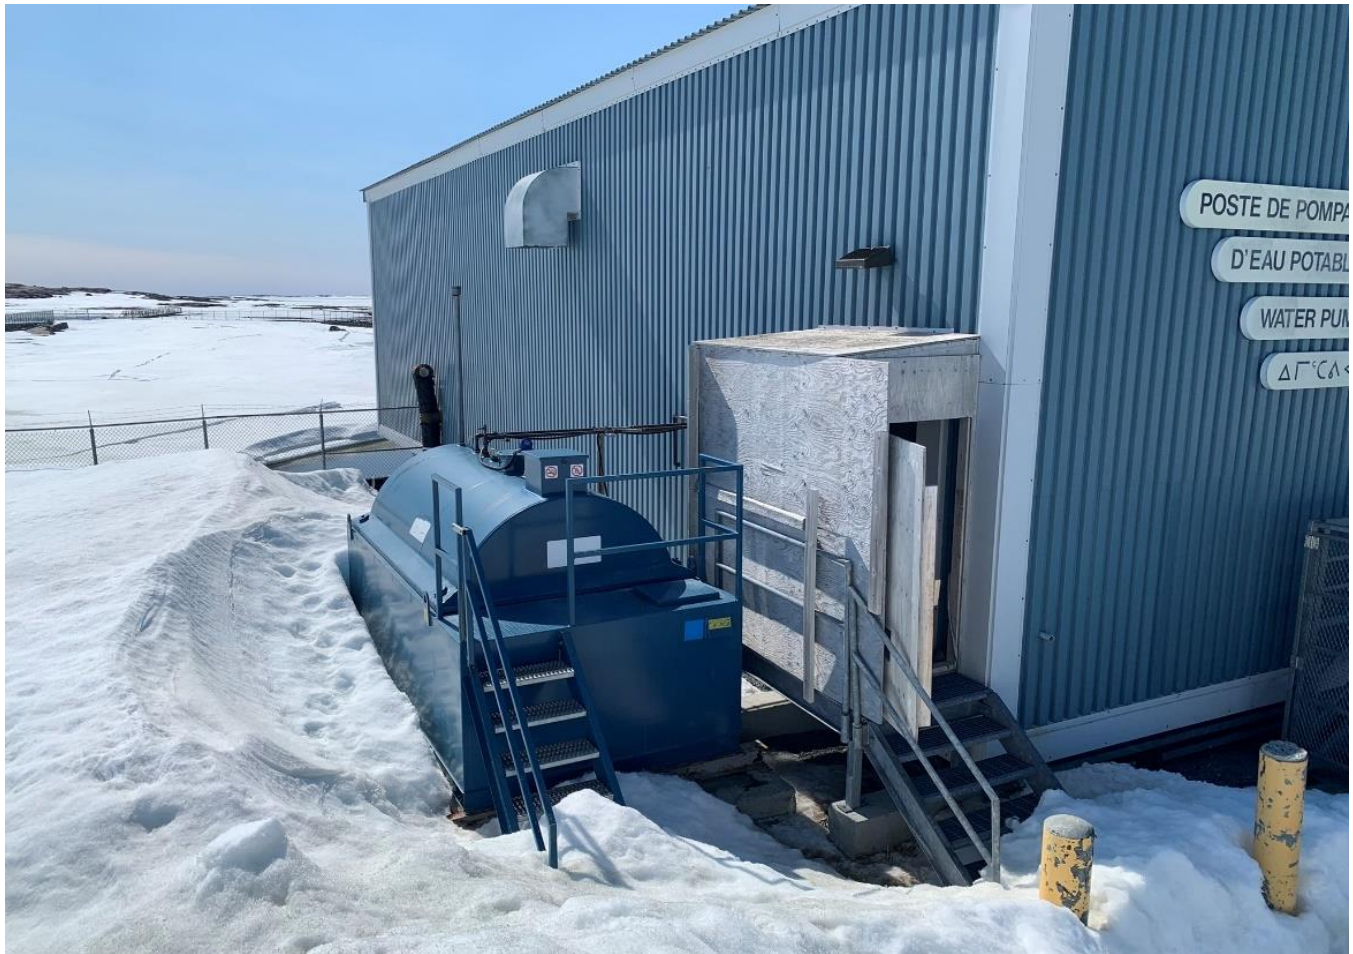
The only chemical used for water treatment and stored in the building is sodium hypochlorite. However, there is also a heating oil (diesel) tank attached to the building (see Figure 5).

Figure 5. Diesel tank attached to the Akulivik WTP building. Photo taken on May 19, 2024.
