Surface water intake vulnerability analysis report for the Northern village of Inukjuak

Water intake number: X2114289

January 2025

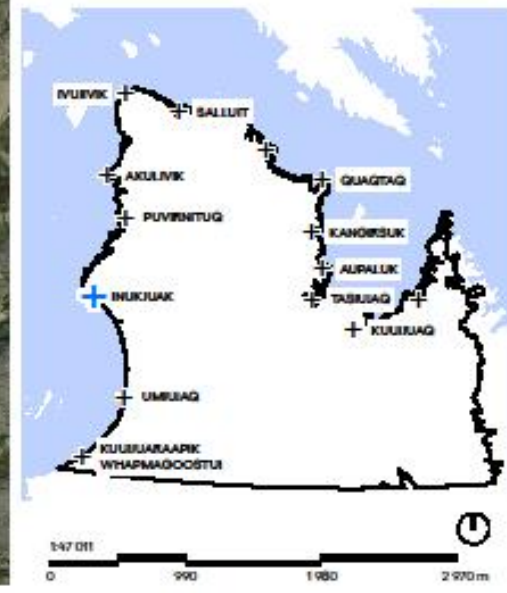
Figure 2. Localisation map for the Northern village of Inukjuak

Figure 1 is a map of the village of Inukjuak, updated by KRG in 2024. Figure 2 shows the municipal boundaries of the Northern village of Inukjuak, as well as the location of the raw water withdrawal site near the Innuksuac River and the water treatment plant in the heart of the village.

The drinking water withdrawal site is located upstream of the municipality's residential core and downstream of the Innuksuac River (Figure 2). The water is piped to the drinking water treatment plant via a 6-inch-diameter, 3 km-long heated pipeline. The pumping station (Figure 4) is powered by a diesel furnace. Attached to the building is a 10,000 L tank, installed in 2009 (shown in blue on Figure 5). The general condition of the building is good, although some clutter was observed inside the pumping station (Figure 6).

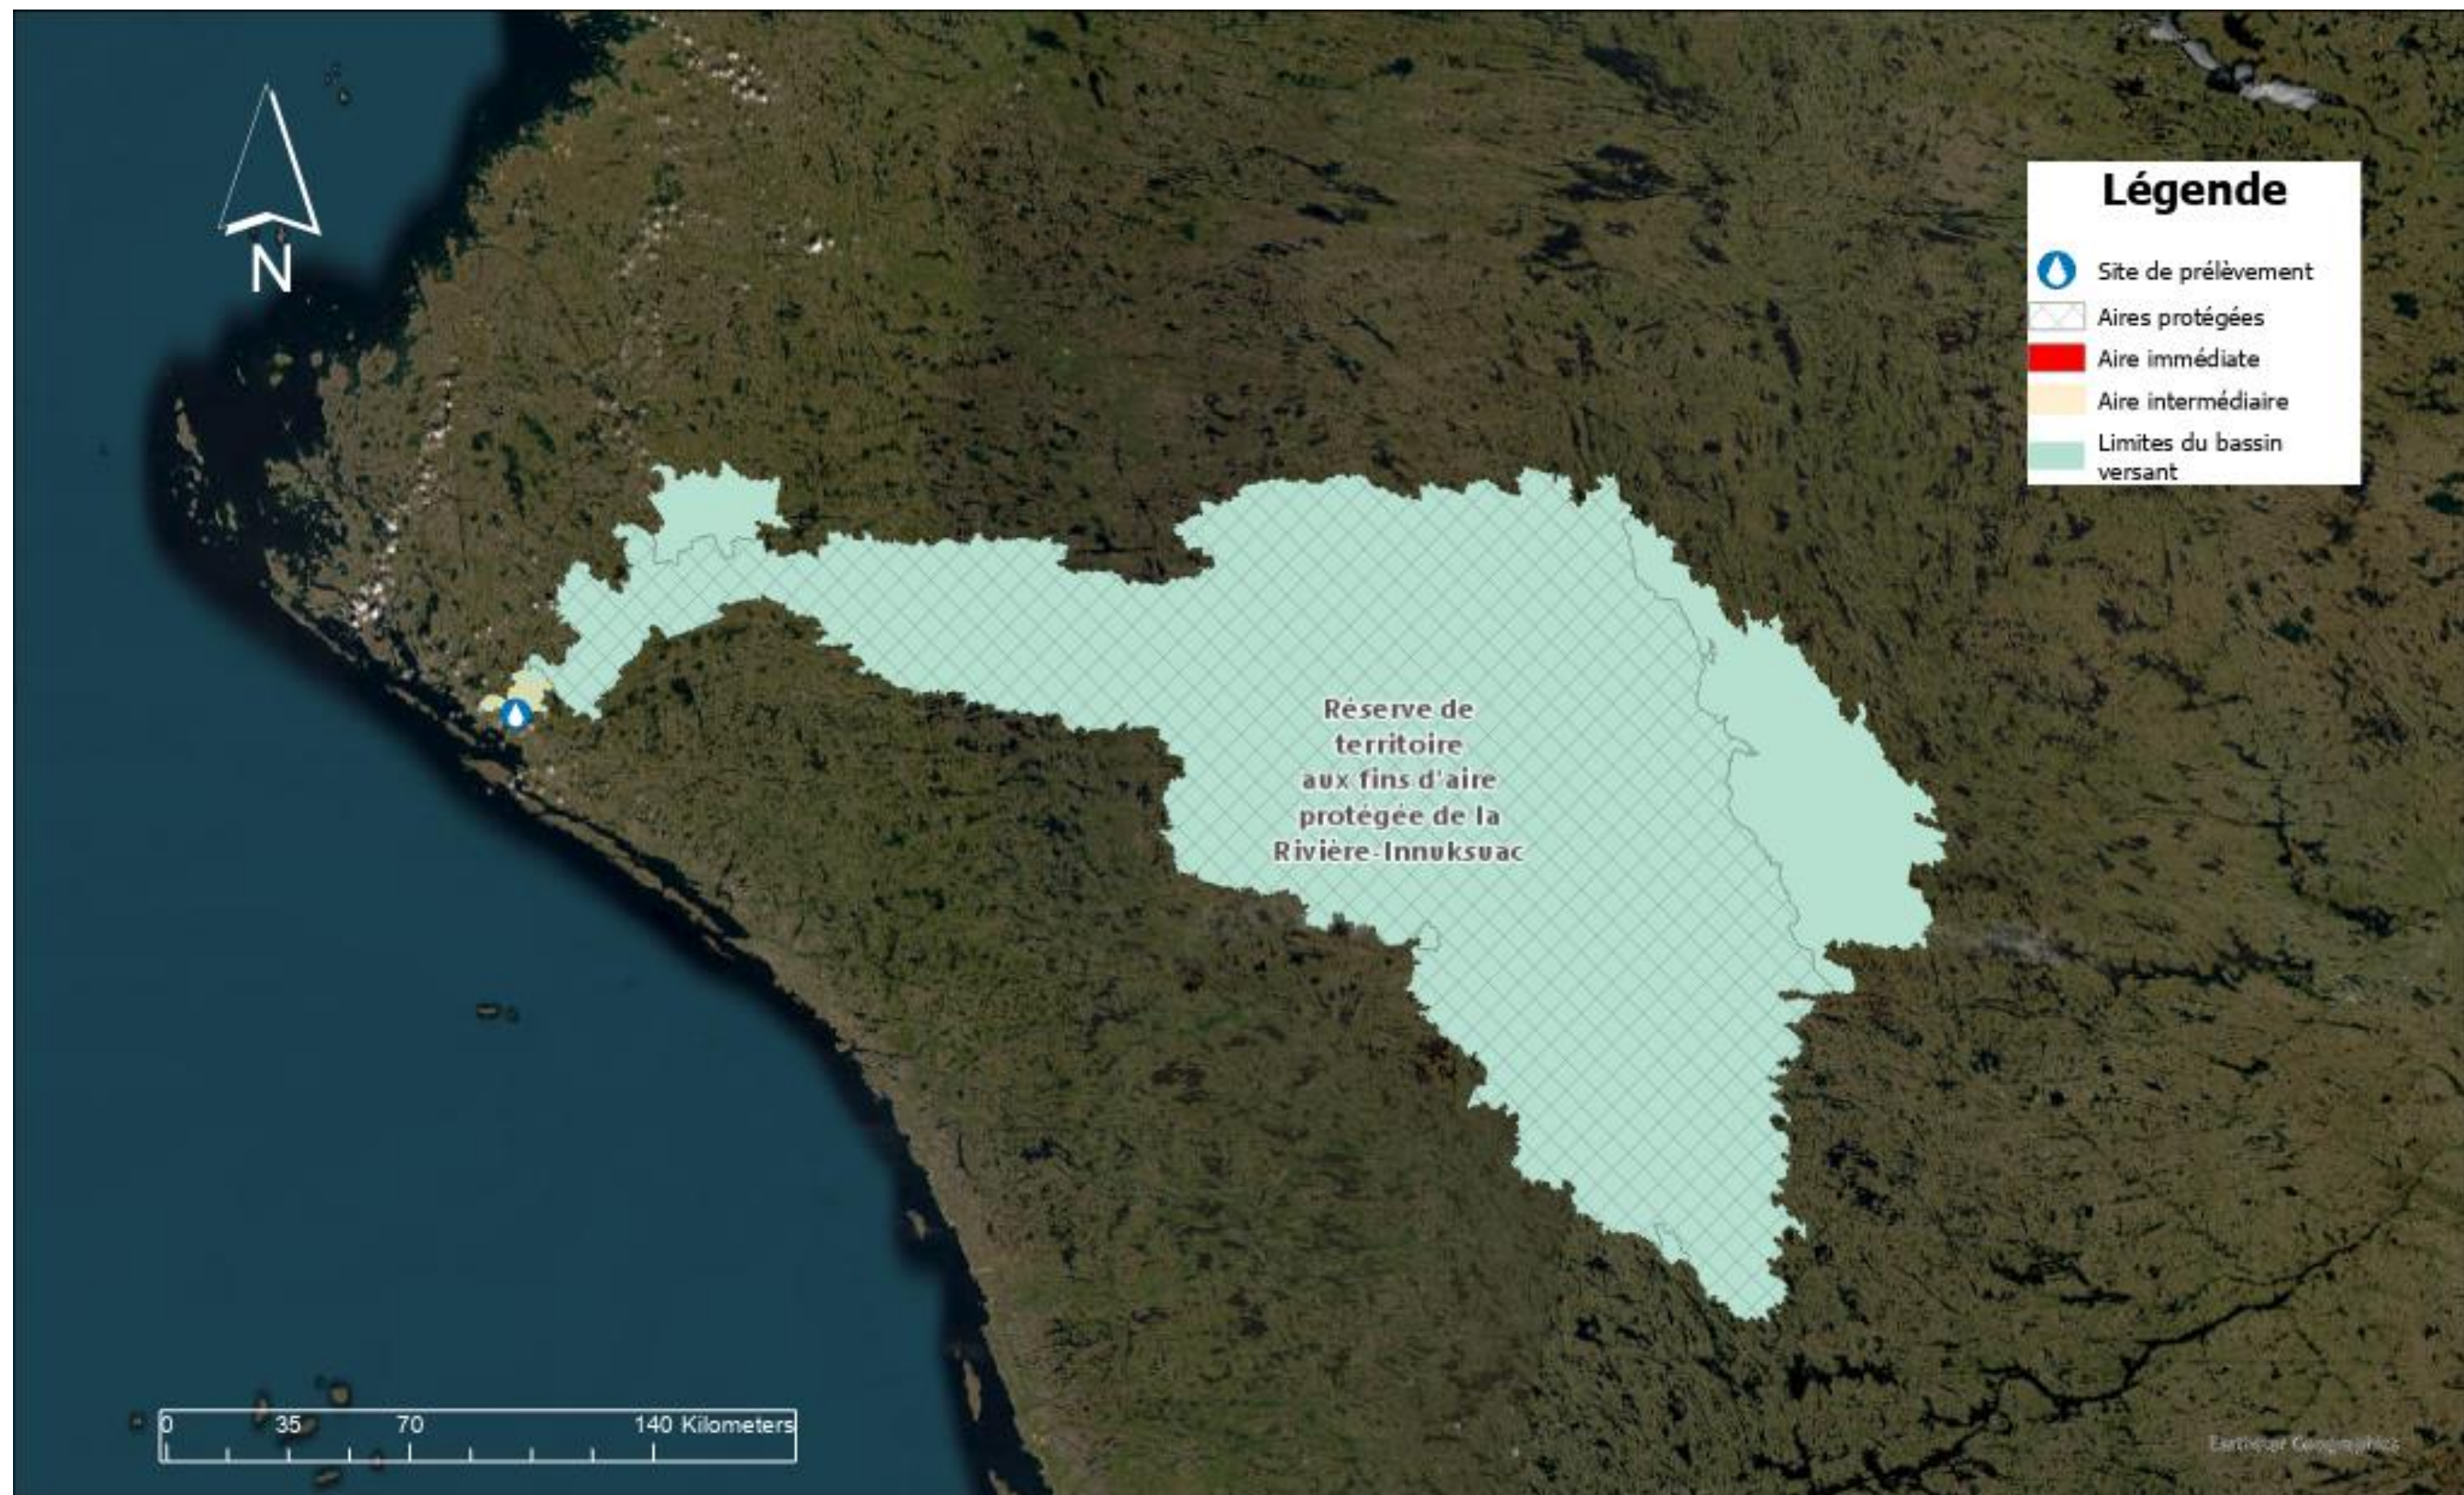
Figure 3. Outer protection zone (Innuksuac River watershed)

Since 2020, most of the Innuksuac River watershed has been included in the *Rivière-Innuksuac territorial reserve for protected area purposes* (Figure 3) [7]. The legal status of *Biodiversity Reserve* prevents, among other things, all exploration and development activities associated with the forestry and mining industries. The map below illustrates the overlap between the watershed and the protected area (Figure 3). This initiative is a significant protective measure for the municipality's water supply source.

Outer protection zone (s. 74): The catchment area of the withdrawal site and the portion of the intermediate protection zone located downstream of the withdrawal site. This includes surface water and the entire territory within the boundaries of the catchment area.

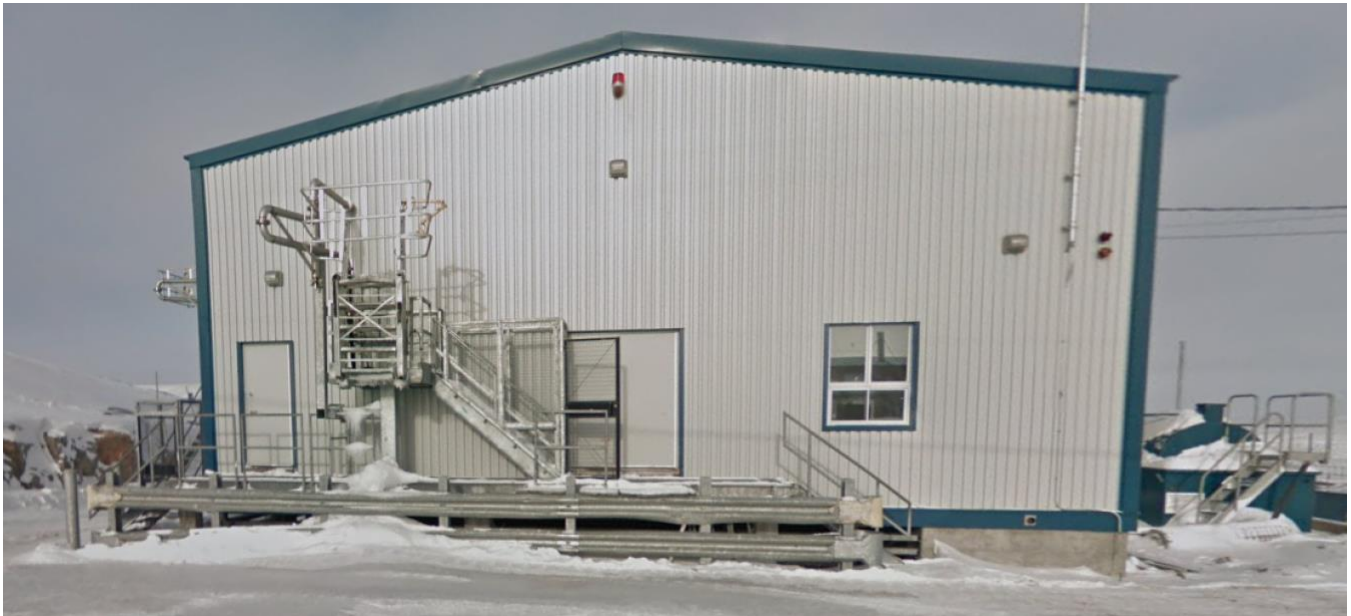
Figure 7. Inukjuak drinking water production facility (Photo: Google Earth)

The Inukjuak drinking water treatment plant was built in 1992 and upgraded in 2013 (**Error! Reference source not found.** and **Error! Reference source not found.**) [9]. The treatment system consists of three granular (activated carbon) filtration systems installed in parallel, followed by filter cartridges. The filtered water is then disinfected with UV lamps. From there, a pipe carries the water to the community tap outside

the building, and another pipe carries the water to a second disinfection unit that uses sodium hypochlorite. The treated water is finally stored in three 90 m³ tanks before being loaded onto tank trucks.

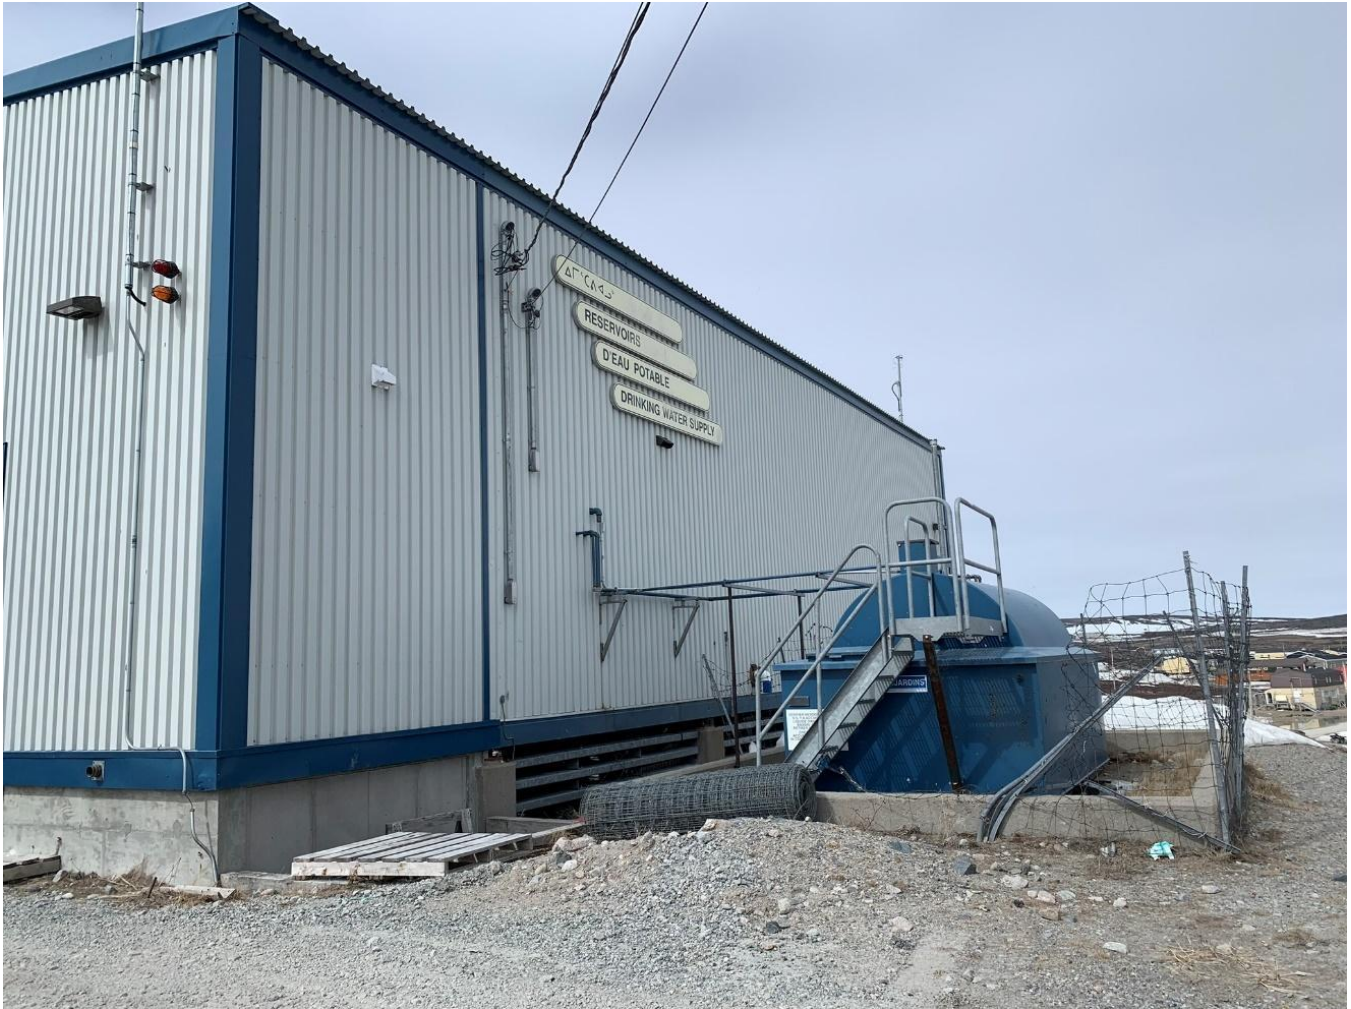
Figure 8. South face of drinking water production building with view of oil tank (photo taken on May 16, 2024)

The only chemical stored in this building is sodium hypochlorite.

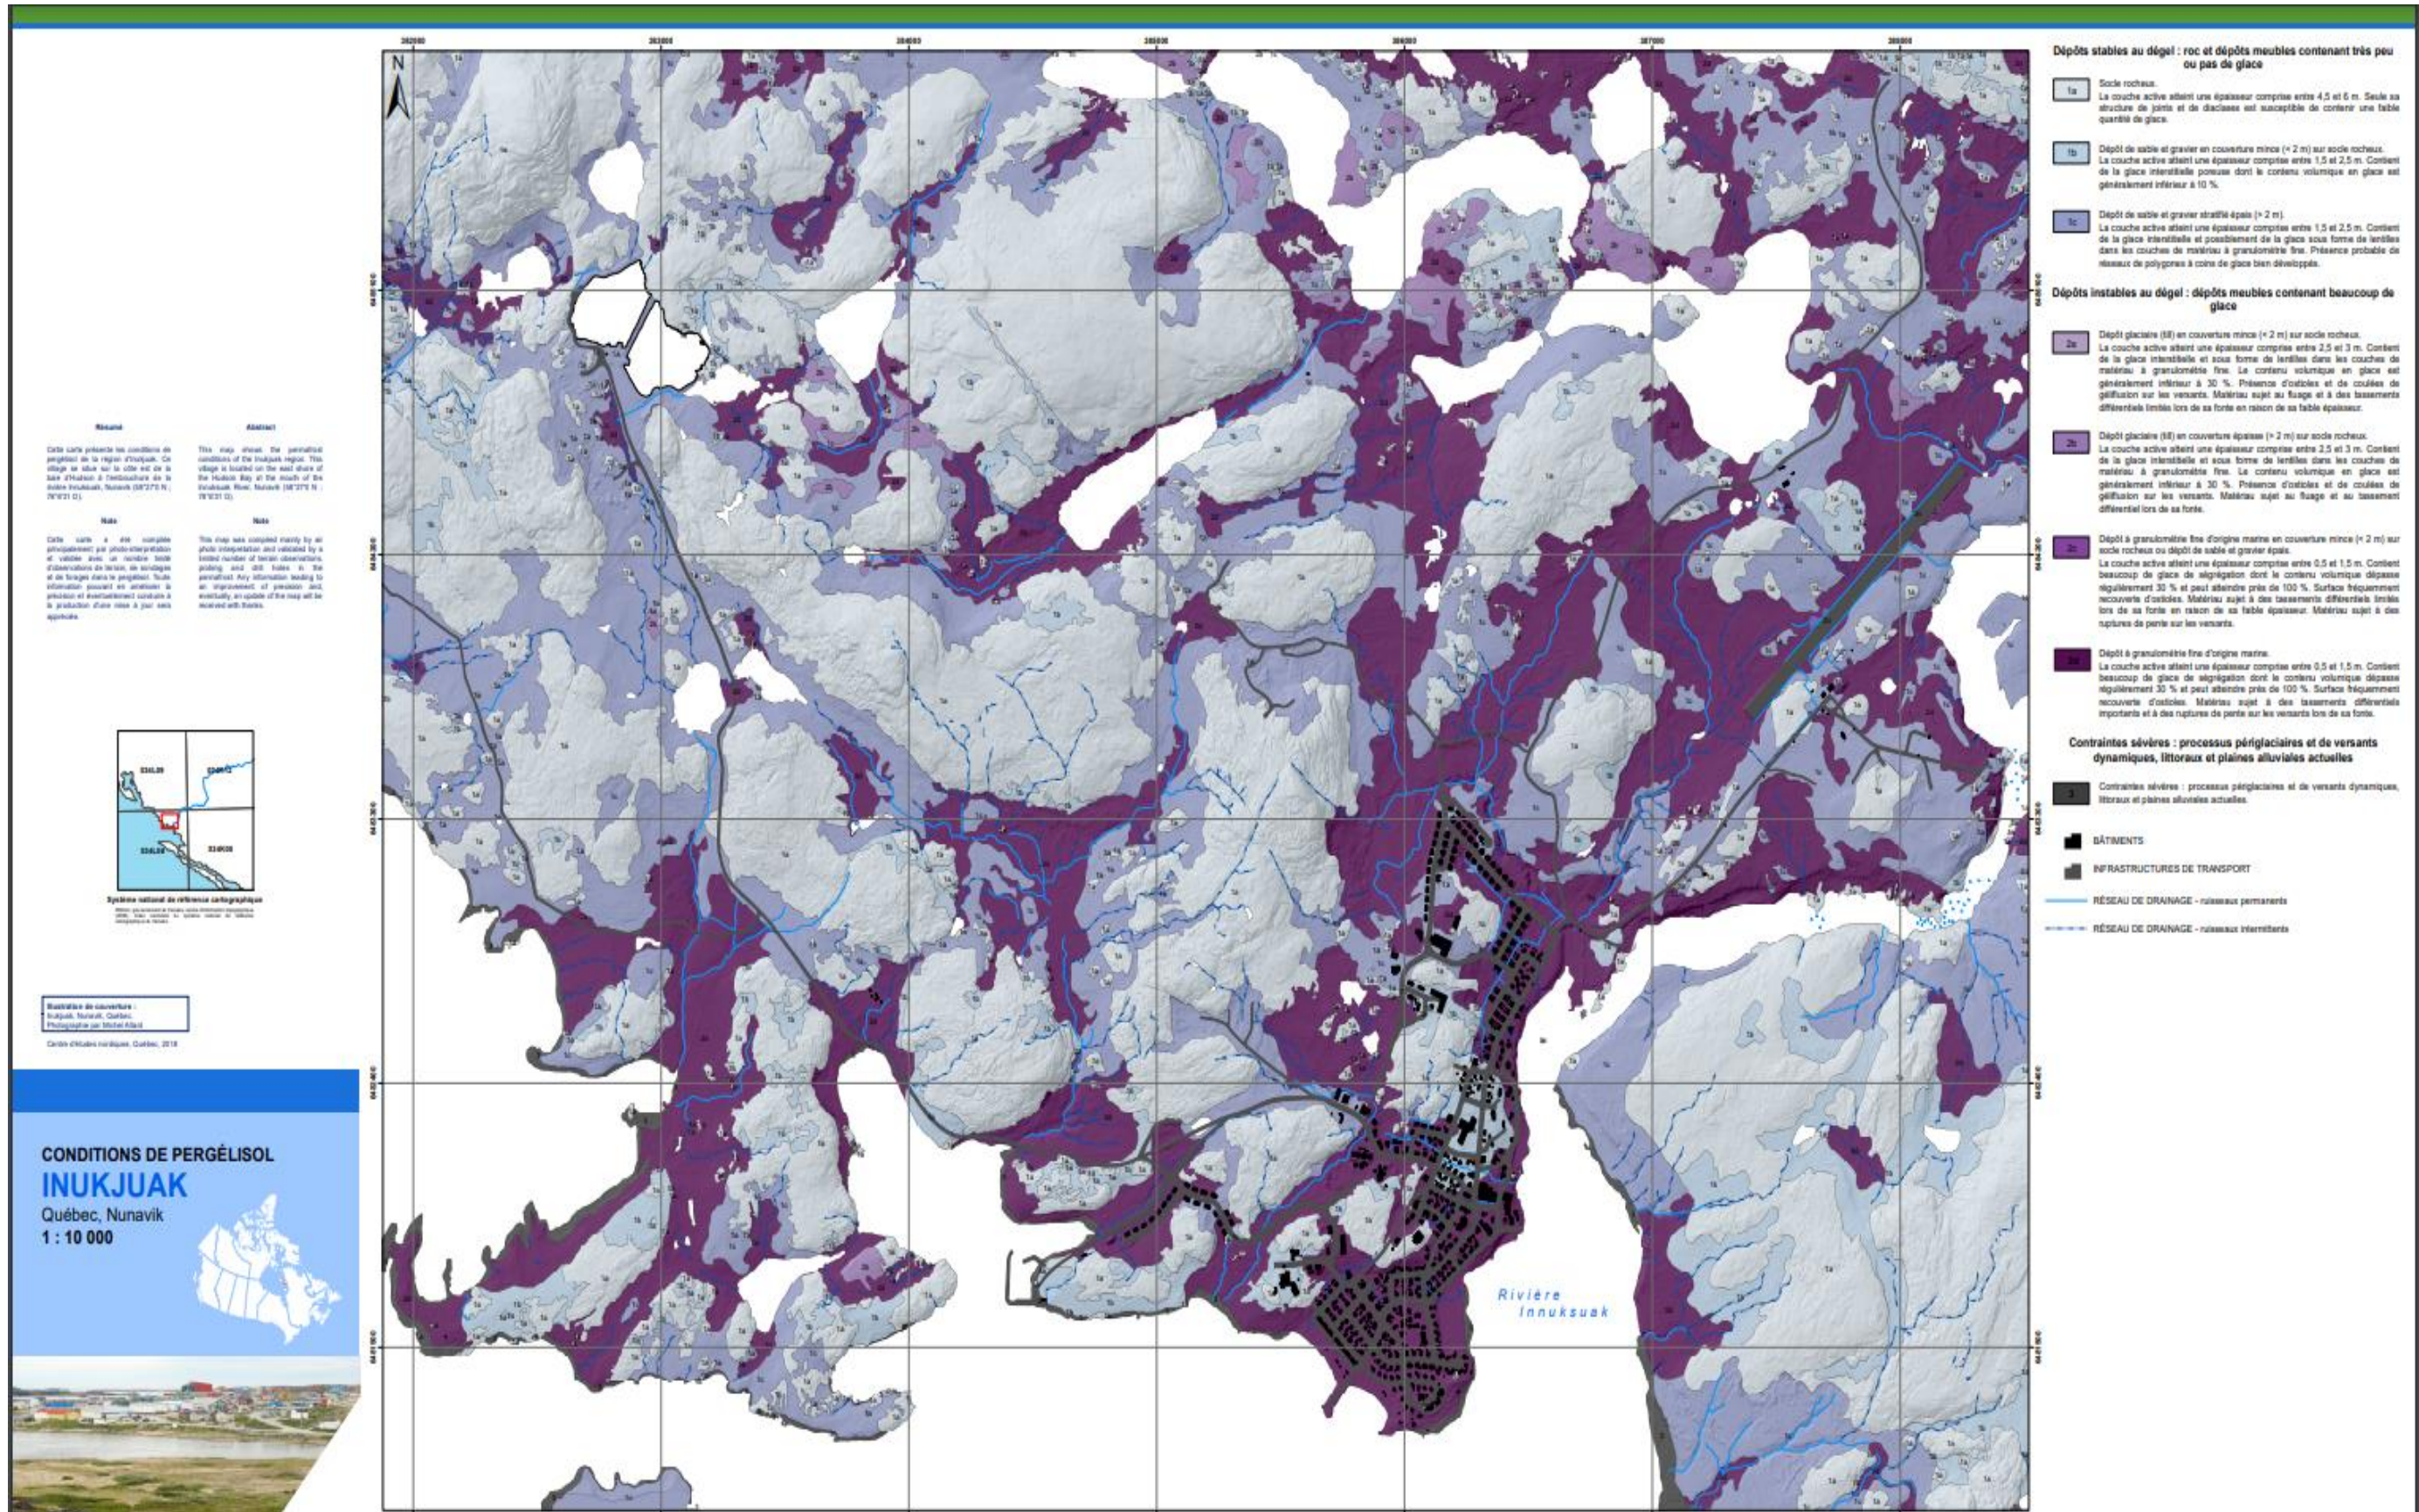
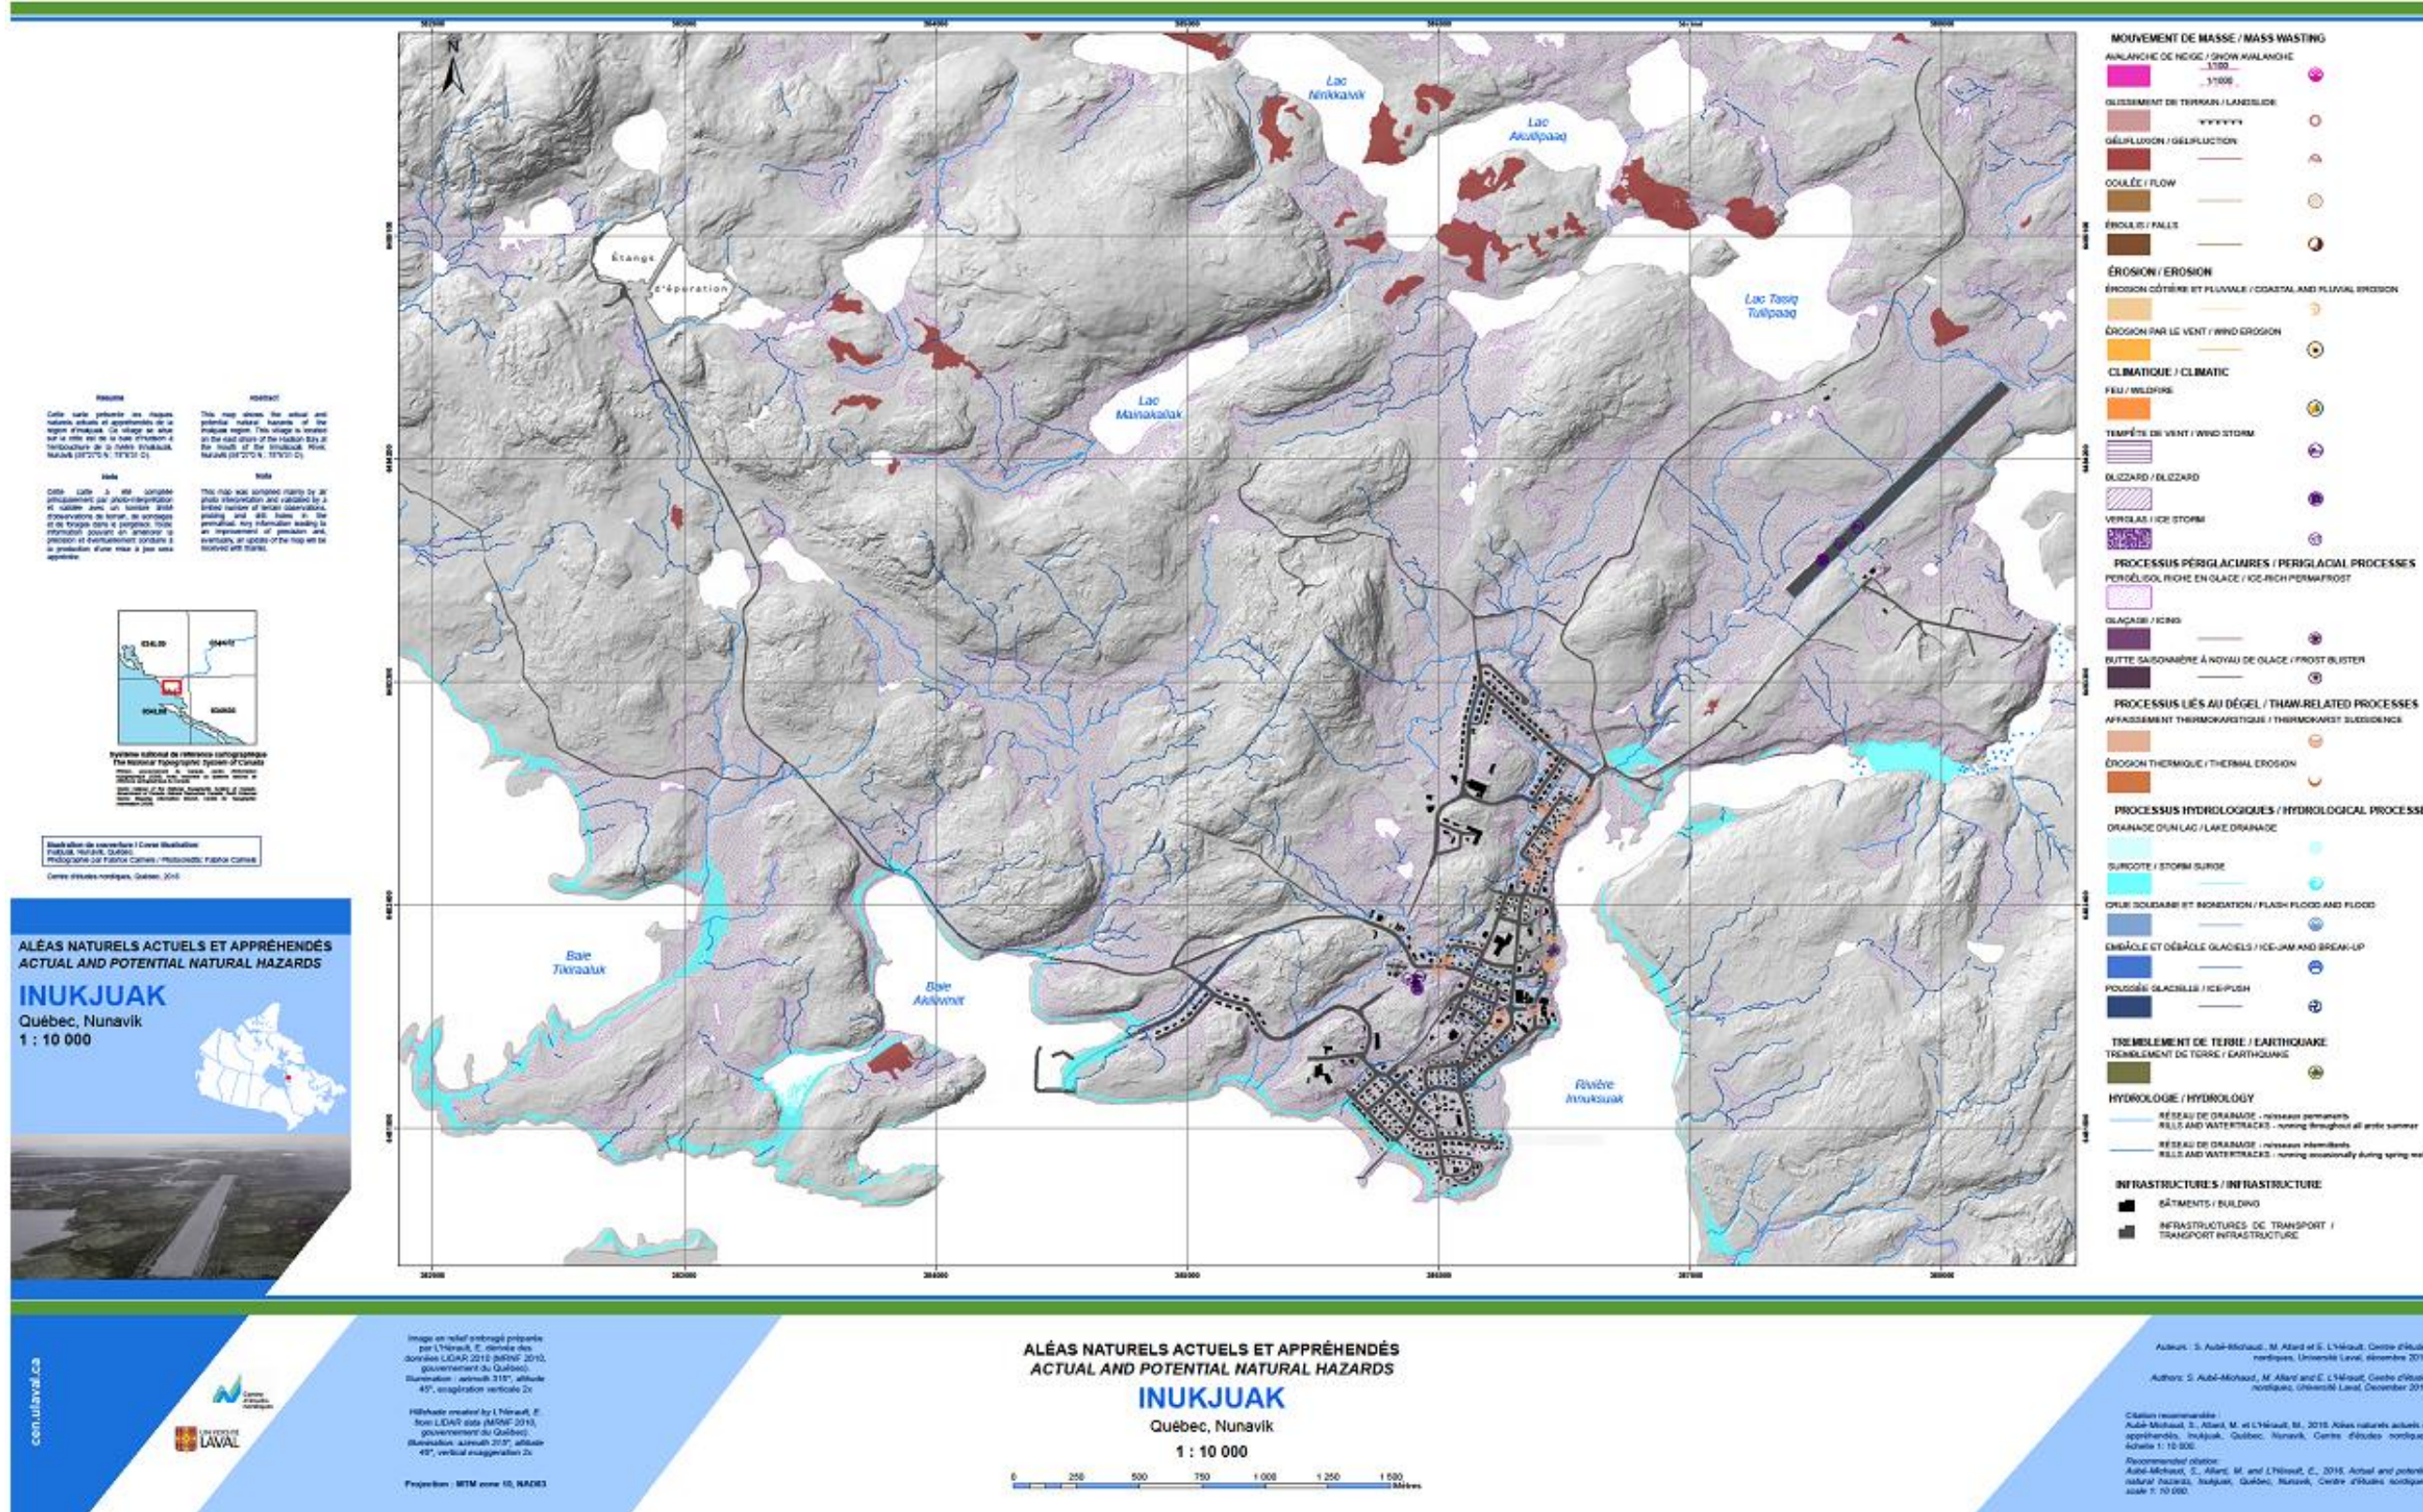
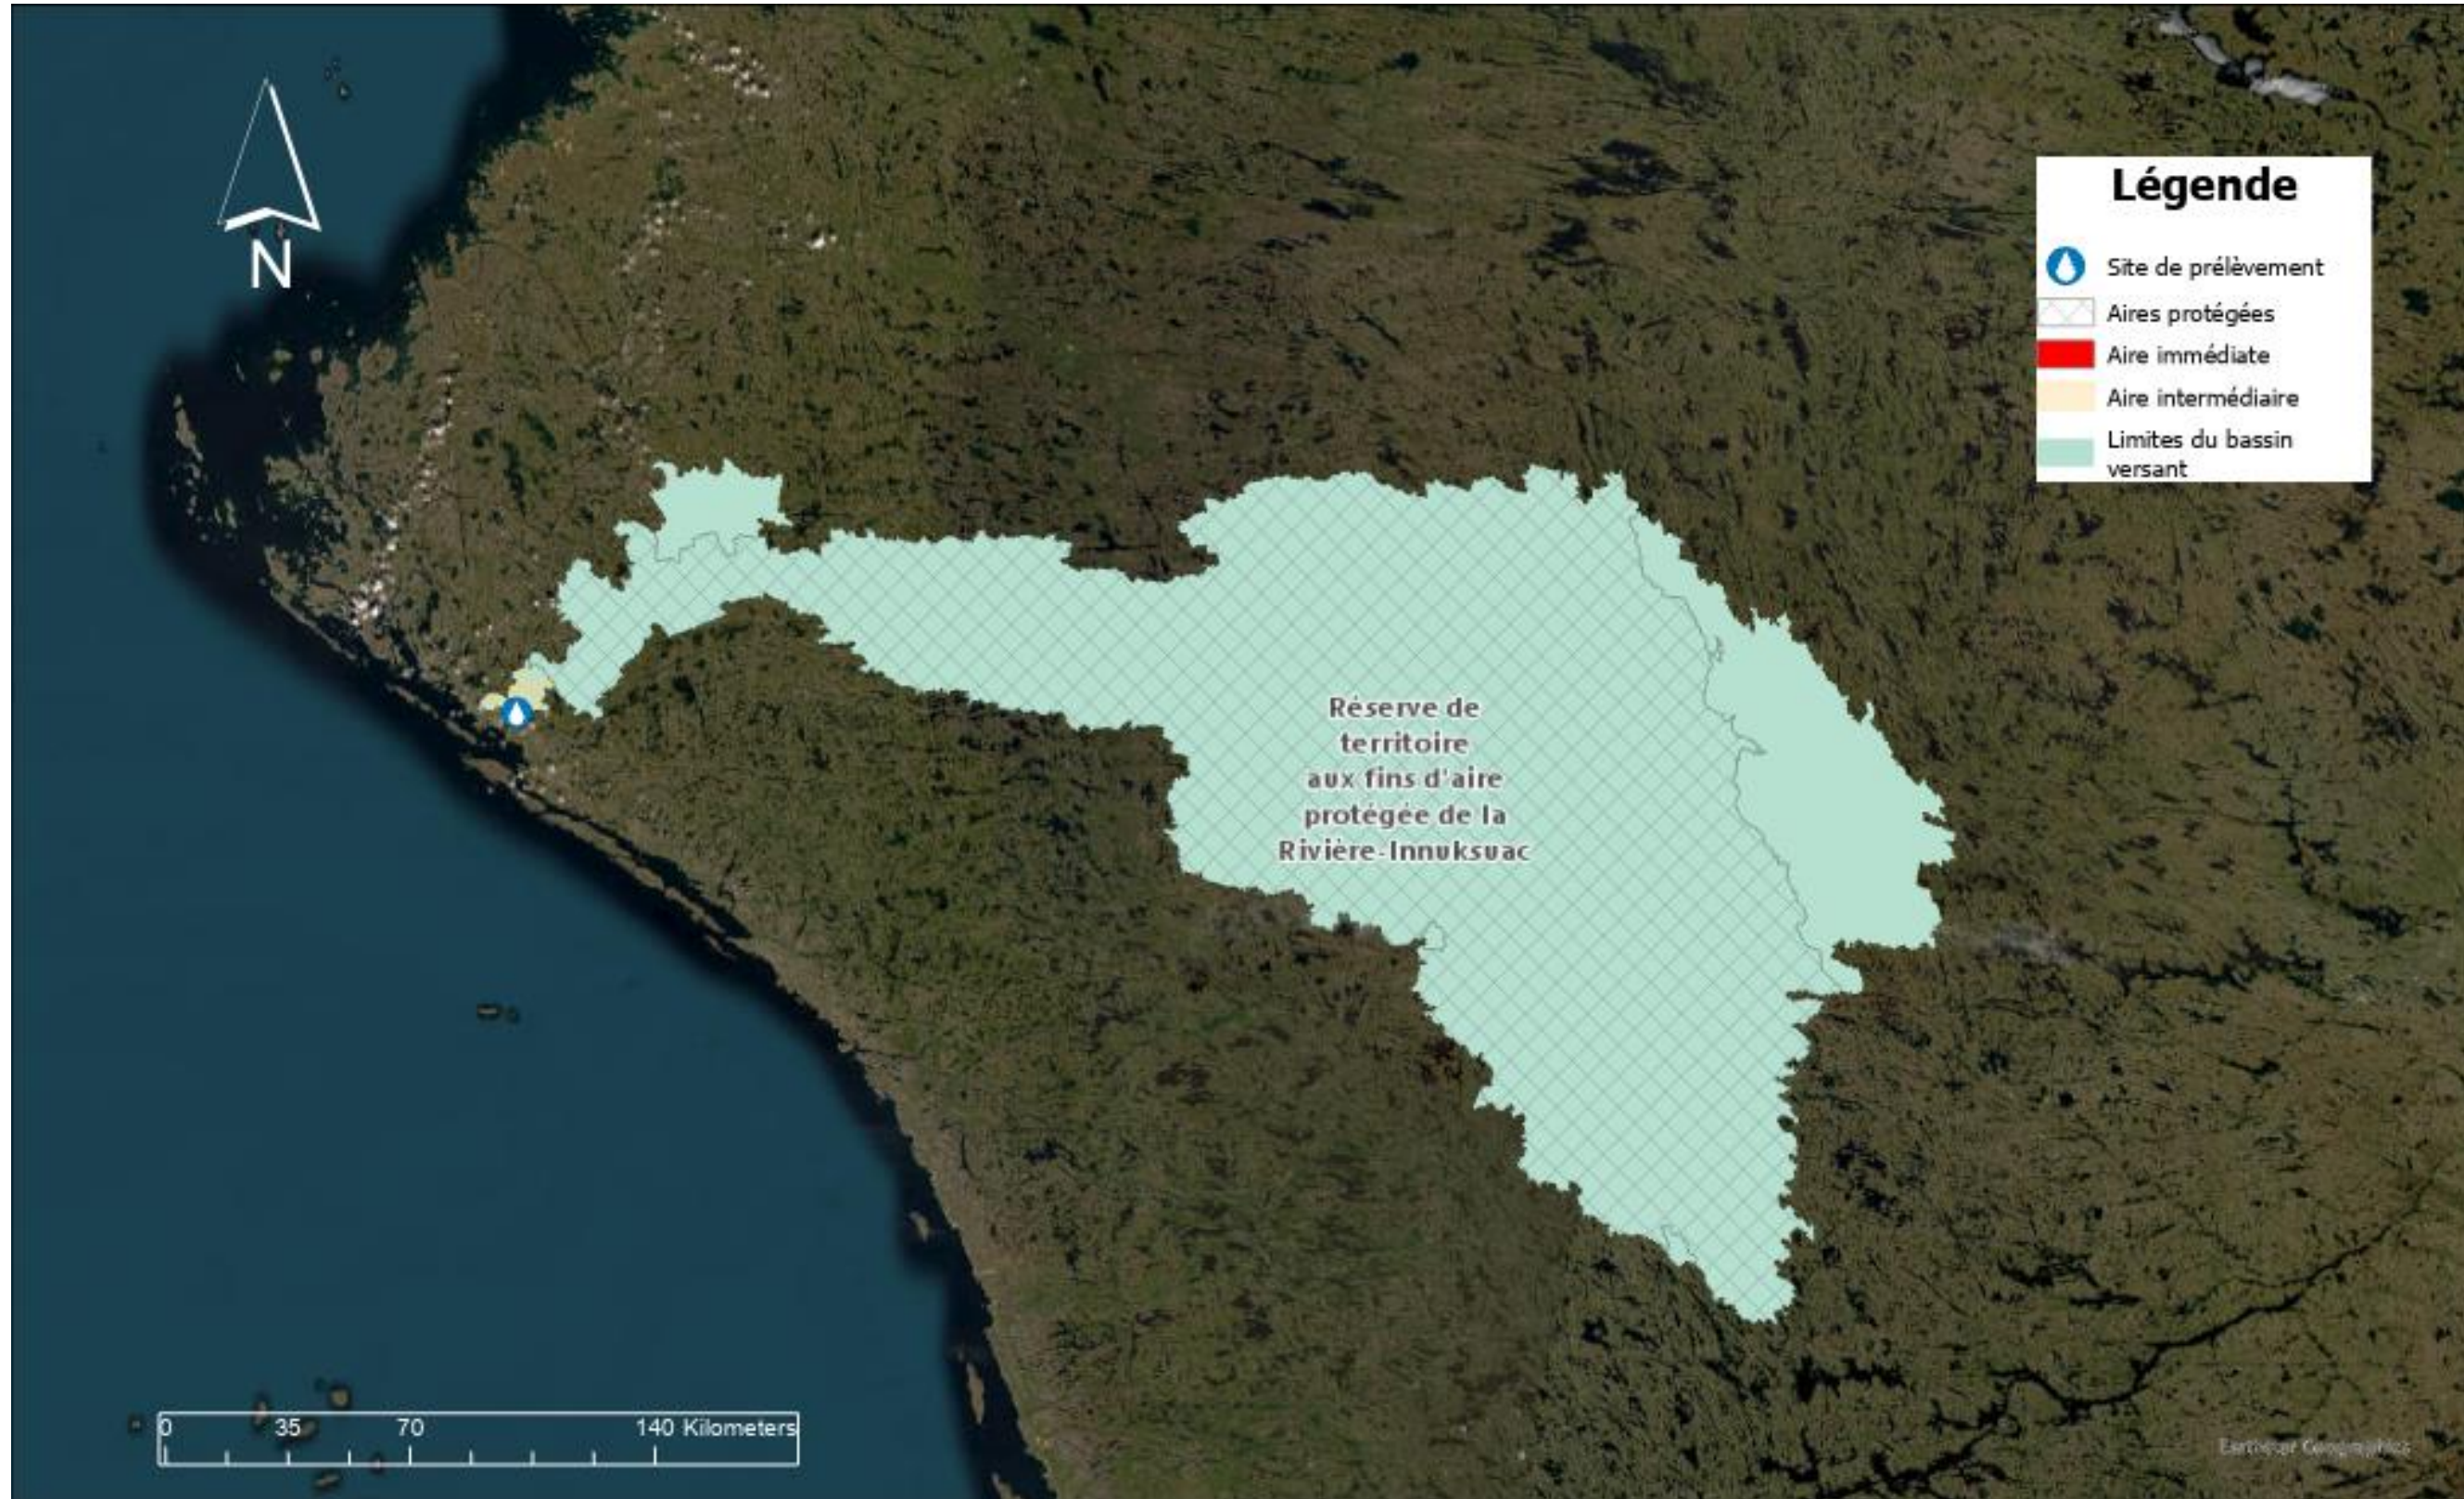
Appendix 3. Permafrost conditions - Inukjuak

Two potential natural events were identified at Inukjuak: the presence of migratory animals and the thawing of permafrost (Table 7). In fact, ice-rich permafrost (unstable to thawing) is found in the inner protection zone (see Appendix 3).
