Surface water intake vulnerability analysis report for the Northern village of Kangiqsujaq

Water intake number: X2114290

January 2025

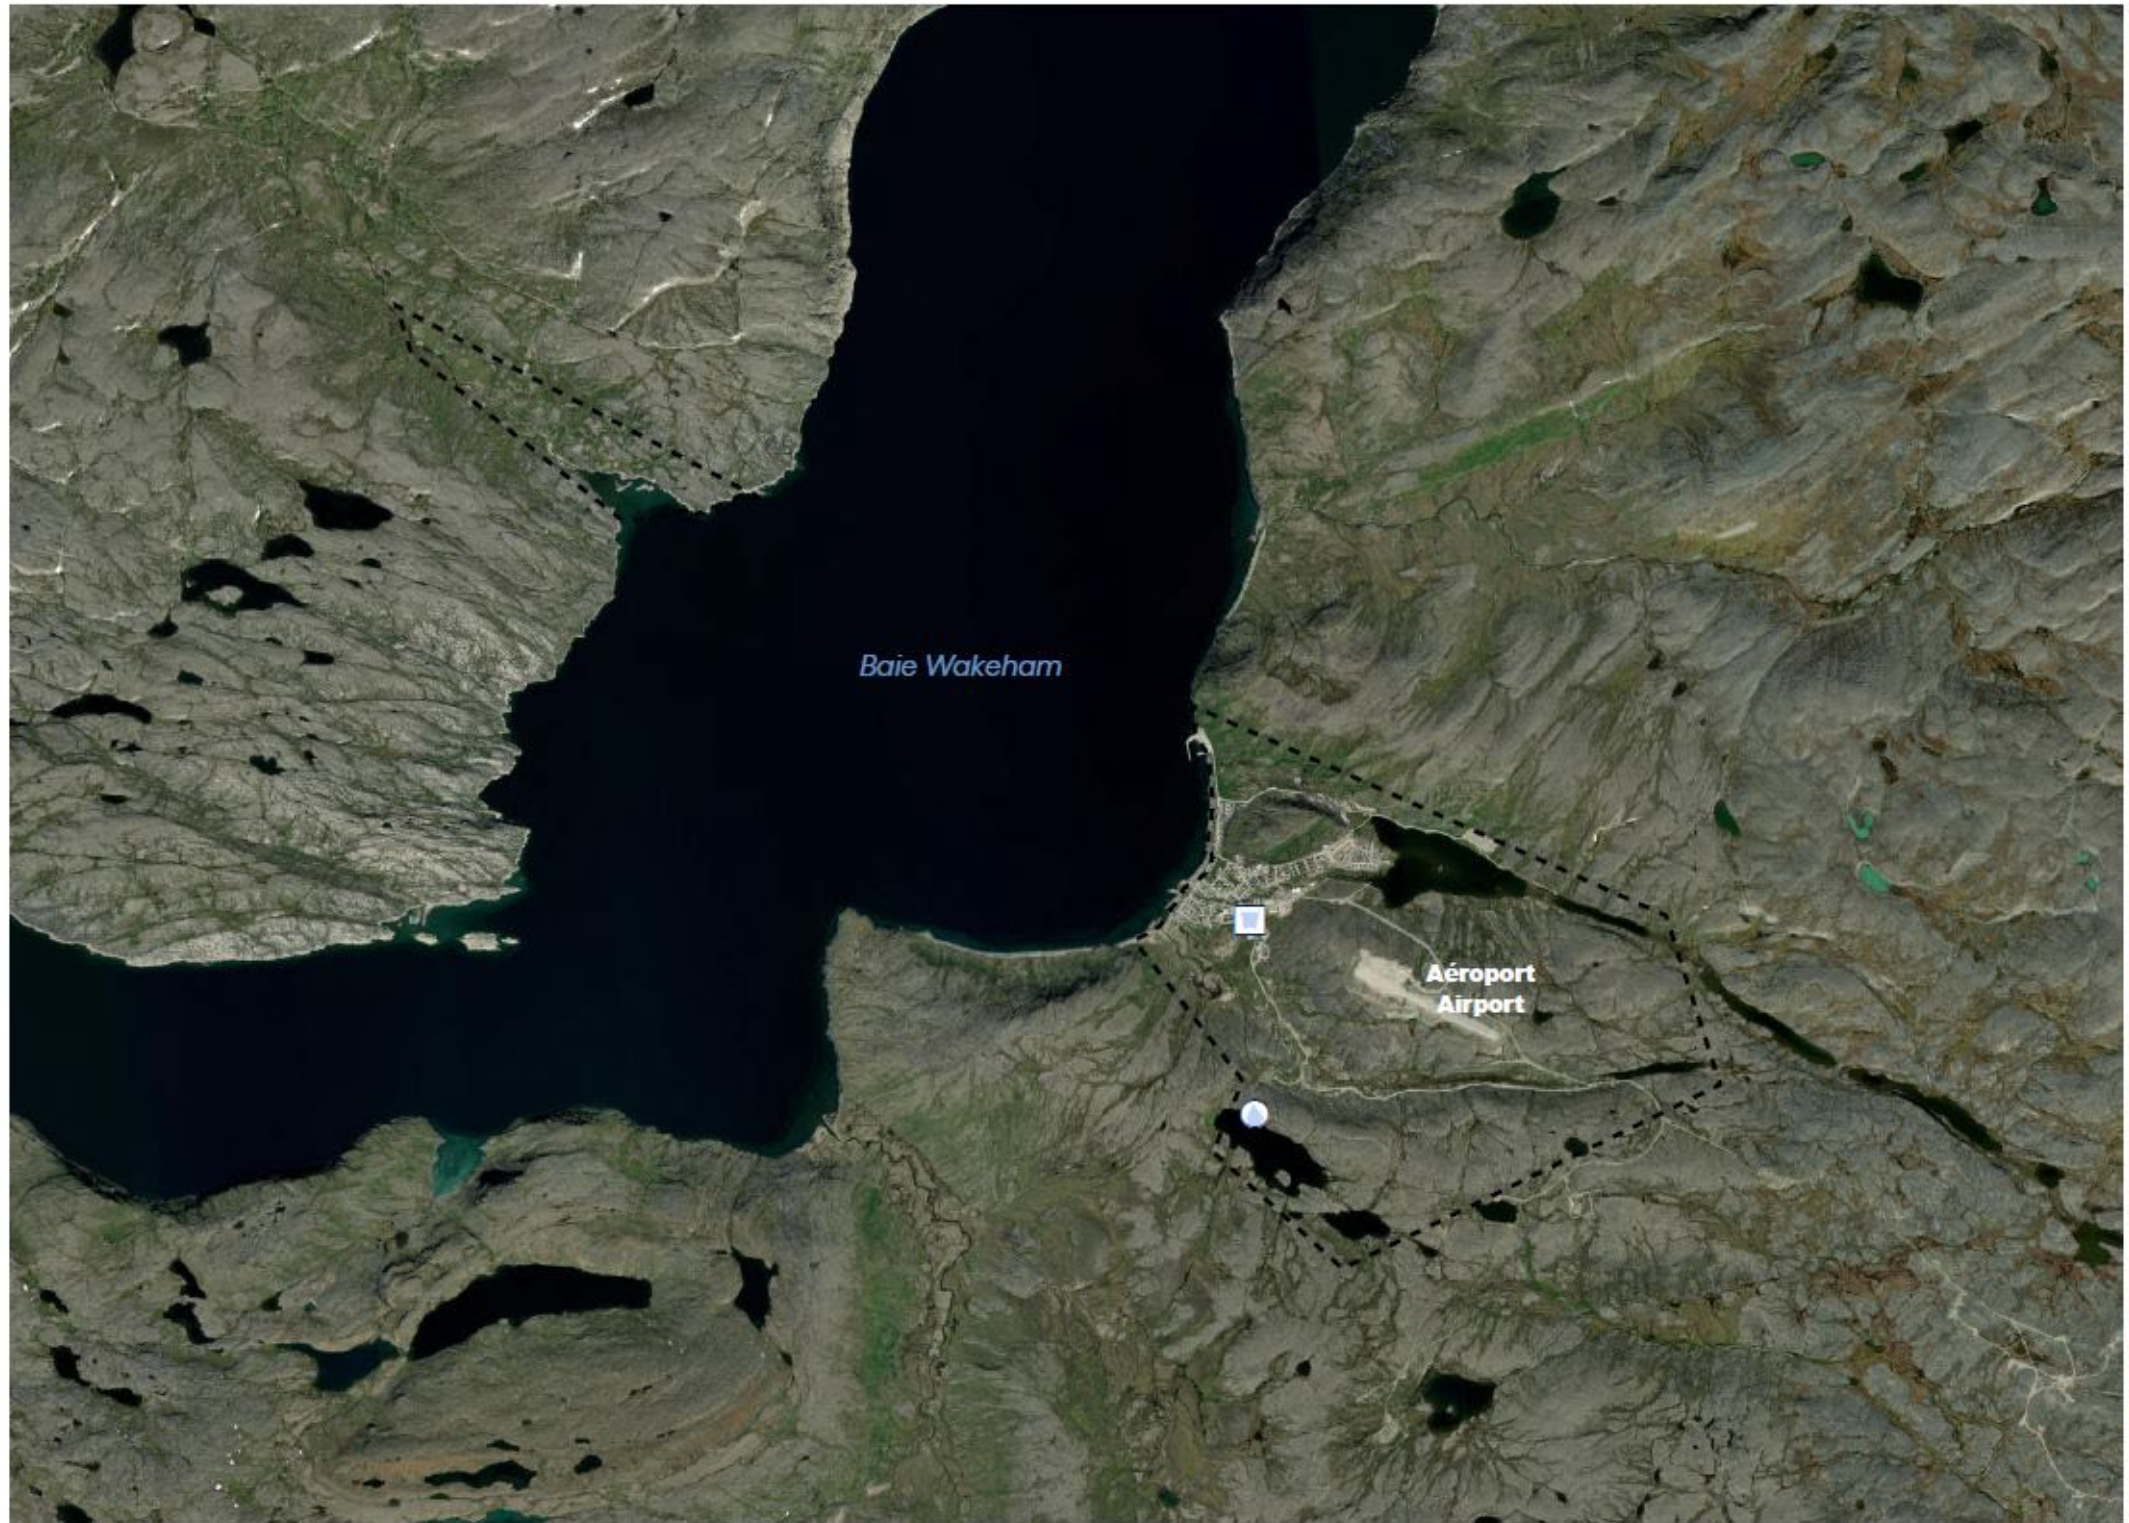
Figure 1 Localisation map for the Northern village of Kangiqsujuaq.

The location of the village in relation to the water withdrawal site is shown on the map below (Figure 1).

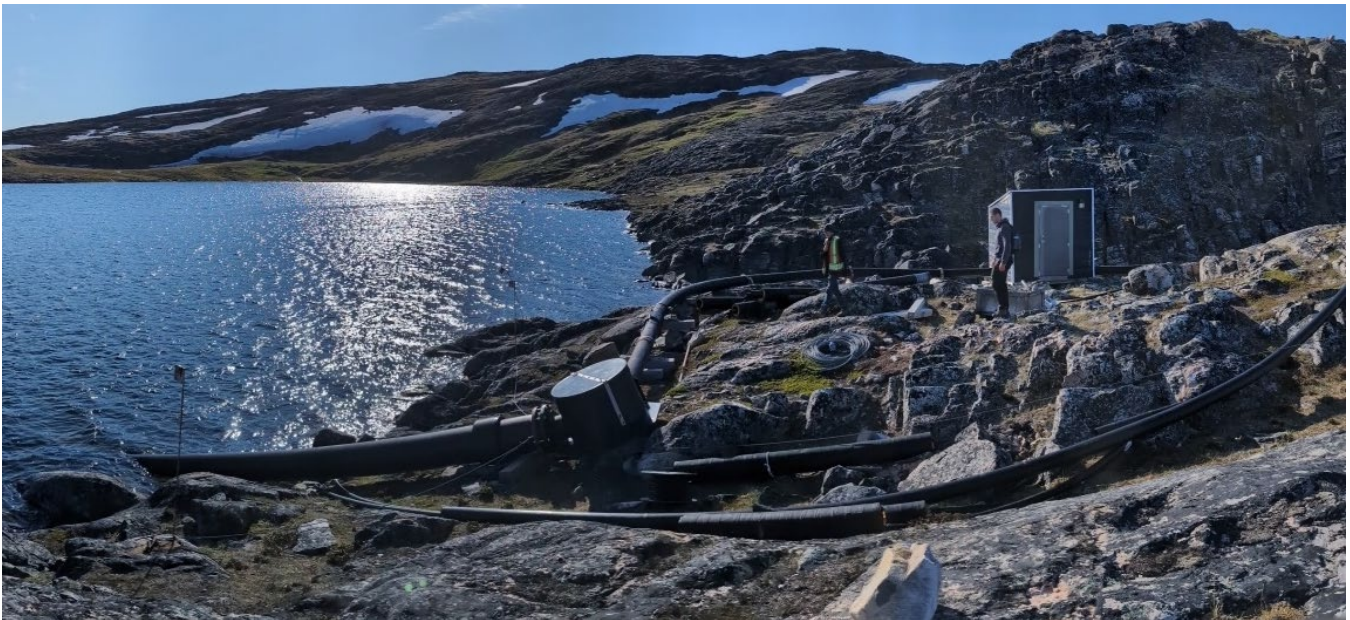
Water is withdrawn from Lake Qurlutuup Tasinga via a supply conduit with a perforated casing placed in the lake (see Figure 3).

Figure 3 Supply conduit and submersible pump used to withdraw water from Lake Qurlutuup Tasinga

- There is no event record.
- The conduit between Shelters #101 and #102 froze in 2022.
- Pumps SPP1 and SPP2 have recently stopped working. Repairs took 3 days on each occasion.
- There is no road access to the withdrawal site.

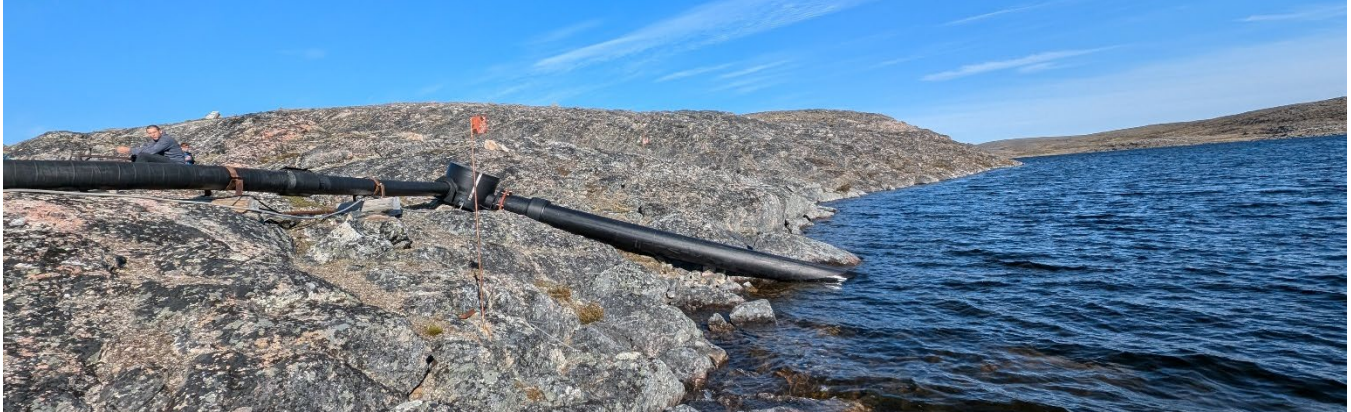
This conduit is connected to a booster pump that allows the water to circulate to a shelter (Shelter #100; Appendix 3. Schematic diagram of the water supply line between Lake Qurlutuup Tasinga and the WTP.), which houses the RP-100 and RP-101 pumps, the power supply, access to the heating cable, and a booster socket (see Figure 4).

Figure 4. Water withdrawal infrastructure (Photo taken on July 26, 2024, by Antoine Thibault)

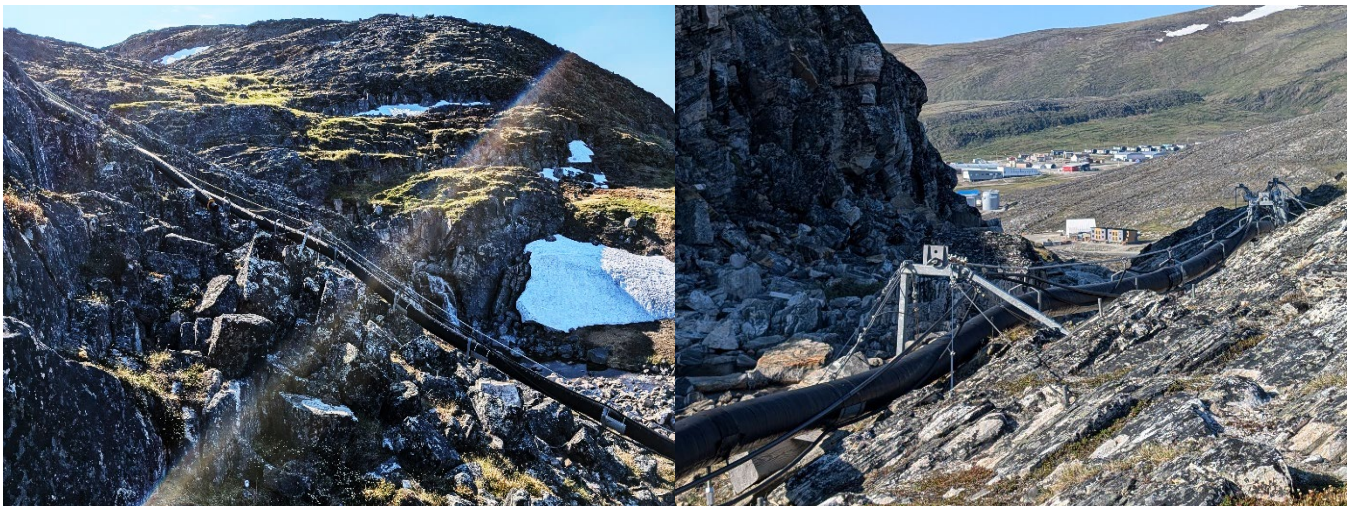
The conduit that carries the raw water to the drinking water treatment plant (WTP) is positioned above ground between the withdrawal site and Shelter #101 (Figure 5). The rest of the conduit is buried underground and accessible via three access chambers.

The total length of the conduit is 1.6 km. In 2022, emergency work was carried out after the conduit between Shelters #101 and #102 froze. A bypass conduit was installed and the necessary repairs were carried out over the following summer.

Figure 5. Above-ground positioning of the supply conduit between the withdrawal site and the WTP (Photos taken on July 26, 2024, by Antoine Thibault)

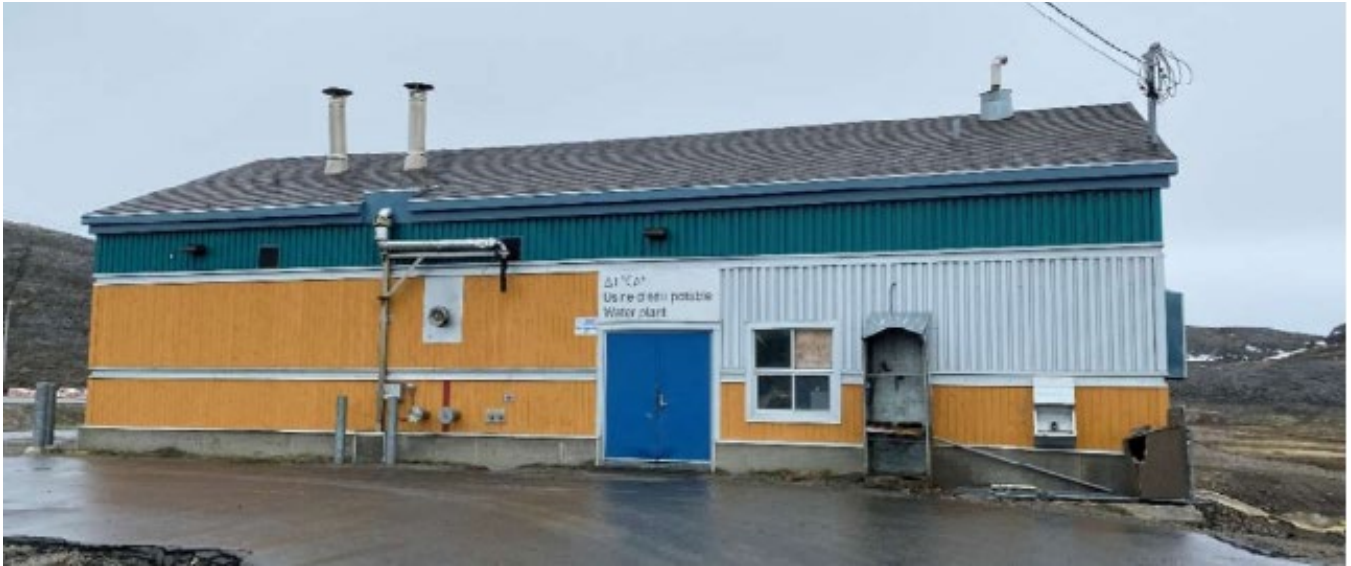
The Kangiqsujuaq WTP was built in 2005 and upgraded in 2011, 2017, and 2018. The treatment involves dual disinfection using UV and chlorine (sodium hypochlorite-based). There is no filtration system, except for activated carbon filtration for the community tap attached to the building.

The treated water is stored in a 450 m³ cylindrical tank, from which pumps are used to load the tankers via loading arms. The plant's infrastructure includes an electrical room with a diesel generator, a chlorination room, a UV zone in the machinery room, a boiler room, a laboratory, an office, and a workshop. To prevent the conduits from freezing, the system is also fitted with a gravity siphon transmission conduit with a recirculation system.

Figure 6. Drinking water treatment plant in the Northern village of Kangiqsujaq [8].

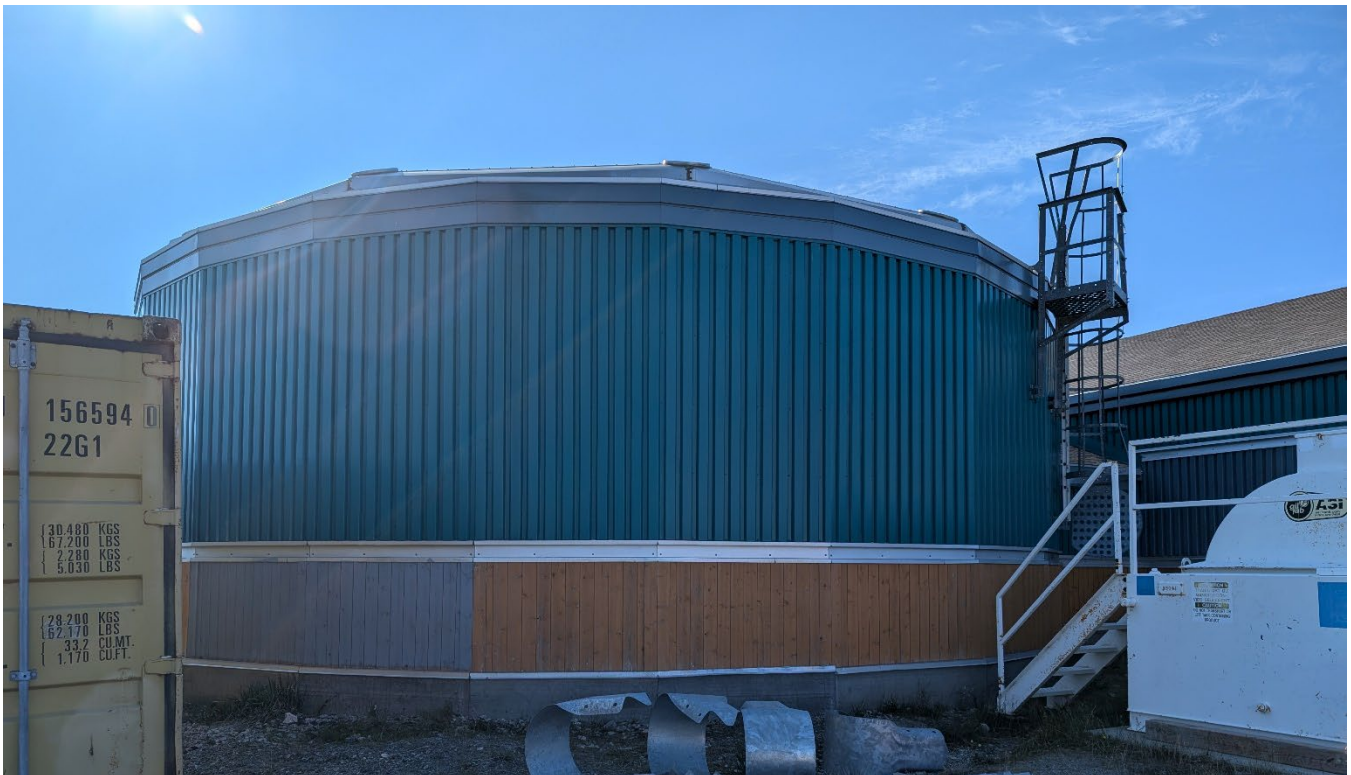
Figure 7. Treated water tank attached to the Kangiqsujaq WTP (450 m^3). Photo taken on July 26, 2024, by Antoine Thibault.

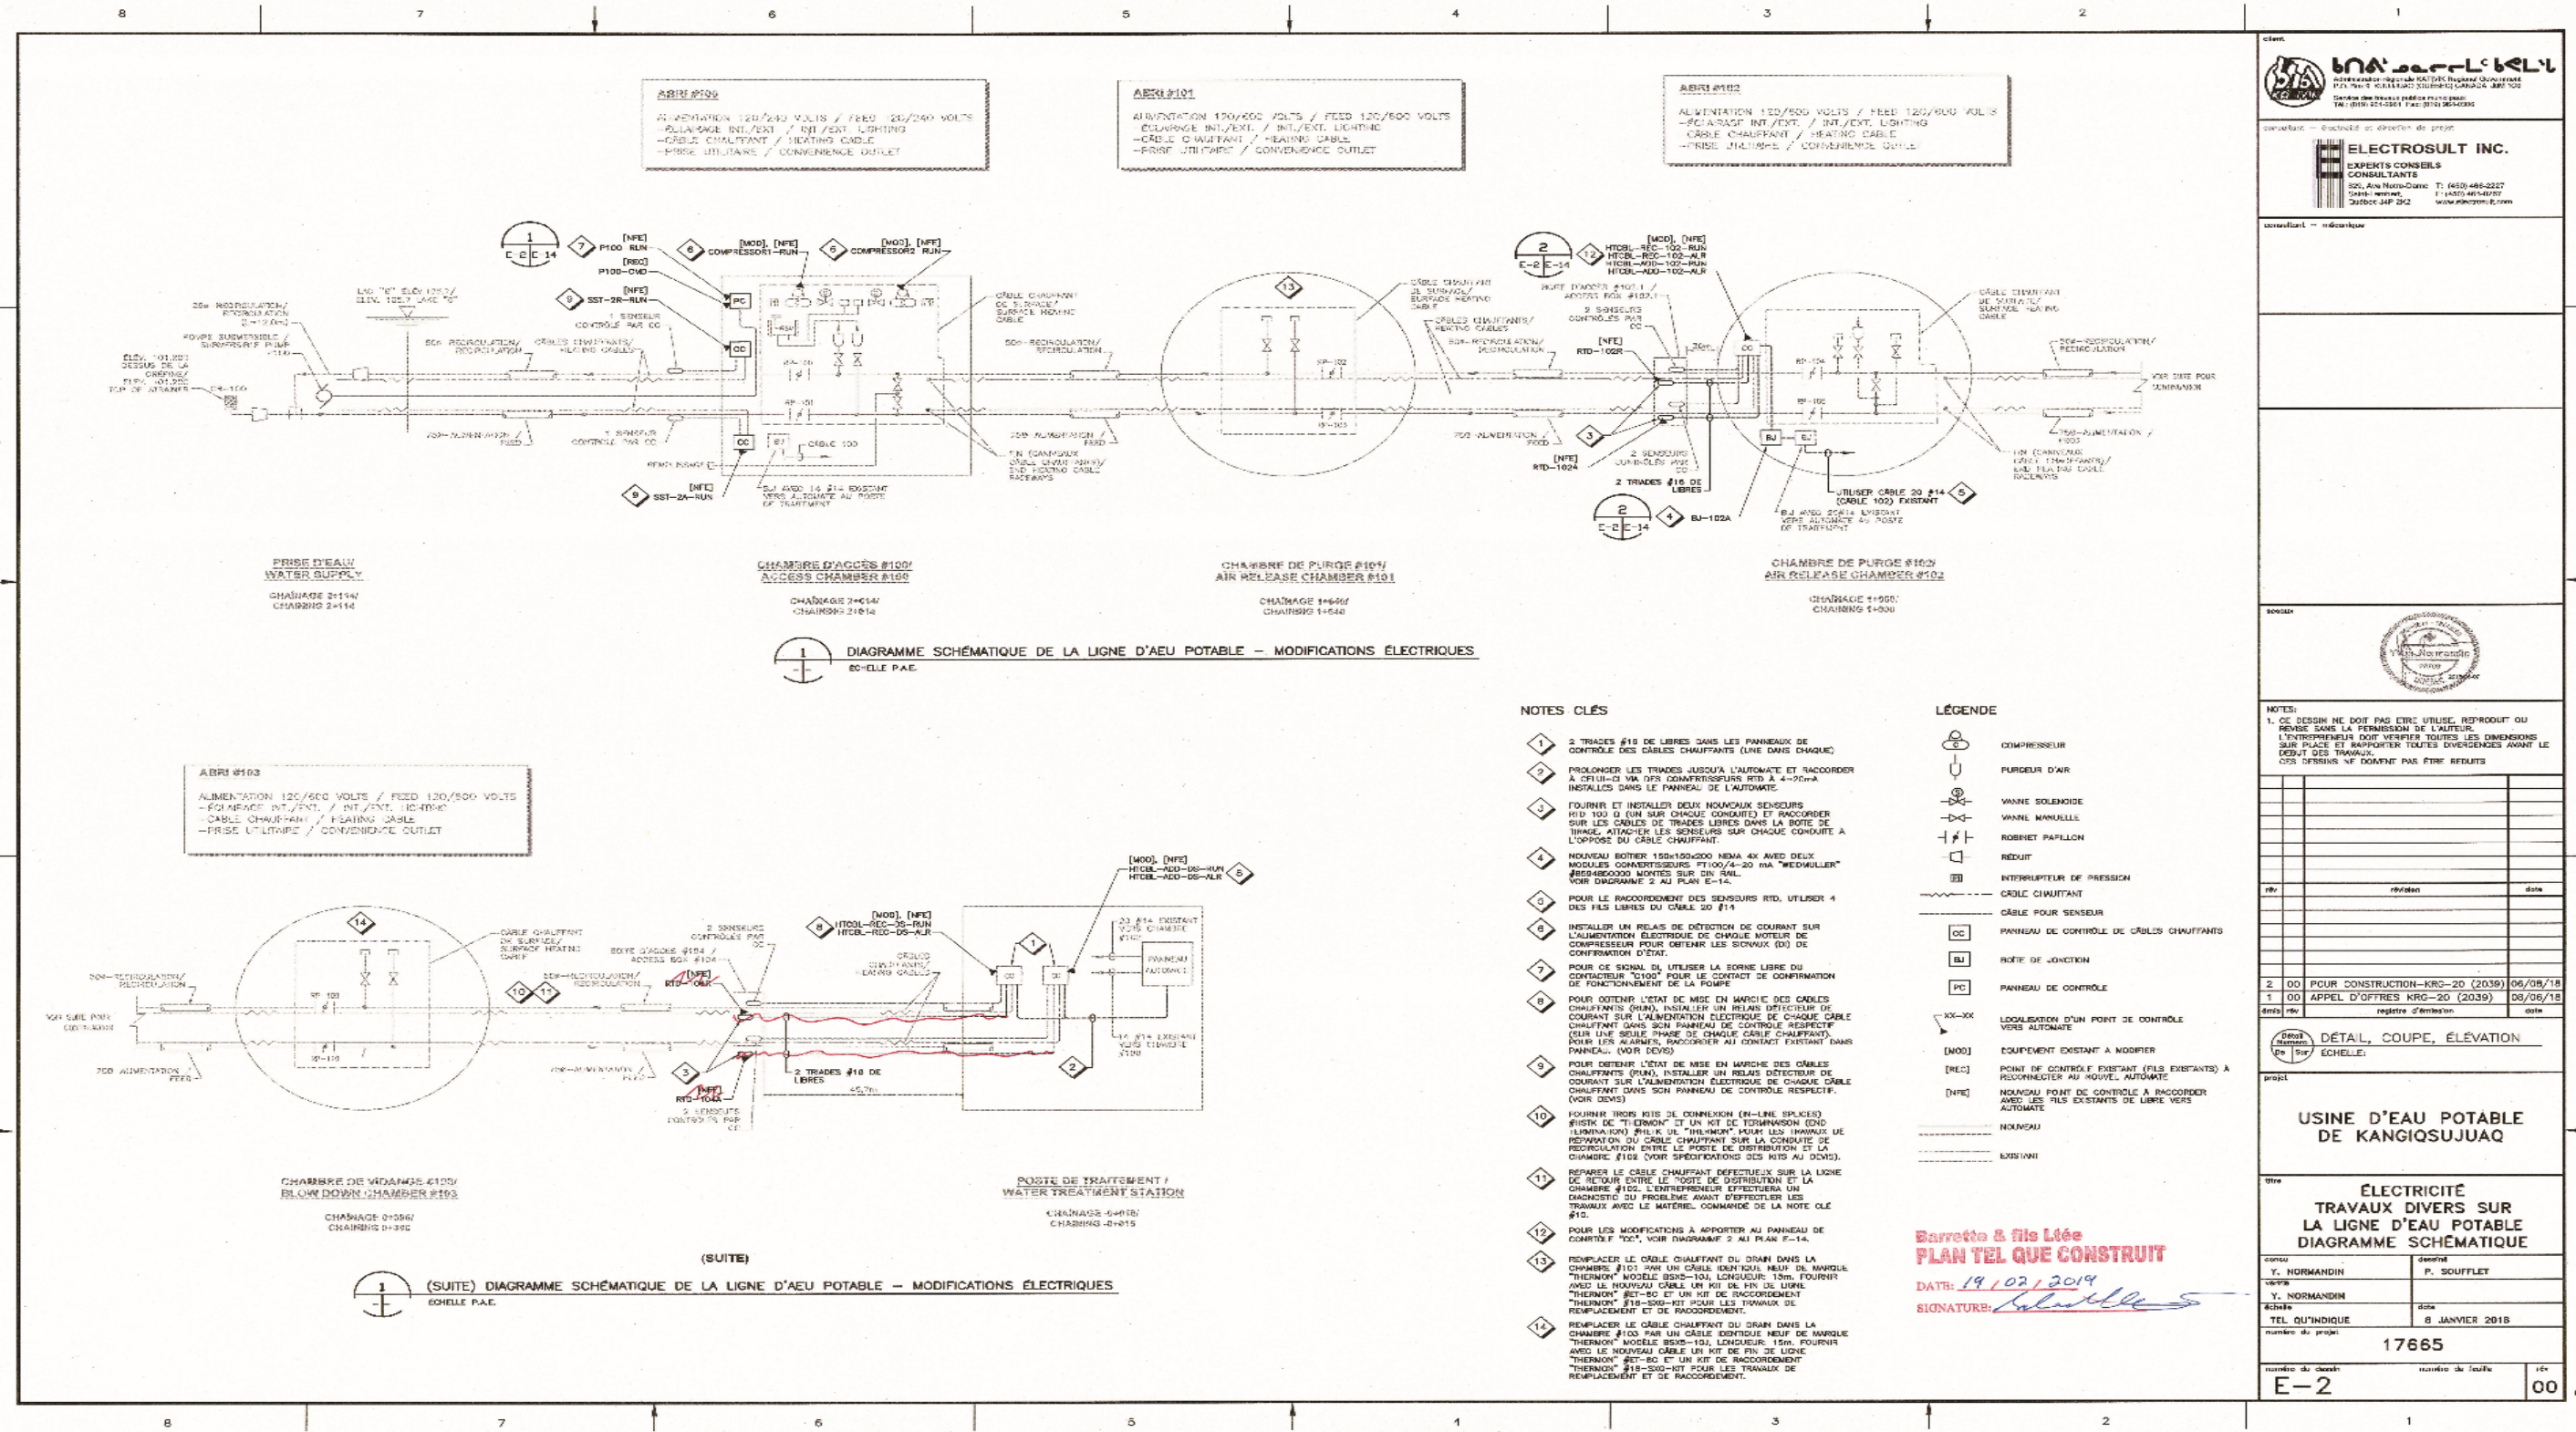
Appendix 3. Schematic diagram of the water supply line between Lake Qurlutuup Tasinga and the WTP.
