**ASSESSMENT AND REMEDIATION OF ABANDONED MINING  
EXPLORATION SITES IN NUNAVIK**

**PROGRESS REPORT  
FOR YEAR 2005-2006 OF THE PROJECT**

**Kativik Regional Government  
Renewable Resources Department**

**MARCH 2006**

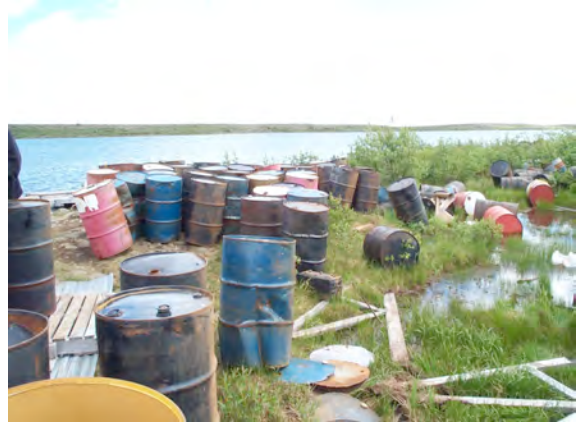
Picture 2. Scattered barrels on site KAW-35.

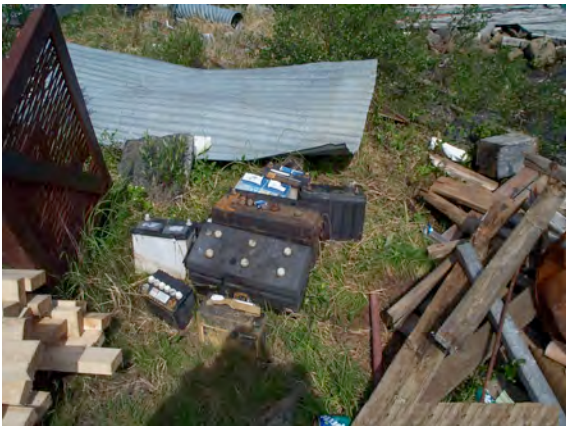
Picture 3. Batteries and debris near lake.

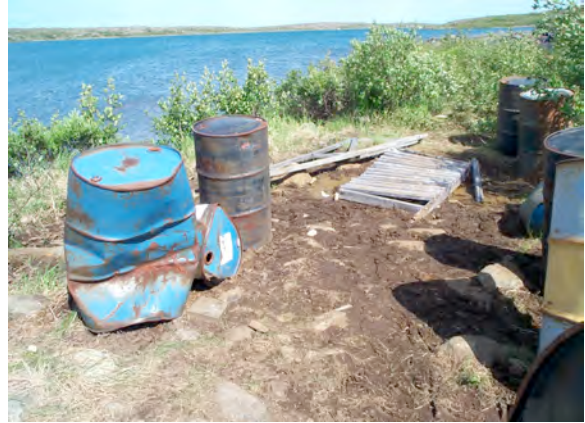
Picture 12. Lakeshore sector, contaminated soil sampling station.

The second contaminated area is located under the piles of barrels observed near the lakeshore. Three samples (S-6, S-8, S-9) collected near the site's dock showed traces of petroleum products (diesel, Jet-B fuel) contamination slightly above the limit for residential land use (Rf.: *Règlement sur la protection et la réhabilitation des terrains* du Gouvernement du Québec). The  $C_{10}$ - $C_{50}$  concentrations are higher a few centimeters deep in the soil than they are on the surface. The contaminated surface is limited and not continuous. It affects an area of approximately 20 m<sup>2</sup> and is strictly localized under the barrels observed on the lakeshore.

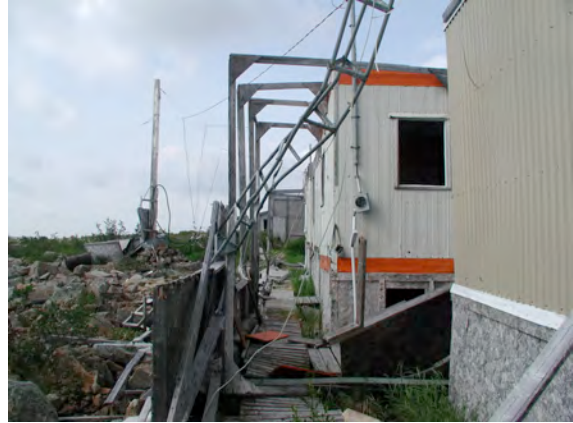
Picture 2. Hazardous metal and wood  
debris.

The condition of the buildings and dwellings observed on-site is poor, in deterioration and may eventually leads to issues of public health and safety. Unstable metallic antennas, suspended wires and unsafe trailers could pose a serious threat (Appendix B, photos 1-3). The second phase of remedial measures on the KAW-35 site should also involve the stabilization and/or demolition of these buildings and the dismantling of any hazardous wires and antennas. All metallic and non-combustible debris should be collected and gathered in the above-mentioned projected non-combustible materials deposit. Finally, combustible debris should be burned on site according to MENV regulations.

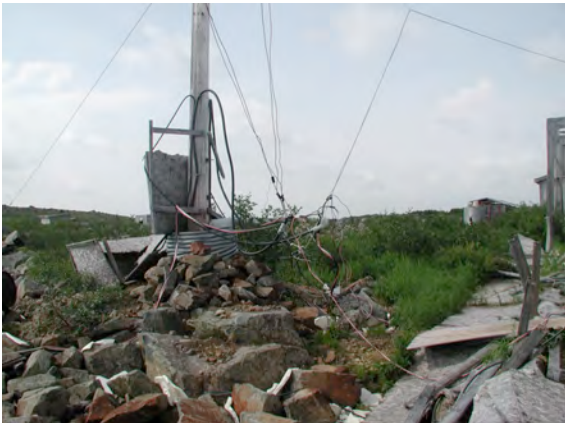
Picture 3. Hazardous suspended wires.

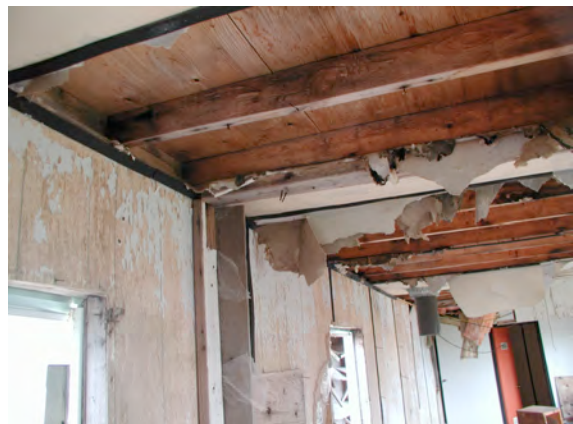
Picture 6. Damaged structures of trailer.

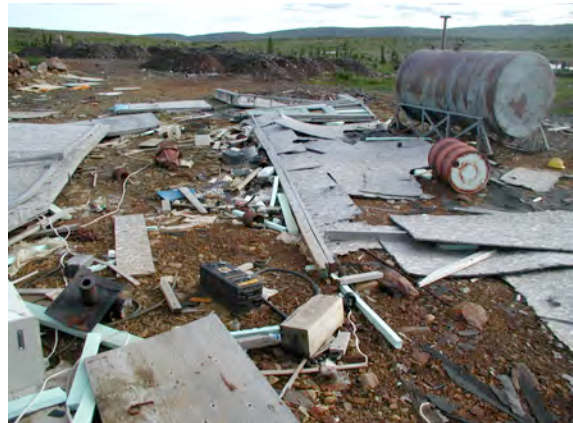
Picture 14. 4,400 L tank and residual materials on sector #2.

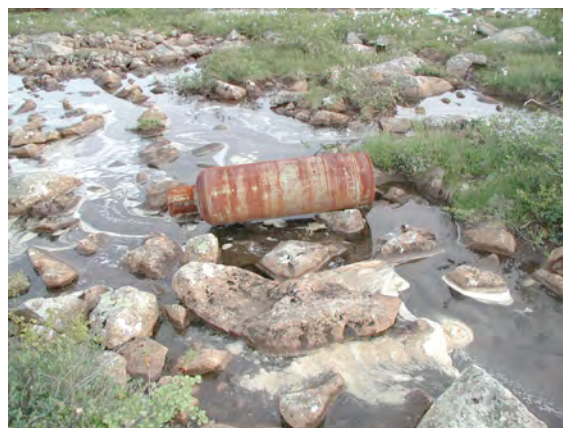
Picture 20. Propane cylinder in southern discharge of the Blue Lake.

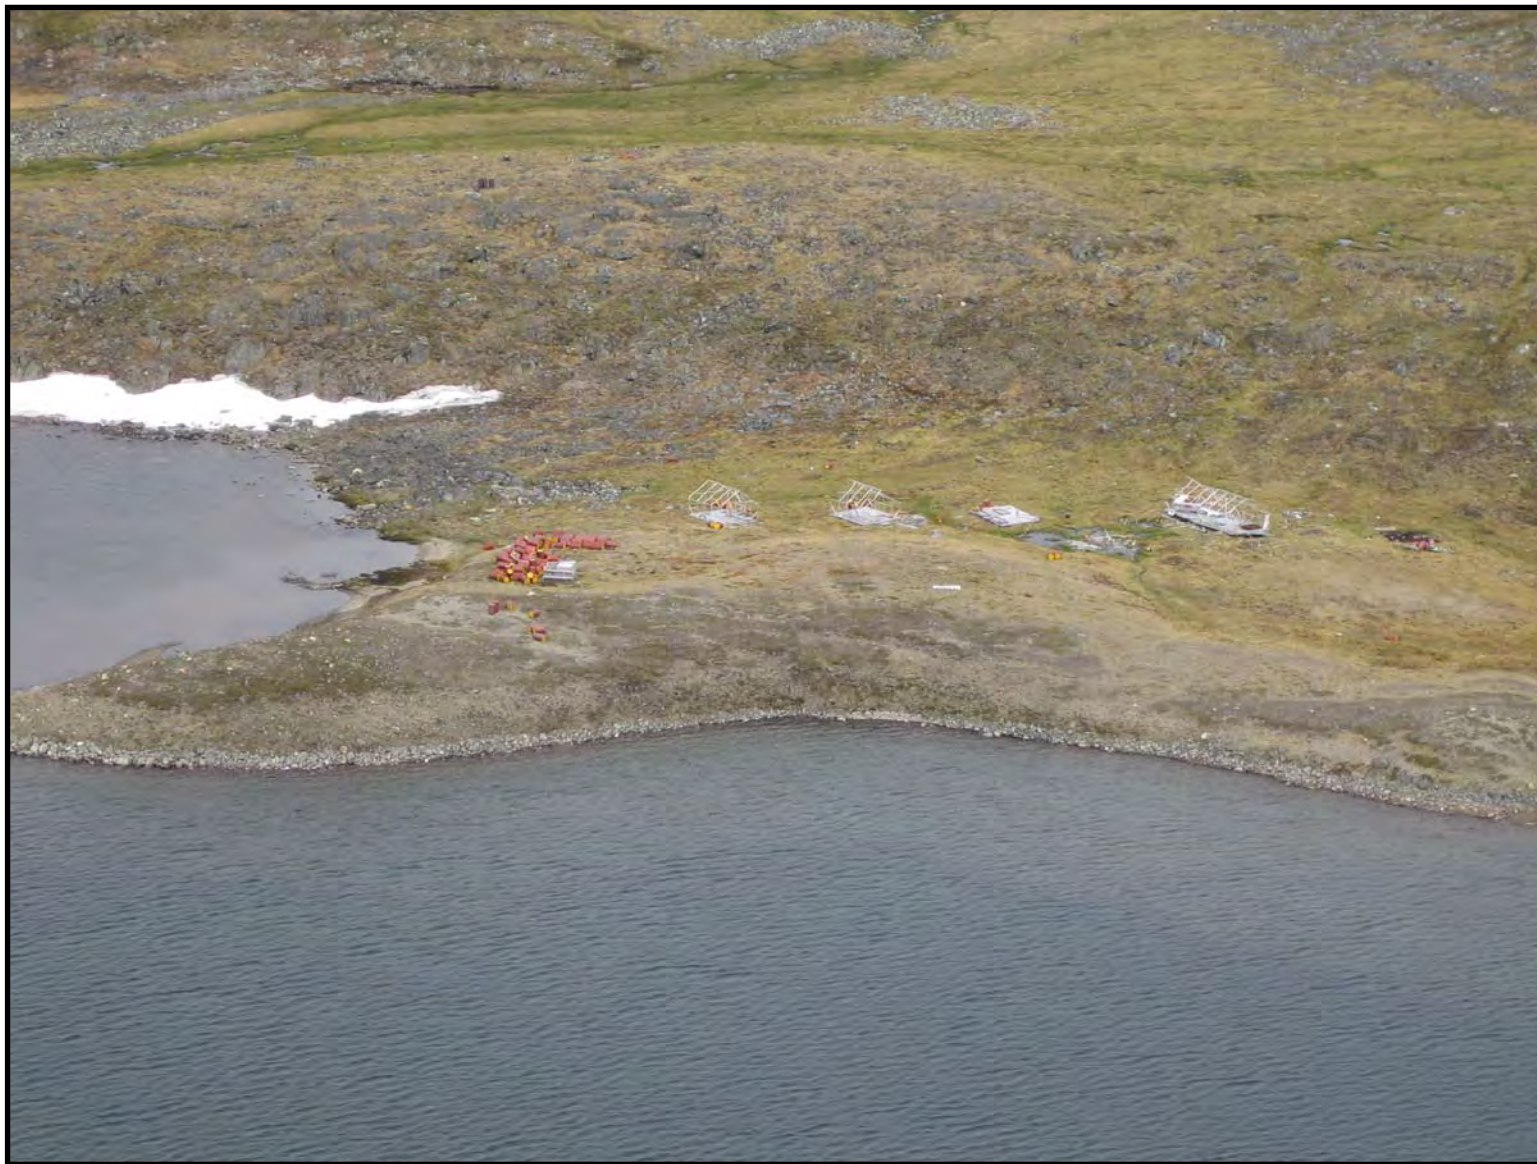
**Photo 1.** Aerial photo of historical abandoned camp near Lac Dumas, Nunavik, before commencement of clean-up efforts. Note large cache of fuel drums at left, tent floors and tent frames in center of photo. View looking north, July 7<sup>th</sup>, 2005.

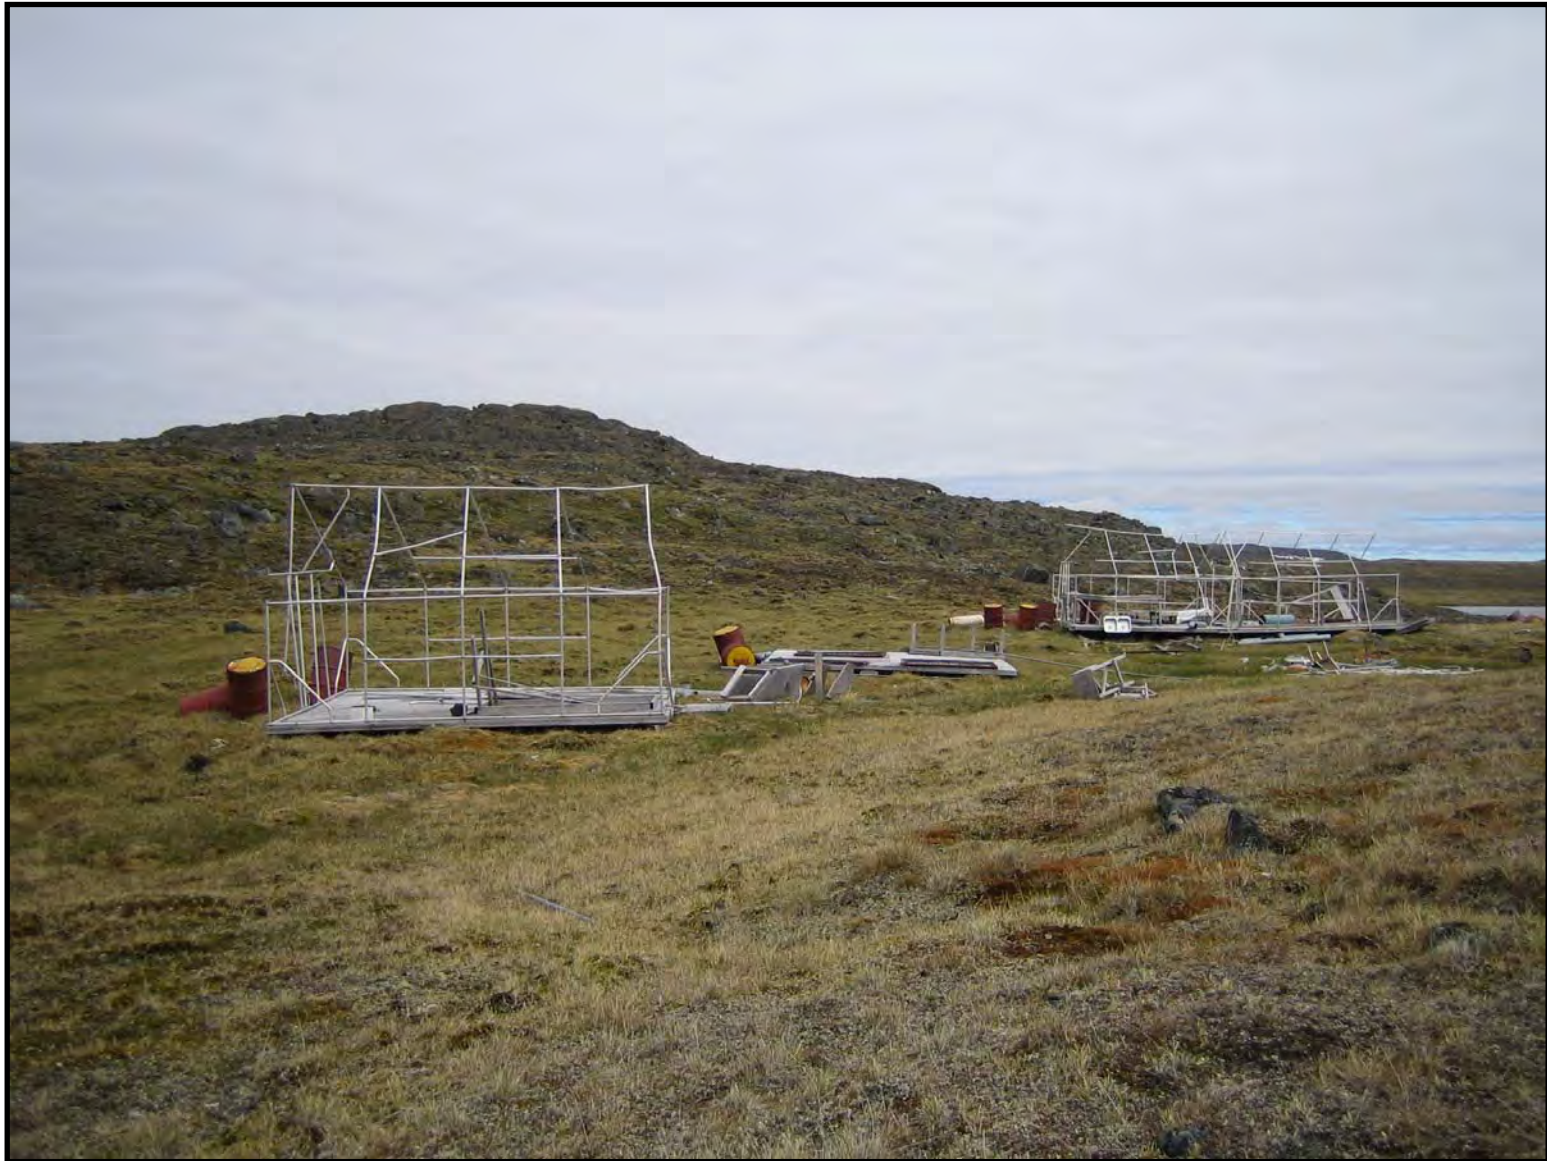
**Photo 2.** Aluminum tent frames and old fuel drums at the abandoned camp near Lac Dumas, Nunavik, before commencement of clean-up efforts. View looking east, July 7<sup>th</sup>, 2005.

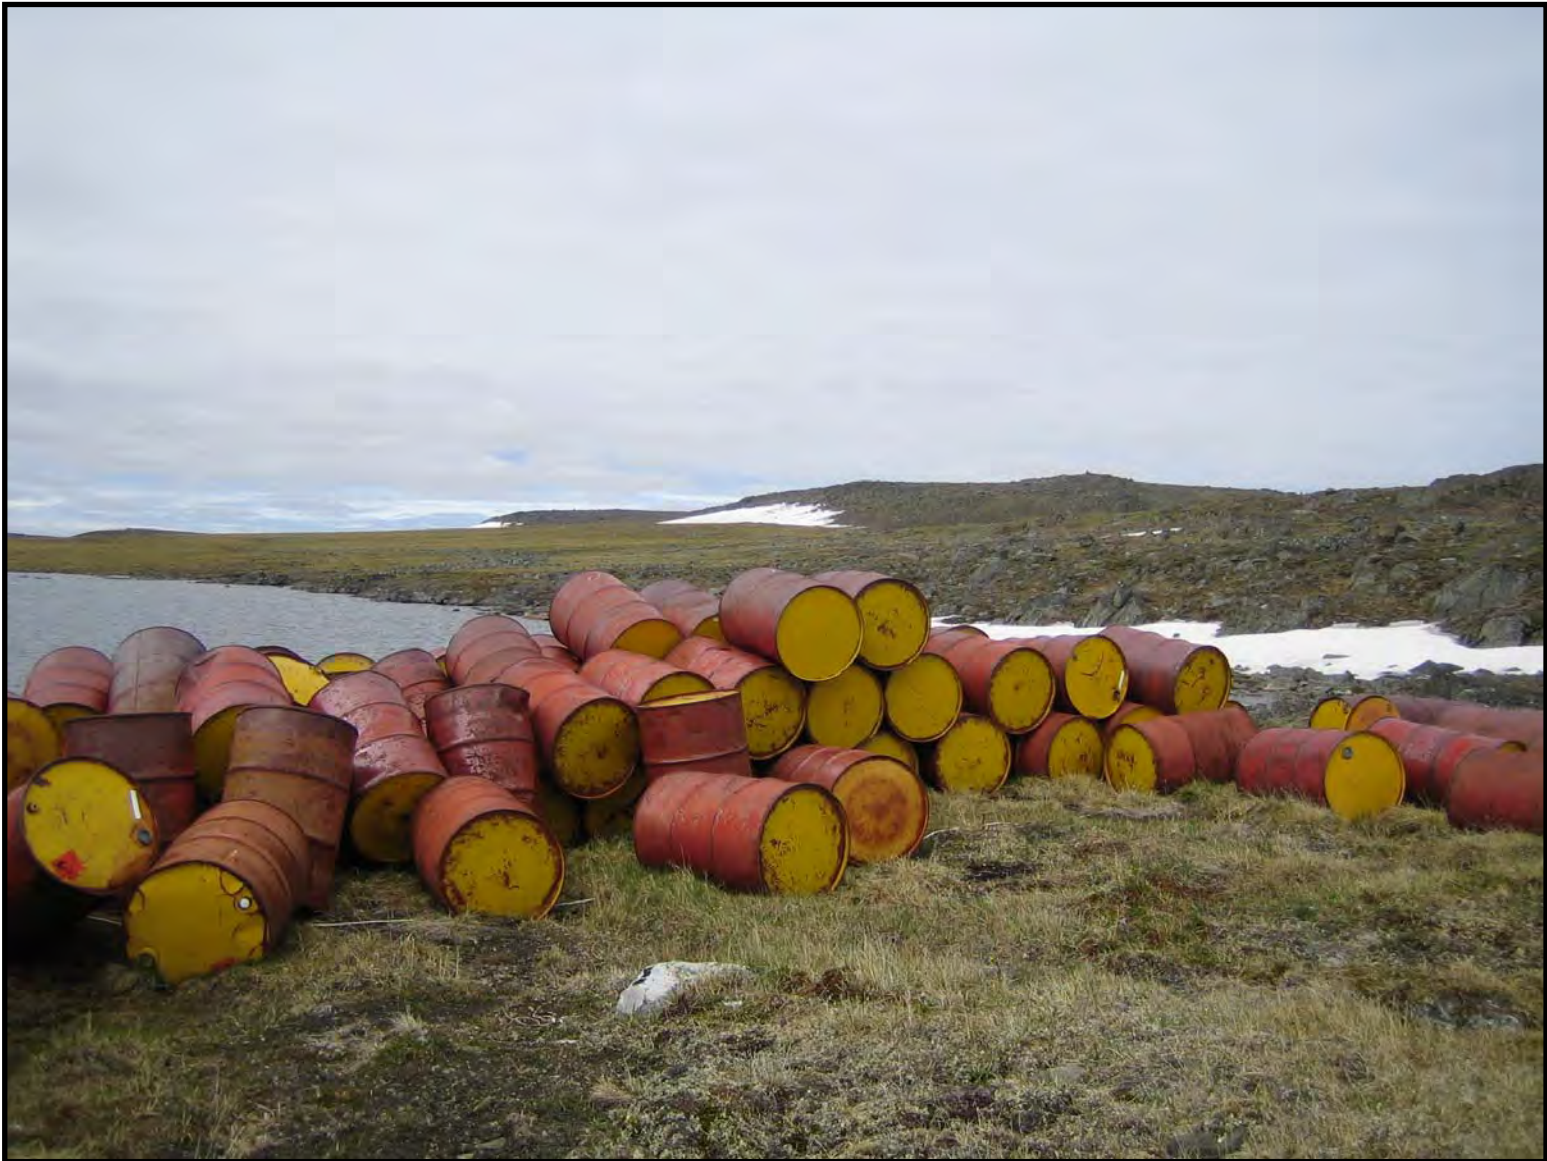
**Photo 3.** Pile of old fuel drums at the abandoned camp near Lac Dumas, Nunavik, before commencement of AAEC's clean-up effort. A total of 30 drums of fuel were transferred to new drums (6 gas, 24 diesel) and 75 empty drums were brought to Belanger camp in 2005. View looking west, July 7<sup>th</sup>, 2005.

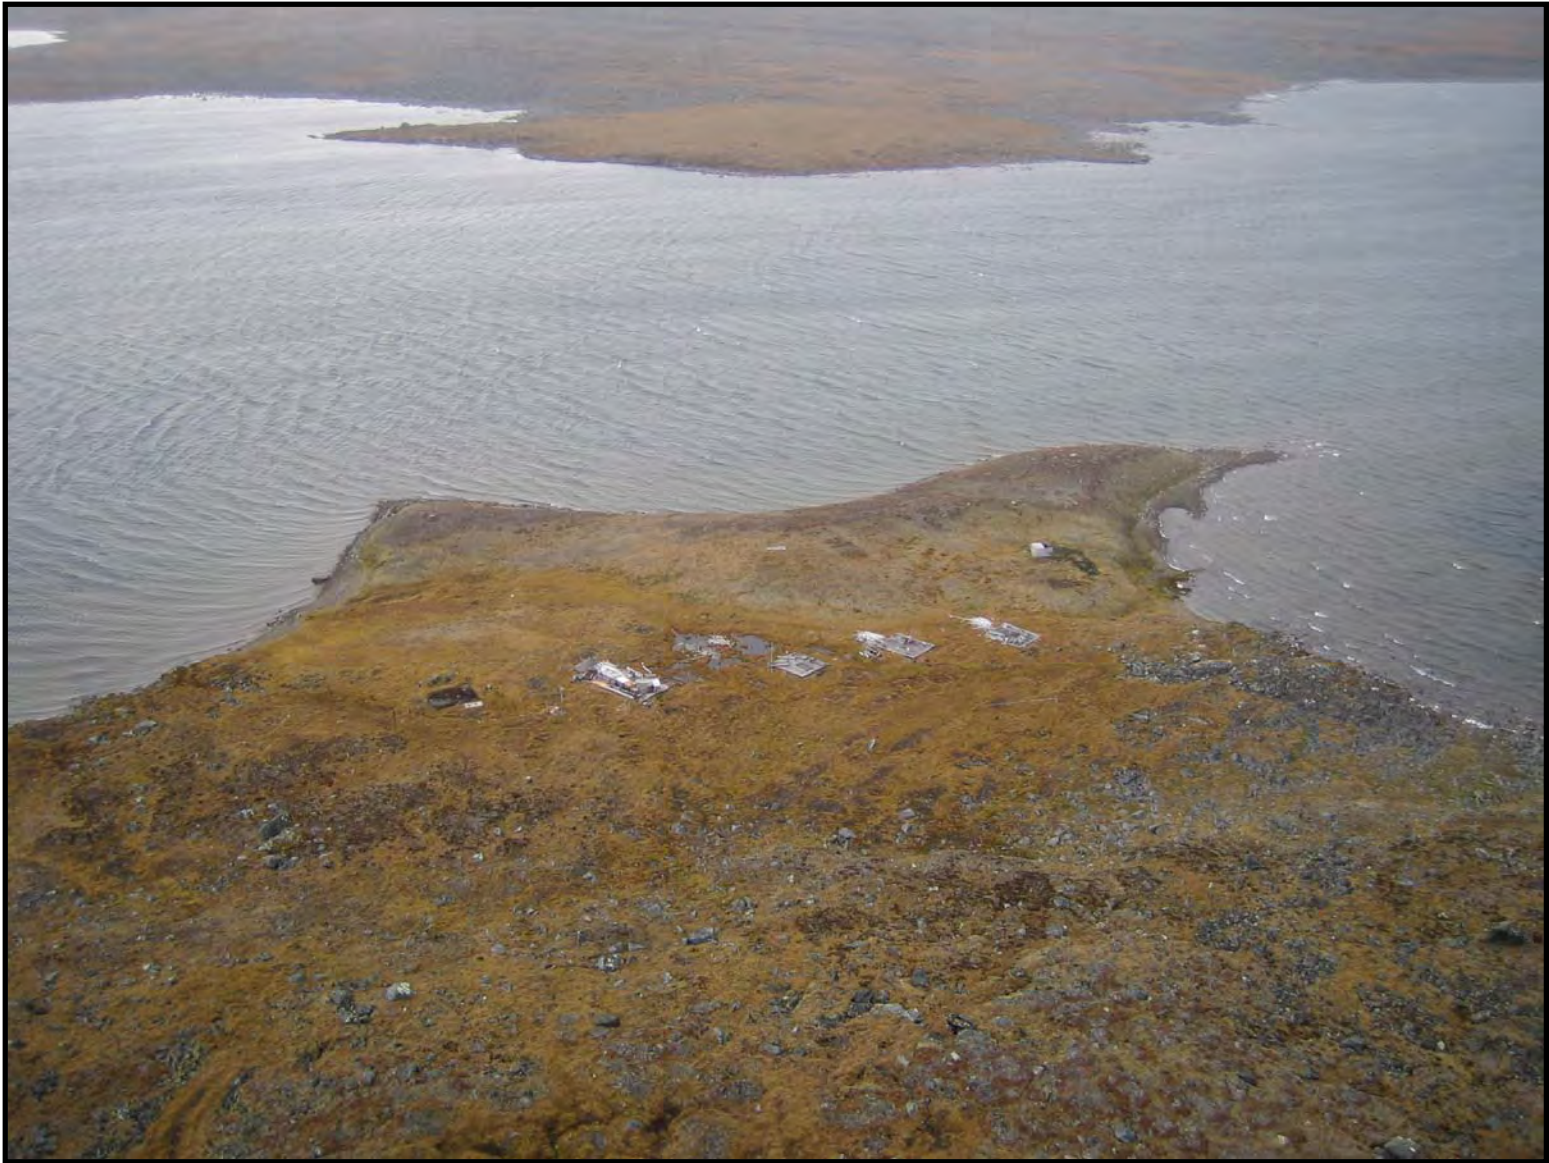
**Photo 7.** Aerial photo of abandoned camp near Lac Dumas, Nunavik, after AAEC's clean-up effort. Note all old fuel drums have been removed from site, and all tent frames have been taken down. A total of 30 drums of fuel were transferred to new drums (6 gas, 24 diesel) and 75 empty drums were brought to Belanger camp in 2005. View looking south, September 5<sup>th</sup>, 2005.

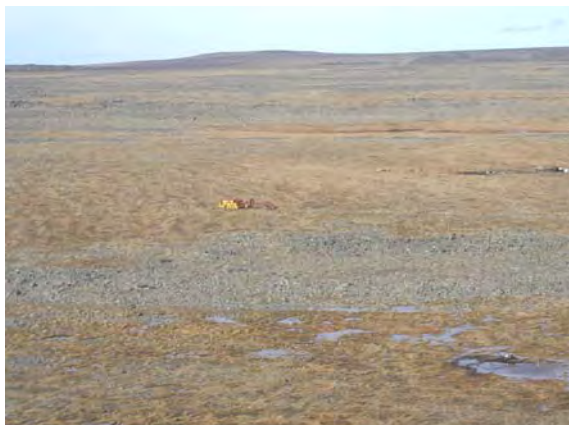
Picture 1. Pile of barrels at abandoned site I-14.

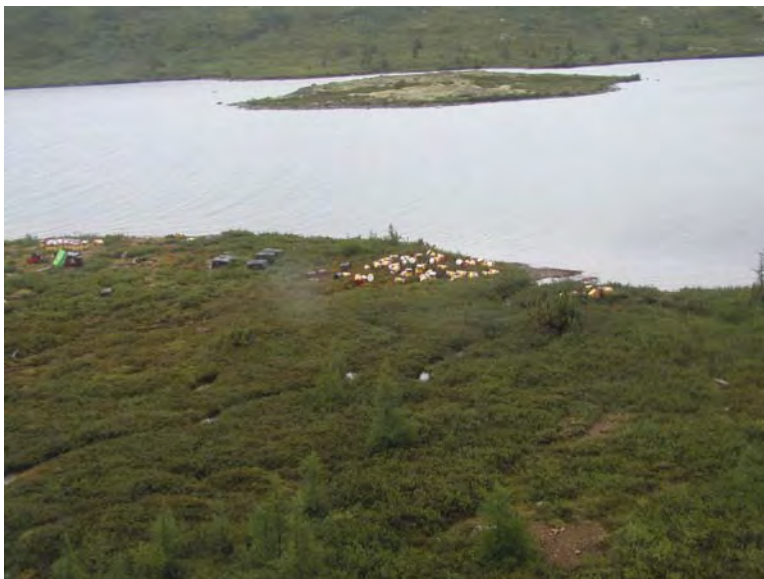
Picture 11. Intermediate site P-24F13-5 located on the shoreline of Lake Gerido, August 2005.

Another site located on the shore of Lake Gerido, approximately 75 kilometers west of Kuujuaq (Appendix E, Map 3), was validated as an intermediate abandoned site. The site P-24F13-5 comprises camp debris, core boxes and about 50 empty barrels that are scattered near the lake shoreline (see Appendix F for picture 11). Approximately 30 barrels full of fuel are still on-site. Informants from Nunavik Rotors communicated that all the barrels will be collected and re-used within upcoming mining activities during summer 2006. Table 8 presents the description of the debris and materials observed on both validated sites.
