# **NUNAVIK ABANDONED MINERAL EXPLORATION SITES REHABILITATION PROJECT**

## **2012-2013 ACTIVITY REPORT**

**Kativik Regional Government**

**March 2013**

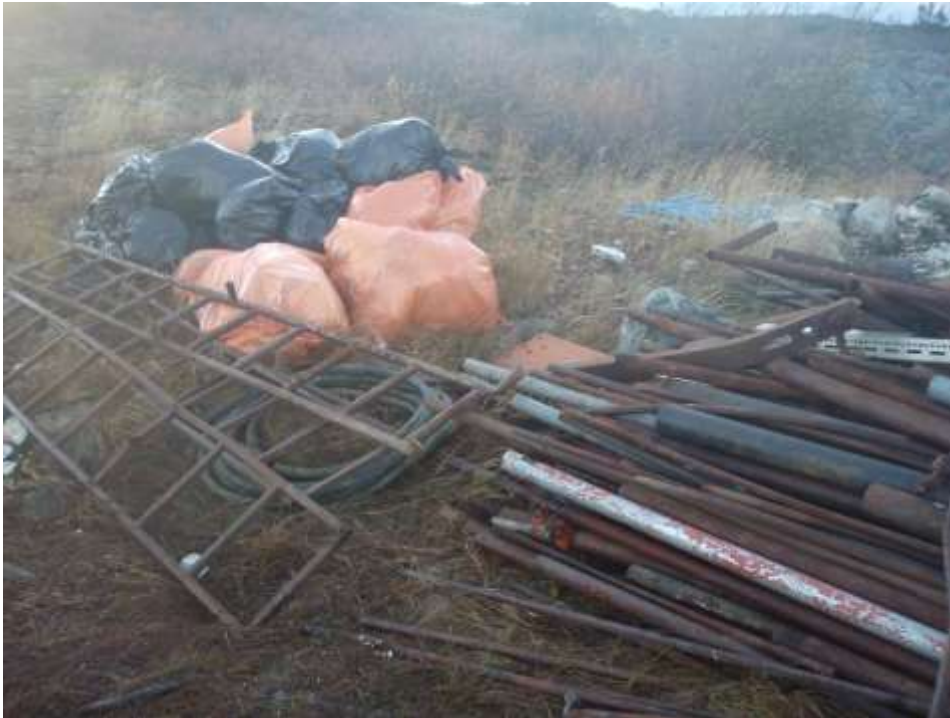
Figure 1: Material loaded on floatplane, September 2012

In collaboration with the Naskapi Nation of Kawawachikamach and the Innu Nation of Matimekush-Lac John, 2 work sessions were carried out in August and September 2012. Nearly all of the remaining scrap metal, found in various piles throughout the site, was removed. Five metal reservoirs were cut up into smaller pieces and removed from the site. Debris in the water and around the newly constructed dock was also collected. A wooden structure located near the water was demolished and burned and the fibreglass reservoir inside was dismantled. The larger wooden structure located on the site was cleaned and will be left as a shelter. Finally, a pipeline (partially covered by a wooden frame) that ran from the lake to an area located near the mine tailings, was cut up into smaller pieces and removed from site. Photographs of the material transported from the site are found in Appendix 2.

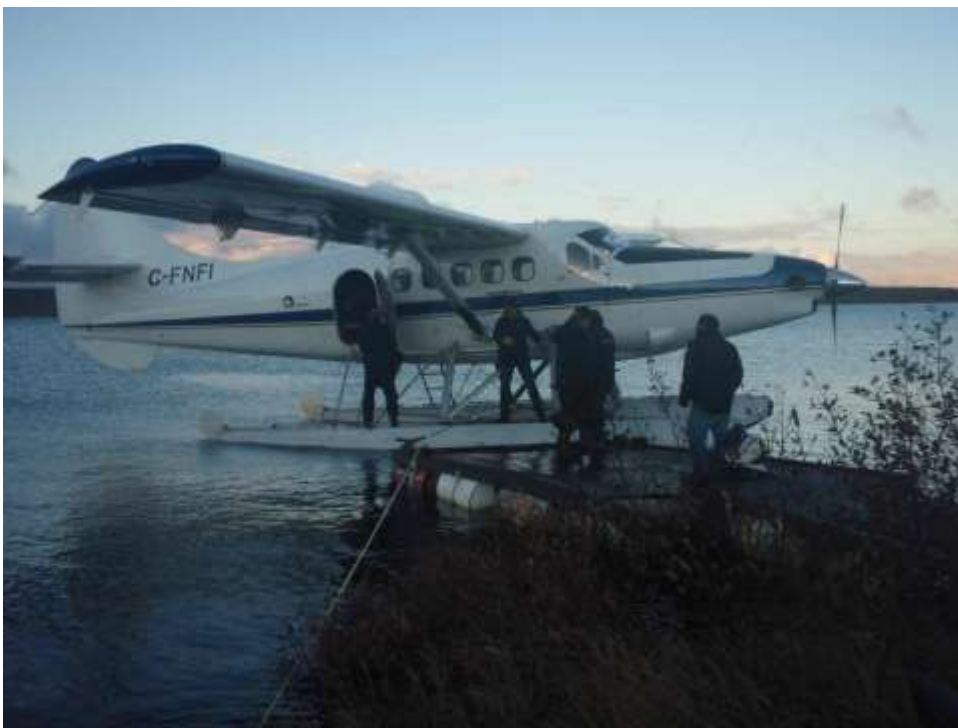
Figure 2: Floatplane being loaded with material, September 2012

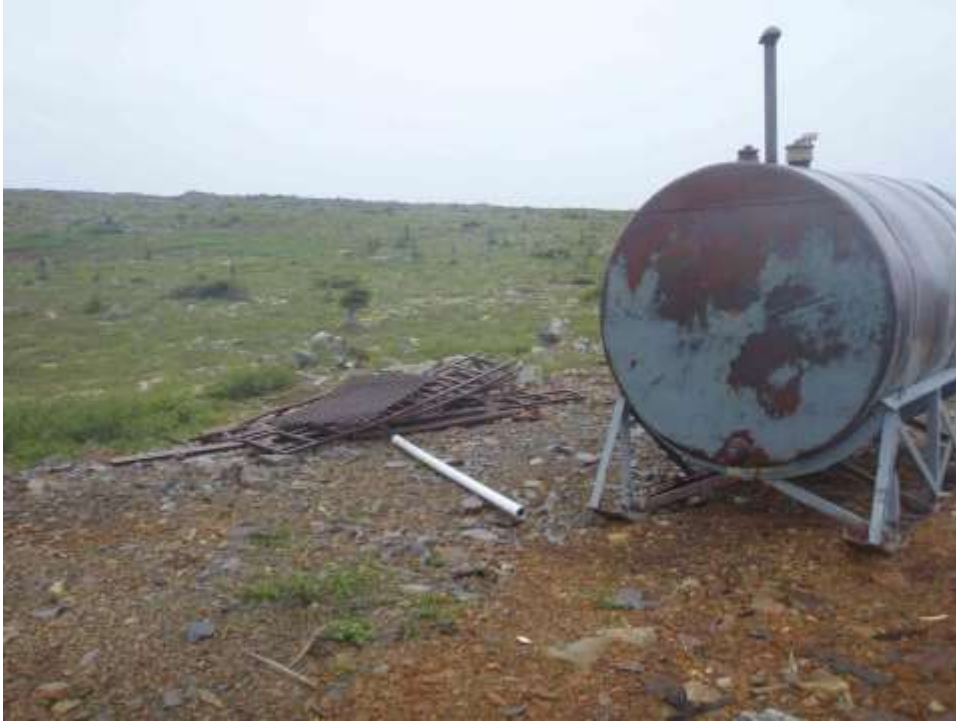
Figure 3: Example of reservoir cut into smaller pieces and transported by floatplane

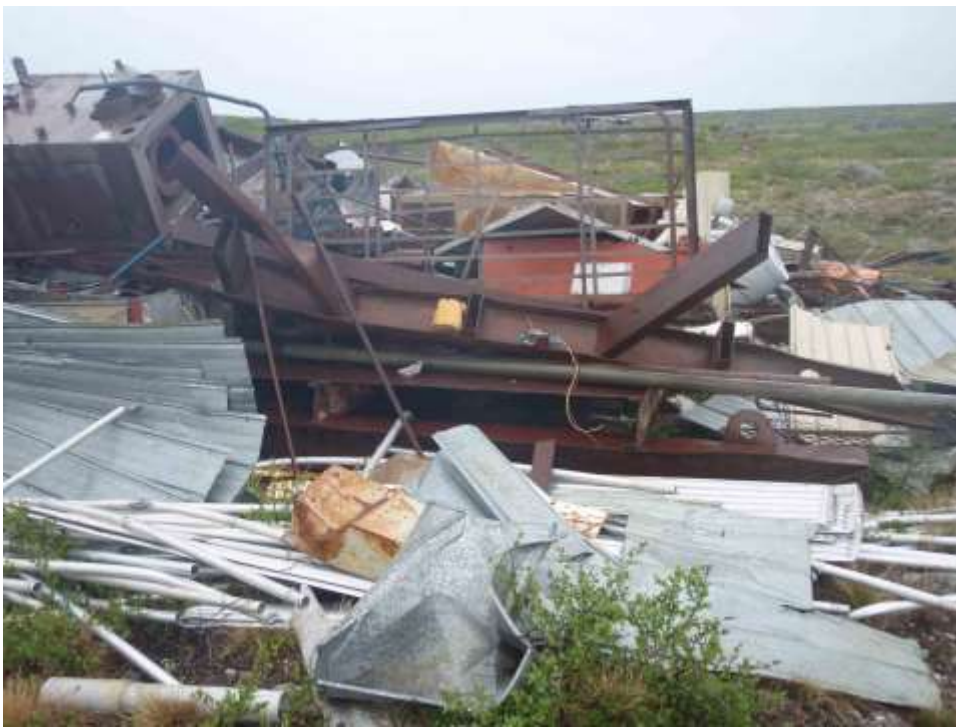
Figure 4: Example of waste transported to Schefferville by floatplane, September 2012

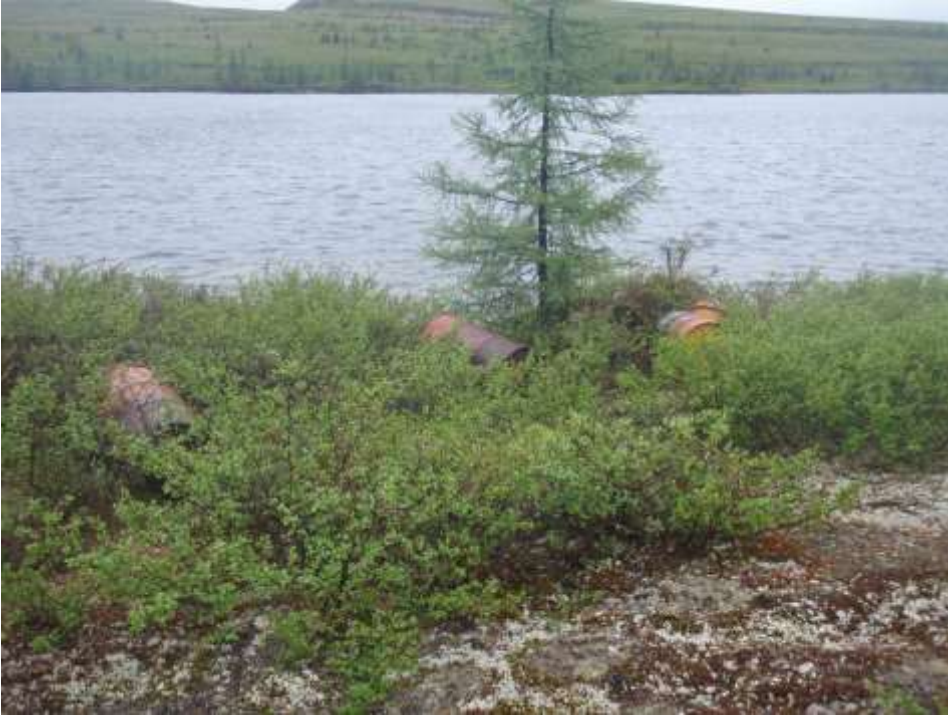
Figure 5: Site VP-11, June 2012

During the 2001-2002 and 2011 inspections, debris of 3 collapsed wooden cabins, 3–4 groups of barrels (all empty) and a small amount of metal debris were found on site. In collaboration with the Northern Village of Kuujuaq, cleanup work took place in June 2012. 12 large and 8 small drum as well as 300 pounds of debris was removed from the site. The wooden debris was left on site. After final inspection in September 2012, the site is now considered as complete.

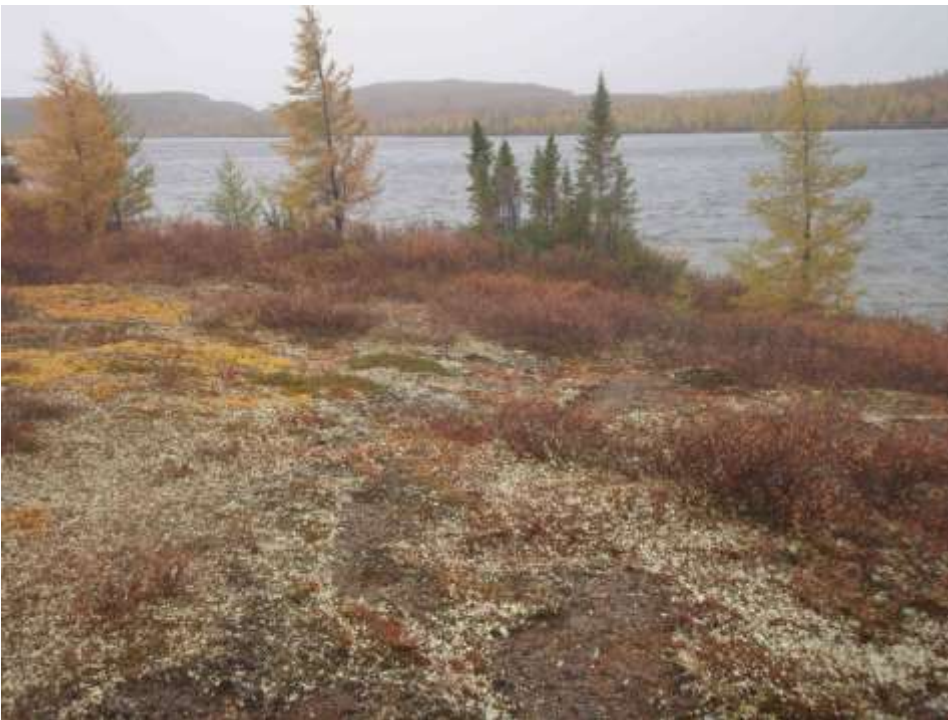
Figure 6: Site VP-11 after cleanup, September 2012

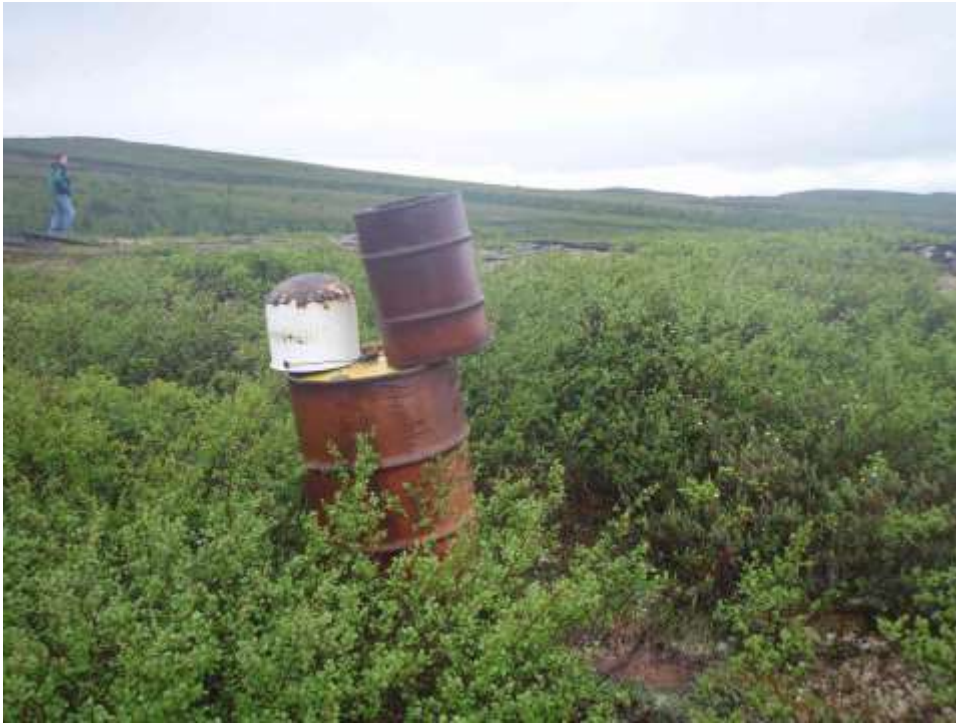
Figure 7: Site VP-11, June 2012

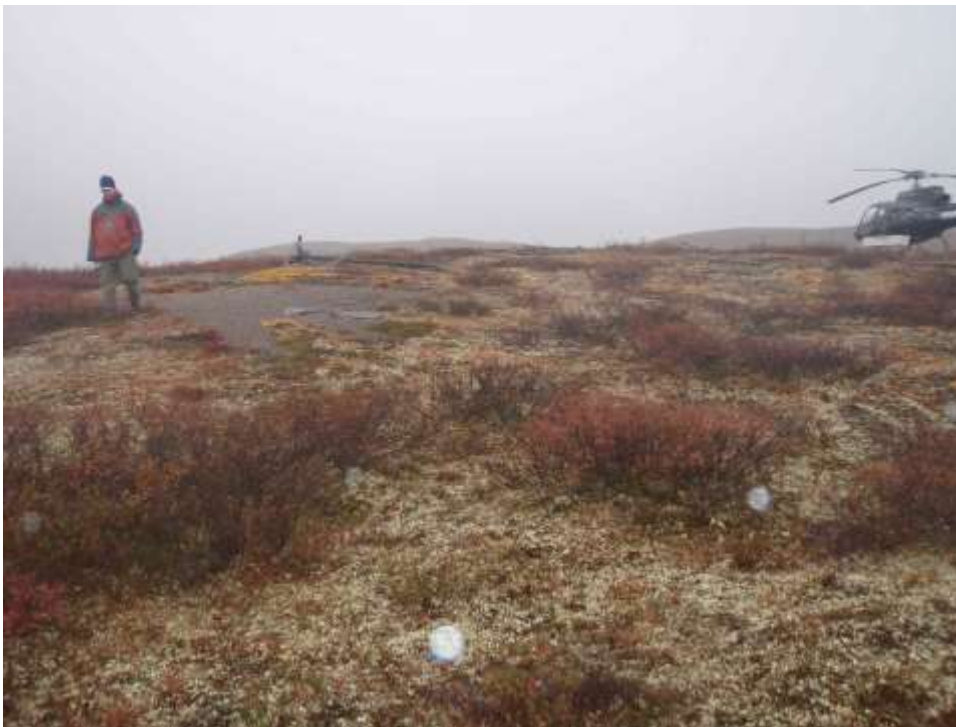
Figure 8: Site VP-11 after cleanup, September 2012

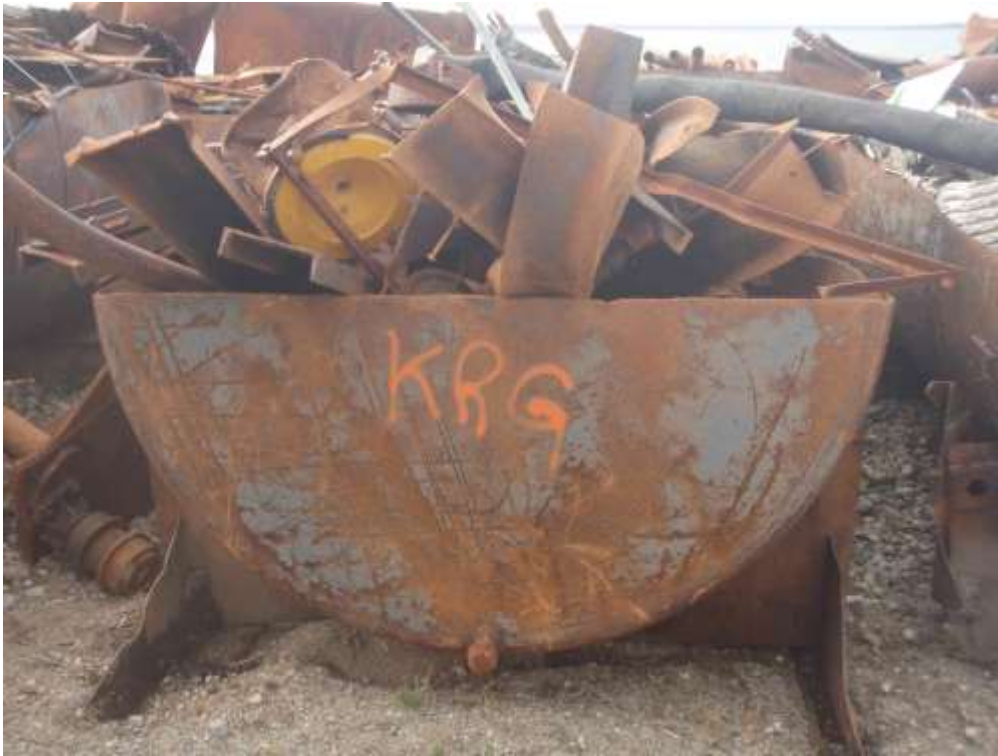
Figure 9: Example of half-reservoir, filled with metal, which was transported by ship in October 2012

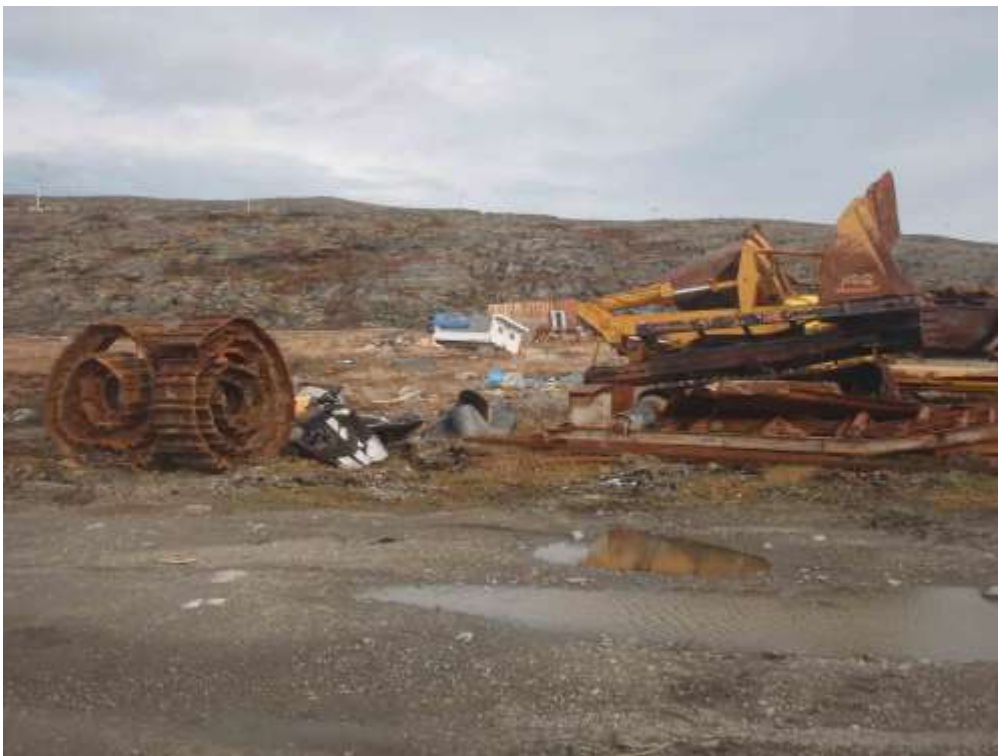
Figure 10: Example of large pieces of metal transported by ship in October 2012

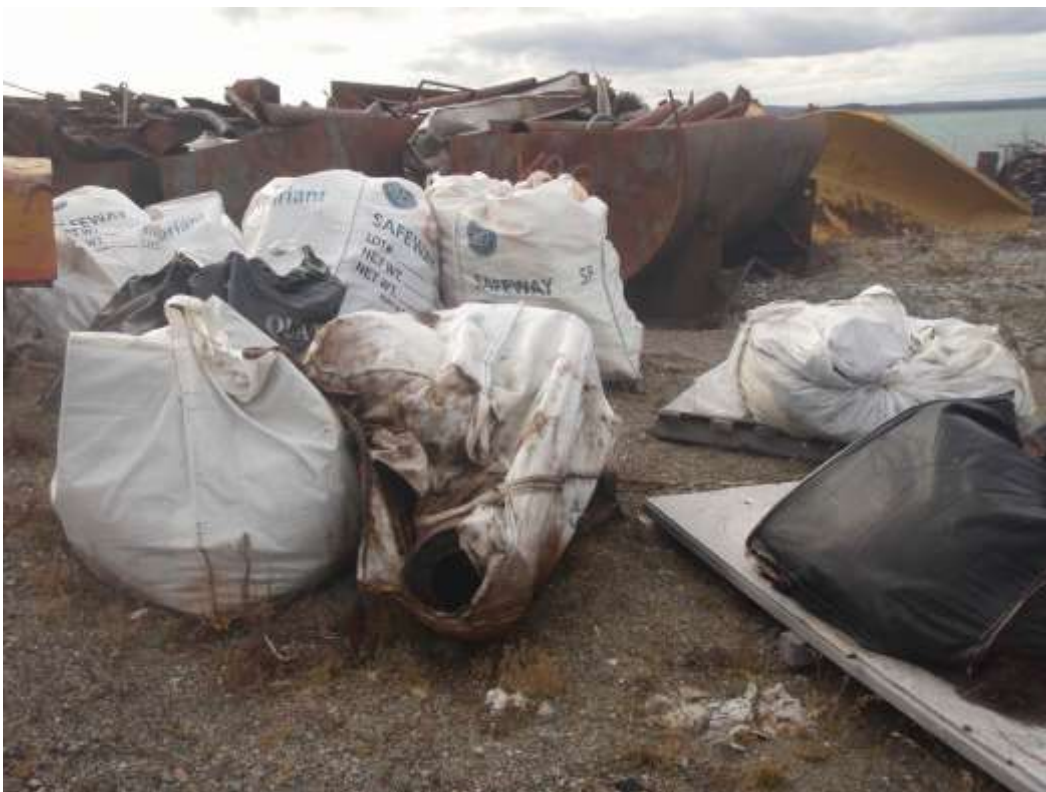
Figure 11: Example of bags of contaminated soil transported by ship in October 2012

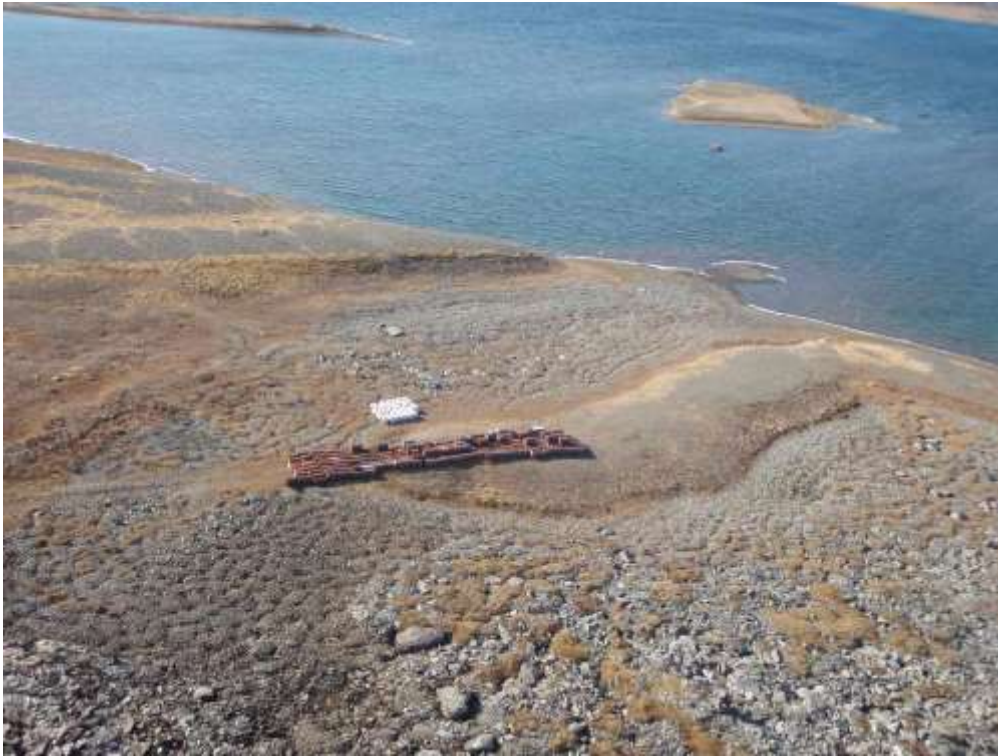
Figure 12: Sector 2 of site SW-34, September 2009

In collaboration with Xstrata Nickel and the Northern Village of Salluit, an 8-day work session was organized for September 2012. However, due to bad weather conditions, the team was only able to complete 2 days of work. Approximately 2,200 pounds of scrap metal was removed from the site by helicopter and slung to a nearby location and stored inside sea containers. These containers will be transported by Xstrata Nickel to their port and shipped south to a metal recycling facility.

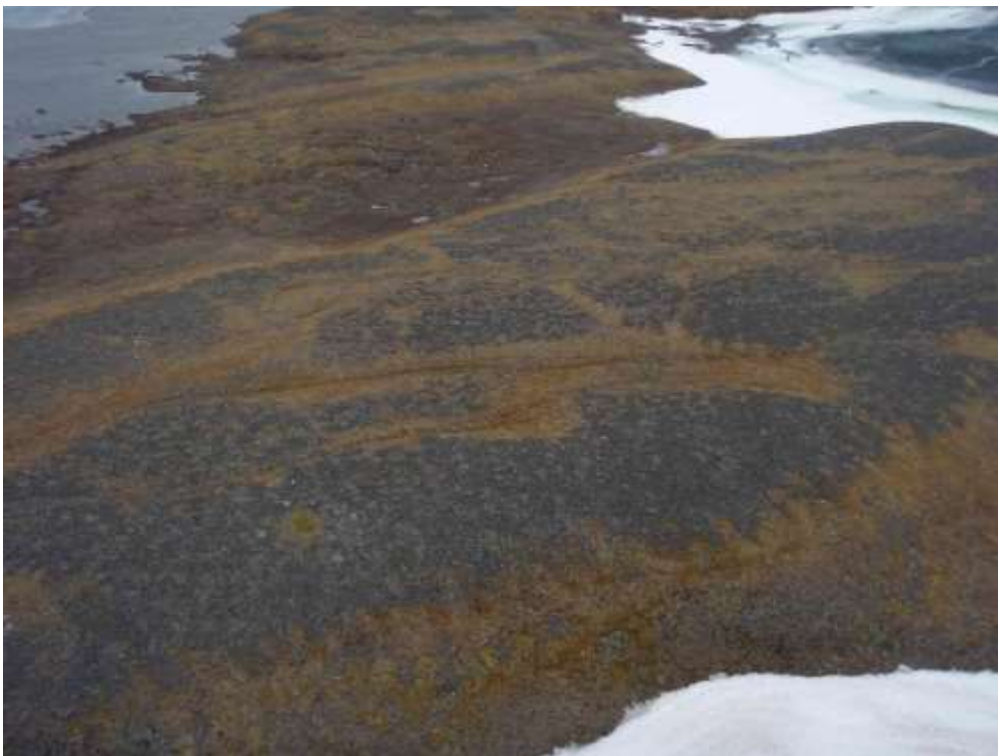
Figure 13: Sector 2 of site SW-34, after cleanup, September 2012

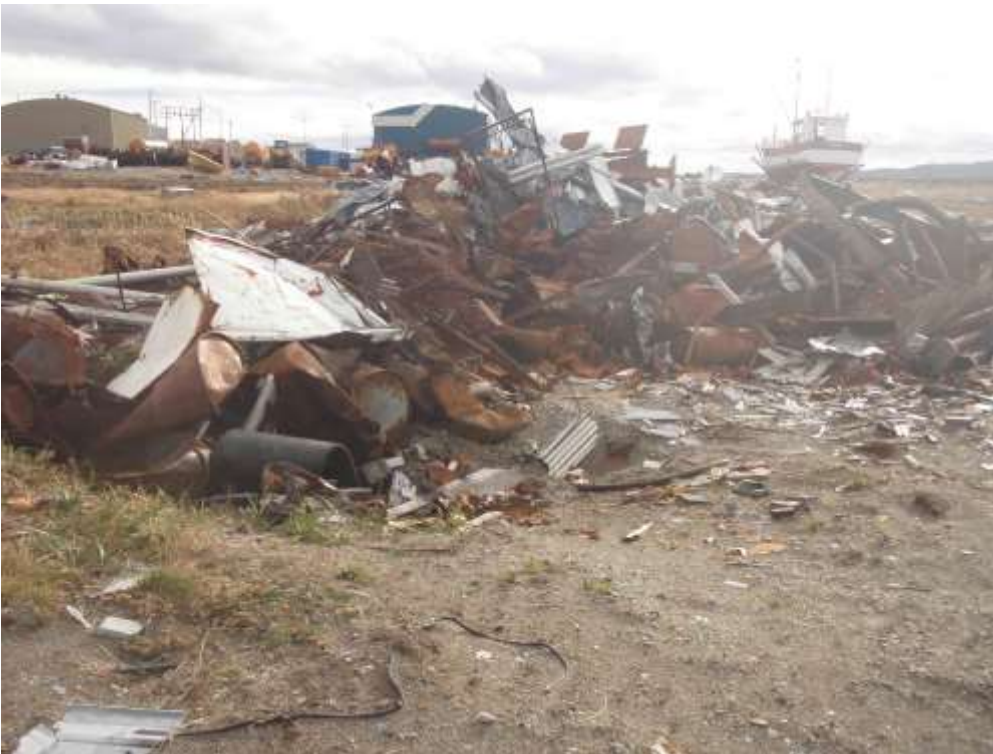
Figure 13: Example of smaller pieces of metal debris remaining in the community of Aupaluk, September 2012

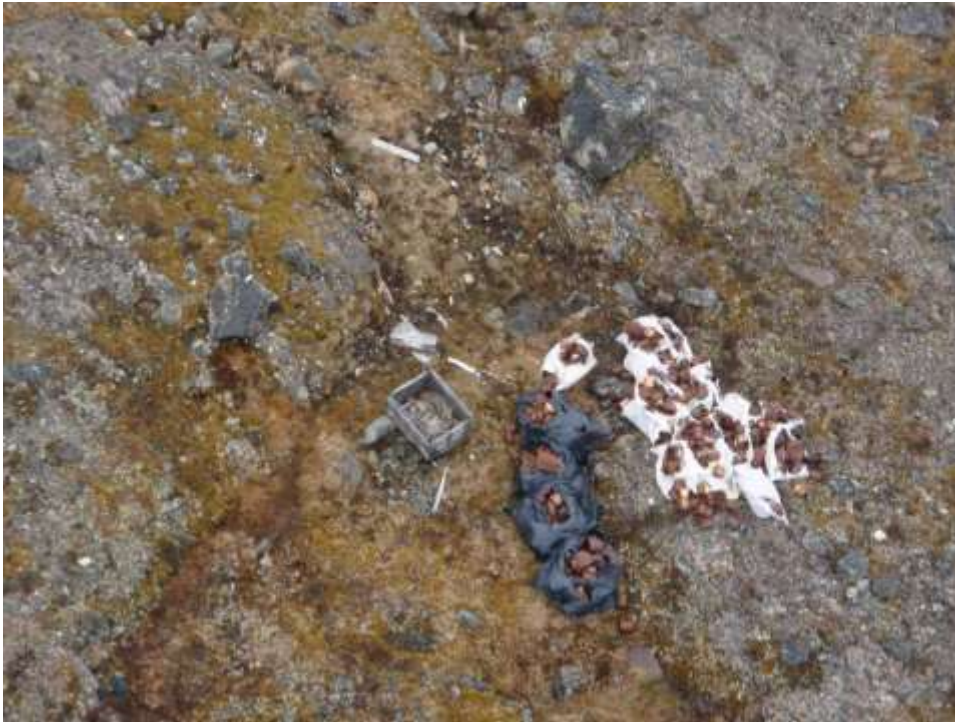
In September 2012, an inspection of site SW-34, classified as requiring major cleanup work, found approximately 15 dumpsites containing rusty cans and metal debris spread out around the site.

Figure 14: Example of waste remaining at site SW-34, September 2012

In 2013, the KRG will need to assemble a team of workers from the communities of Salluit and Kangiqsujaq to undertake several days of work in order to complete the site's rehabilitation. With the assistance of a helicopter, the work team will move the debris from the site to the shipping containers located nearby. Photographs of the dumpsites and the material remaining at the site are found in Appendix 3.

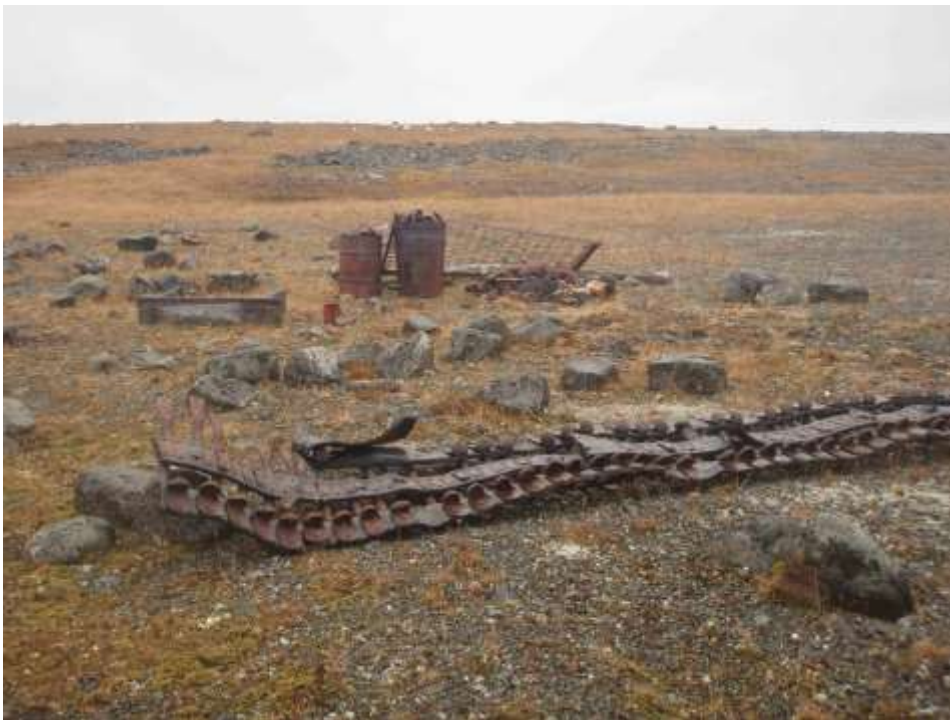
Figure 15: Example of metal debris remaining at site SW-34, September 2012

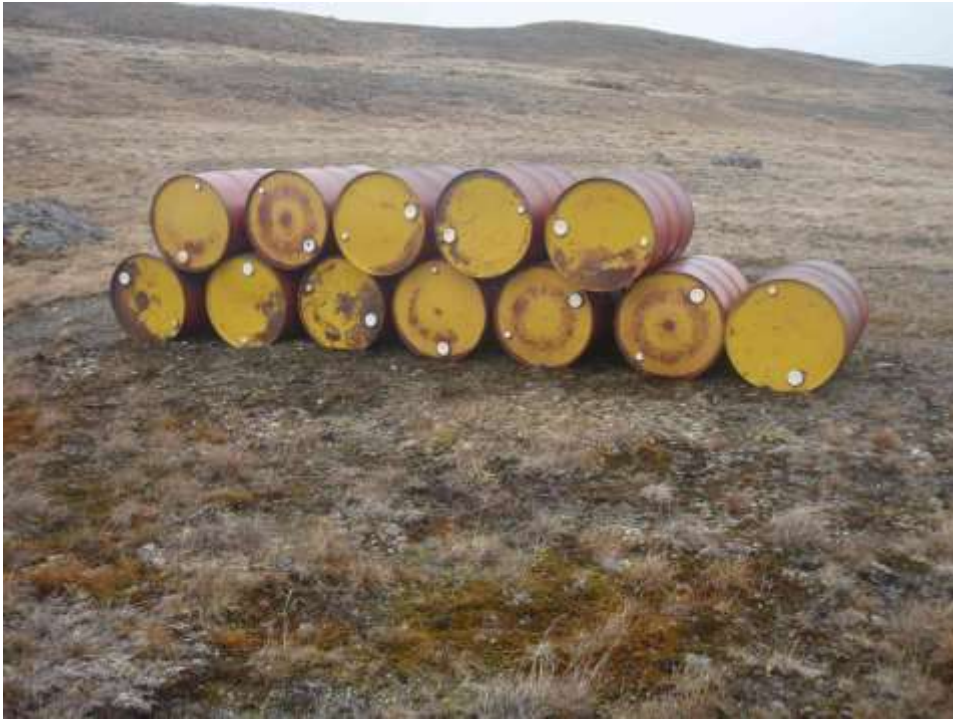
An follow-up inspection was undertaken in June 2012. The site possesses 10 buildings and three small wooden cabins. The condition of the facilities has deteriorated since the original inventory. The site contains a large quantity of non-hazardous waste, such as bed frames, rotten mattresses, a stove-oven, a washing machine, refrigerators etc. Hazardous waste is nonetheless present on site and includes paint, motor oil, propane tanks, fire extinguishers, oil filters and a battery. Several thousand rock/core samples are still housed in a wooden structure on the site. There are approximately 20 barrels stacked close to the buildings, about half of which contain hydrocarbon residue. The soil contamination observed in 2001 underneath two barrels is still present. As well, within a one-kilometre radius of the camp, two groups of drums were observed. The first group, to the west of the site contain approximately 30 full and 10 empty barrels. The second group, located on a hill next to the site contains 18 empty drums. Photographs of the debris and buildings present at the site in 2012 are found in Appendix 3.

Figure 16: One group of barrels found at site WB-9, June 2012-11-02

In 2013 the goal will be to empty the nine wooden structures of metal and non-hazardous waste, and to burn the combustible material on site. Hazardous material will be transported by helicopter to a nearby container (used for site SW-34) and then shipped to a recycling facility in the south.

If time permits, barrels and other non-hazardous debris will be transported by helicopter to a nearby container. Otherwise, this step will be completed in 2014.

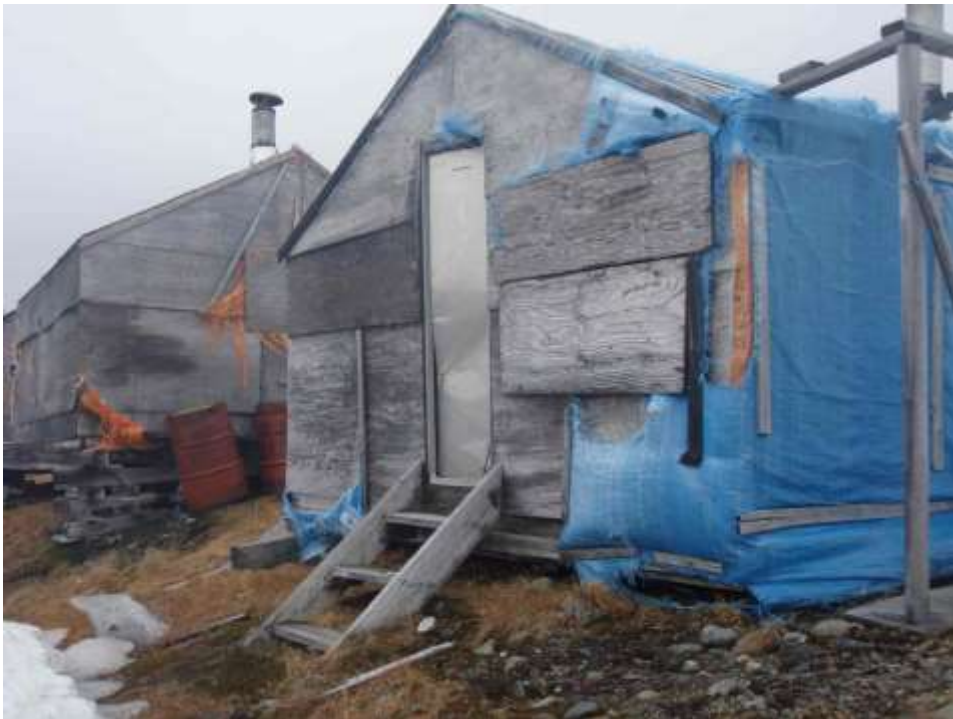
Figure 17: Two of thirteen buildings found on site WB-9, June 2012

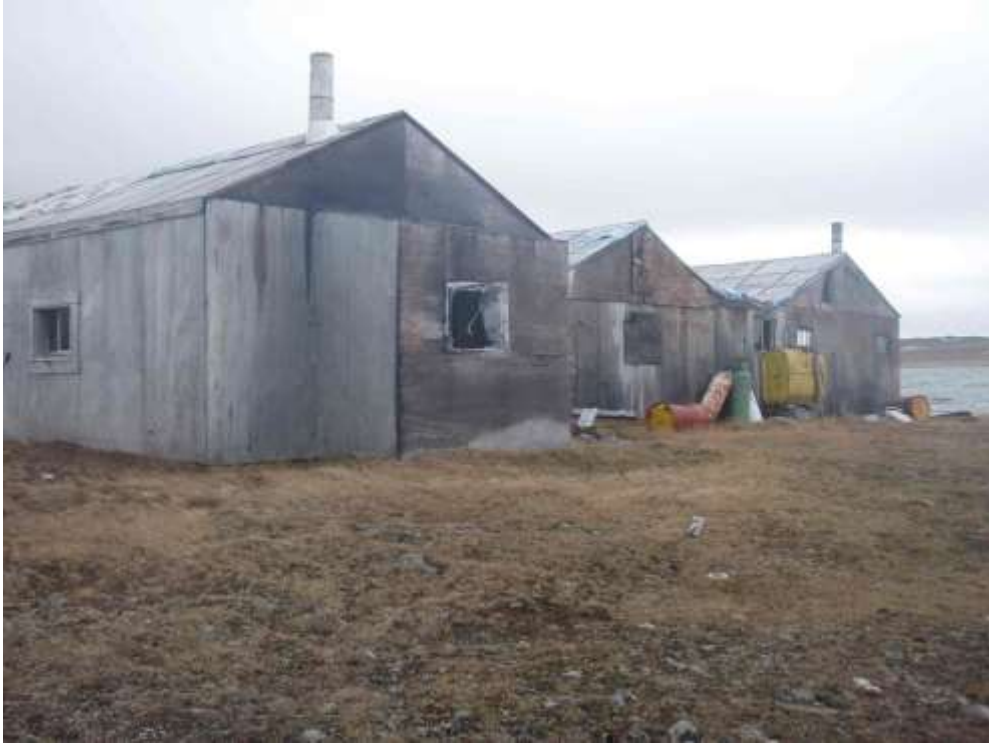
Figure 18: Example of wooden structures and debris found on site WB-9, June 2012

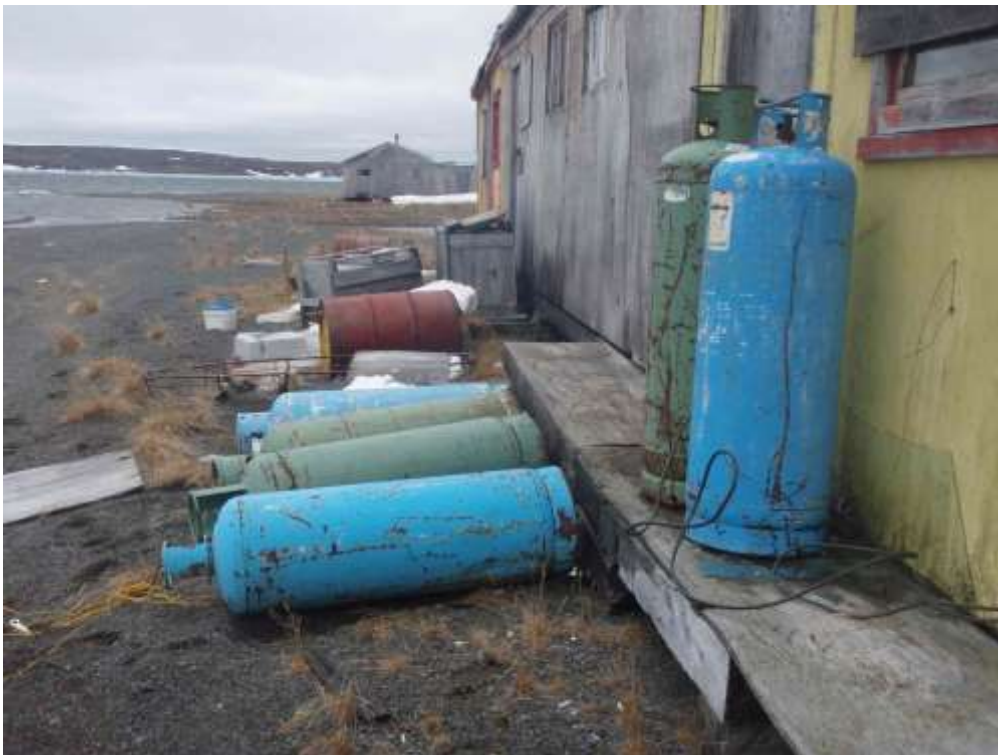
Figure 19: Propane tanks found at site WB-9, June 2012

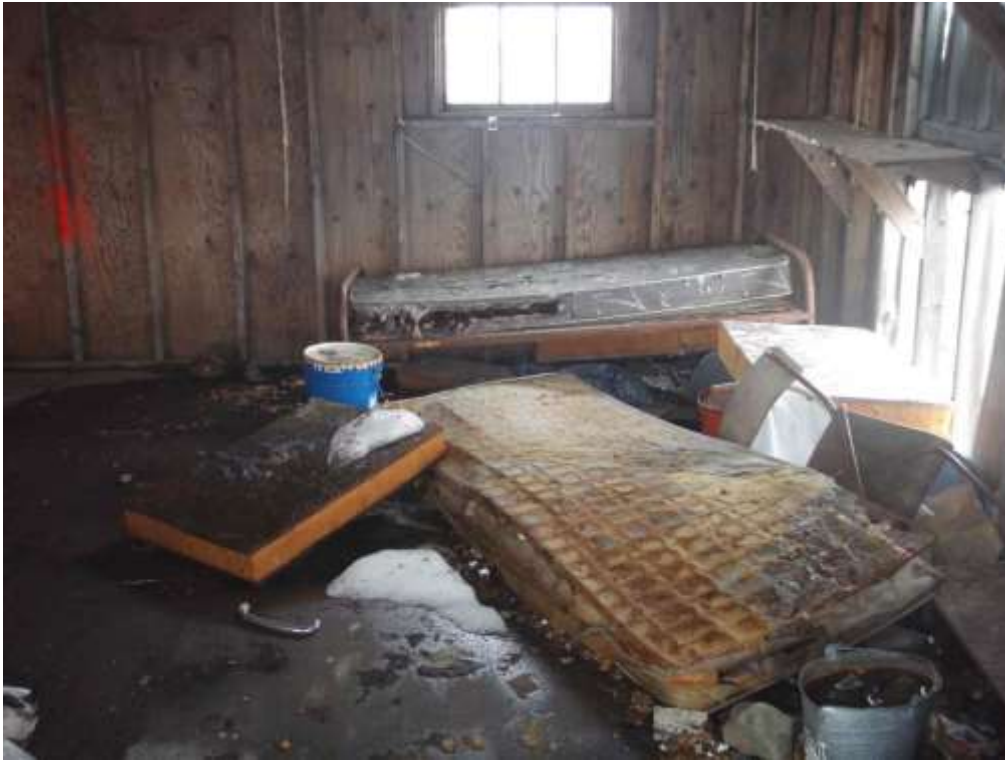
Figure 20: General debris and waste found inside buildings on site WB-9, June 2012

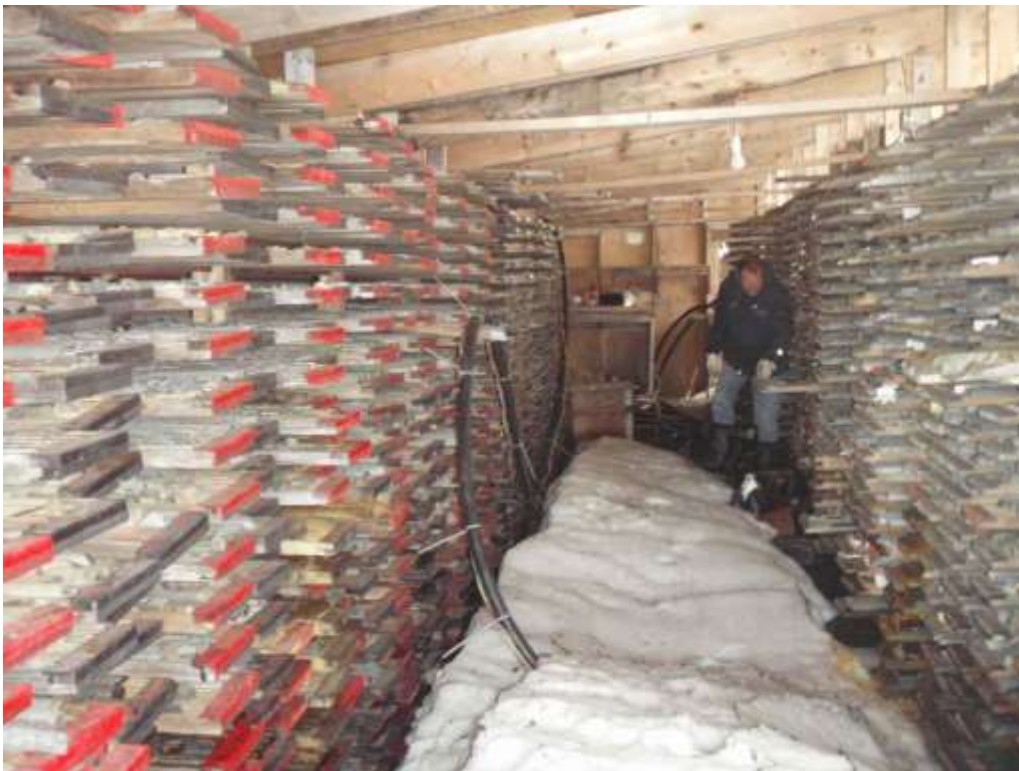
Figure 21: Core sample from previous mining exploration activities found at site WB-9, June 2012

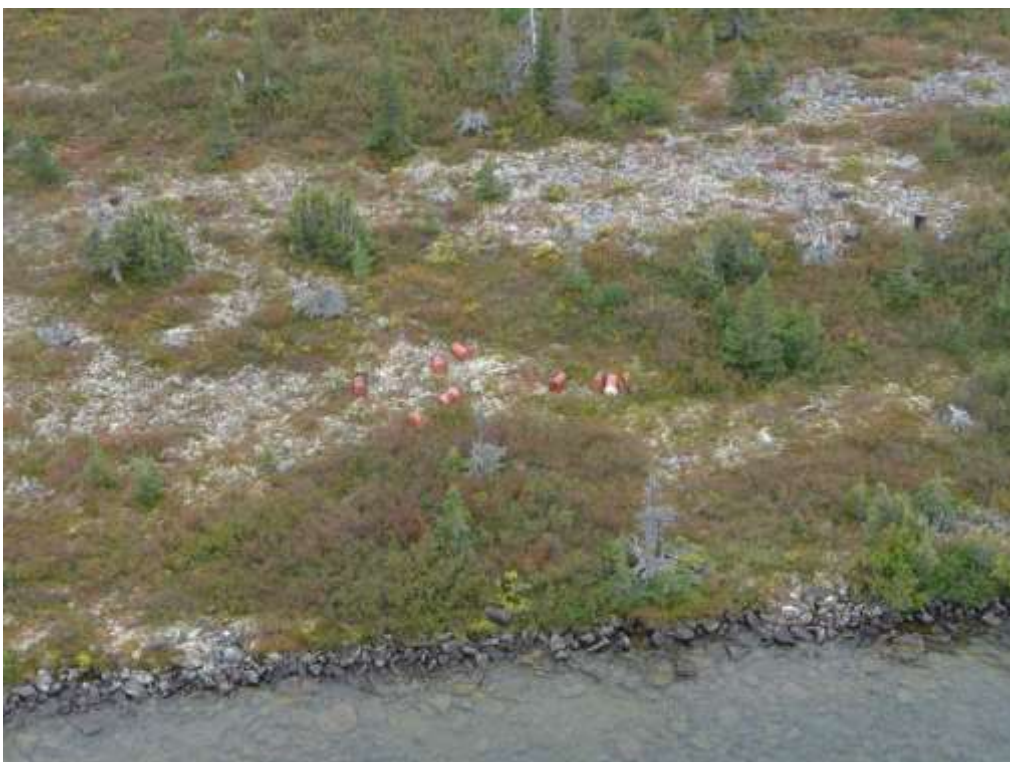
Figure 23: Photo of barrels found near shore at site KAW-36, September 2011

All non-toxic combustible material can be burned on location at all three sites. Photographs of these 3 sites can be found in Appendix 3.

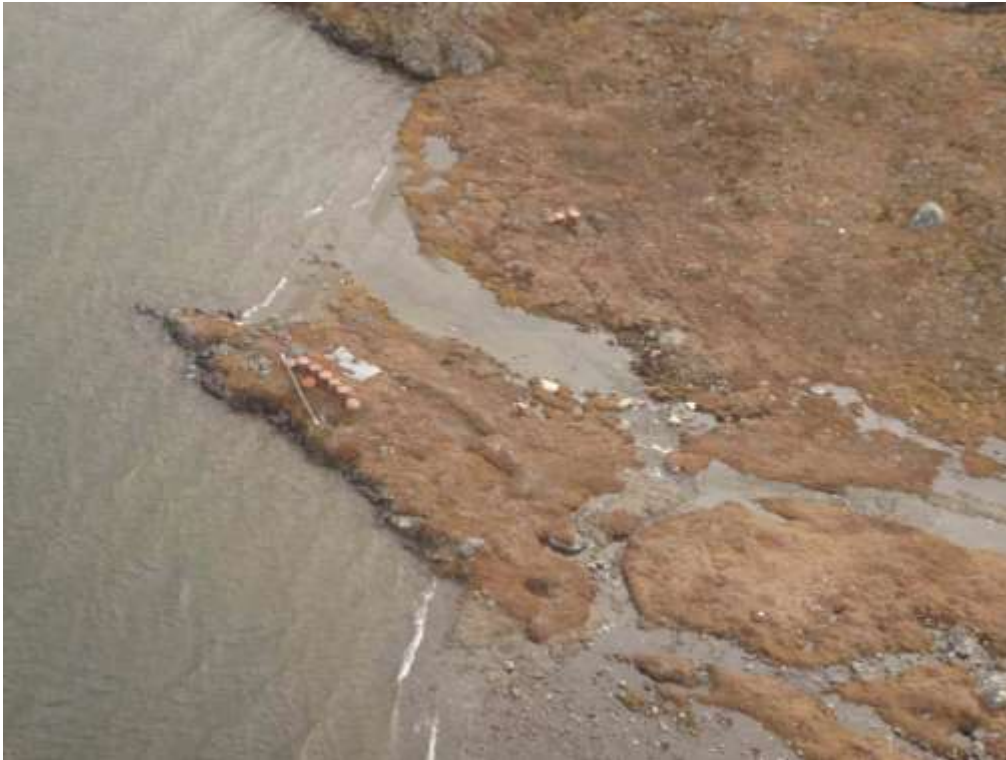
Figure 26: Sector 2 of site KV-1 containing crushed drum and wood, September 2012

Work will consist of gathering barrels and other debris to be removed from the site by helicopter. The combustible material can be burned on location. The site was inspected in September 2012 and photographs are found in Appendix 3.

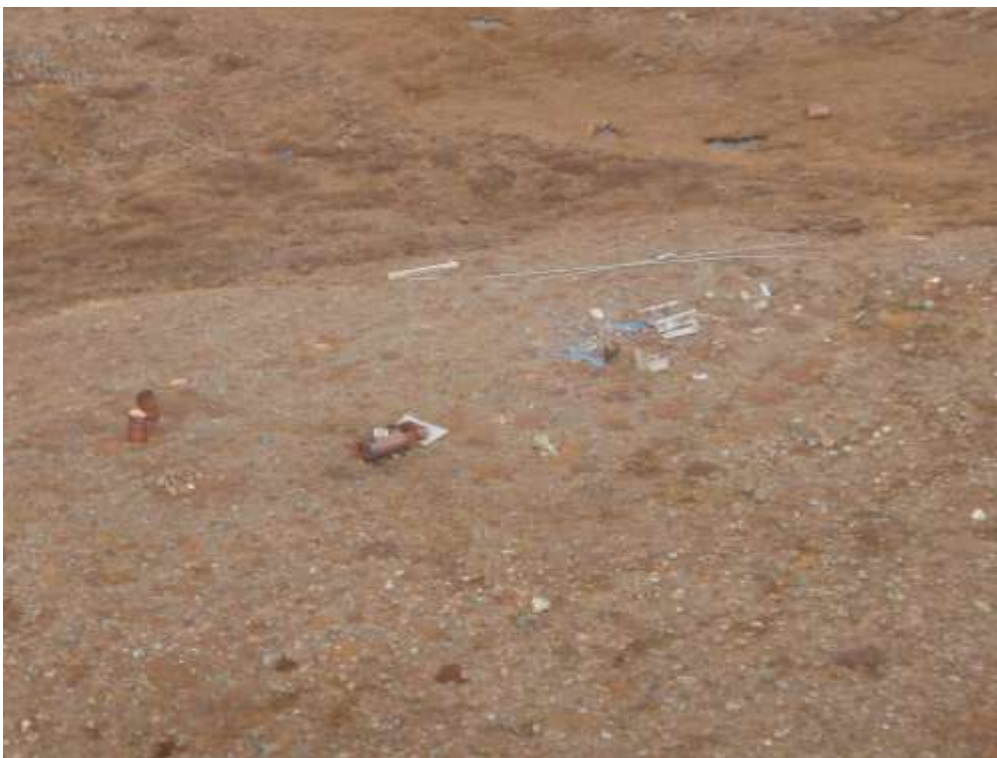
Figure 27: Sector 1 of site KV-1 containing various debris and wood, September 2012

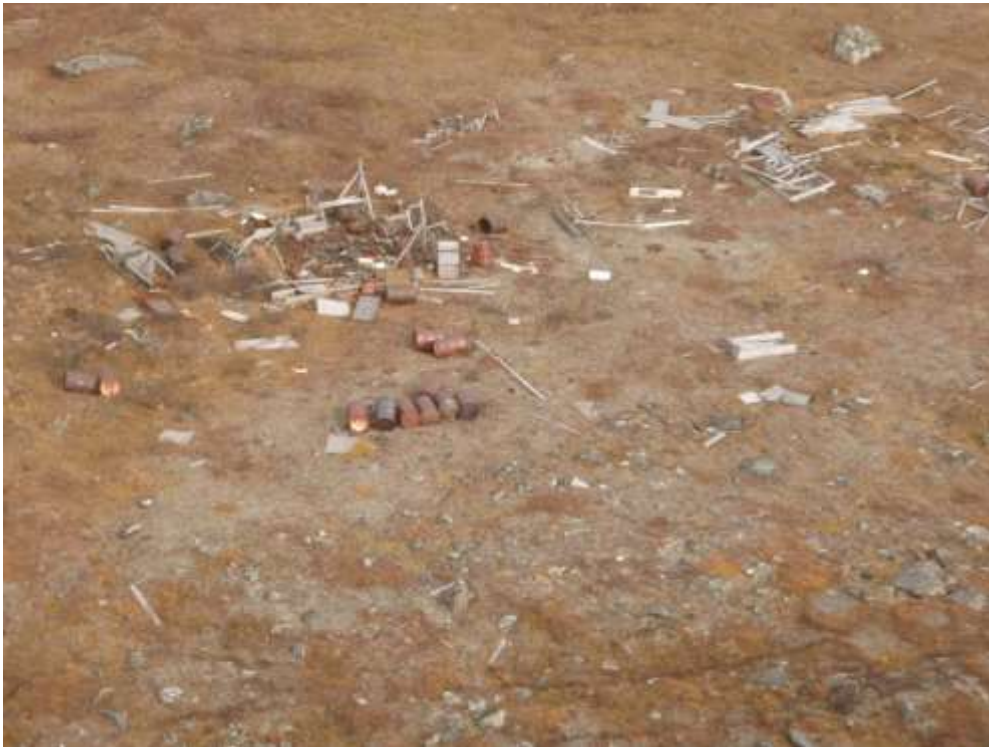
Of all the abandoned mineral exploration sites still requiring clean-up, site SW-27 contains the greatest quantities of residual material and hydrocarbons residue: roughly 1650 L of diesel, 260 L of grease and 26 L of oil. Although covering only 2.5 m<sup>2</sup>, hydrocarbon soil contamination is still very evident. Open or damaged barrels of grease were also observed. The site was inspected in September 2012 and photographs are found in Appendix 3.

Figure 28: Sector 1 of site SW-27, containing wood debris, barrels, propane tanks and hazardous waste, September 2012

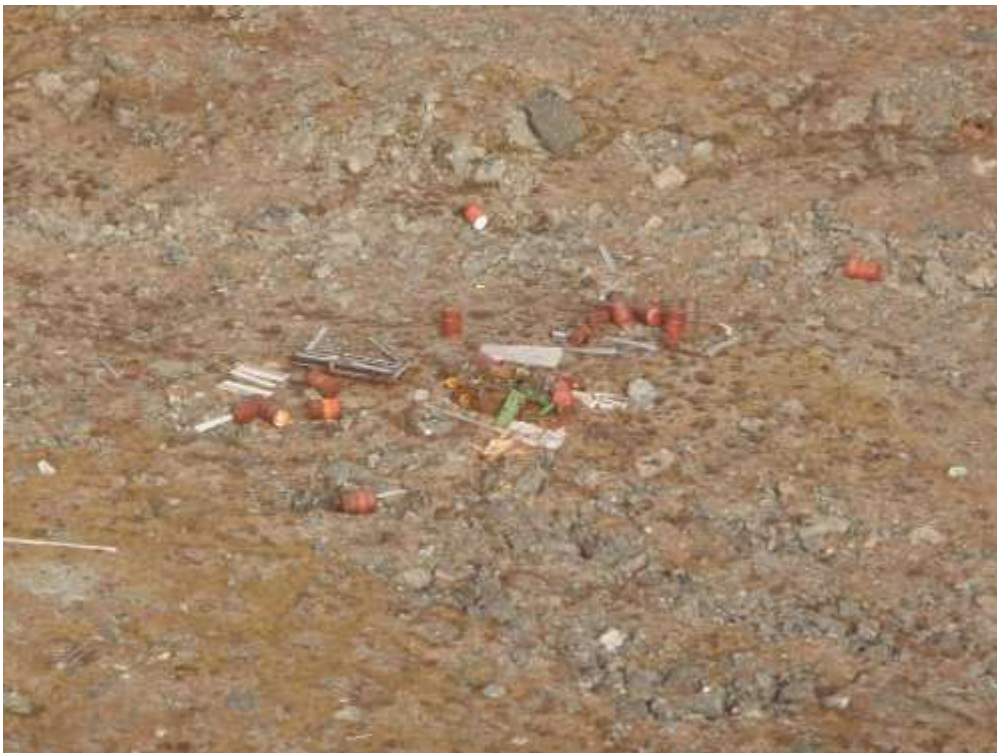
Figure 29: Sector 2 of site SW-27, containing barrels, muskeg, trailer, debris and hazardous waste, September 2012

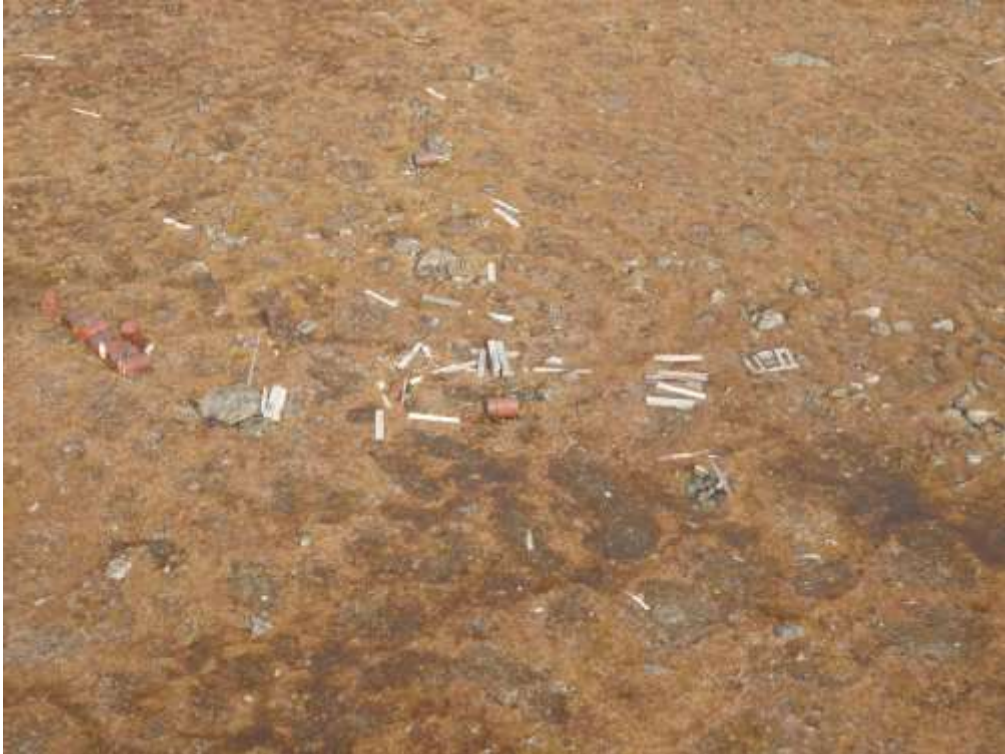
Figure 30: Sector 3 of site SW-27, containing barrels, wood and debris, September 2012
