# **NUNAVIK ABANDONED MINERAL EXPLORATION SITES REHABILITATION PROJECT**

## **2012-2013 ACTIVITY REPORT**

**Kativik Regional Government**

**March 2013**

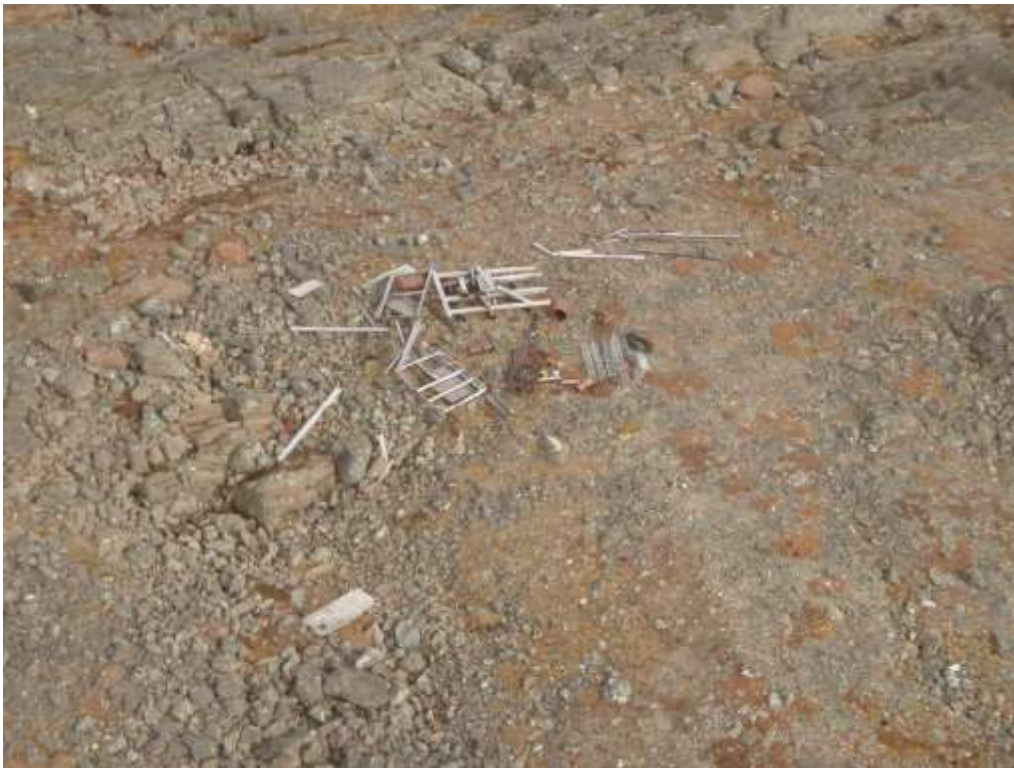
Of all the abandoned mineral exploration sites still requiring clean-up, site SW-27 contains the greatest quantities of residual material and hydrocarbons residue: roughly 1650 L of diesel, 260 L of grease and 26 L of oil. Although covering only 2.5 m<sup>2</sup>, hydrocarbon soil contamination is still very evident. Open or damaged barrels of grease were also observed. The site was inspected in September 2012 and photographs are found in Appendix 3.

Figure 31: Sector 4 of site SW-27, containing barrels, debris and hazardous waste, September 2012

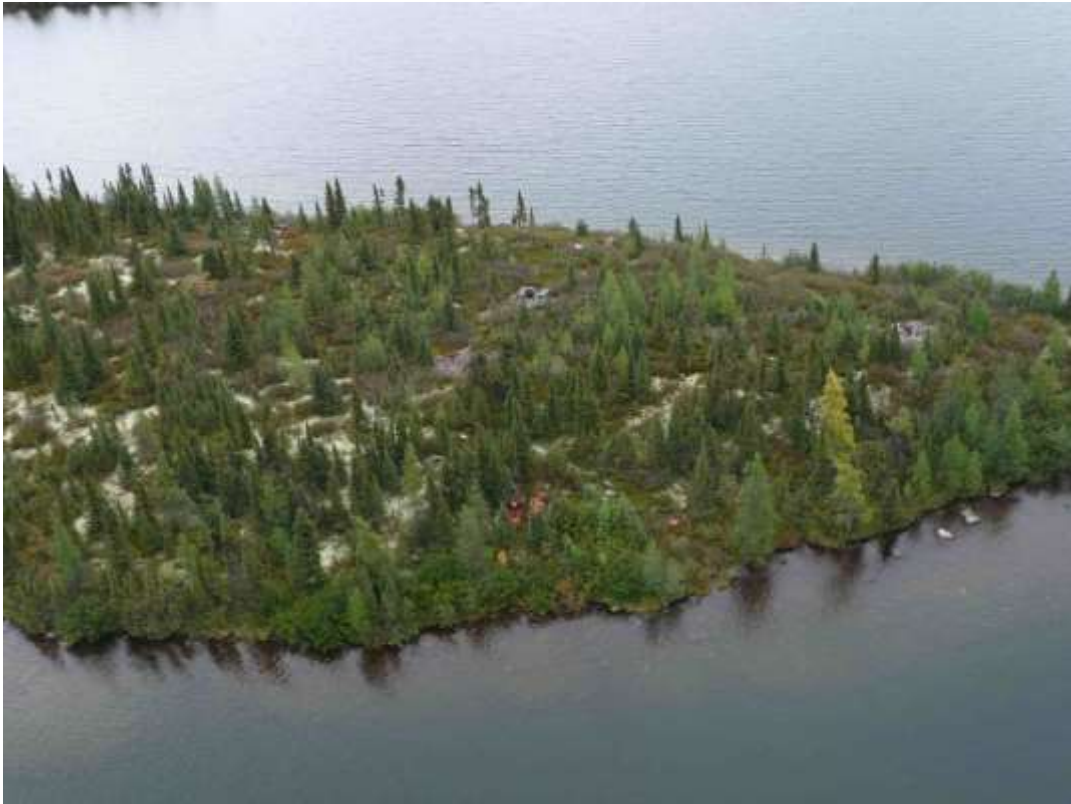
Figure 32: Site P-24F, containing barrels, debris, September 2012

In 2013, KRG will need to mobilize a team of workers from the nearby community of Kuujuaq to undertake a cleanup at site P-24F. During 2011 inspections, it was noted that this site was located on an island on which the trees and shrubs had grown considerably since the last inspection in 2001. The team will have to ensure the site is safe for a helicopter to land and may need to prepare a land area.
